# Harness Structural test Report - EN

Inspection certificate number: PH\_461.2024

Name: **Konvers 3**  
 Type: **ABS**  
 Size: **L**  
 Serial number: **CKONVERS3LV311E**  
 Impact pad type: <sup>(1)</sup> **Airbag**  
 Clip-in weight [kg]: **120**

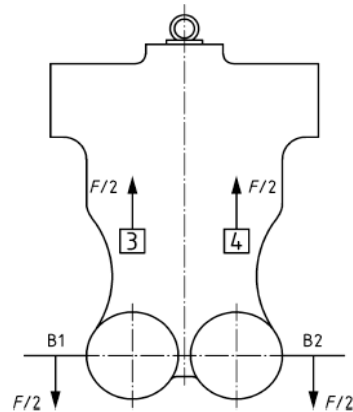
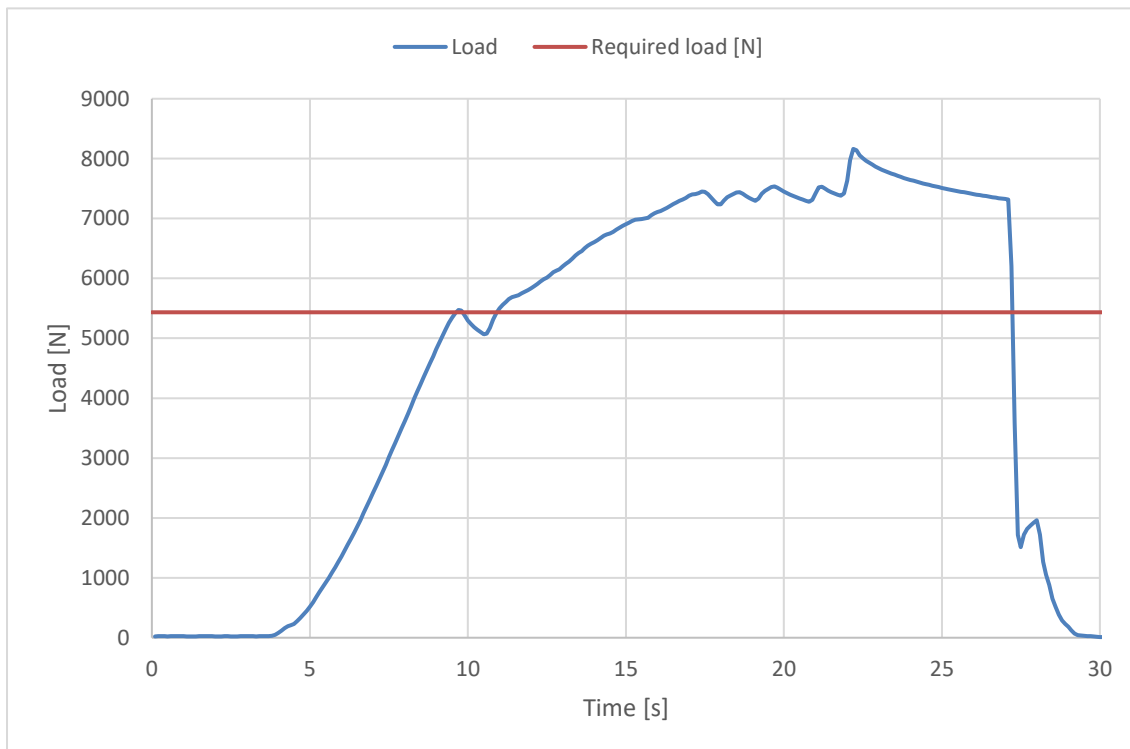
Test ID 01

Test duration [s] **16.3**  
Any signs of structural failure **No**  
Slippery test OK **Yes**  
Test results **POSITIVE**

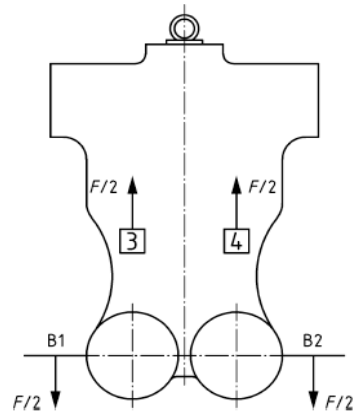
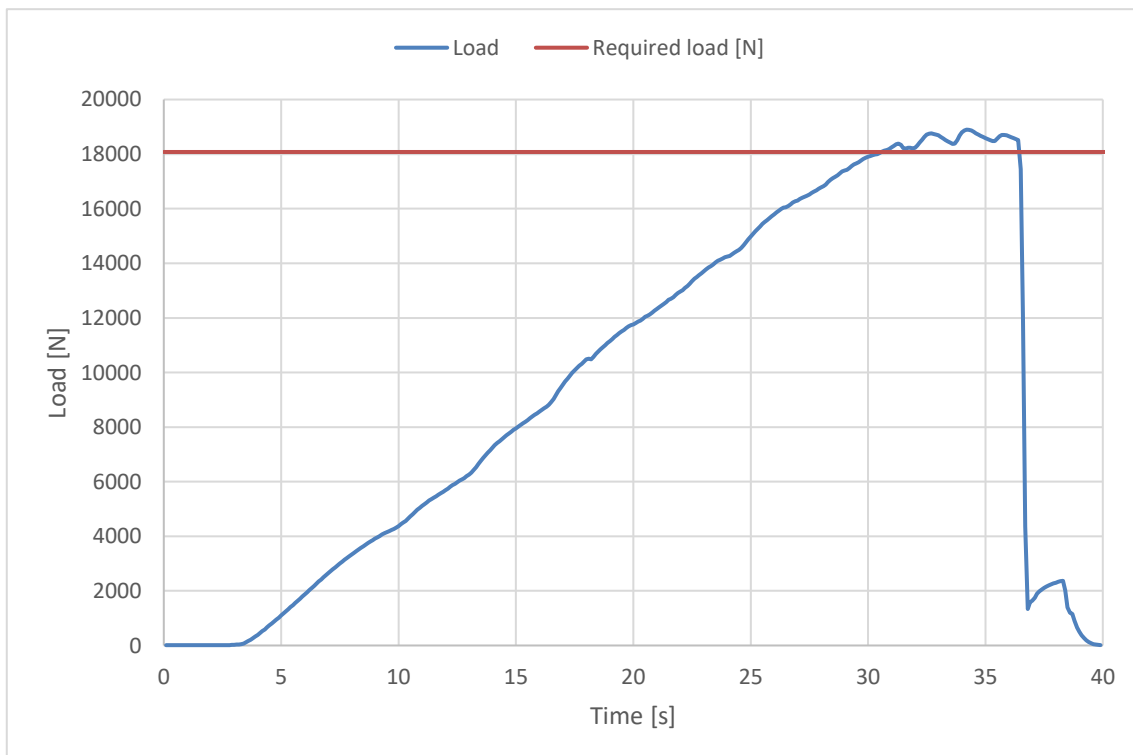
Test ID 03

Test duration [s] **5.9**  
Any signs of structural failure **No**  
Slippery test OK **Yes**  
Test results **POSITIVE**

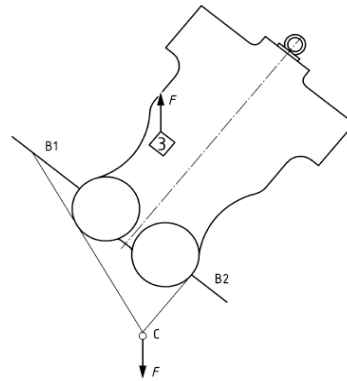
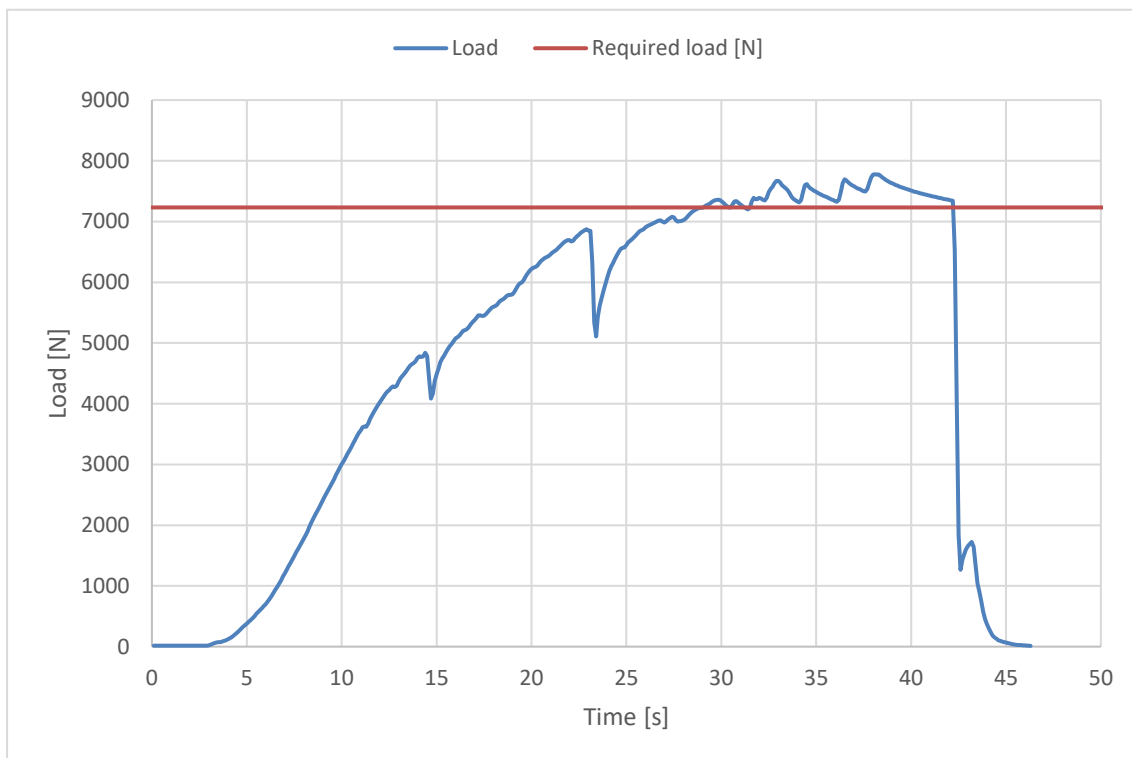
Test ID 05

Test duration [s] **10.7**  
Any signs of structural failure **No**  
Test results **POSITIVE**

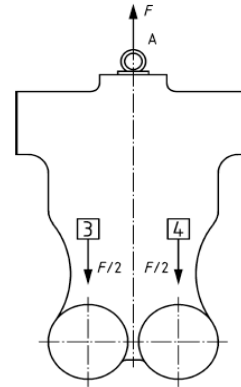
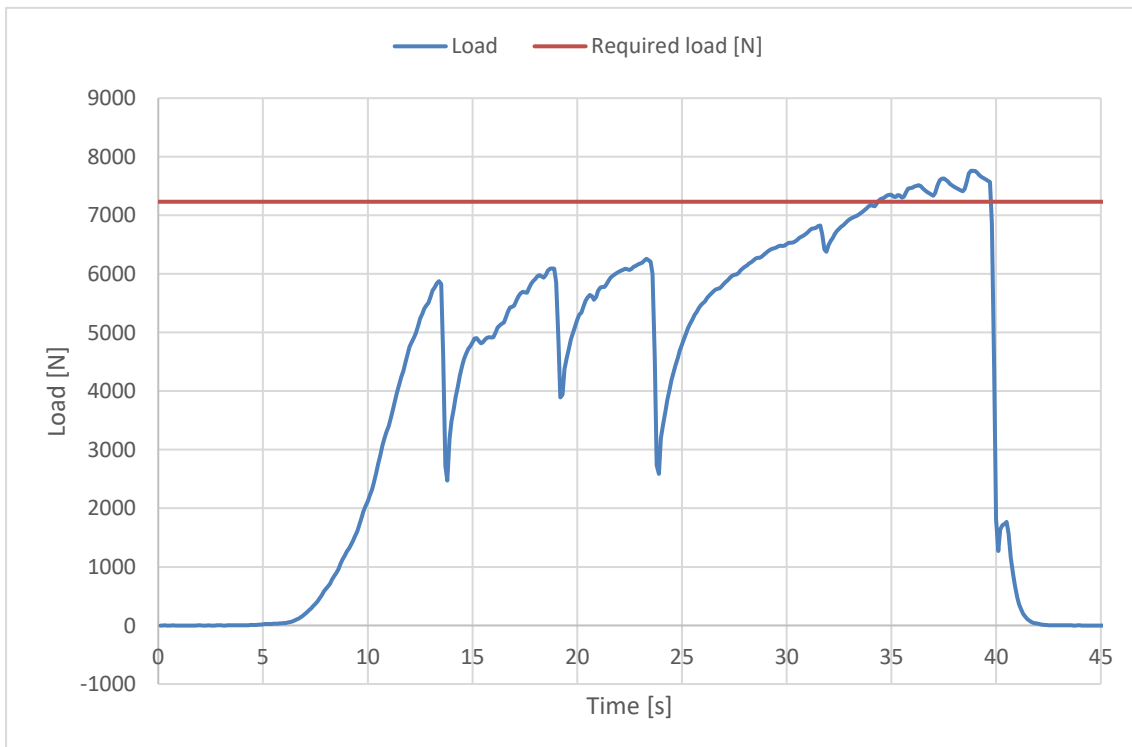
Test ID 06

Test duration [s] **5.4**  
Any signs of structural failure **No**  
Test results **POSITIVE**

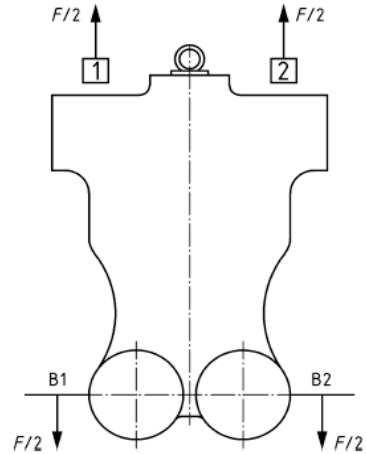
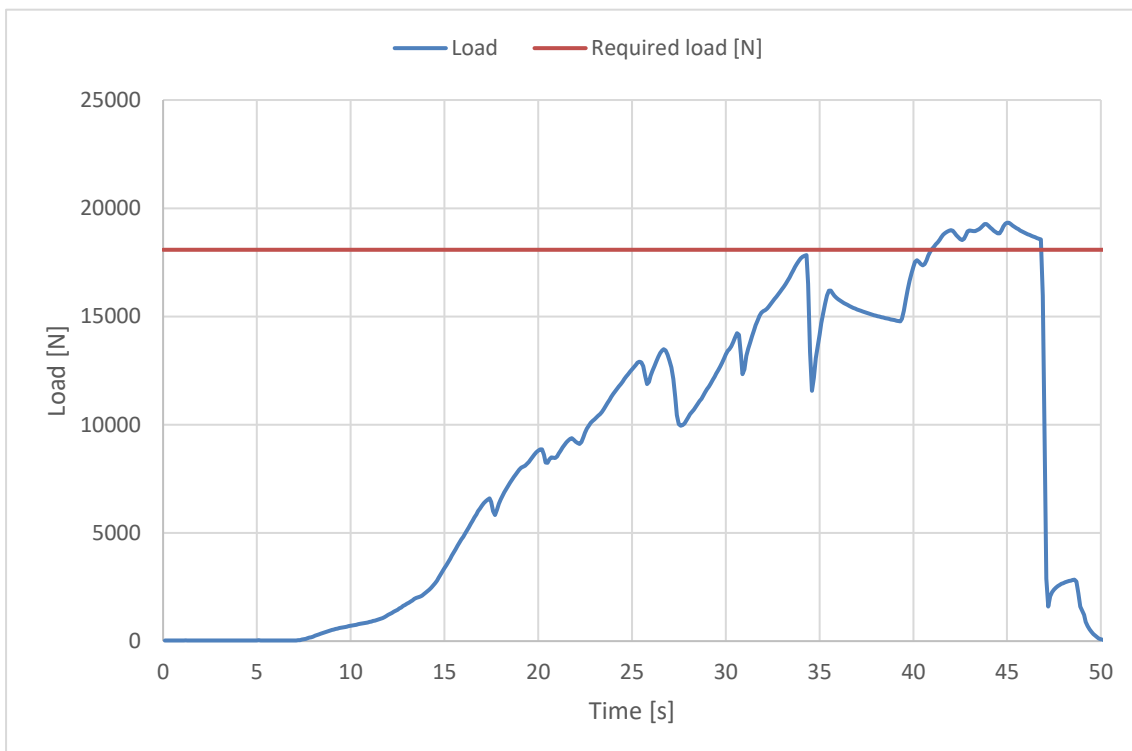
Test ID 09

Test duration [s] **5.9**  
Any signs of structural failure **No**  
Slippery test OK **Yes**  
Test results **POSITIVE**

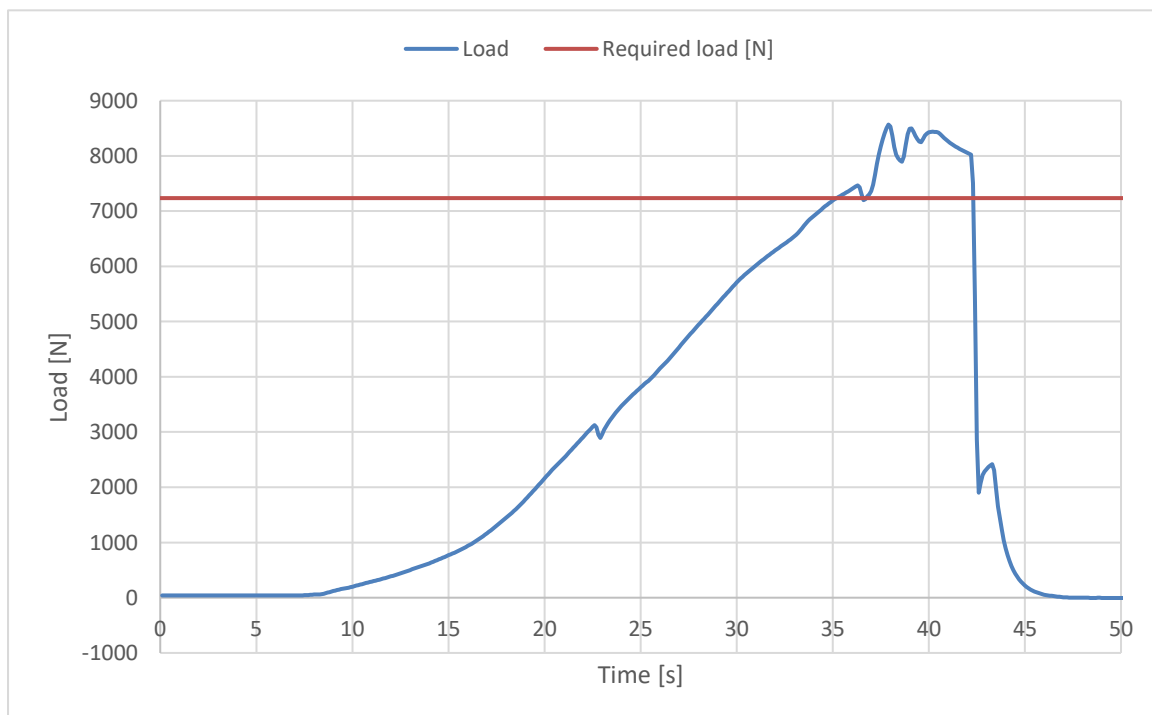
Test ID 12

Test duration [s] **5.6**  
Any signs of structural failure **No**  
Slippery test OK **Yes**  
Test results **POSITIVE**

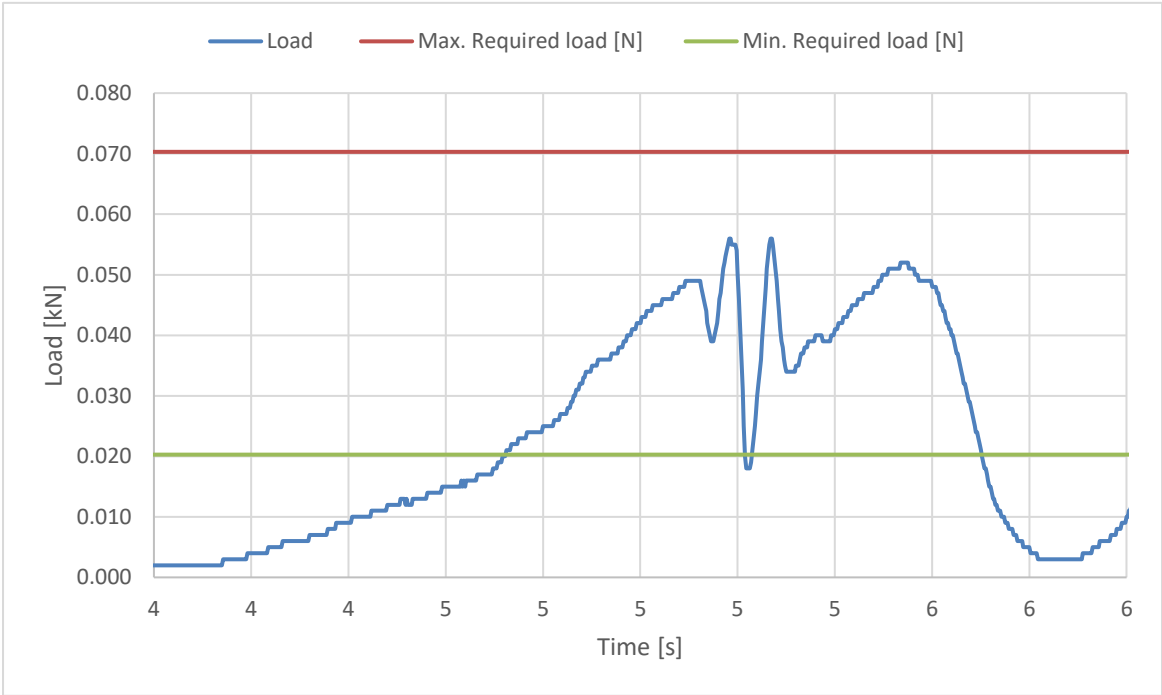
| Rescue Deployment Test | | Test ID RRDT |

| Rescue Deployment Test | | Test ID RRDT |
|---|---|---|
| Load for first action [N] | 56.29 | |
| Test results | POSITIVE | |

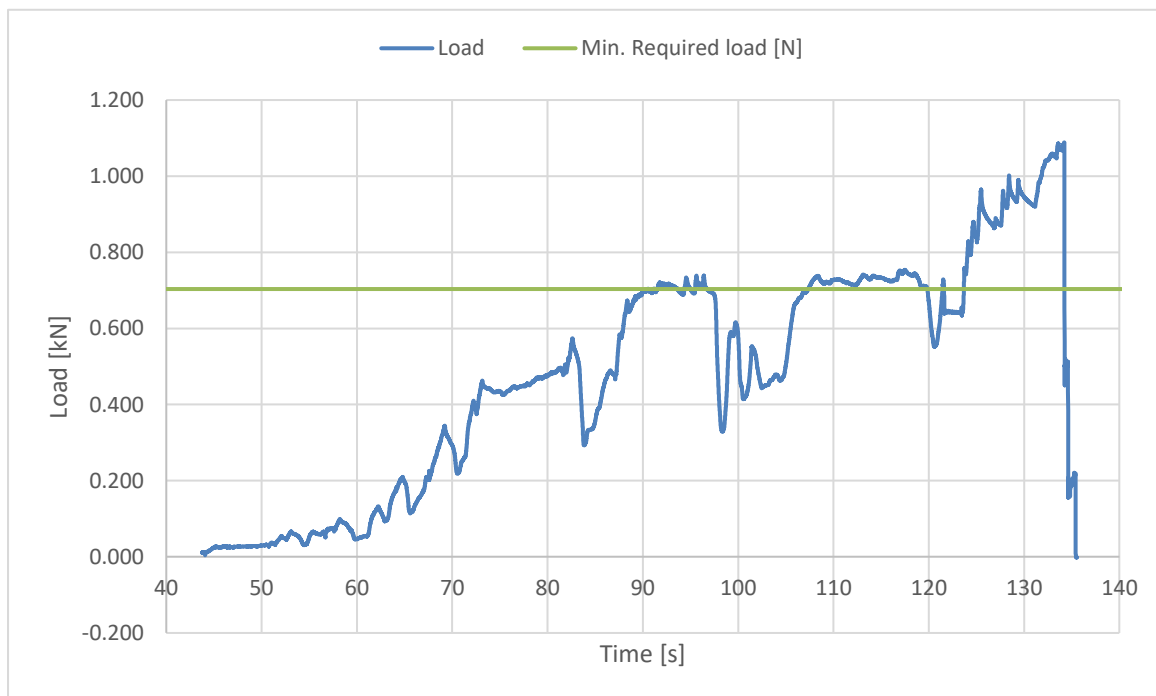
Test ID RRST

Test duration [s]: **12.5**  
Breaking strength [N] **750.13**  
Test results **POSITIVE**
