Harness Structural test Report - EN

Inspection certificate number: **PH_383.2022**

Name: **Roamer 2 P**
 Type: **ABS**
 Size: **M**
 Serial number: **SKINNYM-V6**
 Impact pad type: ⁽¹⁾ **n/a**
 Clip-in weight [kg]: **120**

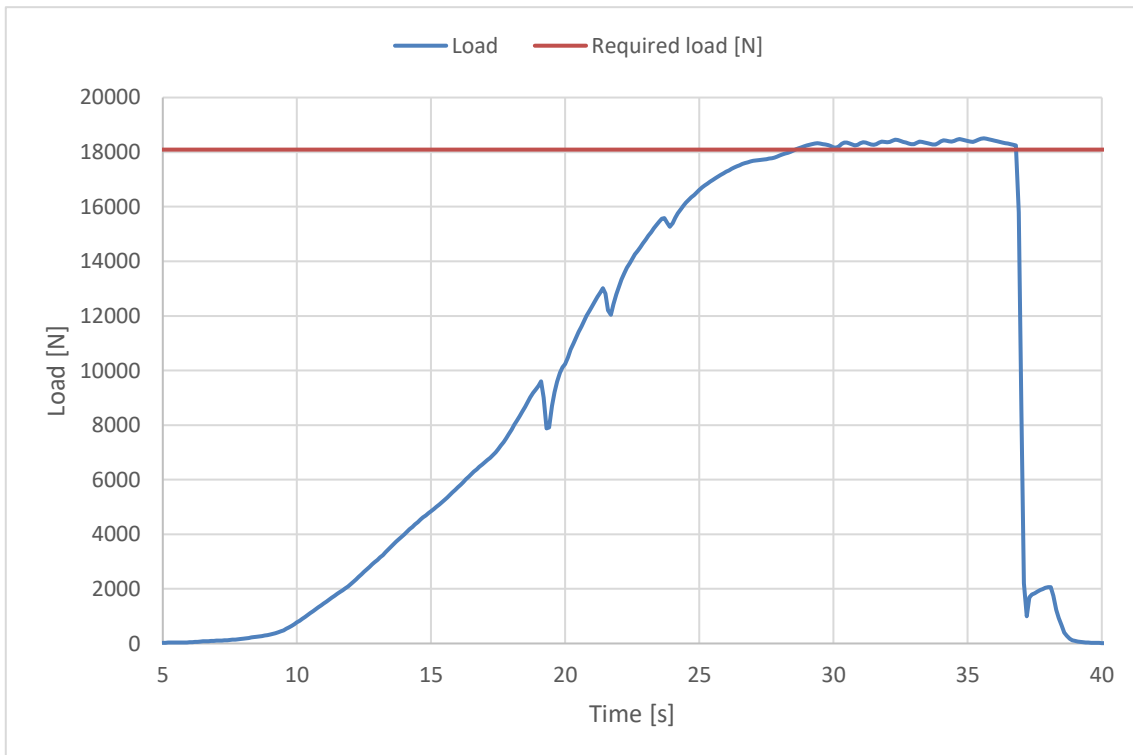
Test ID 03

Test duration [s] **8.3**
 Any signs of structural failure **No**
 Slippery test OK **Yes**
 Test results **POSITIVE**

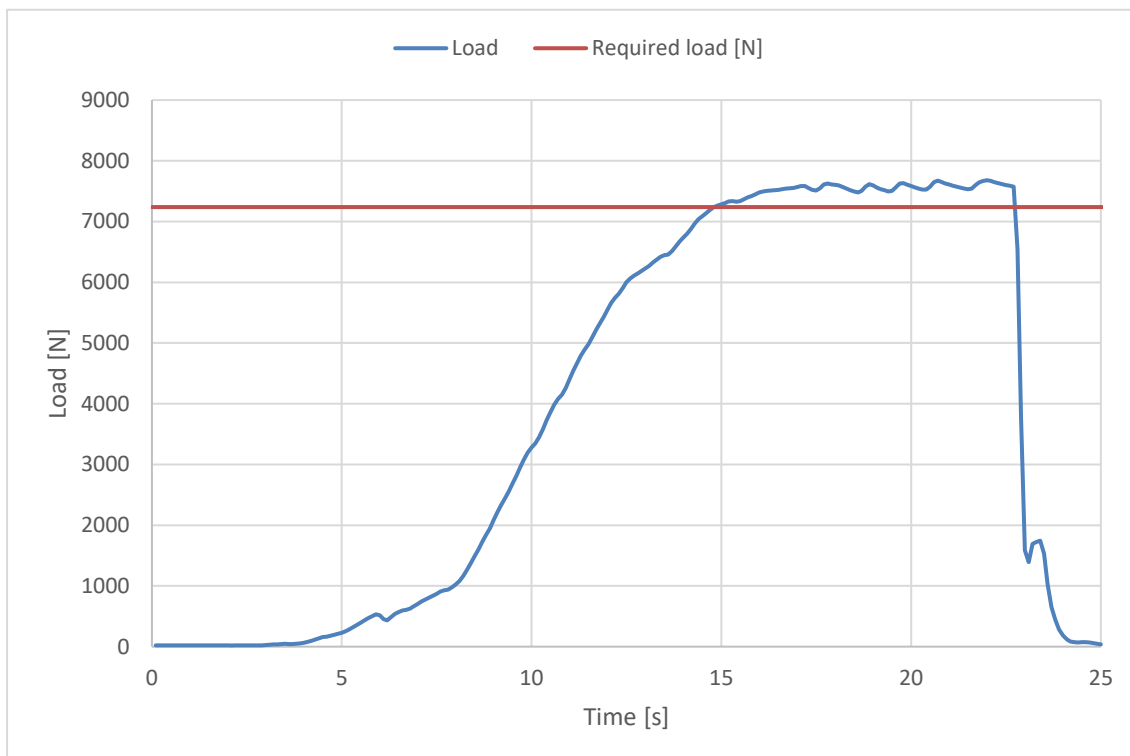
Test ID 05

Standard	EN 1651
Reference in standard	5.5.1.2
Test setup	Positive asymmetric load
Attachment points	One riser attachment (3 or 4)
Anchor points	Dummy (C)
Required load [g]	6
Required load [N]	7200
Minimum test duration [s]	5
Result	
Test duration [s]	7.9
Any signs of structural failure	No
Test results	POSITIVE

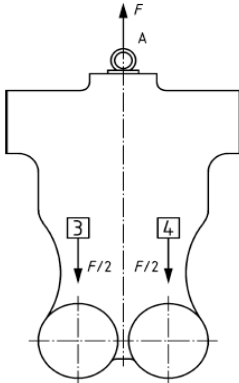
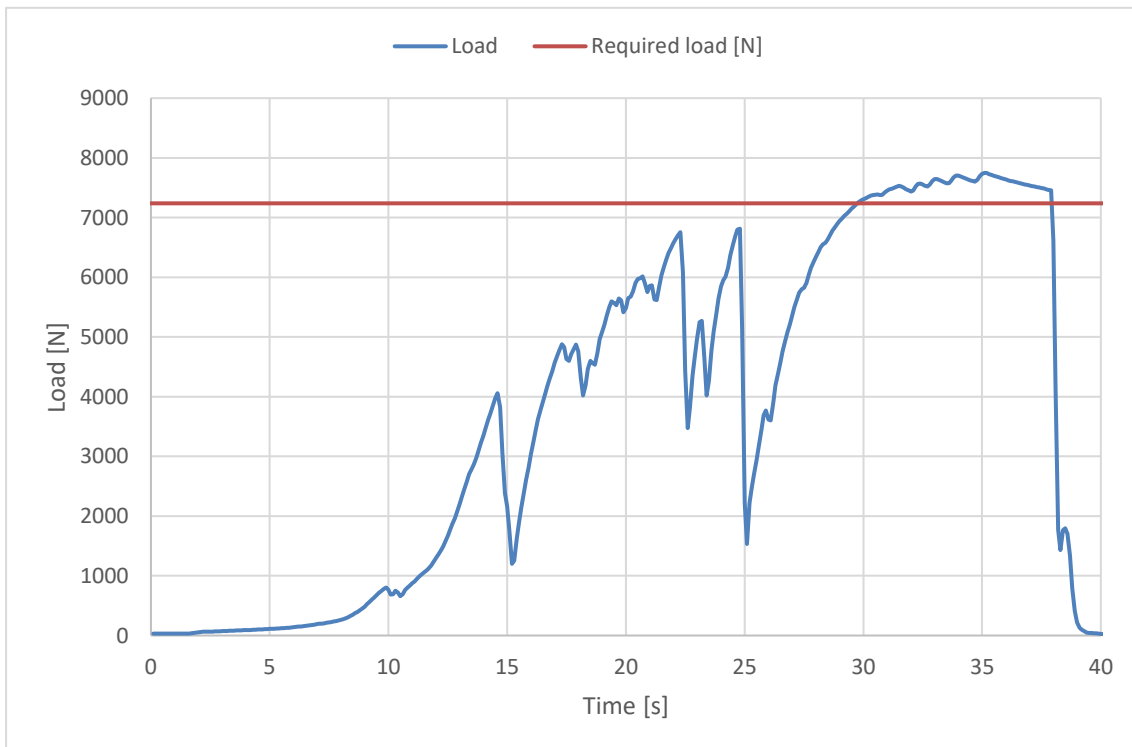
Test ID 06

Standard	EN 1651
Reference in standard	5.5.1.6
Test setup	Negative symmetric load
Attachment points	Both main riser attachment (3,4)
Anchor points	Dummy (A)
Required load [g]	6
Required load [N]	7200
Minimum test duration [s]	5
Result	
Test duration [s]	8.2
Any signs of structural failure	No
Test results	POSITIVE

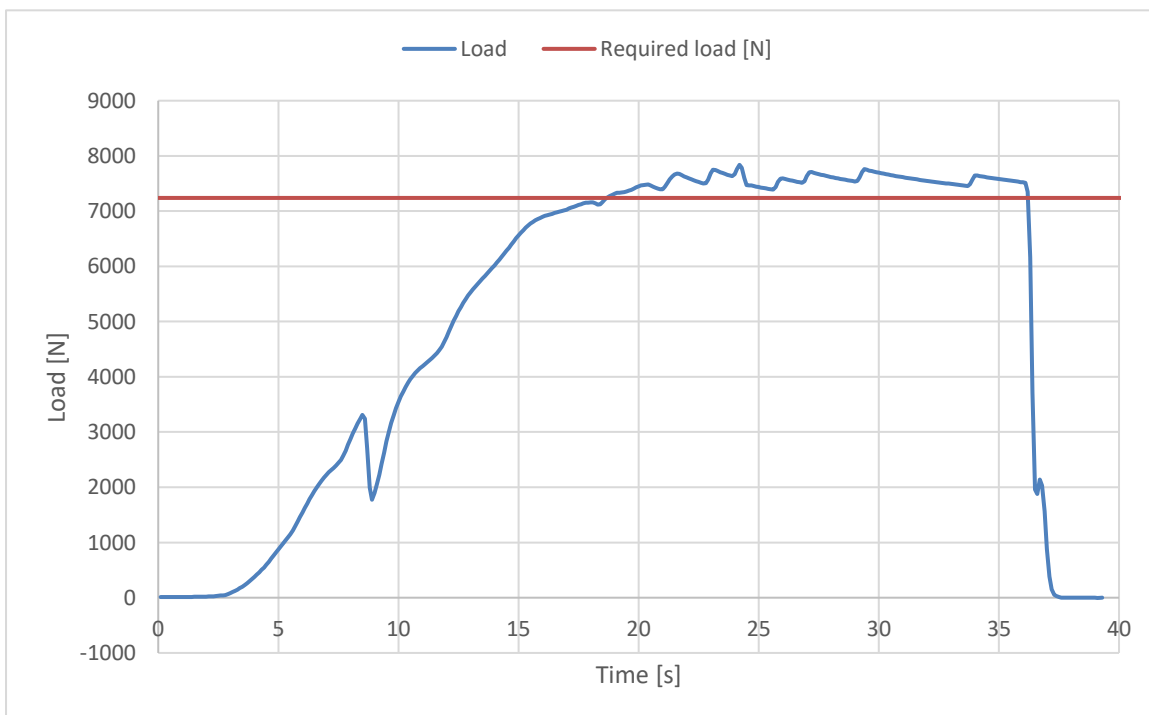
Test ID 12

Standard	EN 1651
Reference in standard	5.5.1.7
Test setup	Upright (landing) position load
Attachment points	Both main riser attachment (3, 4)
Anchor points	Both legstrap of harness (no dummy)
Required load [g]	6
Required load [N]	7200
Minimum test duration [s]	5
Harness type	type c
Result	
Test duration [s]	17.6
Any signs of structural failure	No
Slippery test OK	Yes
Test results	POSITIVE
