## Harness Structural test Report - NfL

Inspection certificate number: **PH\_419.2023**

Name: **Sherlock**  
 Type: **ABS**  
 Size: **M**  
 Serial number: **SHERLOCKMV8**  
 Impact pad type: <sup>(1)</sup> **Airbag**  
 Clip-in weight [kg]: **120**  
 Integrated container: **Yes**  
 Date of test: **03.10.2023**

### Summary of Structural test

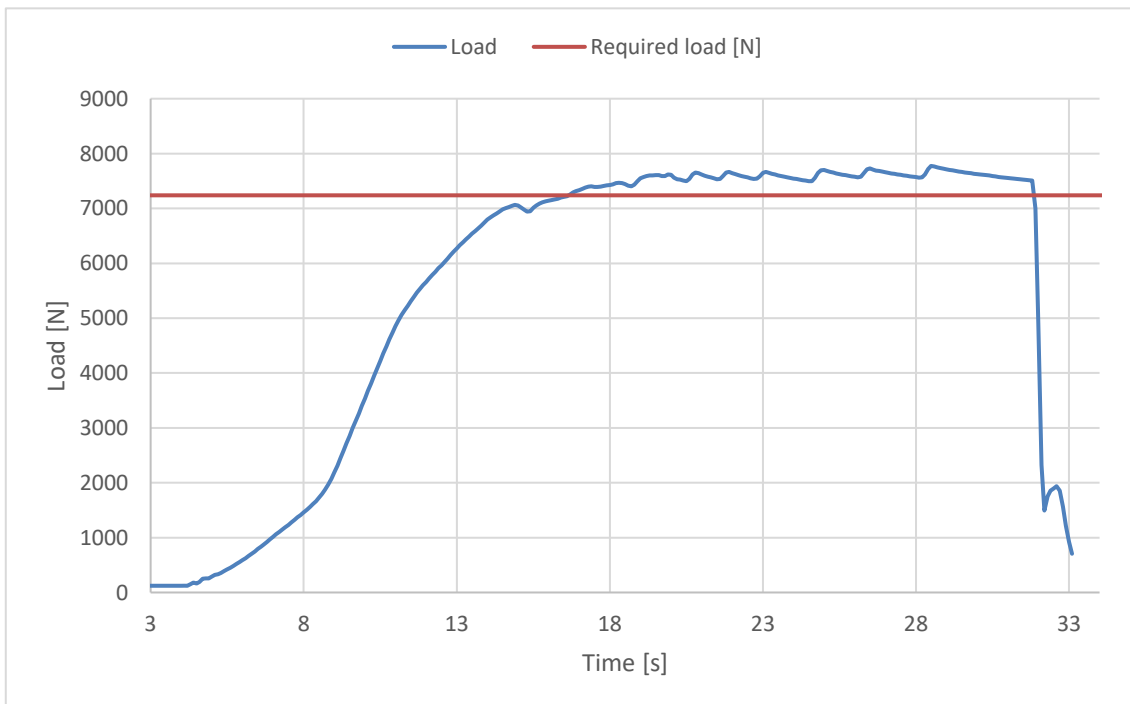
**Test ID 02**

Test duration [s] **15.2**  
 Any signs of structural failure **No**  
 Test results **POSITIVE**

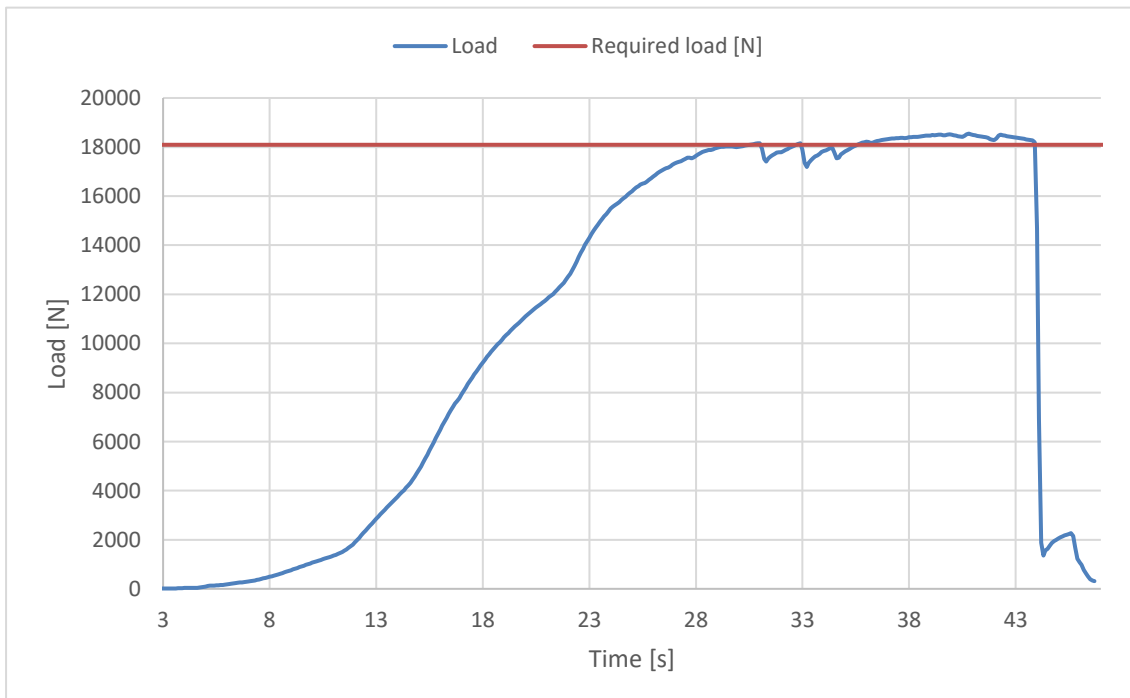
**Test ID 03**

| Test duration [s] | <b>8.4</b> |
| Any signs of structural failure | <b>No</b> |
| Test results | <b>POSITIVE</b> |

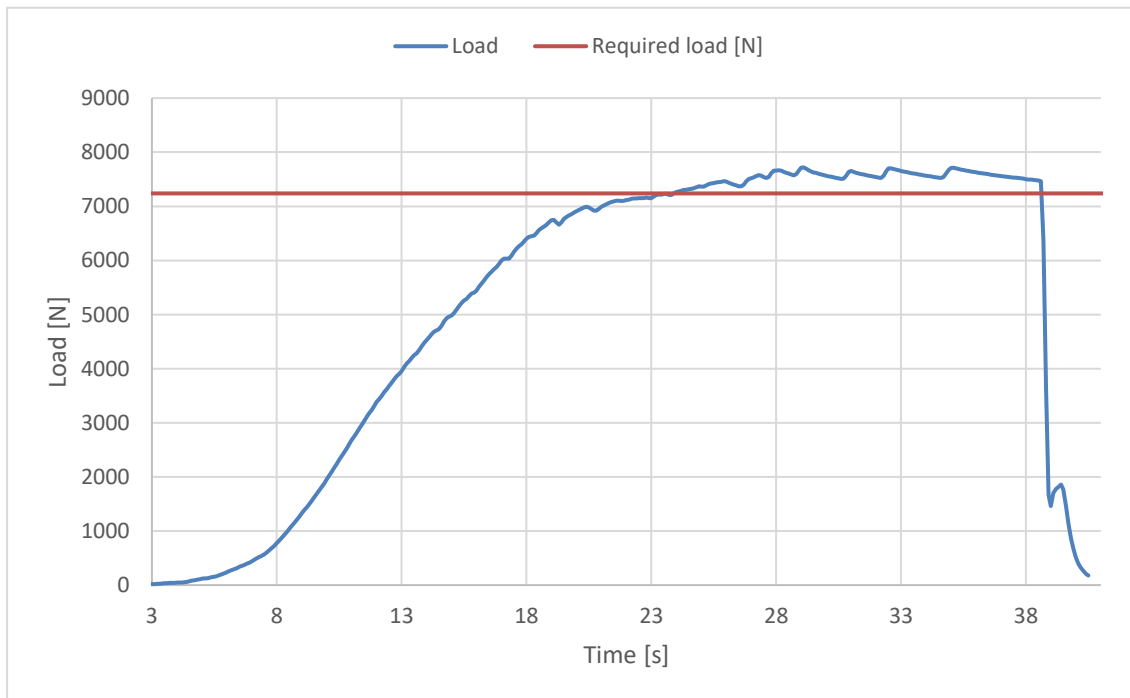
**Test ID 04**

Test duration [s] **14.8**  
 Any signs of structural failure **No**  
 Test results **POSITIVE**

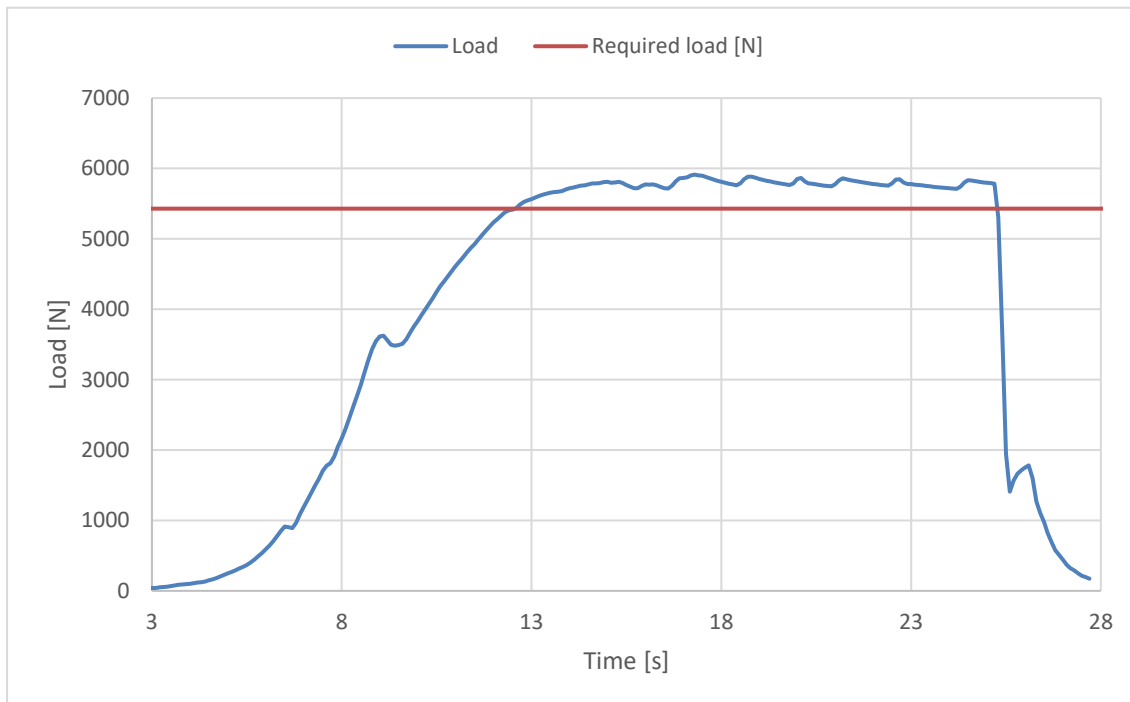
**Test ID 07**

| Test duration [s] | <b>12.7</b> | |
| Any signs of structural failure | <b>No</b> | |
| Test results | <b>POSITIVE</b> | |

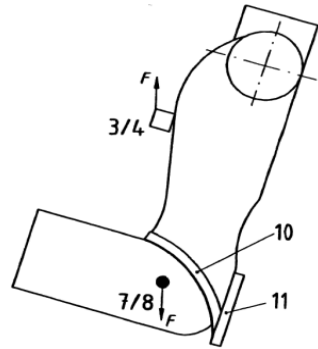
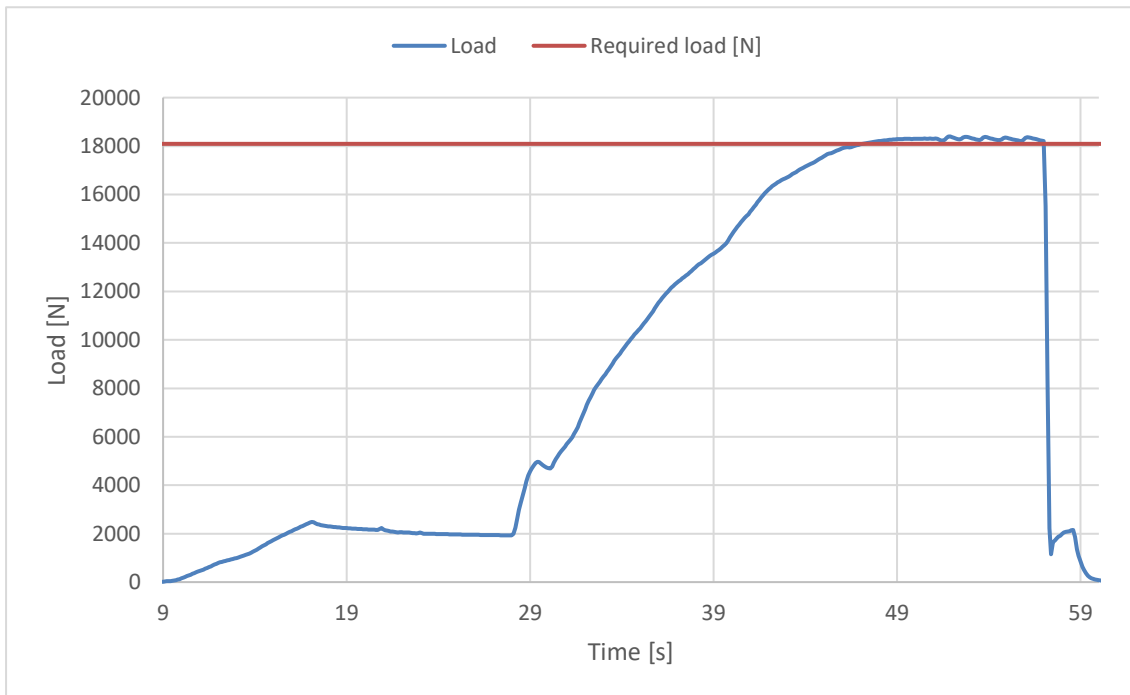
**Test ID 13**

| Test duration [s] | <b>9.9</b> |
| Any signs of structural failure | <b>No</b> |
| Test results | <b>POSITIVE</b> |

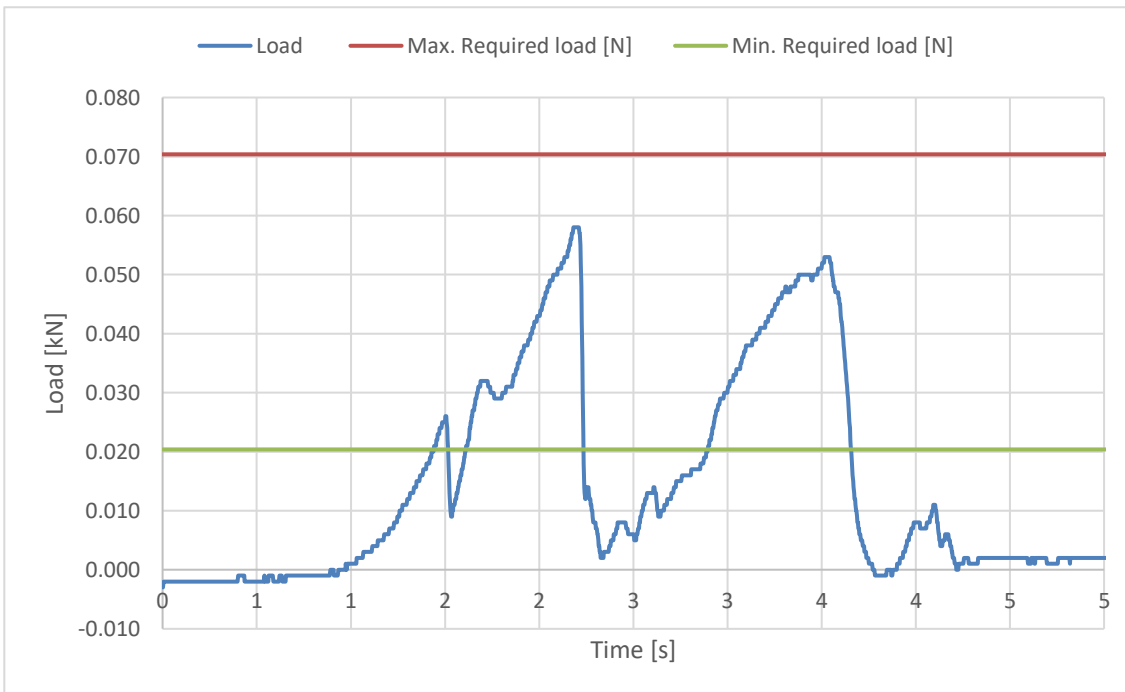
**Test ID RRDT**

Load for first action [N] **57.61**  
 Test results **POSITIVE**

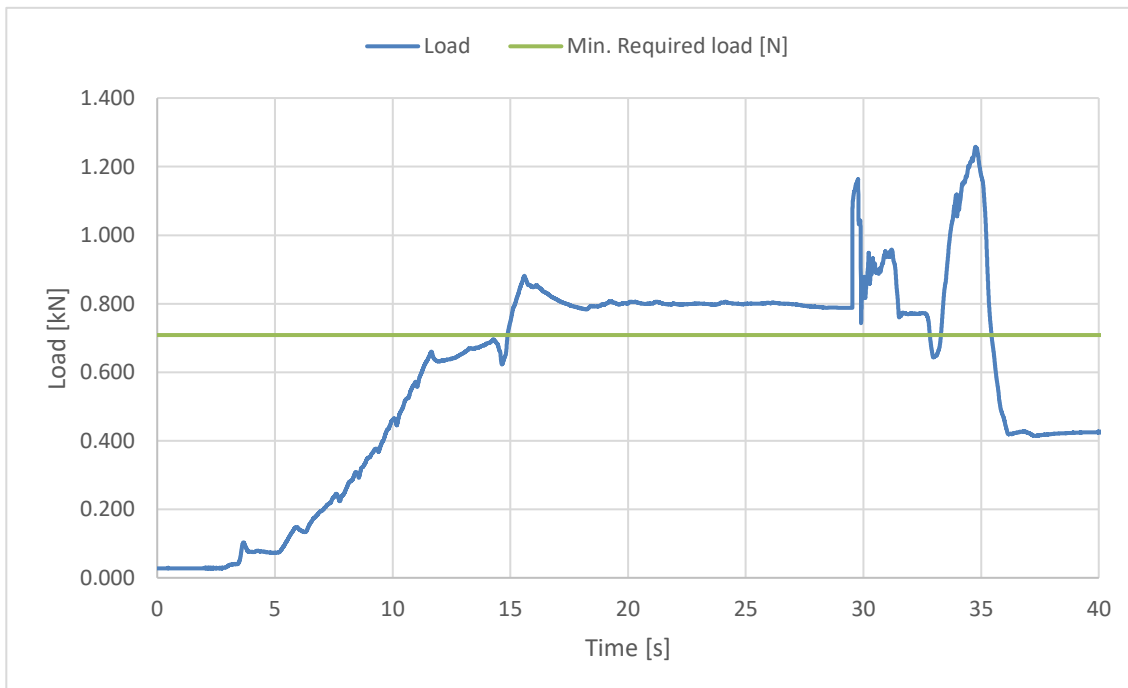
**Test ID RRST**

| Test duration [s]: | <b>17.0</b> |
| Breaking strength [N] | <b>1249.64</b> |
| Test results | <b>POSITIVE</b> |
