Harness Structural test Report - EN

Inspection certificate number: PH_420.2023

Name: **Watson 2**
 Type: **ABS**
 Size: **One size**
 Serial number: **WATSON2OS31**
 Impact pad type: ⁽¹⁾ **Airbag**
 Clip-in weight [kg]: **120**

EN1651:2018+A1:2020⁽⁶⁾ and EN12491:2015+A1:2021⁽⁶⁾

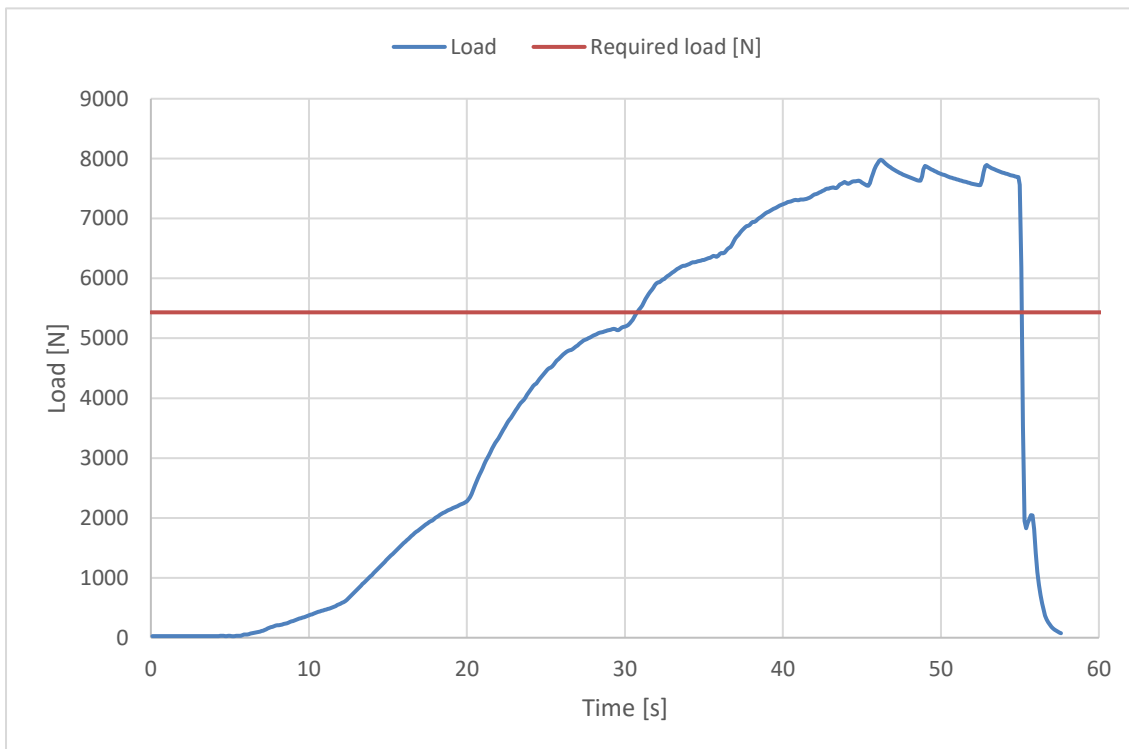
Test ID 01

Standard	EN 1651
Reference in standard	5.5.1.1
Test setup	Positive symmetric load (Slippage)
Attachment points	Both main riser attachment (3,4)
Anchor points	Dummy (B1, B2)
Required load [g]	4.5
Required load [N]	5400
Minimum test duration [s]	5
Result	
Test duration [s]	24.4
Any signs of structural failure	No
Slippery test OK	Yes
Test results	POSITIVE

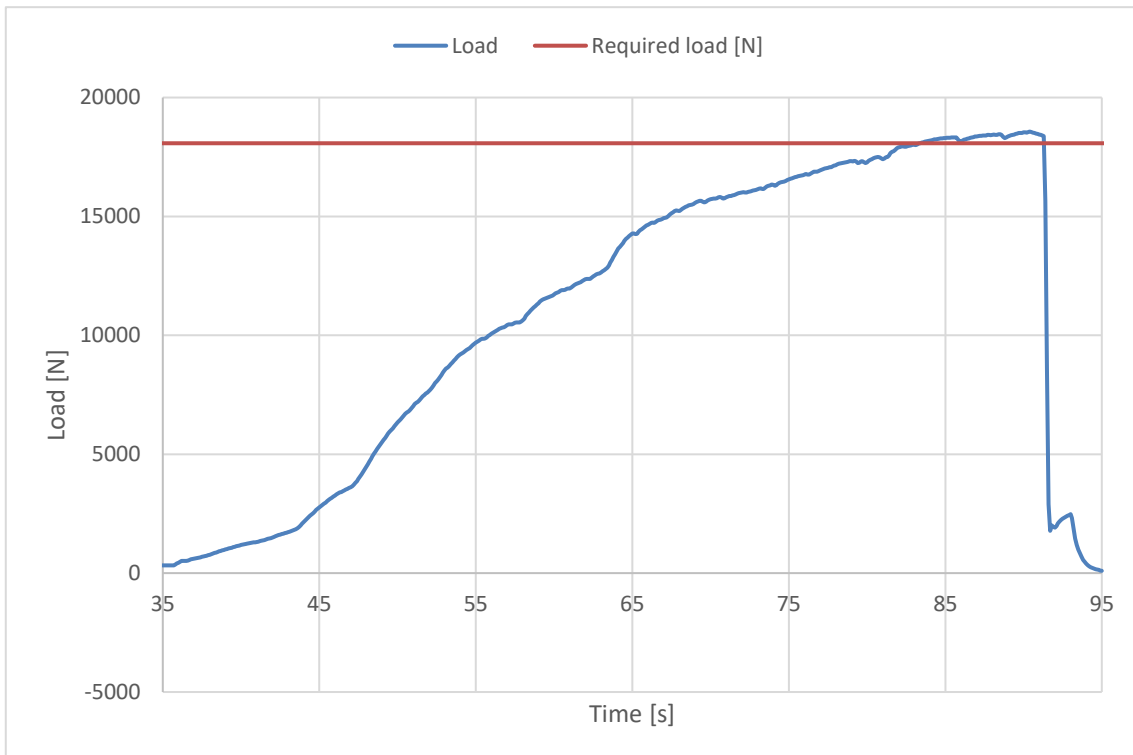
Test ID 03

Standard	EN 1651
Reference in standard	5.5.1.1b
Test setup	Positive symmetric load
Attachment points	Both main riser attachment (3,4)
Anchor points	Dummy (B1, B2)
Required load [g]	15
Required load [N]	18000
Minimum test duration [s]	5
Result	
Test duration [s]	8
Any signs of structural failure	No
Slippery test OK	Yes
Test results	POSITIVE

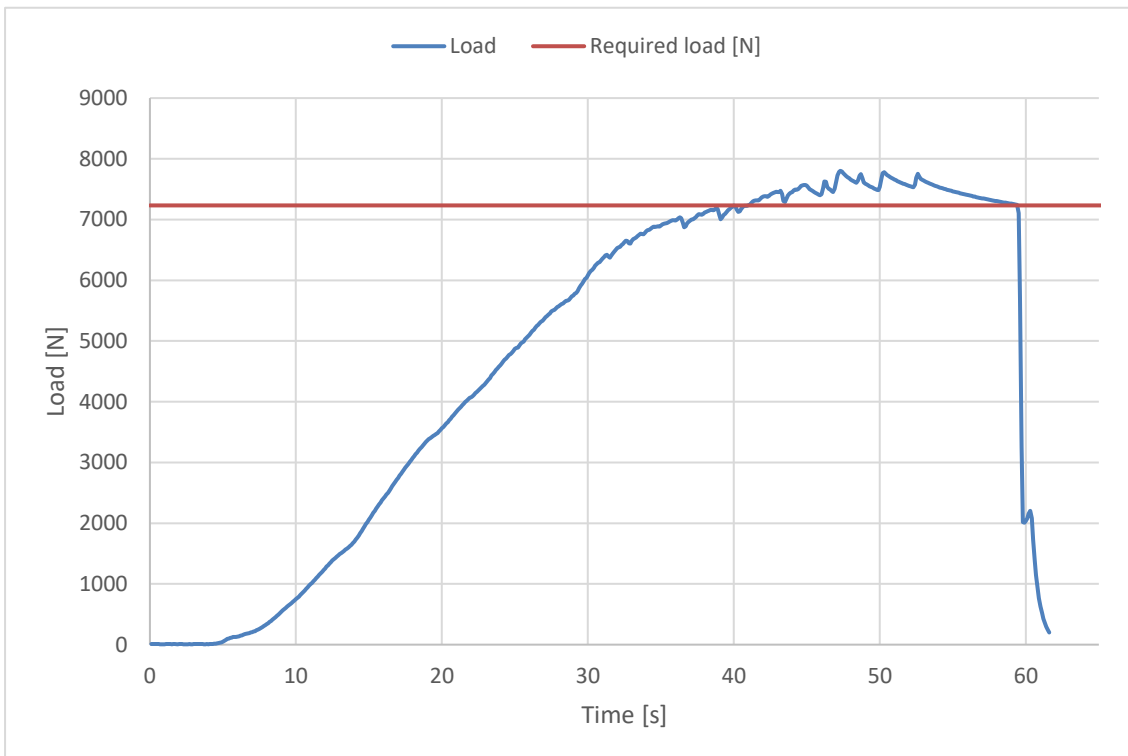
Test ID 05

Standard	EN 1651
Reference in standard	5.5.1.2
Test setup	Positive asymmetric load
Attachment points	One riser attachment (3 or 4)
Anchor points	Dummy (C)
Required load [g]	6
Required load [N]	7200
Minimum test duration [s]	5
Result	
Test duration [s]	18.5
Any signs of structural failure	No
Test results	POSITIVE

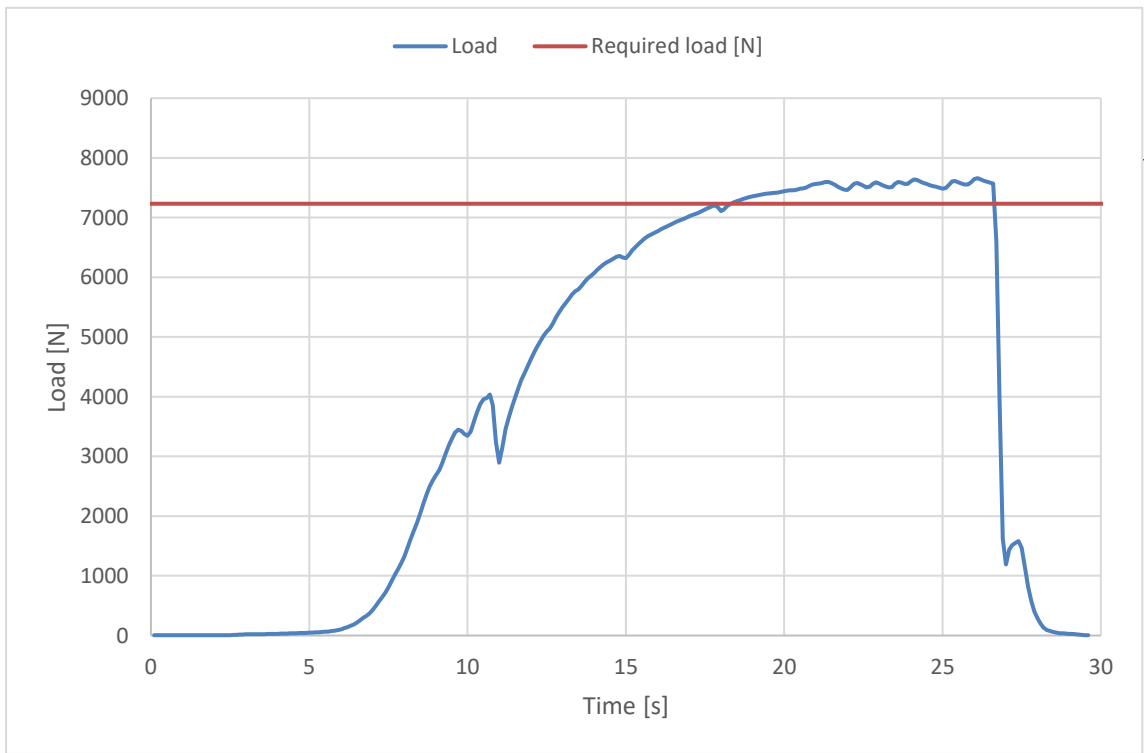
Test ID 06

Standard	EN 1651
Reference in standard	5.5.1.6
Test setup	Negative symmetric load
Attachment points	Both main riser attachment (3,4)
Anchor points	Dummy (A)
Required load [g]	6
Required load [N]	7200
Minimum test duration [s]	5
Result	
Test duration [s]	8.3
Any signs of structural failure	No
Test results	POSITIVE

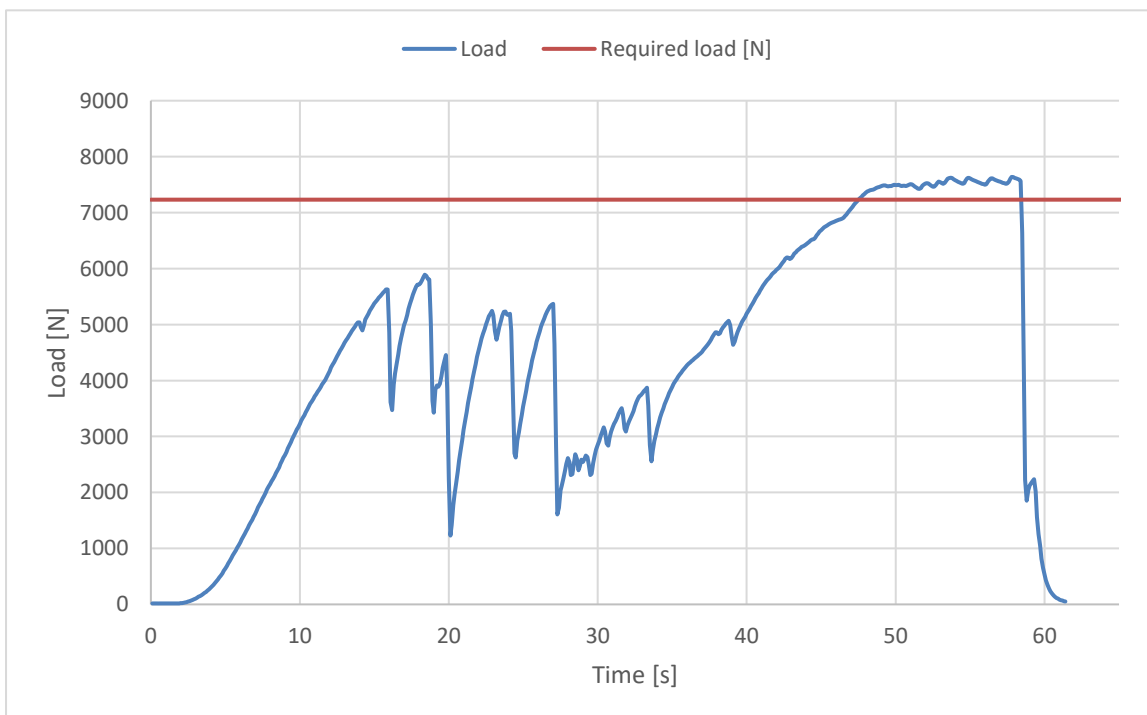
Test ID 12

Standard	EN 1651
Reference in standard	5.5.1.7
Test setup	Upright (landing) position load
Attachment points	Both main riser attachment (3, 4)
Anchor points	Both legstrap of harness (no dummy)
Required load [g]	6
Required load [N]	7200
Minimum test duration [s]	5
Harness type	type b
Result	
Test duration [s]	10.9
Any signs of structural failure	No
Slippery test OK	Yes
Test results	POSITIVE
