Harness Structural test Report - NfL

Inspection certificate number: **PH_420.2023**

Name: **Watson 2**
 Type: **ABS**
 Size: **One size**
 Serial number: **WATSON2OS31**
 Impact pad type: ⁽¹⁾ **Airbag**
 Clip-in weight [kg]: **120**
 Integrated container: **n/a**
 Date of test: **19.10.2023**

Summary of Structural test

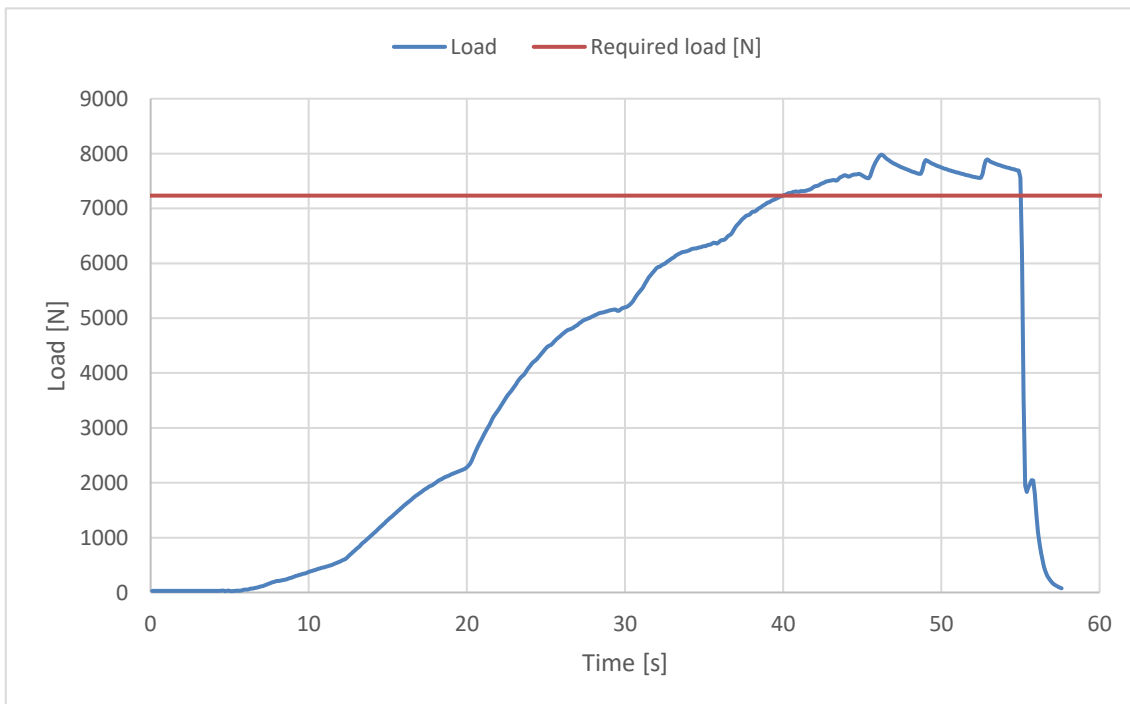
Test ID 02

Test duration [s] **15.1**
 Any signs of structural failure **No**
 Test results **POSITIVE**

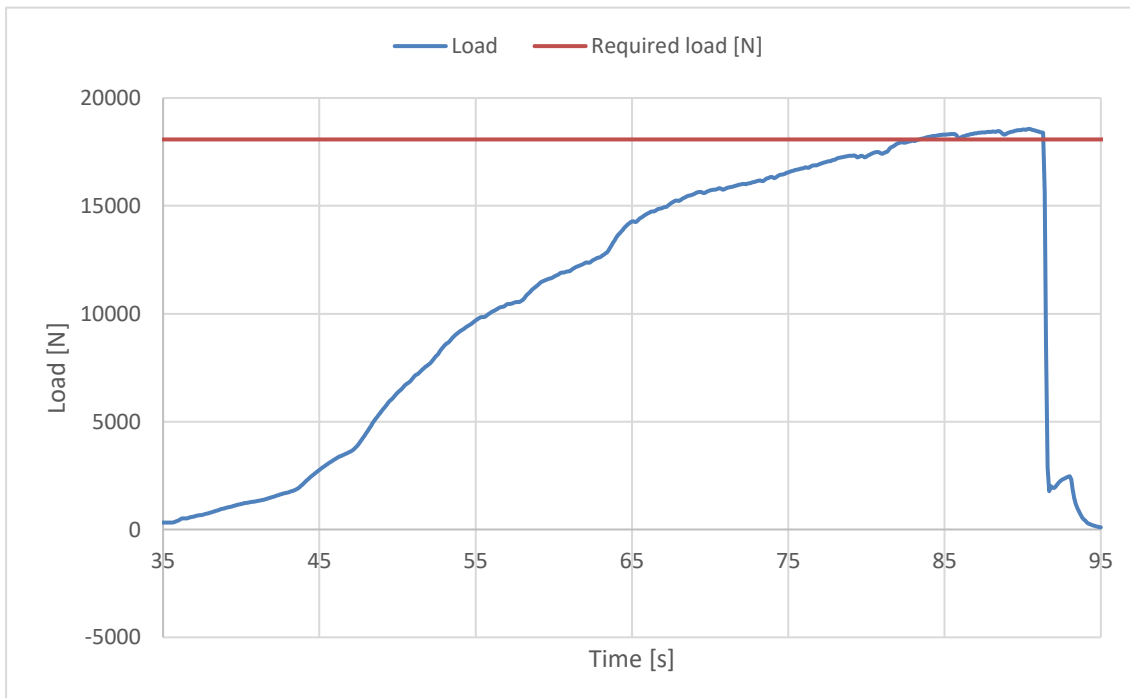
Test ID 03

Standard	EN 1651:1999
Reference	5.3.2.2
Test setup	Default flying position
Attachment points	Both main riser attachment (3,4)
Anchor points	Dummy (B1, B2)
Required load [g]	15
Required load [N]	18000
Minimum test duration [s]	5
Result	
Test duration [s]	8
Any signs of structural failure	No
Test results	POSITIVE

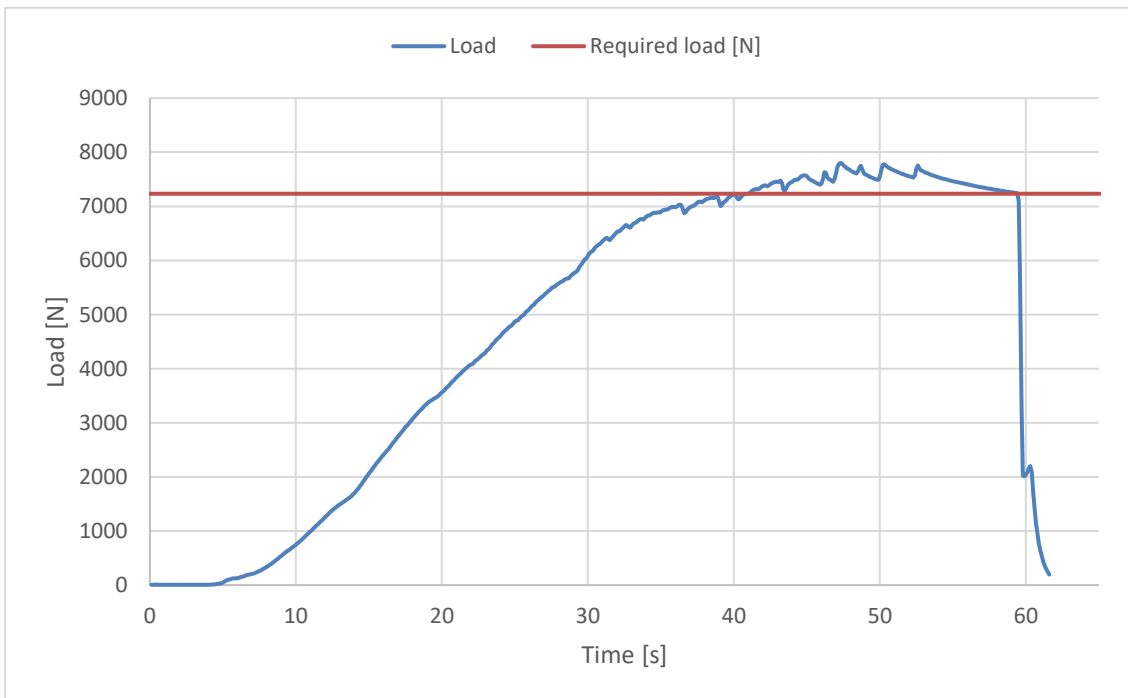
Test ID 04

Standard	EN 1651:1999
Reference	5.3.2.3
Test setup	Asymmetric, one riser
Attachment points	One main riser attachment (3)
Anchor points	Dummy (B1,B2)
Required load [g]	6
Required load [N]	7200
Minimum test duration [s]	10
Result	
Test duration [s]	18.5
Any signs of structural failure	No
Test results	POSITIVE

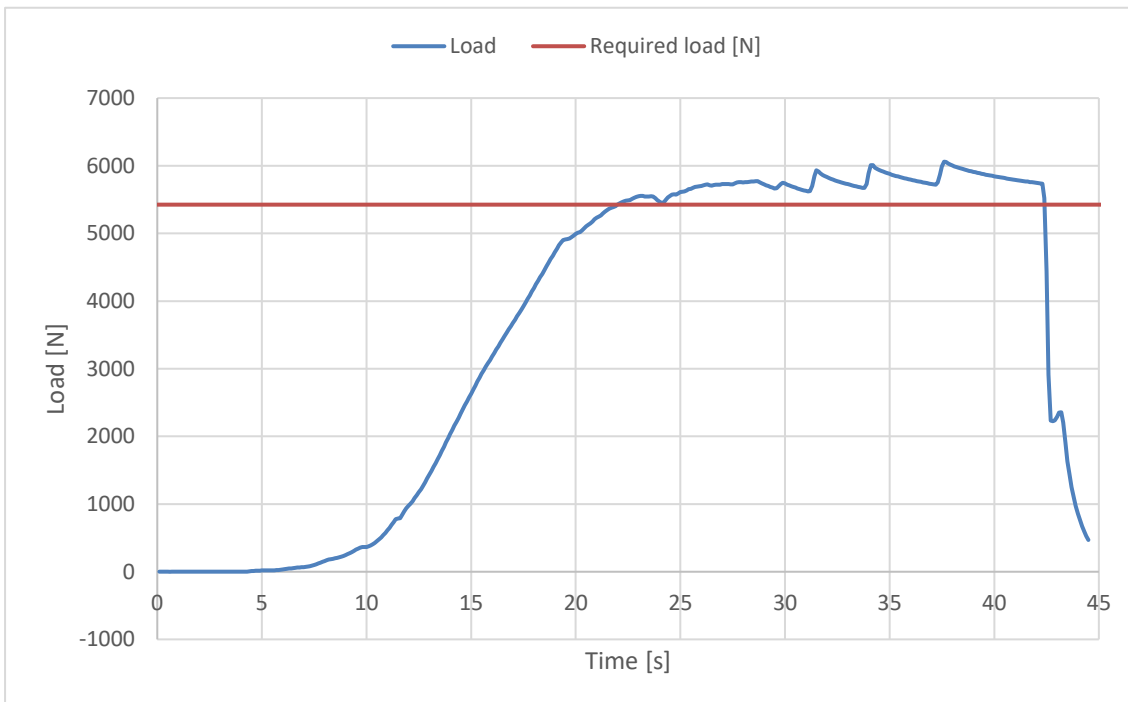
Test ID 07

Standard	EN 1651:1999
Reference	5.3.2.6
Test setup	Asymmetric, negative
Attachment points	One main riser attachment (3 or 4) downwards
Anchor points	Dummy (9)
Required load [g]	4.5
Required load [N]	5400
Minimum test duration [s]	10
Result	
Test duration [s]	20.4
Any signs of structural failure	No
Test results	POSITIVE

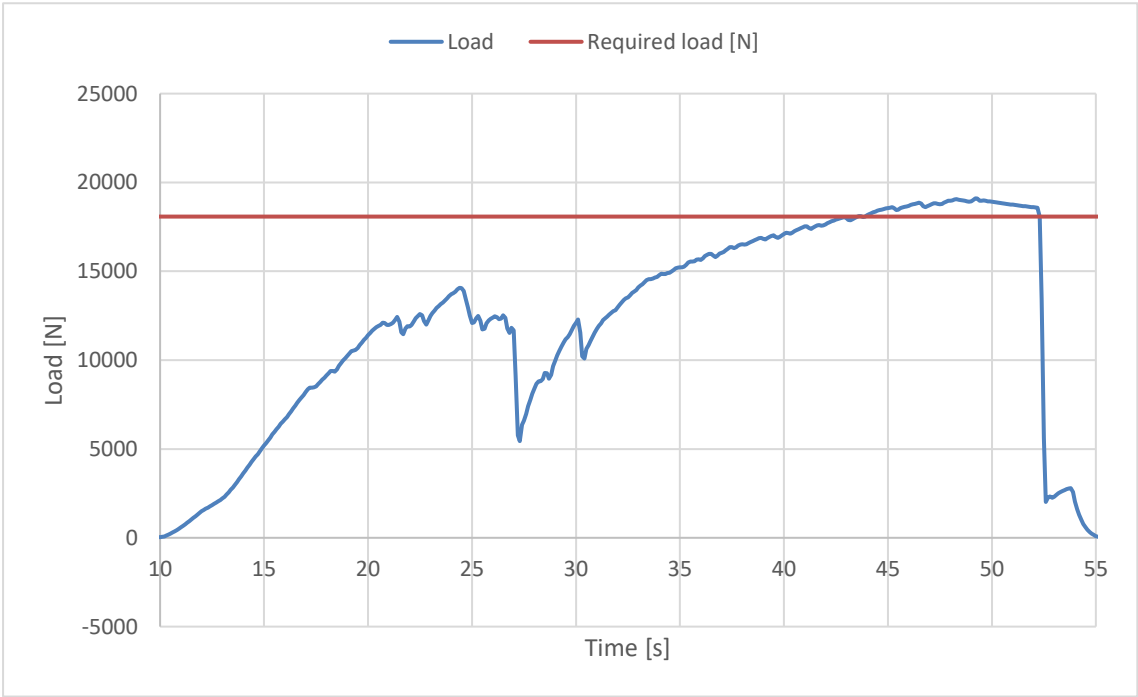
Test ID 13

Standard	EN 1651:1999
Reference	5.3.2.7
Test setup	Flying position before landing
Attachment points	Both main riser attachment (3,4)
Anchor points	Dummy (7,8)
Required load [g]	15
Required load [N]	18000
Minimum test duration [s]	5
Result	
Test duration [s]	8.3
Any signs of structural failure	No
Test results	POSITIVE
