Harness Structural test Report - EN

Inspection certificate number: **PH_421.2023**
Manufacturer data:

Name: **ARTUS**
 Type: **ABS**
 Size: **M**
 Serial number: **AR12001**
 Impact pad type: ⁽¹⁾ **Aluminium**
 Clip-in weight [kg]: **100**
 Date of test: **11.05.2023**

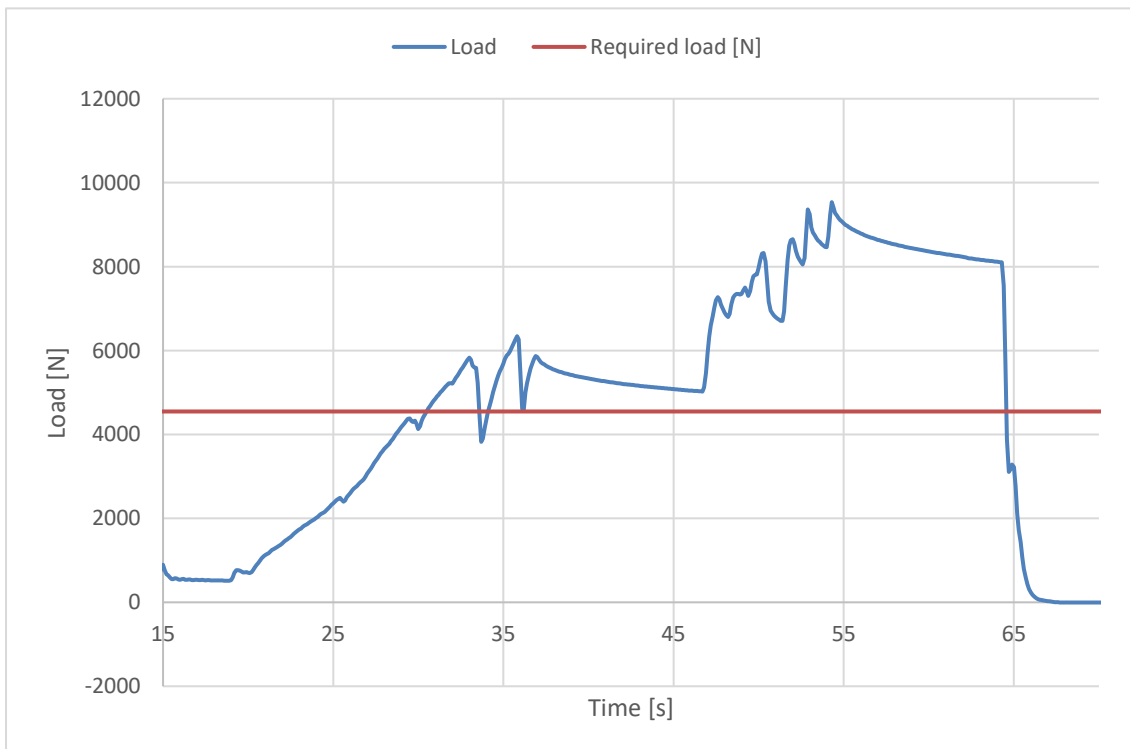
Test ID 01

Test duration [s] **30.4**
 Any signs of structural failure **No**
 Slippery test OK **Yes**
 Test results **POSITIVE**

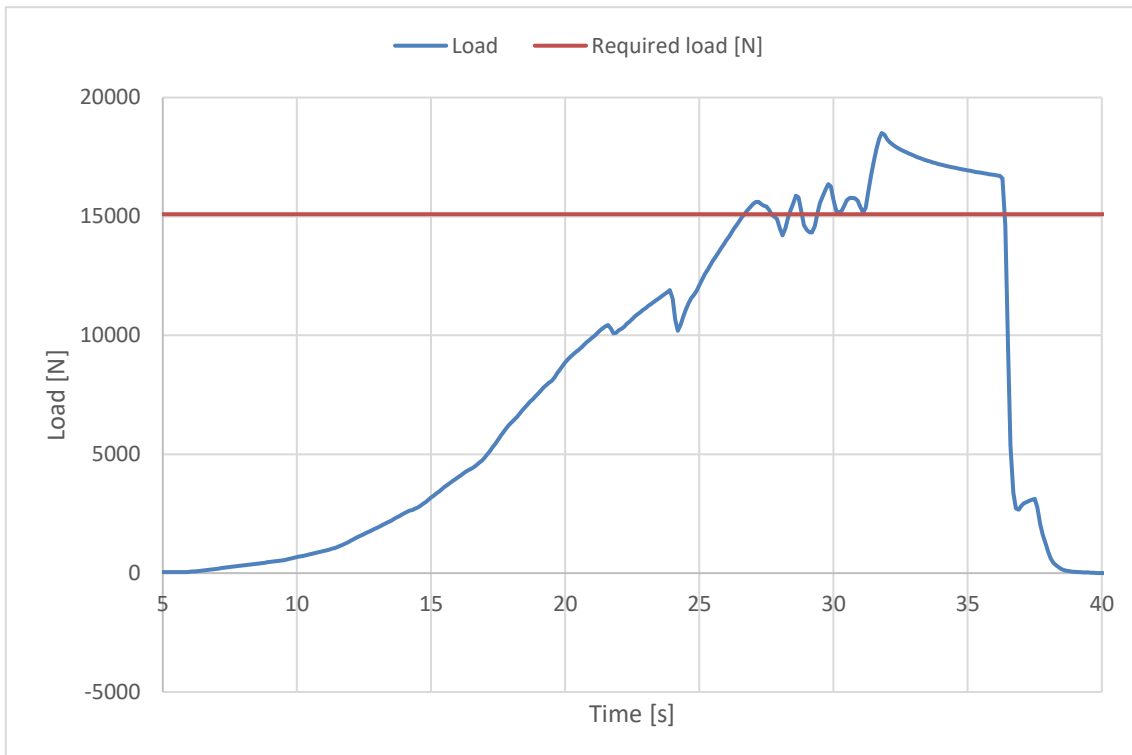
Test ID 03

Test duration [s] **7**
 Any signs of structural failure **No**
 Slippery test OK **Yes**
 Test results **POSITIVE**

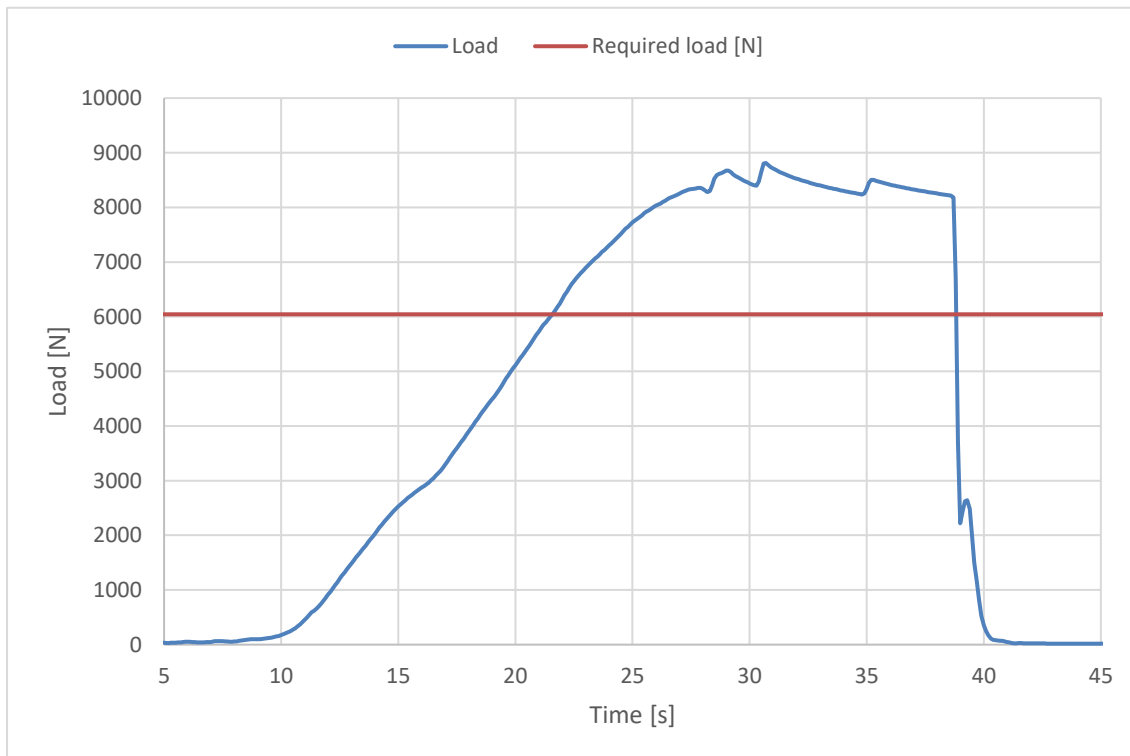
Test ID 05

| Any signs of structural failure | No |
| Test results | POSITIVE |

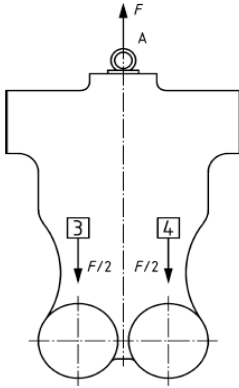
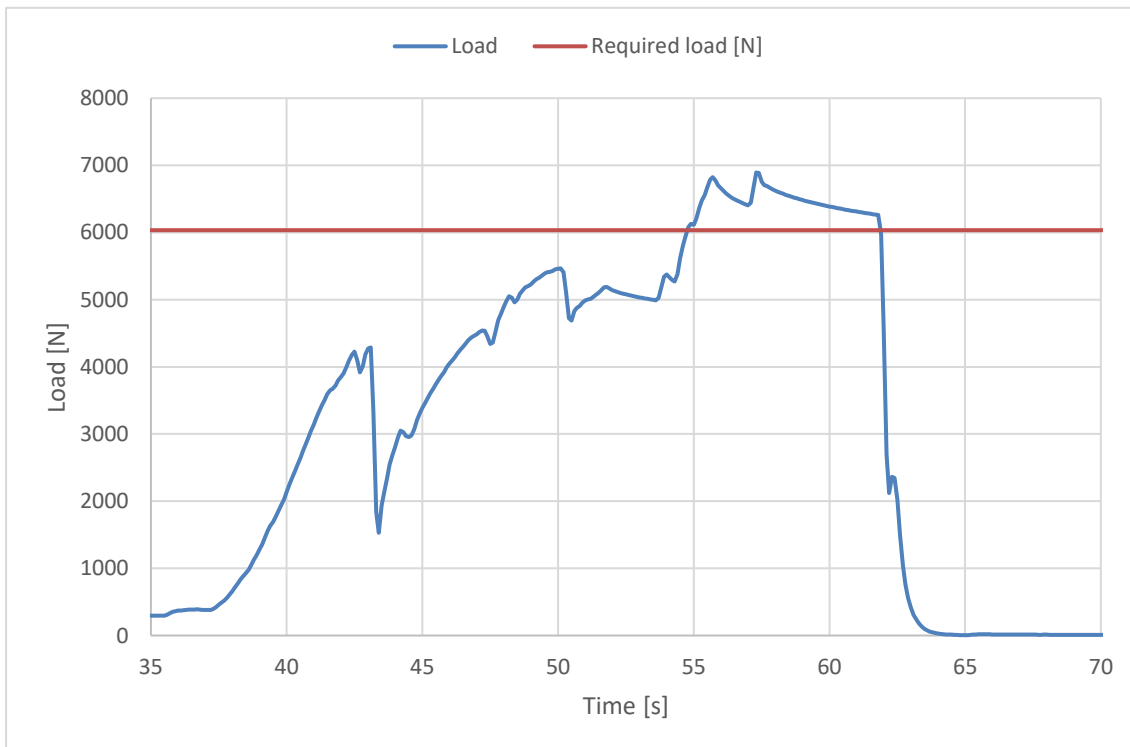
Test ID 06

| Any signs of structural failure | No |
| Test results | POSITIVE |

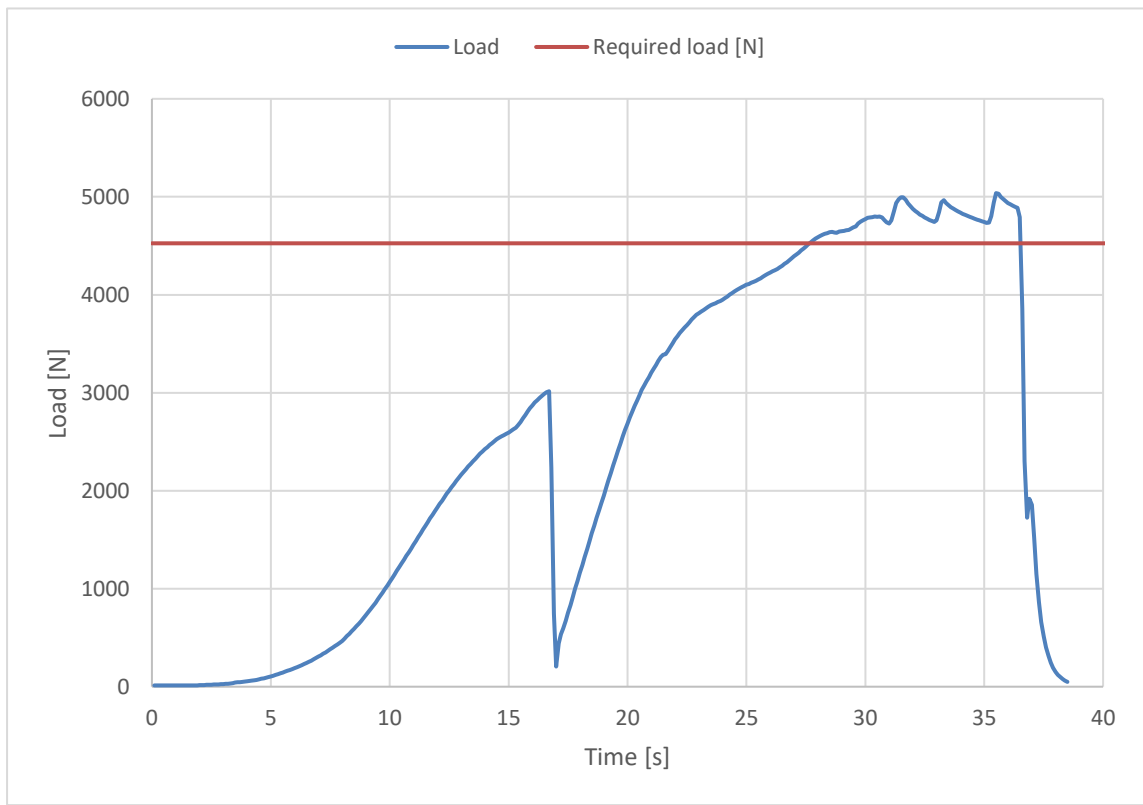
Test ID 08

| Any signs of structural failure | No |
| Test results | POSITIVE |

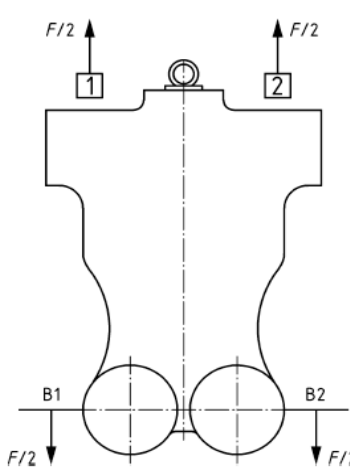
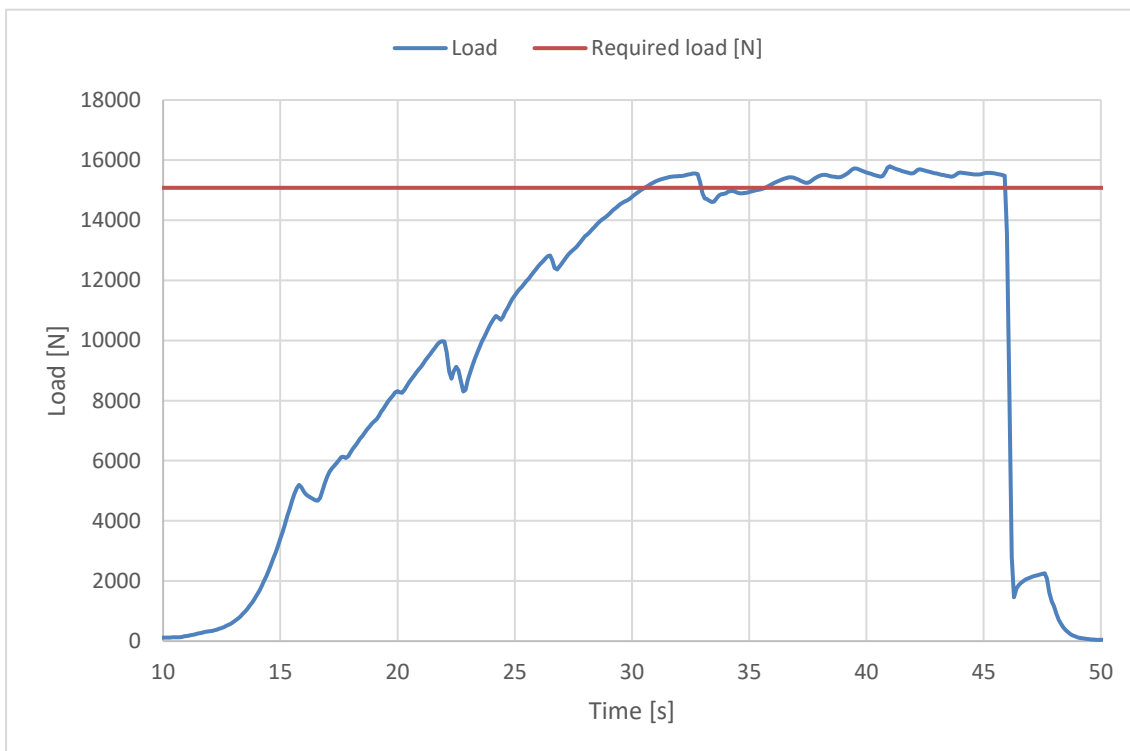
Test ID 09

| Any signs of structural failure | No | |
| Test results | POSITIVE | |

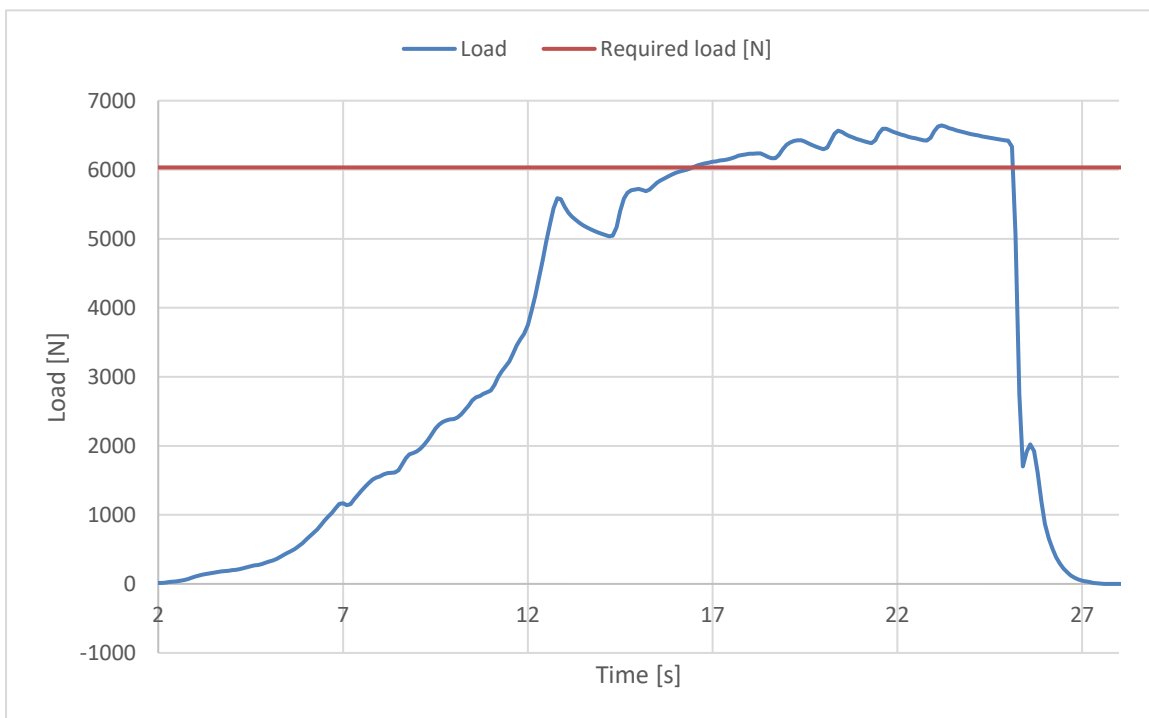
Test ID 12

| Any signs of structural failure | No |
| Test results | POSITIVE |

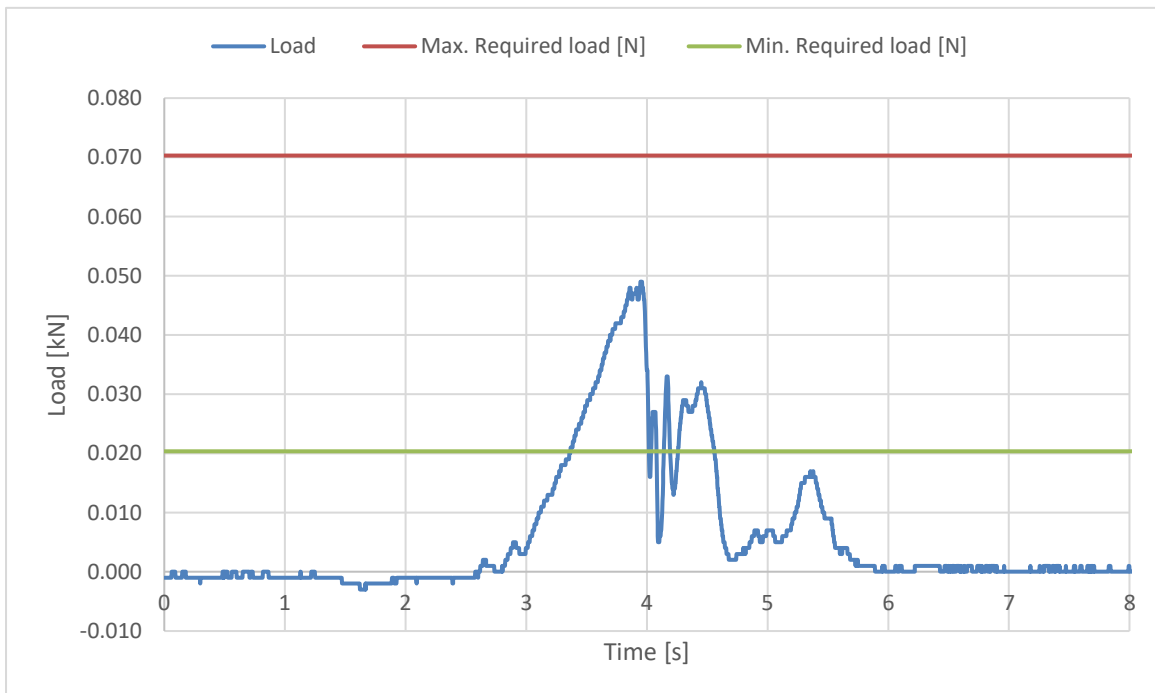
Test ID RRDT

| Load for first action [N] | 48.67 |
| Test results | POSITIVE |

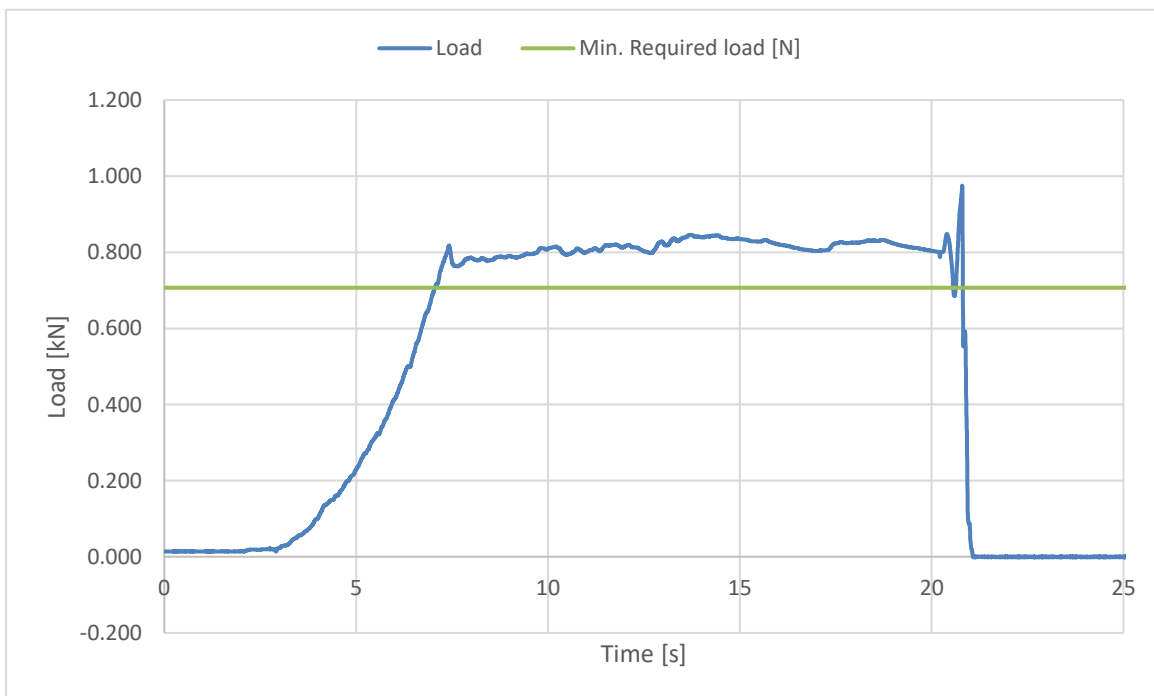
Test ID RRST

| Breaking strength [N] | 968.52 |
| Test results | POSITIVE |
