Harness Structural test Report - EN

Inspection certificate number: **PH_288.2019**

Name: **Itus**
 Type: **ABS**
 Size: **M**
 Serial number: **P16 M Body**
 Impact pad type: ⁽¹⁾ **Airbag**
 Clip-in weight [kg]: **120**

Harness Structural test

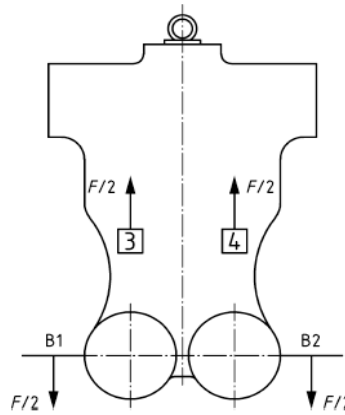
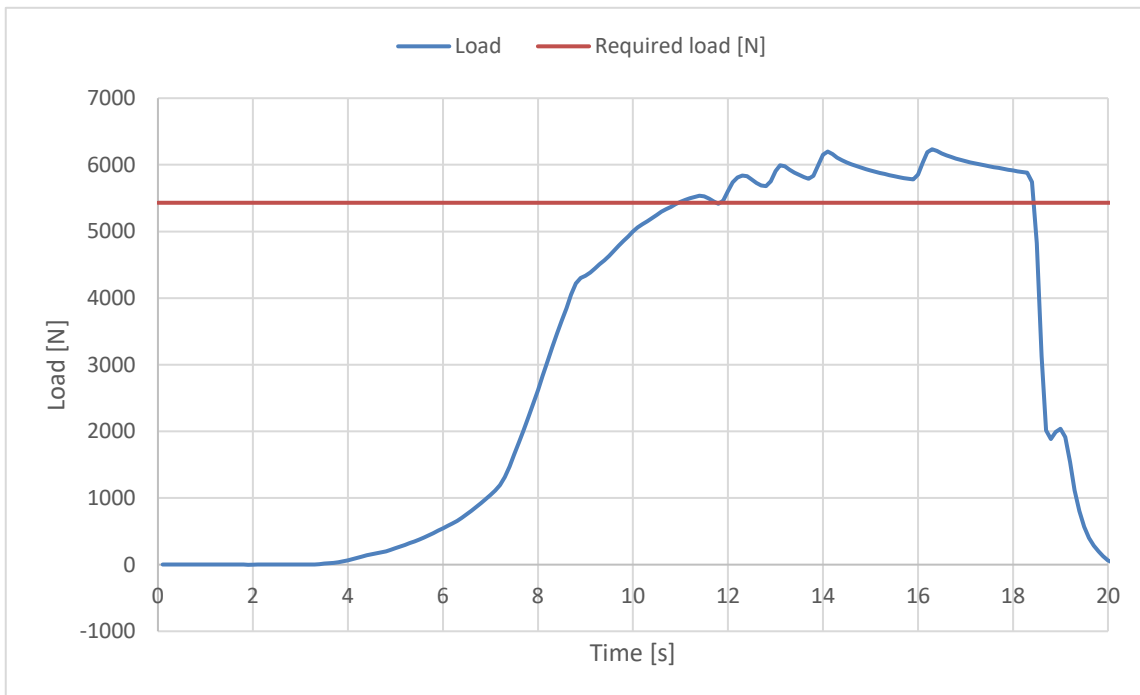
Test ID 01

Test duration [s] **6.6**
 Any signs of structural failure **No**
 Slippery test OK **Yes**
 Test results **POSITIVE**

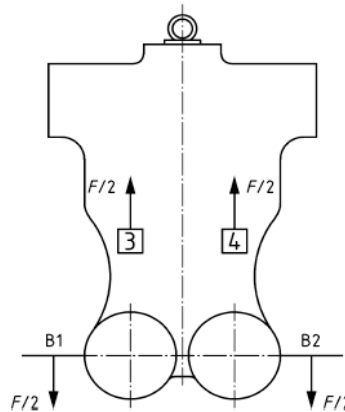
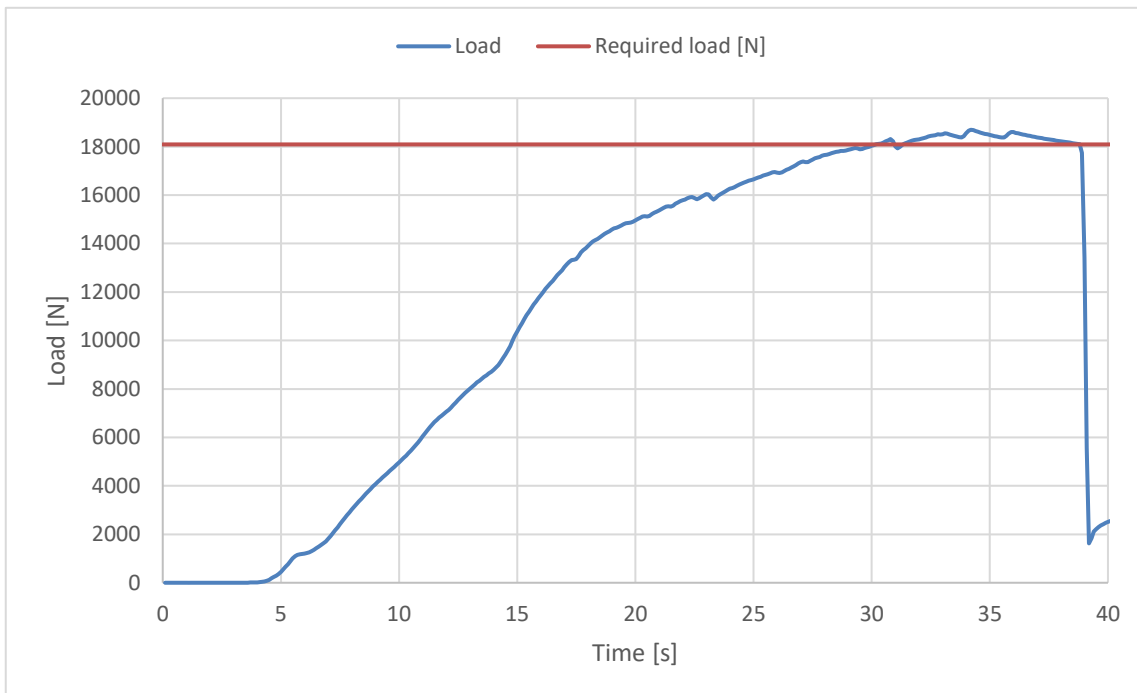
Test ID 03

Test duration [s] **7.5**
 Any signs of structural failure **No**
 Slippery test OK **Yes**
 Test results **POSITIVE**

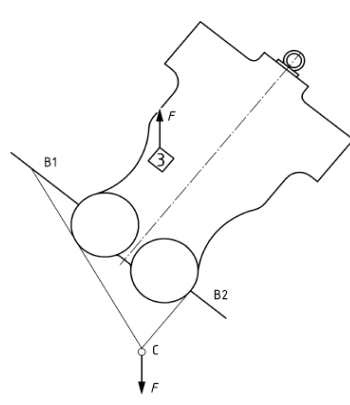
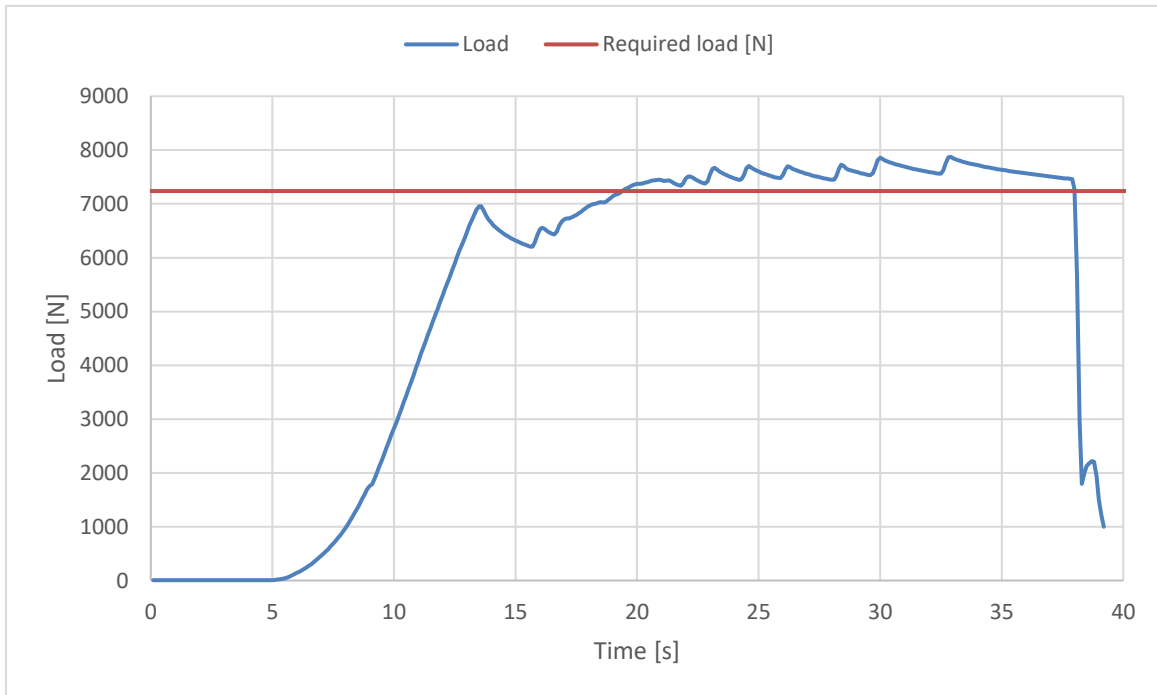
Test ID 05

| Any signs of structural failure | No | |
| Test results | POSITIVE | |

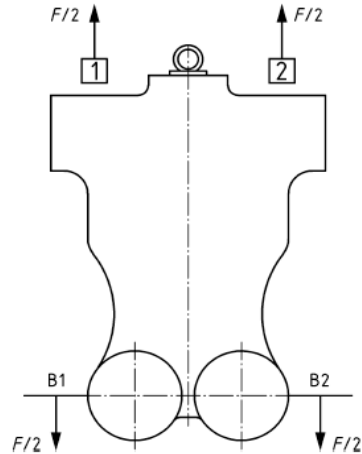
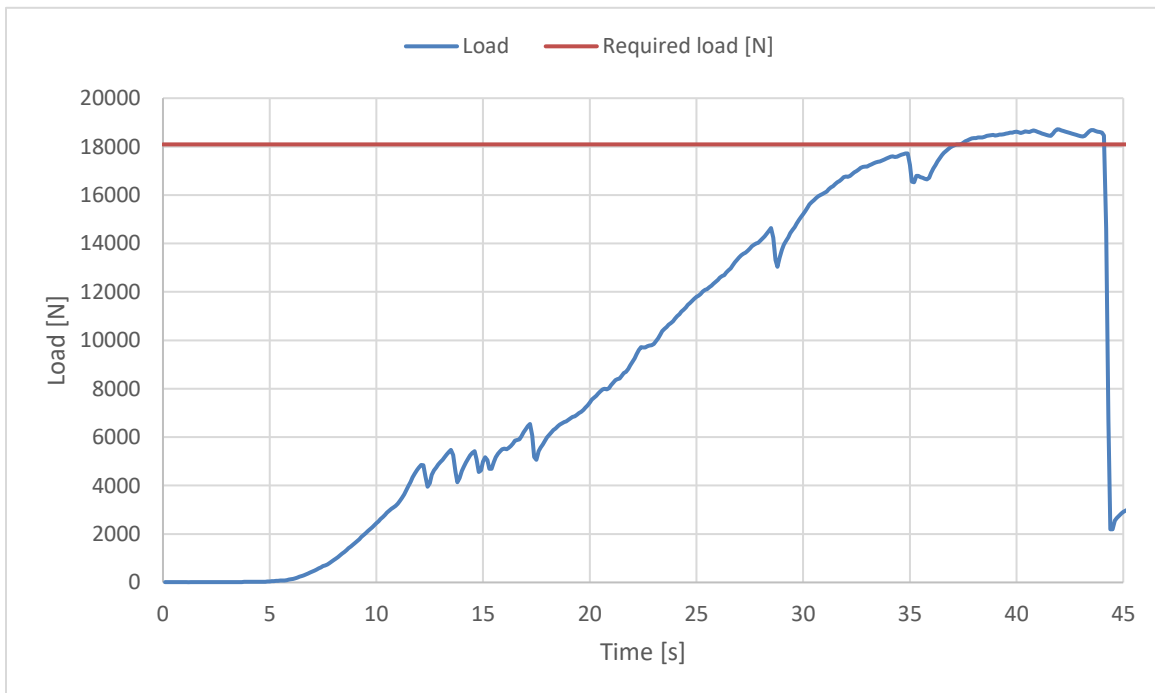
Test ID 09

Test duration [s] **6.8**
 Any signs of structural failure **No**
 Slippery test OK **Yes**
 Test results **POSITIVE**

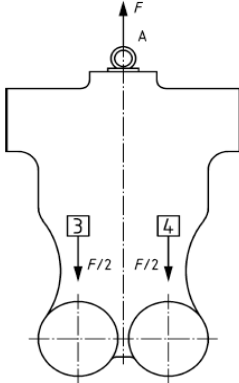
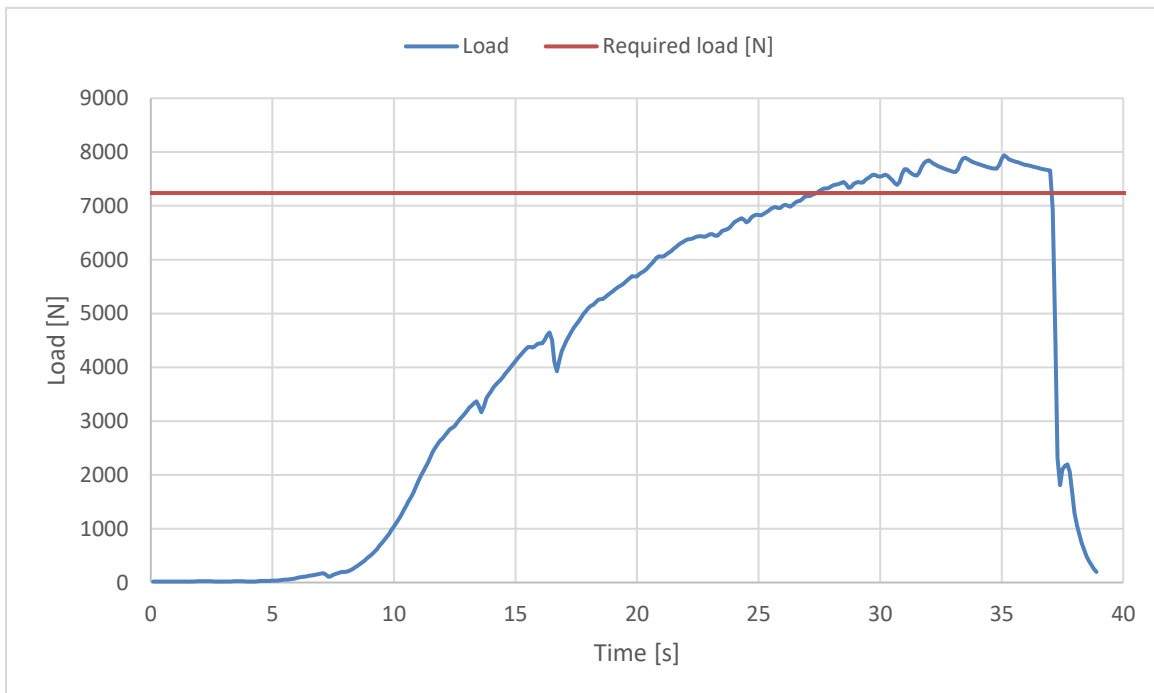
Test ID 06

| Any signs of structural failure | No |
| Test results | POSITIVE |

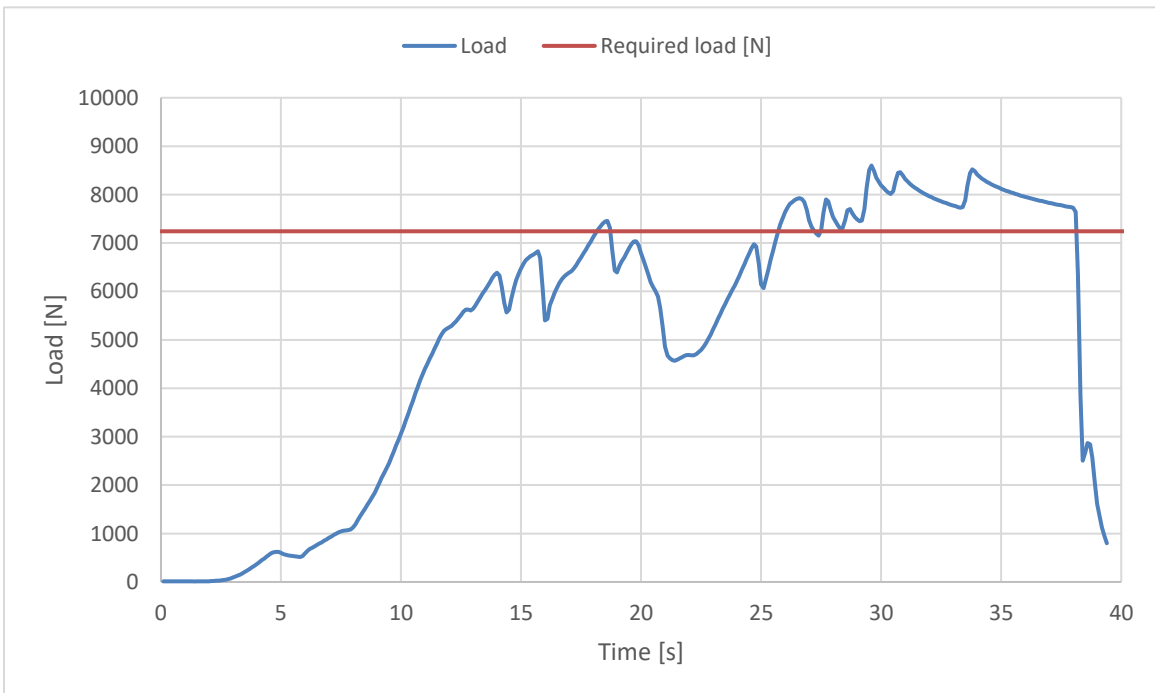
Test ID 12

| Any signs of structural failure | No |
| Slippery test OK | Yes |
| Test results | POSITIVE |

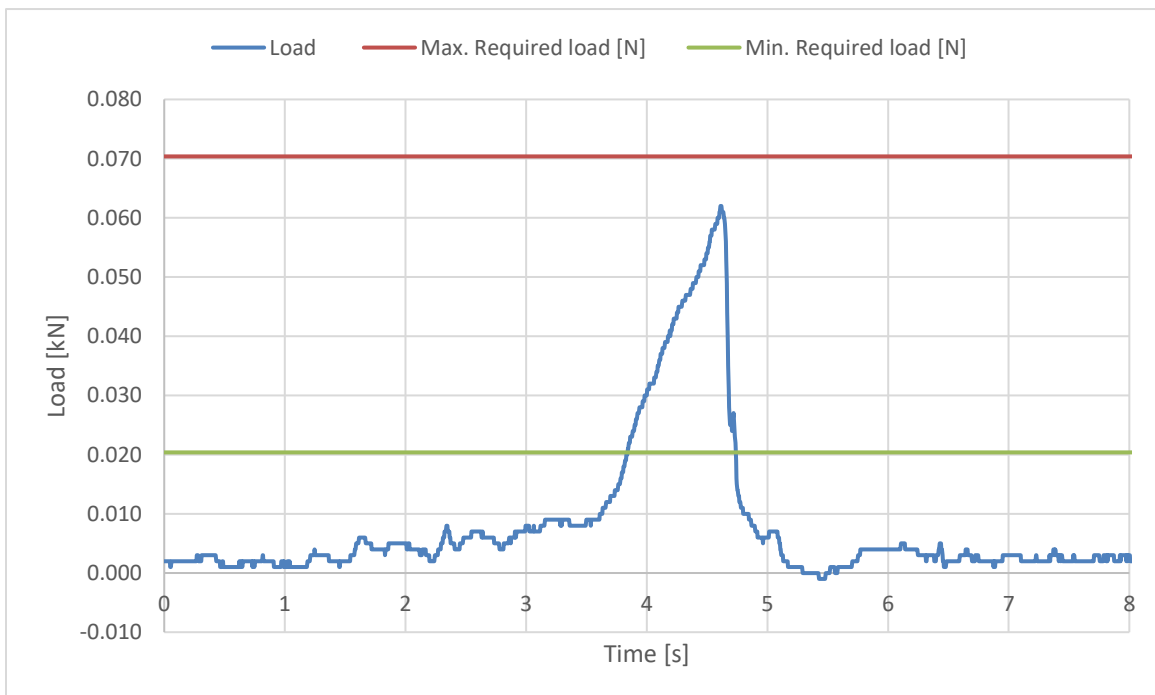
Test ID RRDT

| Load for first action [N] | 61.63 |
| Test results | POSITIVE |

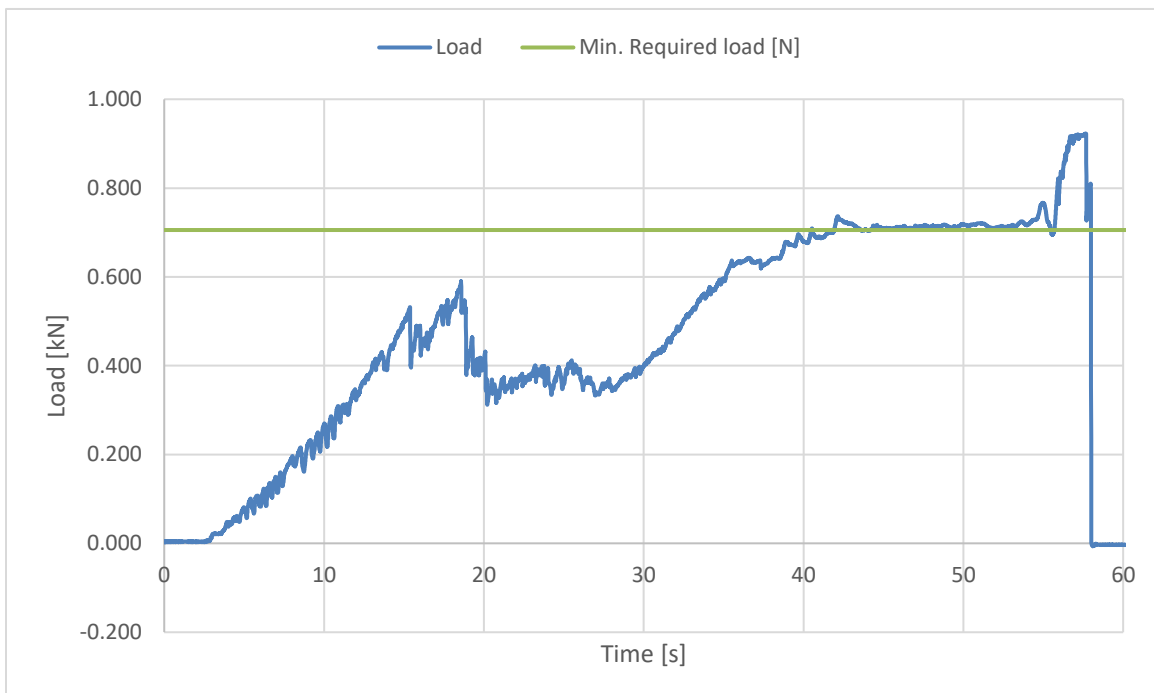
Test ID RRST

| Breaking strength [N] | 917.45 |
| Test results | POSITIVE |
