## Harness Structural test Report - EN / NfL

Inspection certificate number: **PH\_476.2025**

Name: **Atak 2**  
 Type: **ABS**  
 Size: **S/M**  
 Serial number: **V12**  
 Impact pad type: <sup>(1)</sup> **Inflatable**  
 Clip-in weight [kg]: **120**

**EN1651:2018+A1:2020 and EN12491:2015+A1:2021 and NfL 2024-2-785**

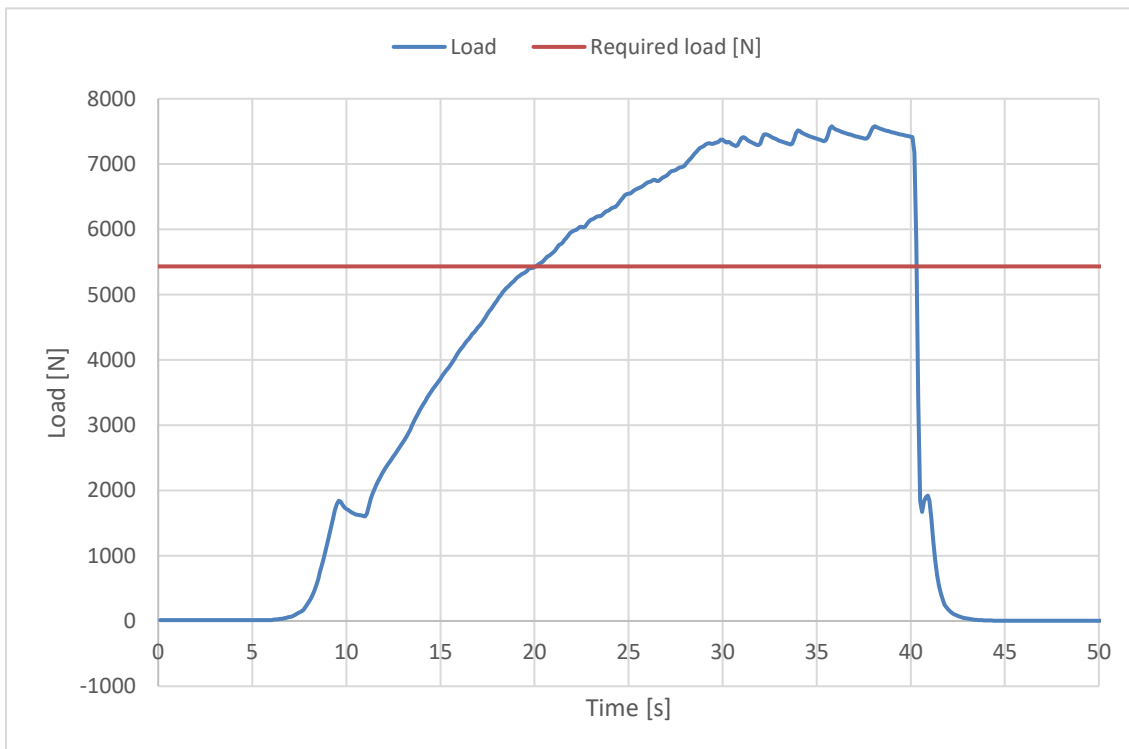
**Test ID 01**

Standard	<b>EN 1651 / NfL 2024-2-785</b>
Reference in standard	<b>5.5.1.1</b>
Test setup	<b>Positive symmetric load (Slippage)</b>
Attachment points	<b>Both main riser attachment (3,4)</b>
Anchor points	<b>Dummy (B1, B2)</b>
Required load [g]	<b>4.5</b>
Required load [N]	<b>5400</b>
Minimum test duration [s]	<b>5</b>
<b>Result</b>	
Test duration [s]	<b>20.3</b>
Any signs of structural failure	<b>No</b>
Slippery test OK	<b>Yes</b>
Test results	<b>POSITIVE</b>

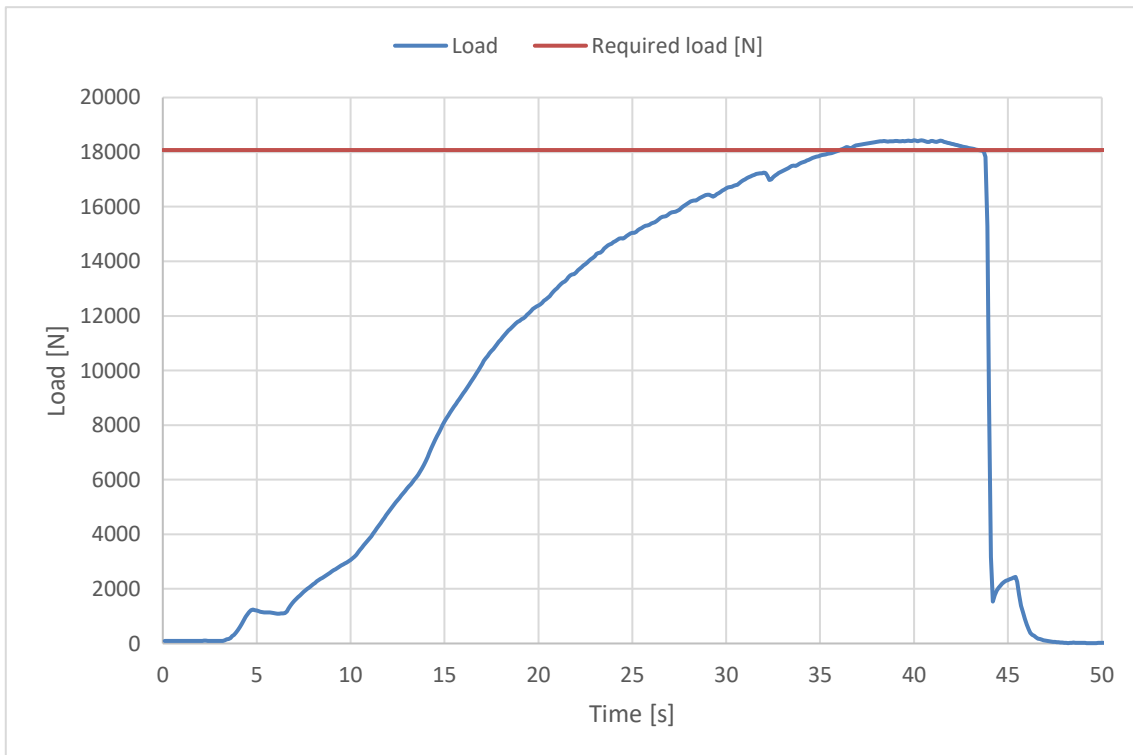
**Test ID 03**

Standard	<b>EN 1651 / NfL 2024-2-785</b>
Reference in standard	<b>5.5.1.1b</b>
Test setup	<b>Positive symmetric load</b>
Attachment points	<b>Both main riser attachment (3,4)</b>
Anchor points	<b>Dummy (B1, B2)</b>
Required load [g]	<b>15</b>
Required load [N]	<b>18000</b>
Minimum test duration [s]	<b>5</b>
<b>Result</b>	
Test duration [s]	<b>7.4</b>
Any signs of structural failure	<b>No</b>
Slippery test OK	<b>Yes</b>
Test results	<b>POSITIVE</b>

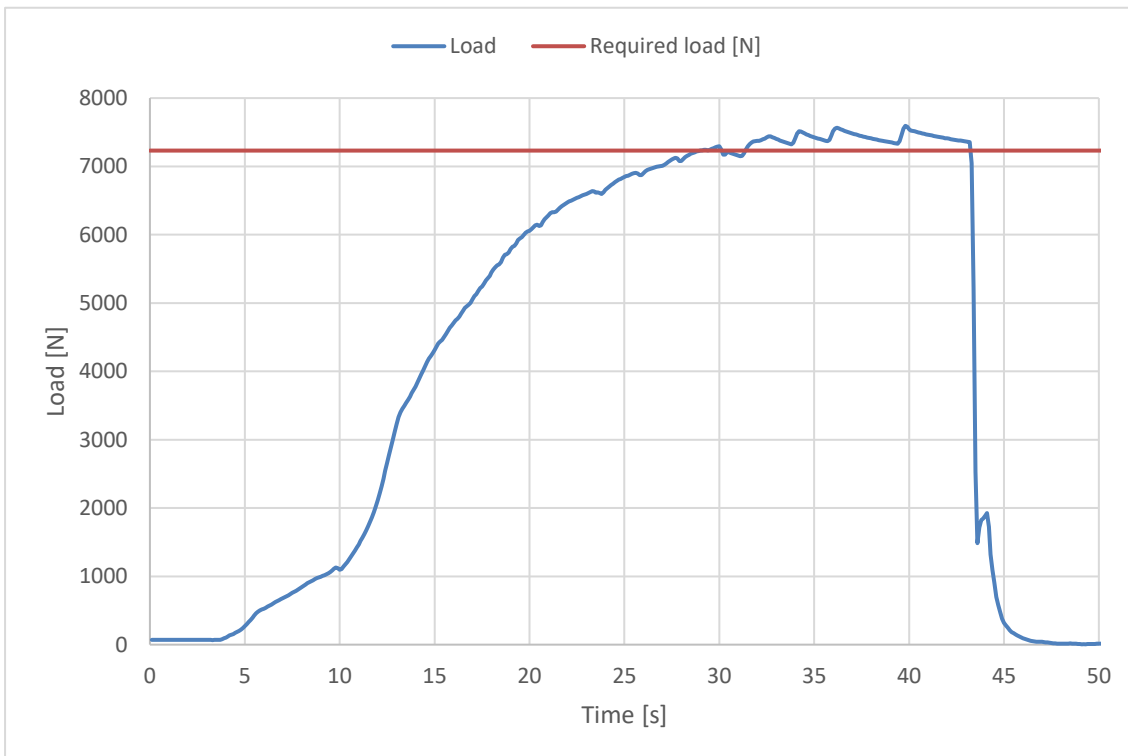
**Test ID 05**

Standard	<b>EN 1651 / NfL 2024-2-785</b>
Reference in standard	<b>5.5.1.2</b>
Test setup	<b>Positive asymmetric load</b>
Attachment points	<b>One riser attachment (3 or 4)</b>
Anchor points	<b>Dummy (C)</b>
Required load [g]	<b>6</b>
Required load [N]	<b>7200</b>
Minimum test duration [s]	<b>5</b>
<b>Result</b>	
Test duration [s]	<b>11.9</b>
Any signs of structural failure	<b>No</b>
Test results	<b>POSITIVE</b>

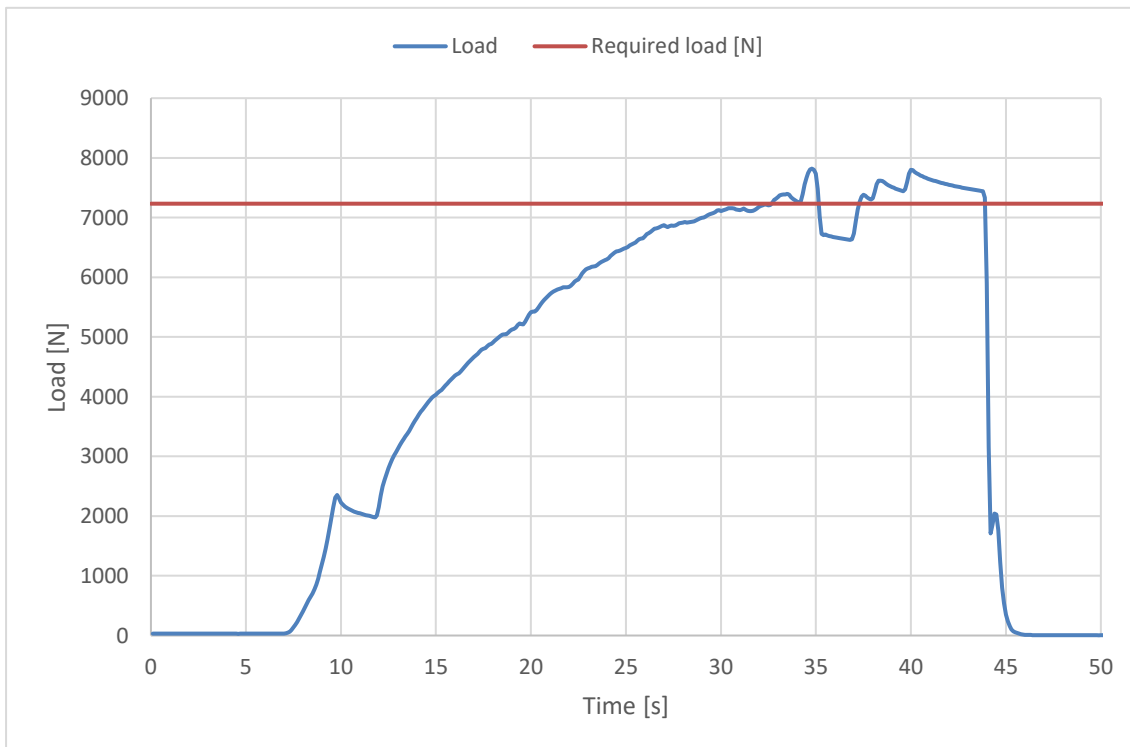
**Test ID 06**

Standard	<b>EN 1651 / NfL 2024-2-785</b>
Reference in standard	<b>5.5.1.6</b>
Test setup	<b>Negative symmetric load</b>
Attachment points	<b>Both main riser attachment (3,4)</b>
Anchor points	<b>Dummy (A)</b>
Required load [g]	<b>6</b>
Required load [N]	<b>7200</b>
Minimum test duration [s]	<b>5</b>
<b>Result</b>	
Test duration [s]	<b>6.7</b>
Any signs of structural failure	<b>No</b>
Test results	<b>POSITIVE</b>

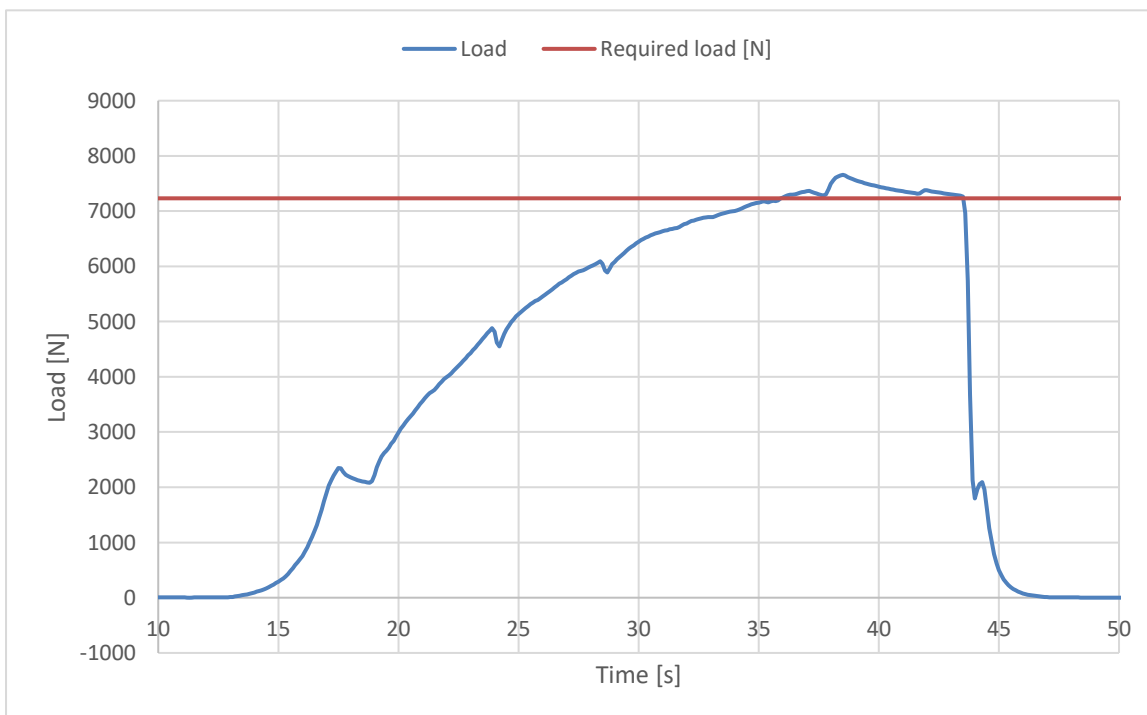
**Test ID 12**

Standard	<b>EN 1651 / NfL 2024-2-785</b>
Reference in standard	<b>5.5.1.7</b>
Test setup	<b>Upright (landing) position load</b>
Attachment points	<b>Both main riser attachment (3, 4)</b>
Anchor points	<b>Both legstrap of harness (no dummy)</b>
Required load [g]	<b>6</b>
Required load [N]	<b>7200</b>
Minimum test duration [s]	<b>5</b>
Harness type	<b>type c</b>
<b>Result</b>	
Test duration [s]	<b>7.6</b>
Any signs of structural failure	<b>No</b>
Slippery test OK	<b>Yes</b>
Test results	<b>POSITIVE</b>
