Harness Structural test Report - EN

Inspection certificate number: **PH_358.2022**

Name: **F*Lite 2**
 Type: **ABS**
 Size: **M**
 Serial number: **FL2-PROTO1**
 Impact pad type: ⁽¹⁾ **n/a**
 Clip-in weight [kg]: **120**
 Date of test: **13.12.2021**

Air Turquoise SA, having thoroughly assessed the sample mentioned above, declare it was found conform with
 European Standard **EN1651:2018**, and **EN12491:2015**

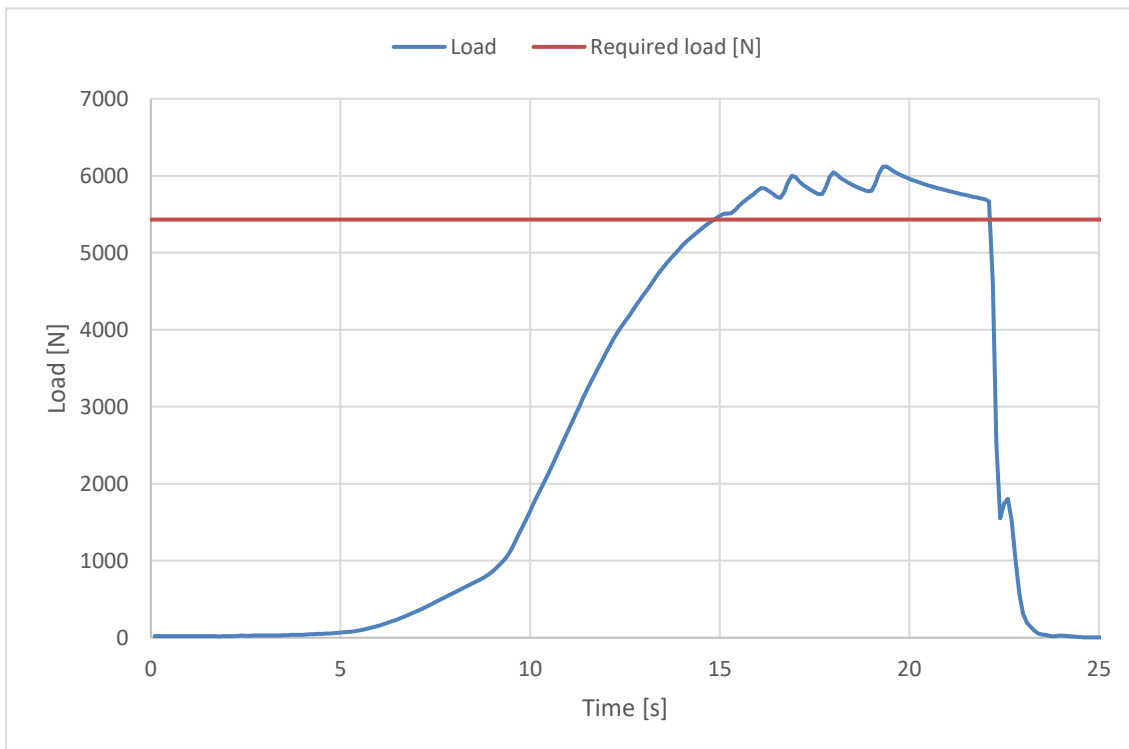
Test ID 01

Standard	EN 1651
Reference in standard	5.5.1.1
Test setup	Positive symmetric load (Slippage)
Attachment points	Both main riser attachment (3,4)
Anchor points	Dummy (B1, B2)
Required load [g]	4.5
Required load [N]	5400
Minimum test duration [s]	5
Result	
Test duration [s]	7.3
Any signs of structural failure	No
Slippery test OK	Yes
Test results	POSITIVE

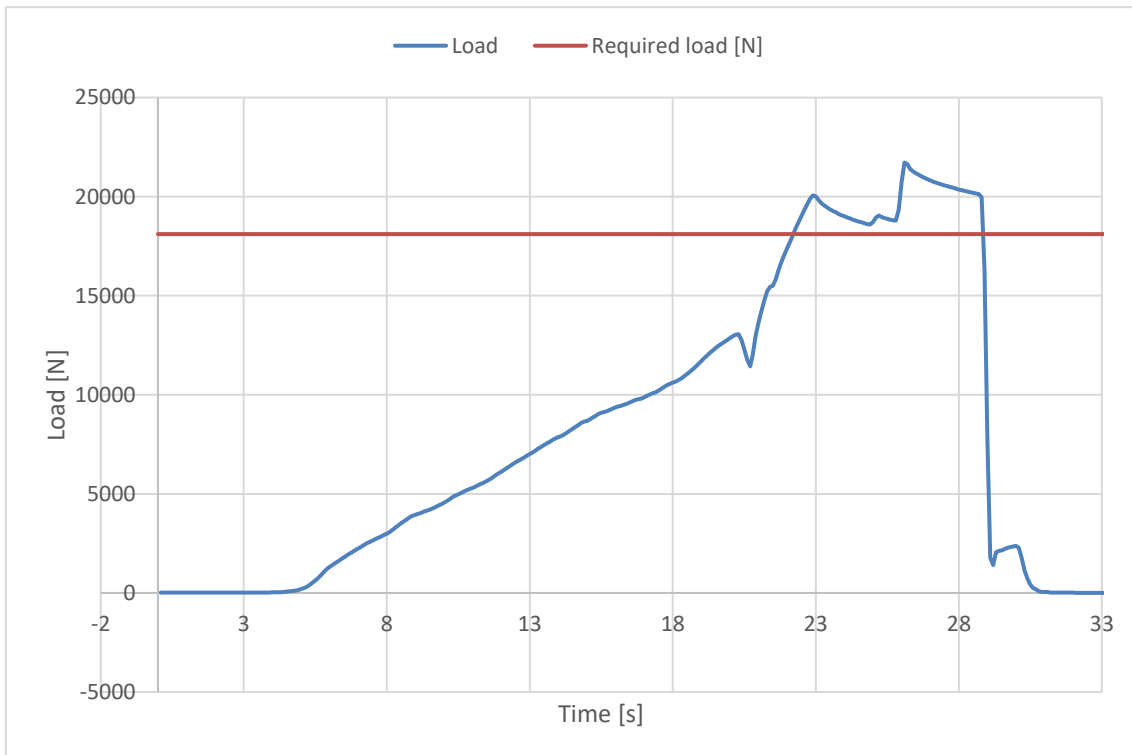
Test ID 03

Standard **EN 1651**
 Reference in standard **5.5.1.1b**
 Test setup **Positive symmetric load**
 Attachment points **Both main riser attachment (3,4)**
 Anchor points **Dummy (B1, B2)**

Test duration [s] **6.6**
 Any signs of structural failure **No**
 Slippery test OK **Yes**
 Test results **POSITIVE**

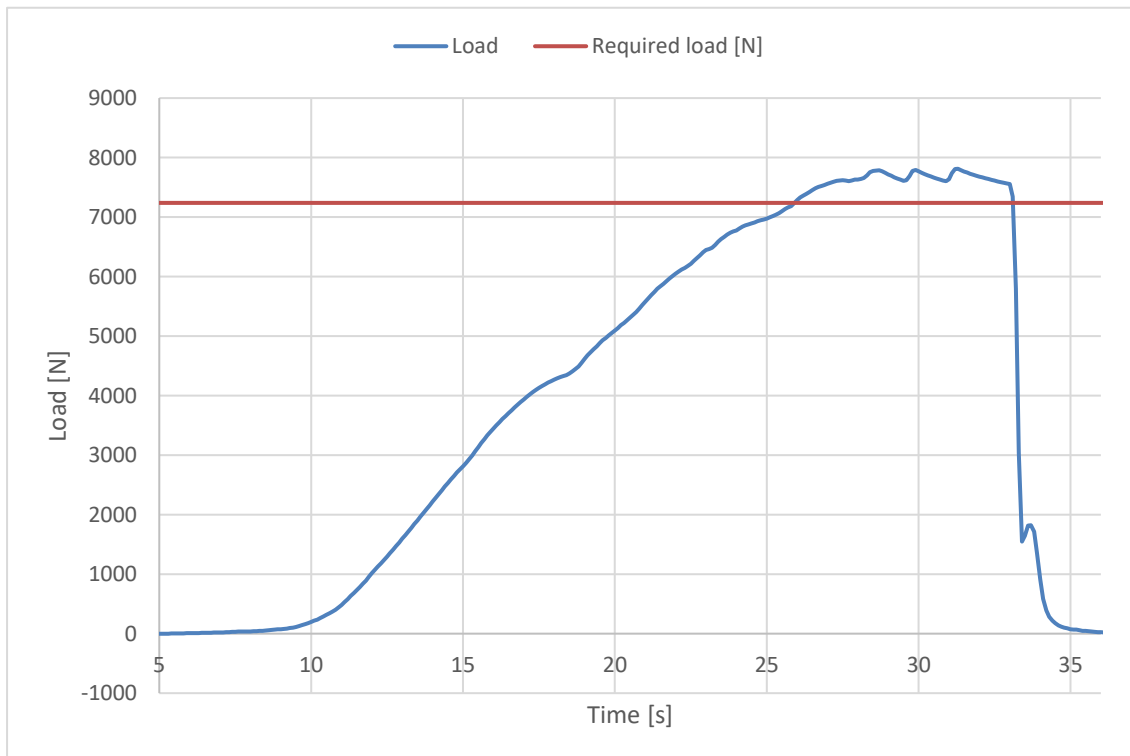
Test ID 05

Standard	EN 1651
Reference in standard	5.5.1.2
Test setup	Positive asymmetric load
Attachment points	One riser attachment (3 or 4)
Anchor points	Dummy (C)
Required load [g]	6
Required load [N]	7200
Minimum test duration [s]	5
Result	
Test duration [s]	7.2
Any signs of structural failure	No
Test results	POSITIVE

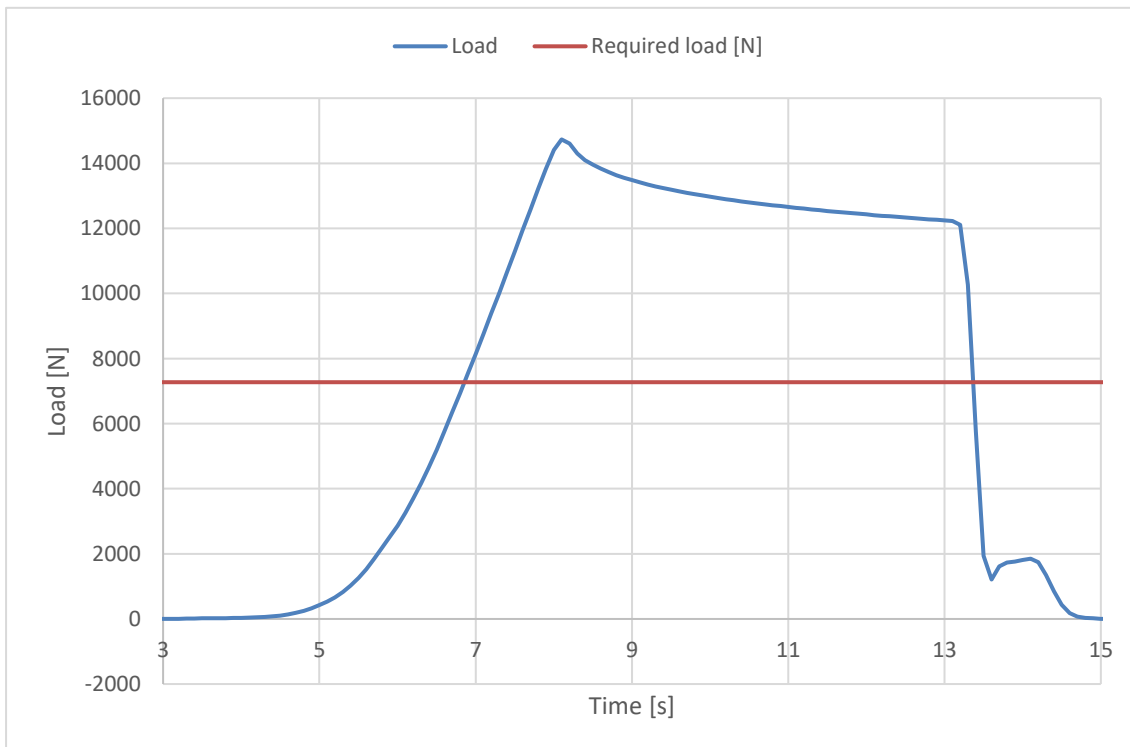
Test ID 06

Standard	EN 1651
Reference in standard	5.5.1.6
Test setup	Negative symmetric load
Attachment points	Both main riser attachment (3,4)
Anchor points	Dummy (A)
Required load [g]	6
Required load [N]	7200
Minimum test duration [s]	5
Result	
Test duration [s]	6.5
Any signs of structural failure	No
Test results	POSITIVE

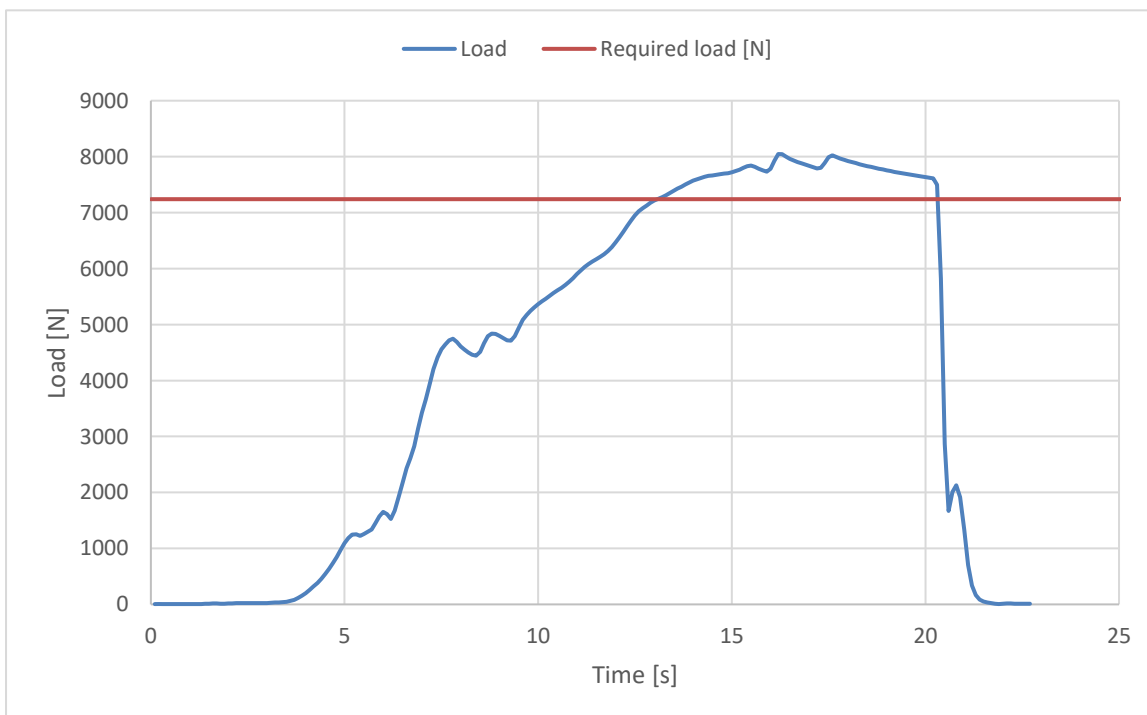
Test ID 12

Standard	EN 1651
Reference in standard	5.5.1.7
Test setup	Upright (landing) position load
Attachment points	Both main riser attachment (3, 4)
Anchor points	Both legstrap of harness (no dummy)
Required load [g]	6
Required load [N]	7200
Minimum test duration [s]	5
Harness type	type c
Result	
Test duration [s]	7.3
Any signs of structural failure	No
Slippery test OK	Yes
Test results	POSITIVE
