## Harness Structural test Report

Inspection certificate number: **PH\_263.2019**

Name: **F\*Race**  
 Type: **ABS**  
 Size: **M**  
 Serial number: **Frace-M-095-01**  
 Impact pad type: <sup>(1)</sup> **Foam**  
 Clip-in weight [kg]: **100**

### Summary of Structural test

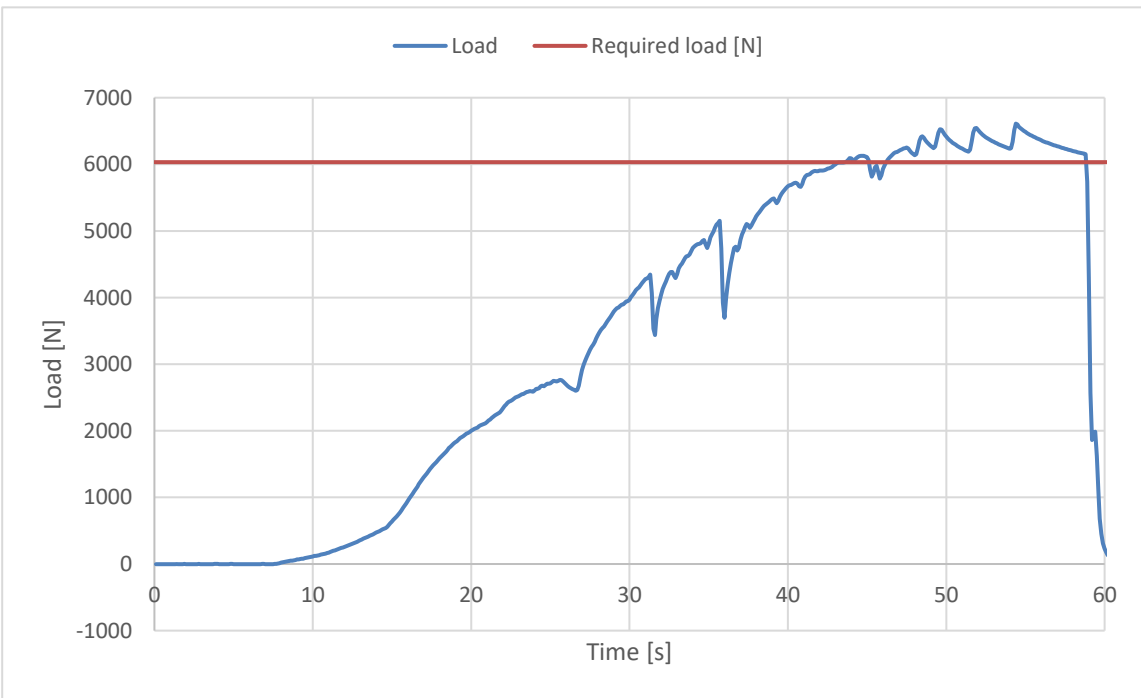
**Test ID R0**

Standard	<b>EN 1651:1999</b>	
Reference in standard	<b>5.3.2.1</b>	
Test setup	<b>Default flying position</b>	
Attachment points	<b>Both main riser attachment (3,4)</b>	
Anchor points	<b>Dummy (B1, B2)</b>	
Required load [g]	<b>6</b>	<p>####</p>
Required load [N]	<b>6000</b>	
Minimum test duration [s]	<b>10</b>	
<b>Result</b>		
Test duration [s]	<b>12.6</b>	
Any signs of structural failure	<b>No</b>	
Test results	<b>POSITIVE</b>

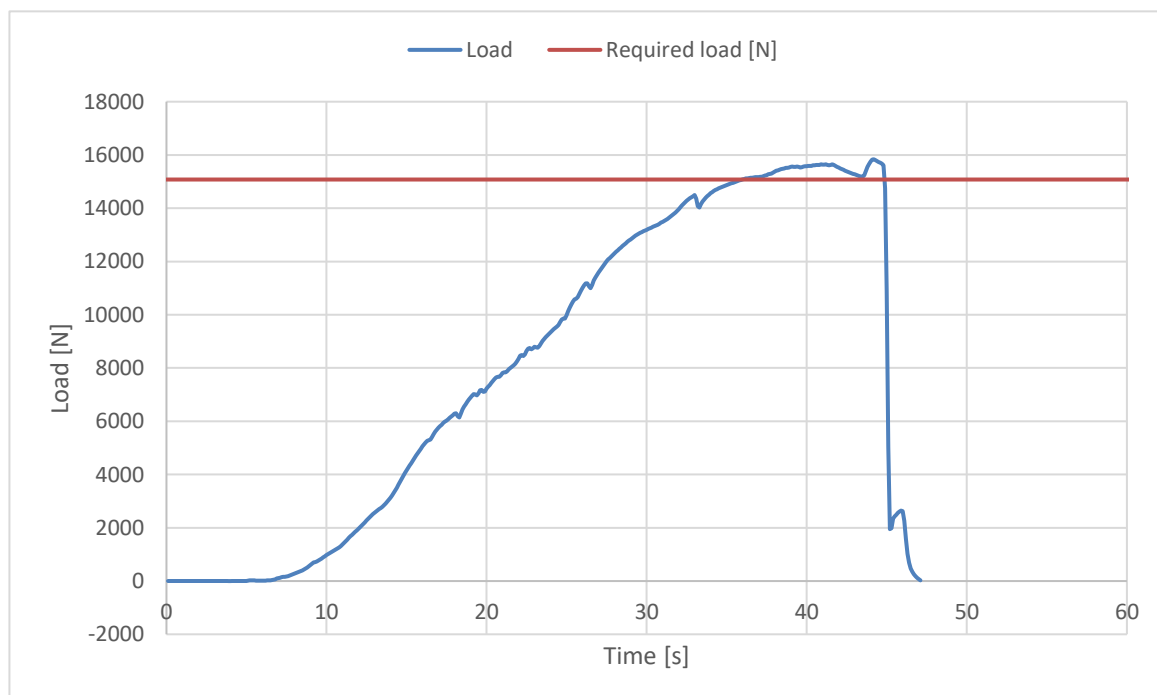
**Test ID R2**

Reference in standard	<b>5.3.2.2</b>	
Test setup	<b>Default flying position</b>	
Attachment points	<b>Both main riser attachment (3,4)</b>	
Anchor points	<b>Dummy (B1, B2)</b>	
Required load [g]	<b>15</b>	
Required load [N]	<b>15000</b>	
Minimum test duration [s]	<b>5</b>	
<b>Result</b>		
Test duration [s]	<b>8.9</b>	
Any signs of structural failure	<b>No</b>	
Test results	<b>POSITIVE</b>

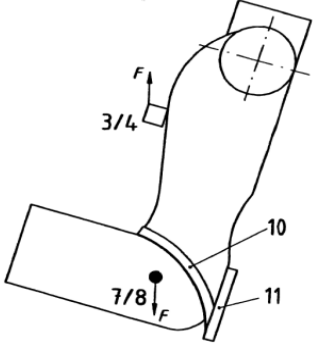
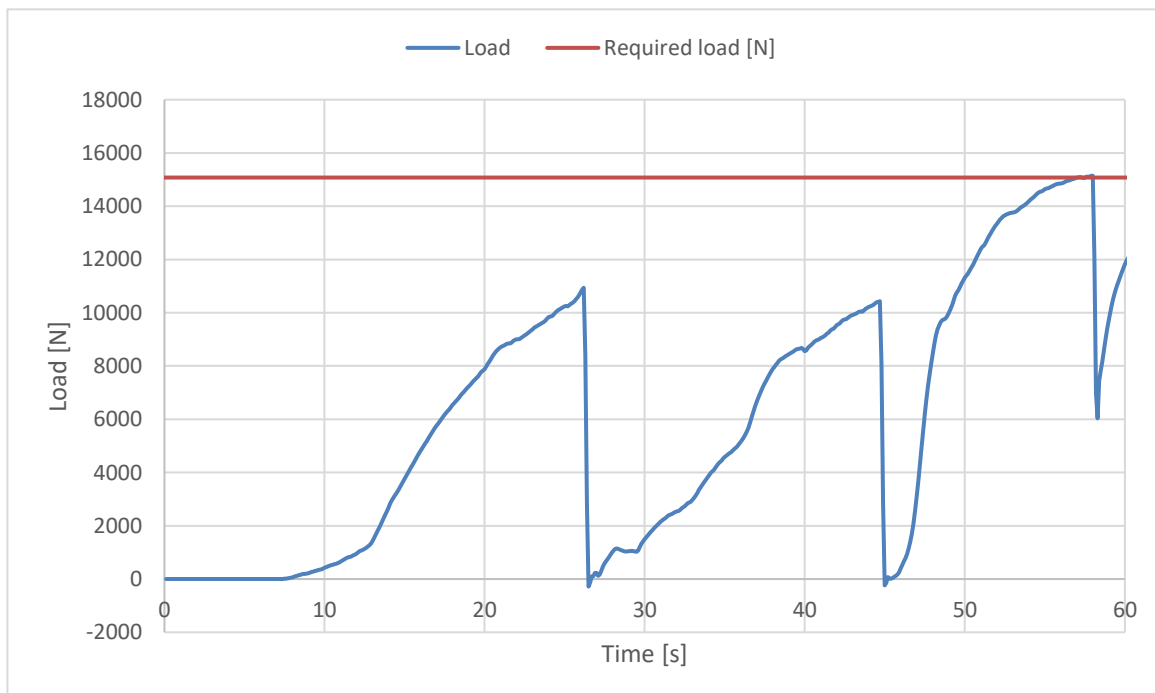
**Test ID R4**

Standard	<b>EN 1651:1999</b>
Reference in standard	<b>5.3.2.7</b>
Test setup	<b>Flying position before landing</b>
Attachment points	<b>Both main riser attachment (3,4)</b>
Anchor points	<b>Dummy (7,8)</b>
Required load [g]	<b>15</b>
Required load [N]	<b>15000</b>
Minimum test duration [s]	<b>5</b>
<b>Result</b>	
Test duration [s]	<b>8.4</b>
Any signs of structural failure	<b>No</b>
Test results	<b>POSITIVE</b>

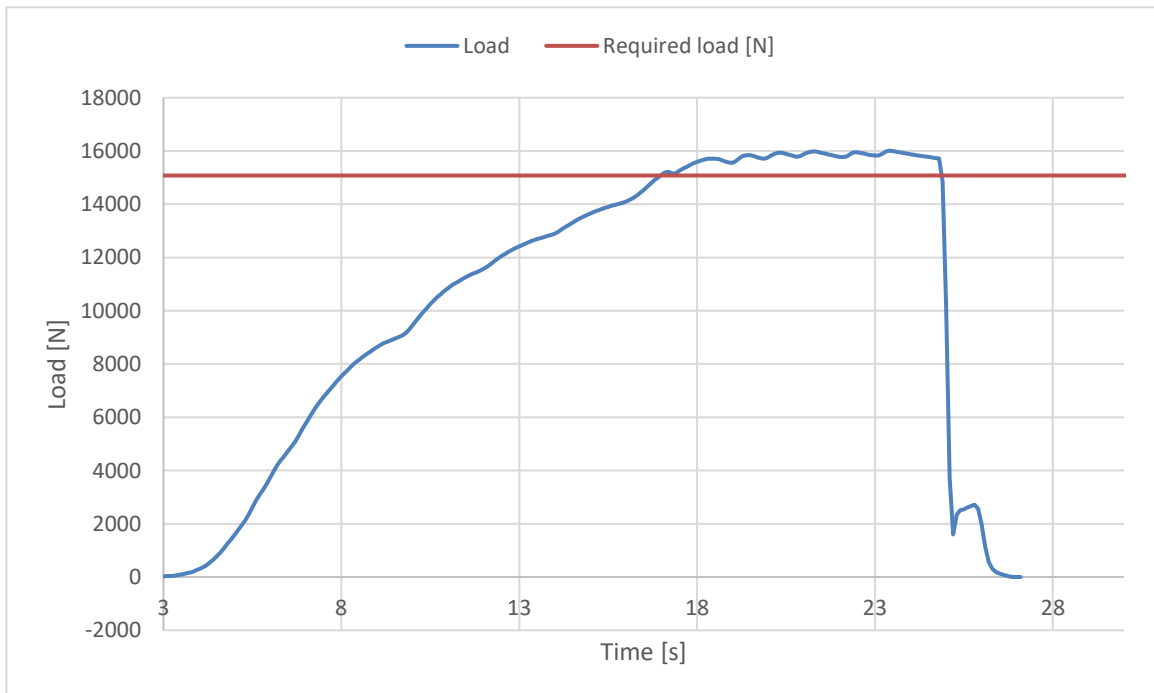
**Test ID R6**

Standard	<b>EN 1651:1999</b>	
Reference in standard	<b>5.3.2.4</b>	
Test setup	<b>Rescue attachments</b>	
Attachment points	<b>Rescue riser attachment (1,2)</b>	
Anchor points	<b>Dummy (B1,B2)</b>	
Required load [g]	<b>15</b>	
Required load [N]	<b>15000</b>	
Minimum test duration [s]	<b>5</b>	
<b>Result</b>		
Test duration [s]	<b>7.9</b>	
Any signs of structural failure	<b>No</b>	
Test results	<b>POSITIVE</b>

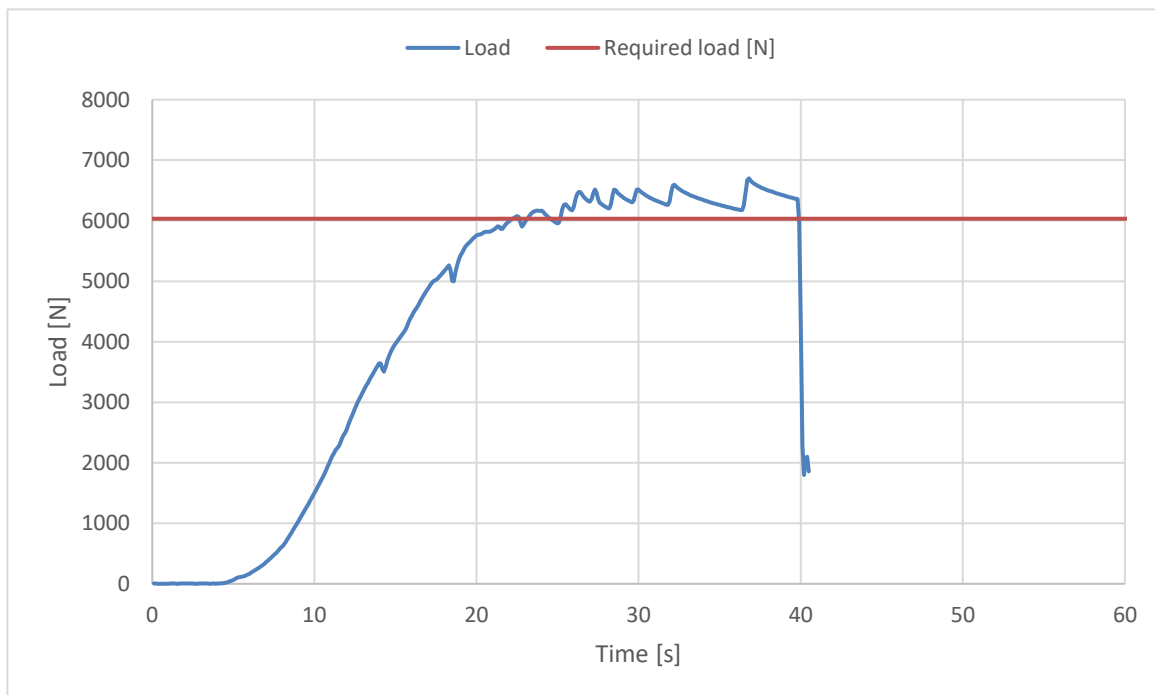
**Test ID R8**

Standard	<b>EN 1651:1999</b>	<p>###</p>
Reference in standard	<b>5.3.2.3</b>	
Test setup	<b>Asymmetric, one riser</b>	
Attachment points	<b>One main riser attachment (3)</b>	
Anchor points	<b>Dummy (B1,B2)</b>	
Required load [g]	<b>6</b>	
Required load [N]	<b>6000</b>	
Minimum test duration [s]	<b>10</b>	
<b>Result</b>		
Test duration [s]	<b>14.7</b>	
Any signs of structural failure	<b>No</b>	
Test results	<b>POSITIVE</b>

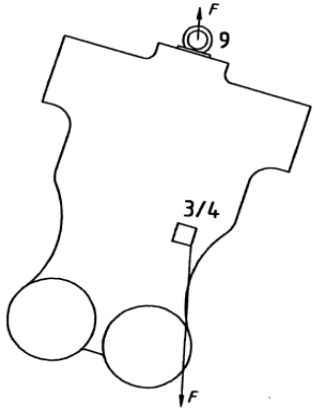
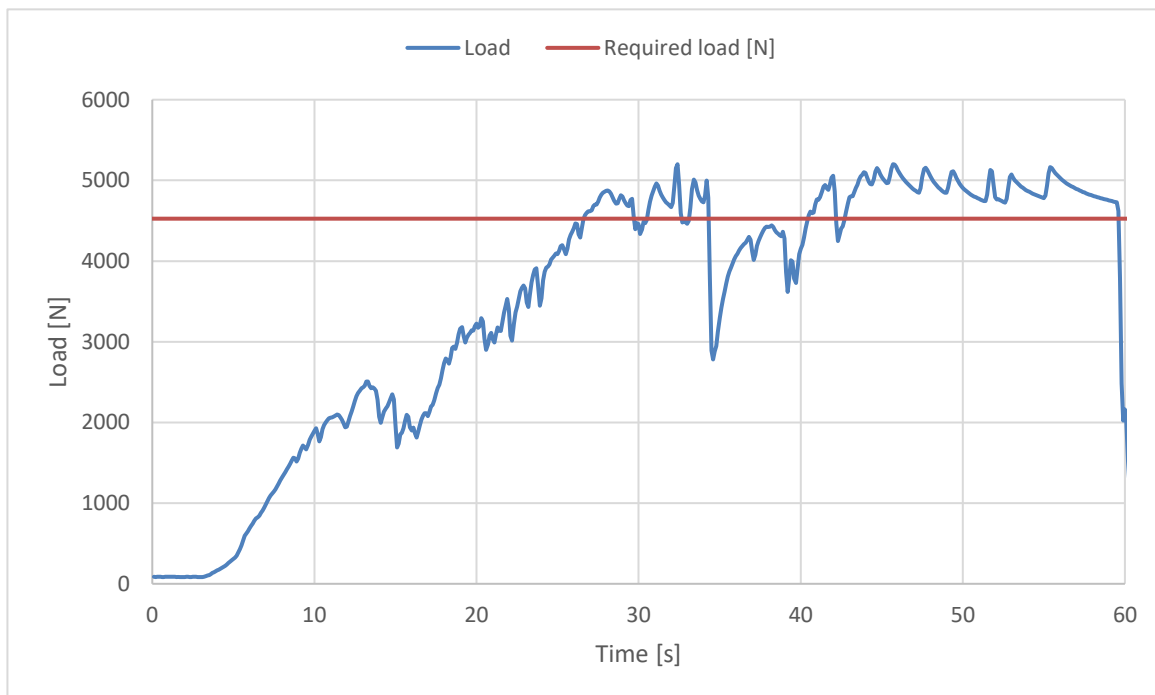
**Test ID R10**

Reference in standard	<b>5.3.2.6</b>	
Test setup	<b>Asymmetric, negative</b>	
Attachment points	<b>One main riser attachment (3 or 4) downwards</b>	
Anchor points	<b>Dummy (9)</b>	
Required load [g]	<b>4.5</b>	
Required load [N]	<b>4500</b>	
Minimum test duration [s]	<b>10</b>	
<b>Result</b>		
Test duration [s]	<b>16.9</b>	
Any signs of structural failure	<b>No</b>	
Test results	<b>POSITIVE</b>

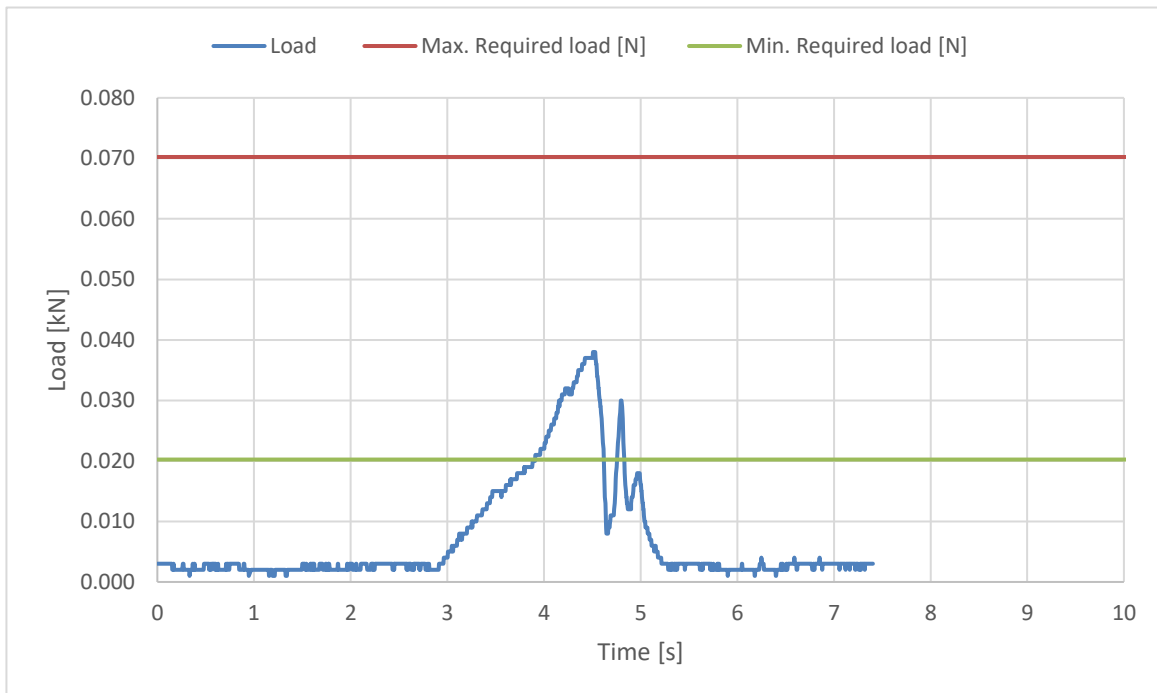
**Test ID RRDT**

Standard	<b>LTF NfL II 91/09</b>
Reference in standard	<b>6.1.5</b>
Test setup	<b>Default flying position</b>
Attachment points	<b>Sensor connect to handle, and pull in opening direction</b>
	The test is to simulate the load required to open the emergency parachute(1st action).
Min. Required load [N]	<b>20</b>
Max. Required load [N]	<b>70</b>
<b>Result</b>	
Load for first action [N]	<b>37.77</b>
Test results	<b>POSITIVE</b>

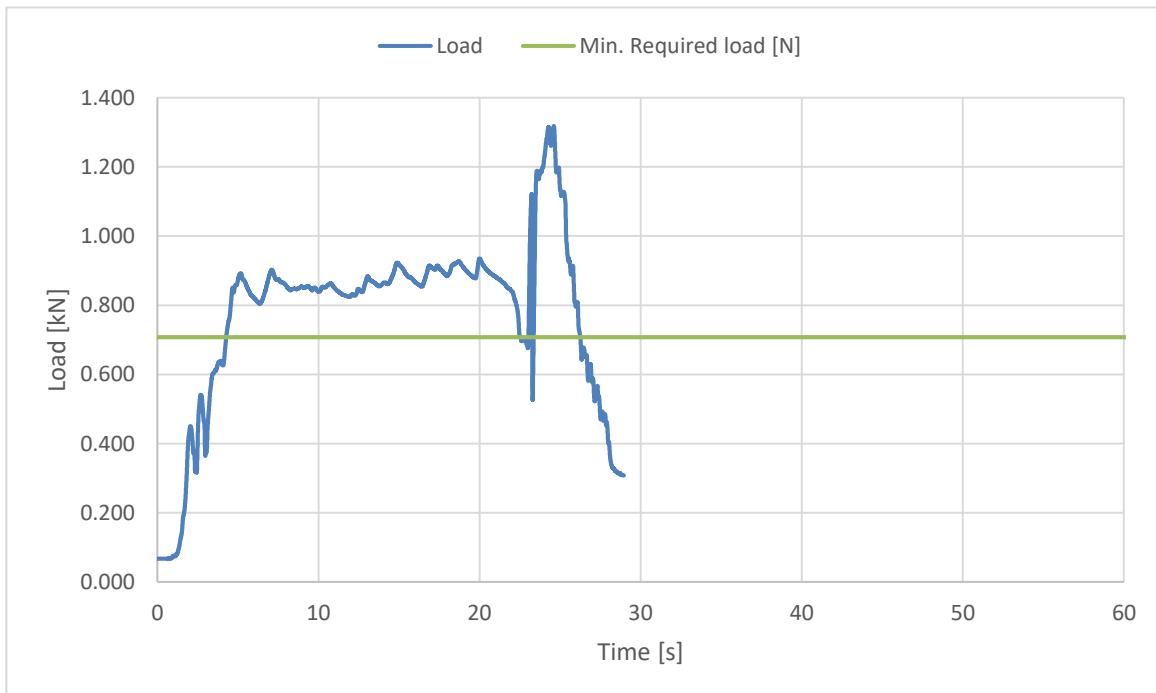
**Test ID RRST**

Standard	<b>EN12491:2015</b>
Reference in standard	<b>5.3.2</b>
Test setup	<b>Two end points of handle</b>
Attachment points	<b>Sensor connect to end of handle, pull on the other side</b>
	The handle must support min 700 N for 10 s, after measure breaking strength
Min. Required load [N]	<b>700</b>
Minimum test duration [s]	<b>10</b>
<b>Result</b>	
Test duration [s]:	<b>18.2</b>
Breaking strength [N]	<b>1310.08</b>
Test results	<b>POSITIVE</b>
