# Harness Structural test Report

Inspection certificate number: **PH\_266.2019**
**Manufacturer data:**

Name: **Solos**  
 Type: **ABS**  
 Size: **M**  
 Serial number: **V2**  
 Impact pad type: <sup>(1)</sup> **Foam**  
 Clip-in weight [kg]: **120**

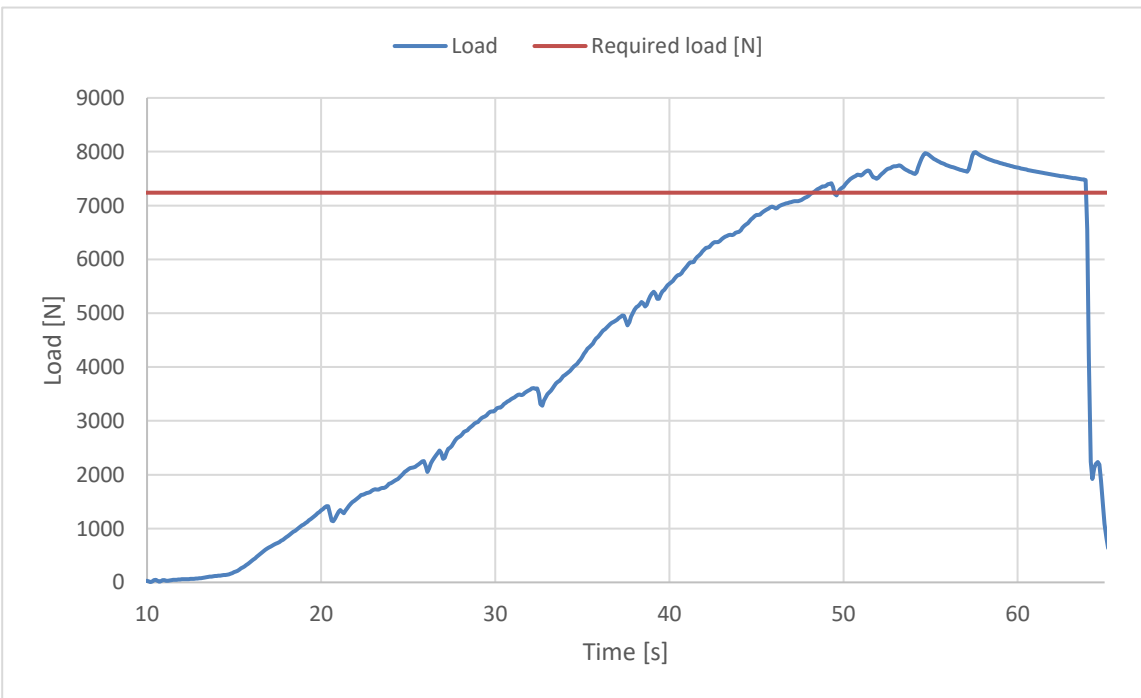
**Test ID R0**

Reference in standard	<b>5.3.2.1</b>	
Test setup	<b>Default flying position</b>	
Attachment points	<b>Both main riser attachment (3,4)</b>	
Anchor points	<b>Dummy (B1, B2)</b>	
Required load [g]	<b>6</b>	
Required load [N]	<b>7200</b>	
Minimum test duration [s]	<b>10</b>	
<b>Result</b>		
Test duration [s]	<b>14.3</b>	
Any signs of structural failure	<b>No</b>	
Test results	<b>POSITIVE</b>

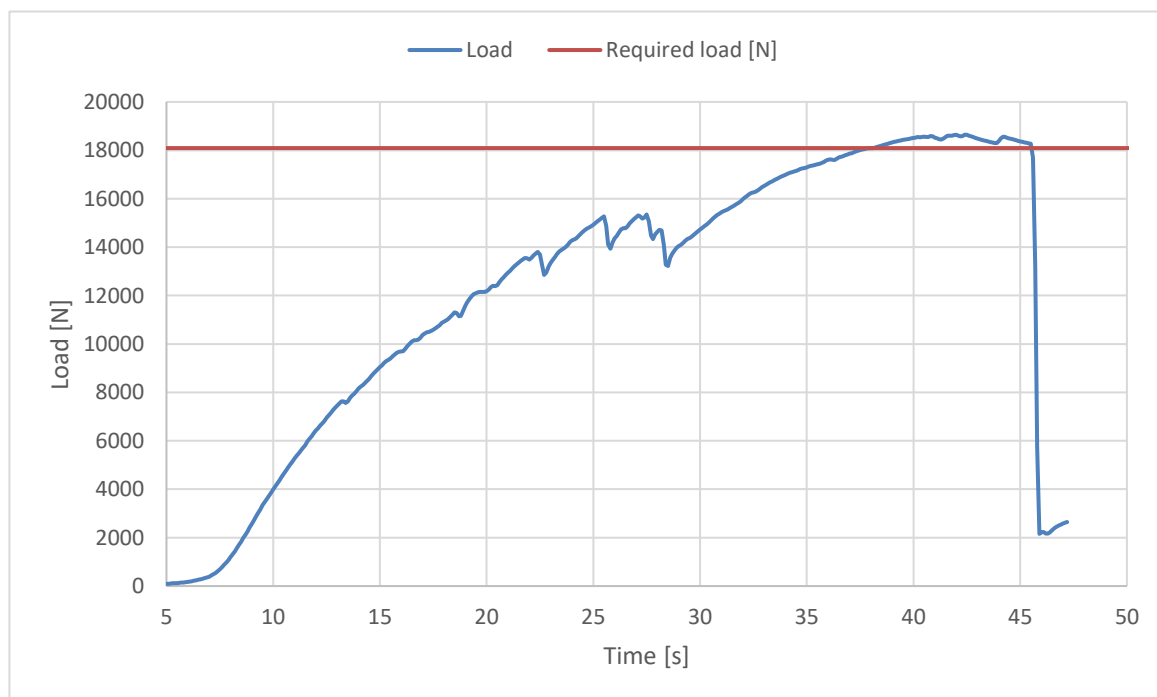
**Test ID R2**

Standard	<b>EN 1651:1999</b>
Reference in standard	<b>5.3.2.2</b>
Test setup	<b>Default flying position</b>
Attachment points	<b>Both main riser attachment (3,4)</b>
Anchor points	<b>Dummy (B1, B2)</b>
Required load [g]	<b>15</b>
Required load [N]	<b>18000</b>
Minimum test duration [s]	<b>5</b>
<b>Result</b>	
Test duration [s]	<b>7.4</b>
Any signs of structural failure	<b>No</b>
Test results	<b>POSITIVE</b>

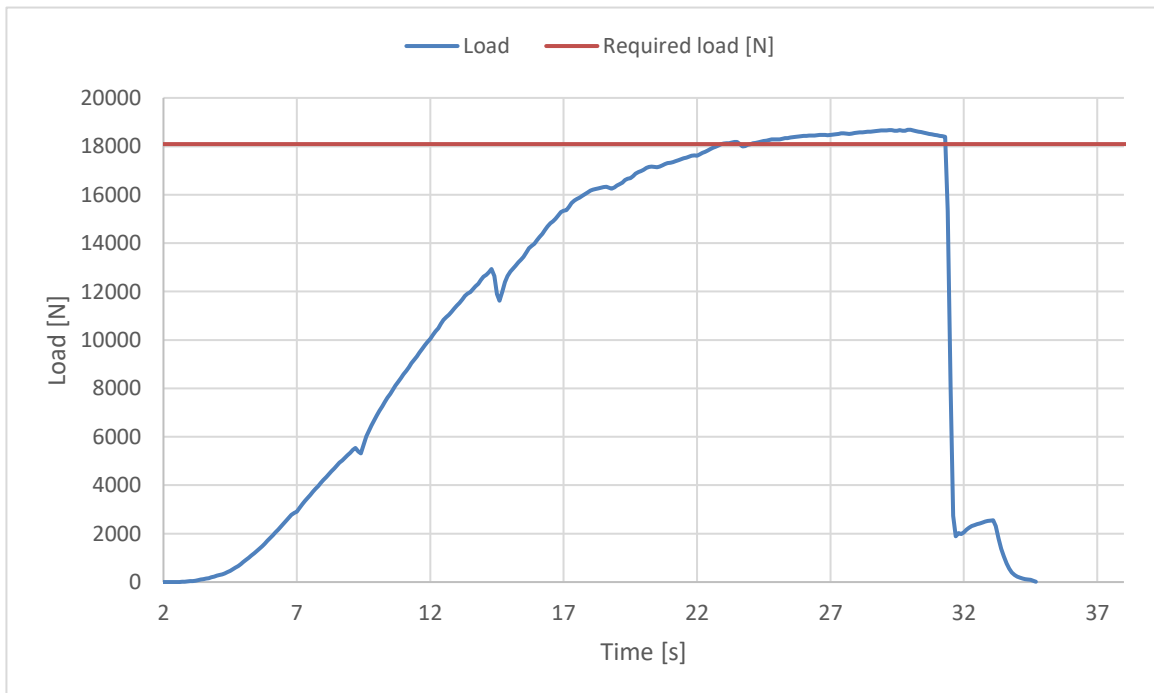
**Test ID R4**

Standard	<b>EN 1651:1999</b>
Reference in standard	<b>5.3.2.7</b>
Test setup	<b>Flying position before landing</b>
Attachment points	<b>Both main riser attachment (3,4)</b>
Anchor points	<b>Dummy (7,8)</b>
Required load [g]	<b>15</b>
Required load [N]	<b>18000</b>
Minimum test duration [s]	<b>5</b>
<b>Result</b>	
Test duration [s]	<b>7.4</b>
Any signs of structural failure	<b>No</b>
Test results	<b>POSITIVE</b>

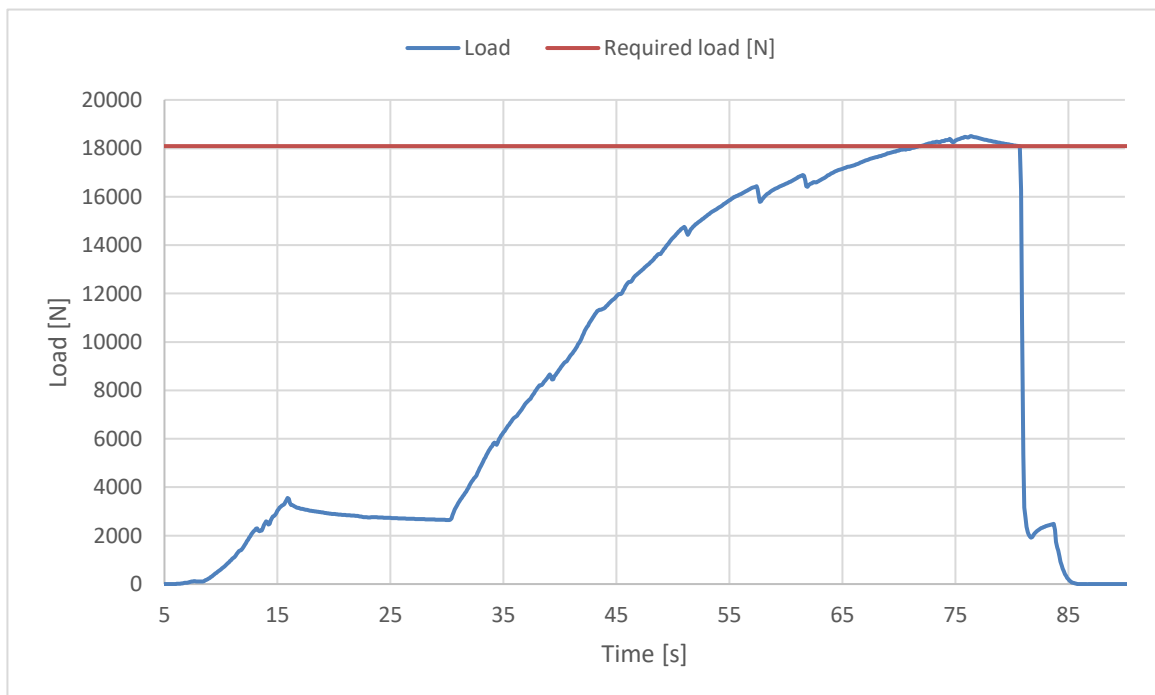
**Test ID R6**

Standard	<b>EN 1651:1999</b>
Reference in standard	<b>5.3.2.4</b>
Test setup	<b>Rescue attachments</b>
Attachment points	<b>Rescue riser attachment (1,2)</b>
Anchor points	<b>Dummy (B1,B2)</b>
Required load [g]	<b>15</b>
Required load [N]	<b>18000</b>
Minimum test duration [s]	<b>5</b>
<b>Result</b>	
Test duration [s]	<b>8.8</b>
Any signs of structural failure	<b>No</b>
Test results	<b>POSITIVE</b>

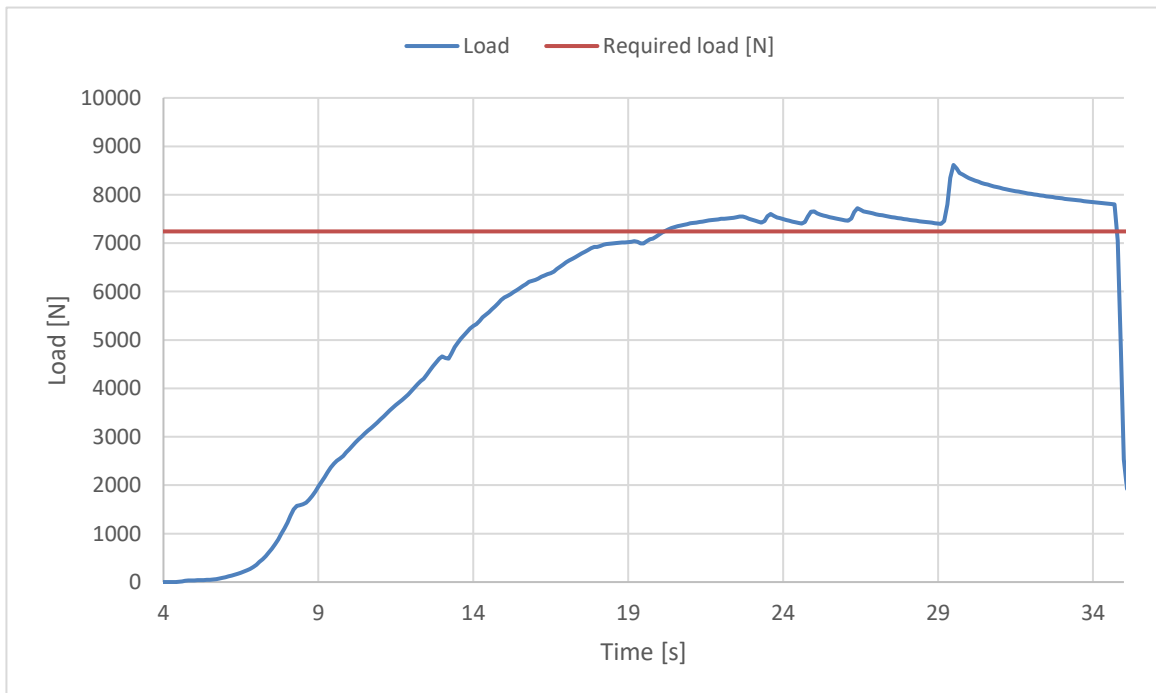
**Test ID R8**

Reference in standard	<b>5.3.2.3</b>	
Test setup	<b>Asymmetric, one riser</b>	
Attachment points	<b>One main riser attachment (3)</b>	
Anchor points	<b>Dummy (B1,B2)</b>	
Required load [g]	<b>6</b>	
Required load [N]	<b>7200</b>	
Minimum test duration [s]	<b>10</b>	
<b>Result</b>		
Test duration [s]	<b>14.6</b>	
Any signs of structural failure	<b>No</b>	
Test results	<b>POSITIVE</b>

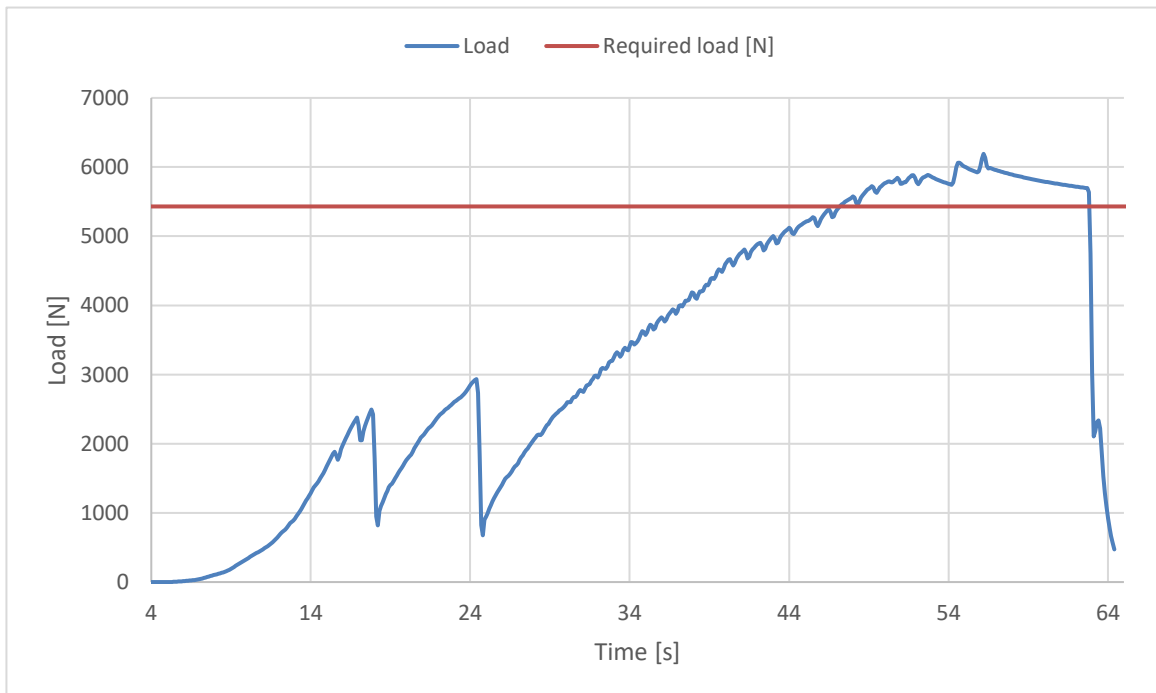
**Test ID R10**

Reference in standard	<b>5.3.2.6</b>	
Test setup	<b>Asymmetric, negative</b>	
Attachment points	<b>One main riser attachment (3 or 4) downwards</b>	
Anchor points	<b>Dummy (9)</b>	
Required load [g]	<b>4.5</b>	
Required load [N]	<b>5400</b>	
Minimum test duration [s]	<b>10</b>	
<b>Result</b>		
Test duration [s]	<b>15.7</b>	
Any signs of structural failure	<b>No</b>	
Test results	<b>POSITIVE</b>

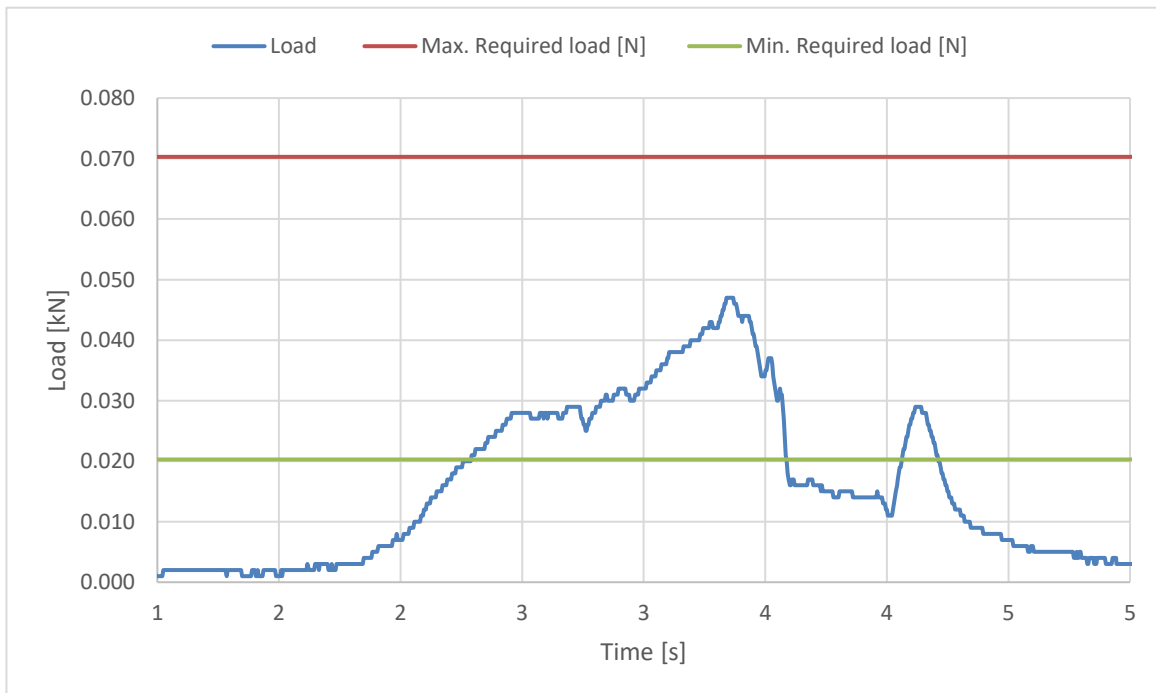
**Test ID RRDT**

Standard	<b>LTF NfL II 91/09</b>
Reference in standard	<b>6.1.5</b>
Test setup	<b>Default flying position</b>
Attachment points	<b>Sensor connect to handle, and pull in opening direction</b>
	The test is to simulate the load required to open the emergency parachute(1st action).
Min. Required load [N]	<b>20</b>
Max. Required load [N]	<b>70</b>
<b>Result</b>	
Load for first action [N]	<b>46.72</b>
Test results	<b>POSITIVE</b>

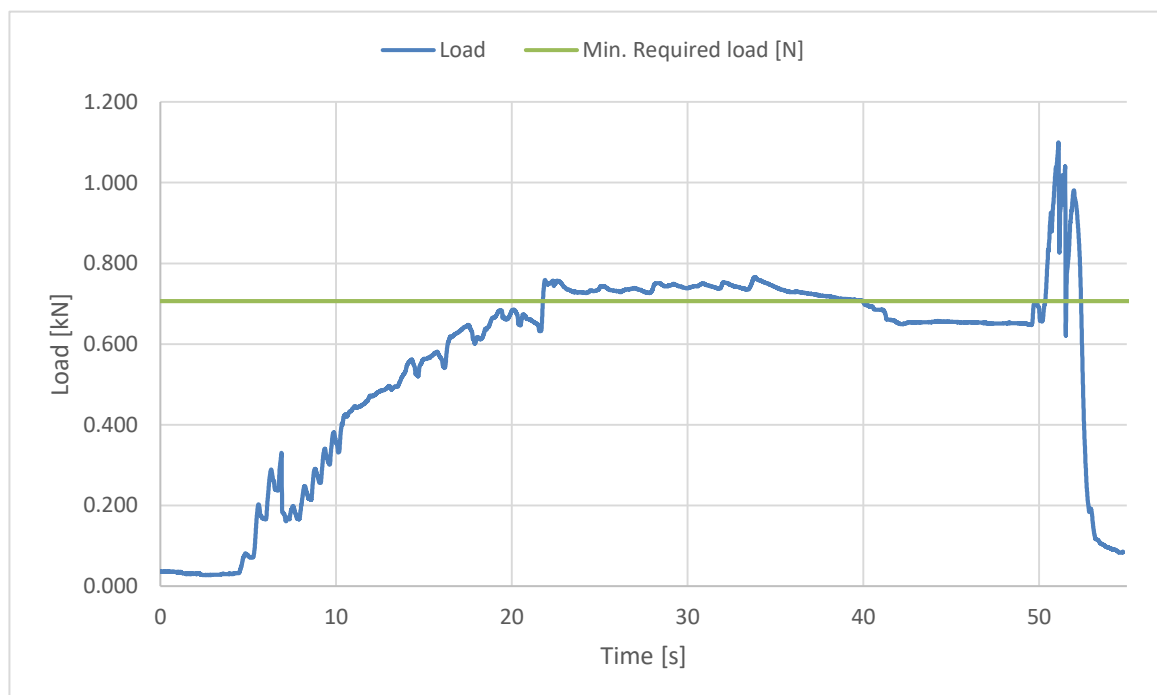
**Test ID RRST**

Standard	<b>EN12491:2015</b>
Reference in standard	<b>5.3.2</b>
Test setup	<b>Two end points of handle</b>
Attachment points	<b>Sensor connect to end of handle, pull on the other side</b>
	The handle must support min 700 N for 10 s, after measure breaking strength
Min. Required load [N]	<b>700</b>
Minimum test duration [s]	<b>10</b>
<b>Result</b>	
Test duration [s]:	<b>18.1</b>
Breaking strength [N]	<b>1093.39</b>
Test results	<b>POSITIVE</b>
