## Harness Structural test Report - EN

Inspection certificate number: **PH\_366.2022**

Name: **Halo**  
 Type: **ABS**  
 Size: **M**  
 Serial number: **Halo-PROTO 1**  
 Impact pad type: <sup>(1)</sup> **Foam**  
 Clip-in weight [kg]: **140**

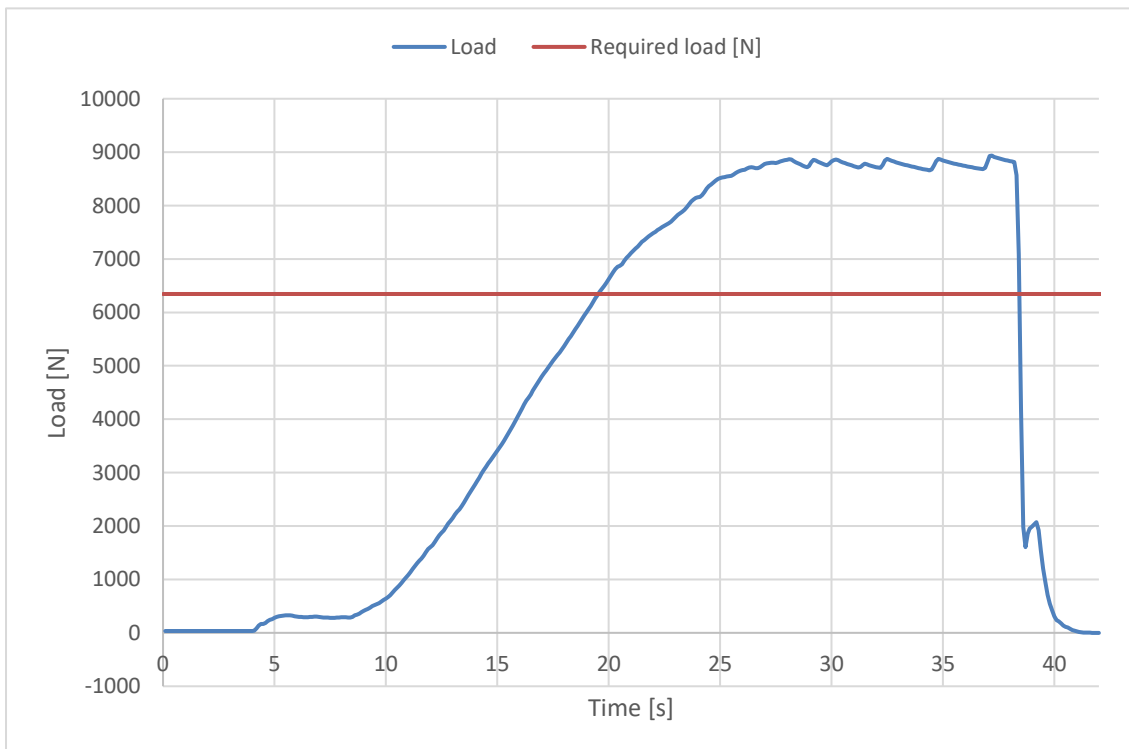
**Test ID 01**

Standard	<b>EN 1651</b>
Reference in standard	<b>5.5.1.1</b>
Test setup	<b>Positive symmetric load (Slippage)</b>
Attachment points	<b>Both main riser attachment (3,4)</b>
Anchor points	<b>Dummy (B1, B2)</b>
Required load [g]	<b>4.5</b>
Required load [N]	<b>6300</b>
Minimum test duration [s]	<b>5</b>
<b>Result</b>	
Test duration [s]	<b>18.9</b>
Any signs of structural failure	<b>No</b>
Slippery test OK	<b>Yes</b>
Test results	<b>POSITIVE</b>

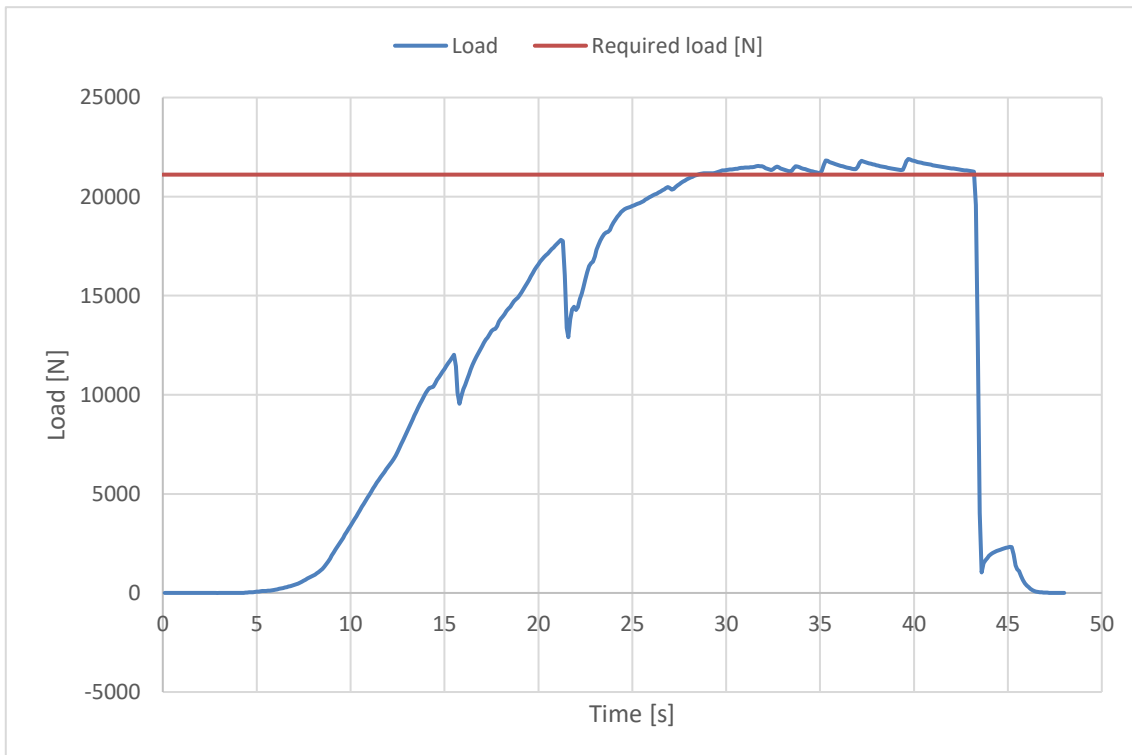
**Test ID 03**

Standard **EN 1651**  
 Reference in standard **5.5.1.1b**  
 Test setup **Positive symmetric load**  
 Attachment points **Both main riser attachment (3,4)**  
 Anchor points **Dummy (B1, B2)**

Test duration [s] **14.8**  
 Any signs of structural failure **No**  
 Slippery test OK **Yes**  
 Test results **POSITIVE**

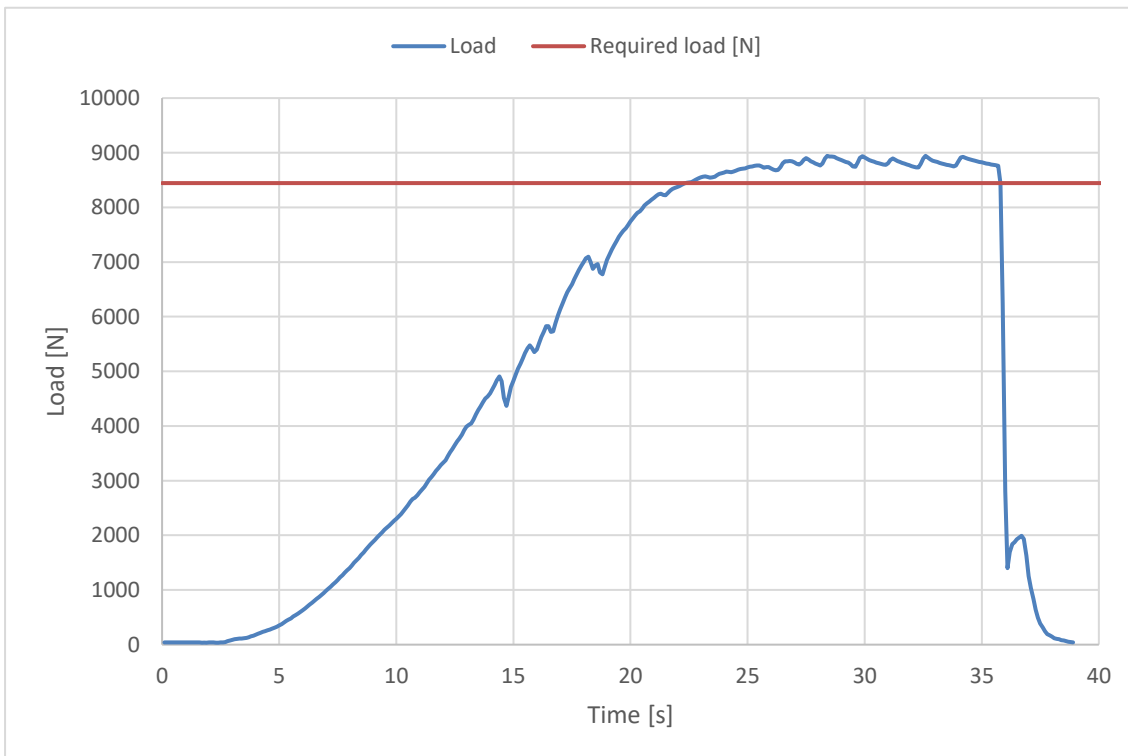
**Test ID 05**

Standard	<b>EN 1651</b>
Reference in standard	<b>5.5.1.2</b>
Test setup	<b>Positive asymmetric load</b>
Attachment points	<b>One riser attachment (3 or 4)</b>
Anchor points	<b>Dummy (C)</b>
Required load [g]	<b>6</b>
Required load [N]	<b>8400</b>
Minimum test duration [s]	<b>5</b>
<b>Result</b>	
Test duration [s]	<b>13.4</b>
Any signs of structural failure	<b>No</b>
Test results	<b>POSITIVE</b>

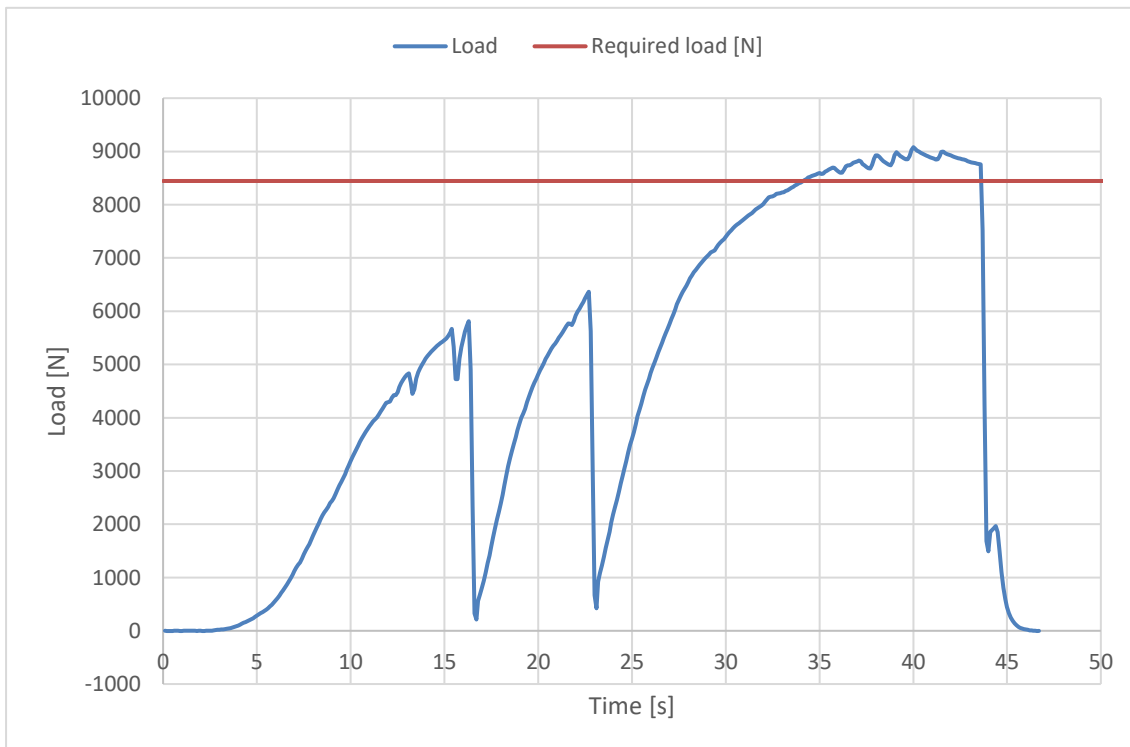
**Test ID 06**

Standard	<b>EN 1651</b>
Reference in standard	<b>5.5.1.6</b>
Test setup	<b>Negative symmetric load</b>
Attachment points	<b>Both main riser attachment (3,4)</b>
Anchor points	<b>Dummy (A)</b>
Required load [g]	<b>6</b>
Required load [N]	<b>8400</b>
Minimum test duration [s]	<b>5</b>
<b>Result</b>	
Test duration [s]	<b>9.5</b>
Any signs of structural failure	<b>No</b>
Test results	<b>POSITIVE</b>

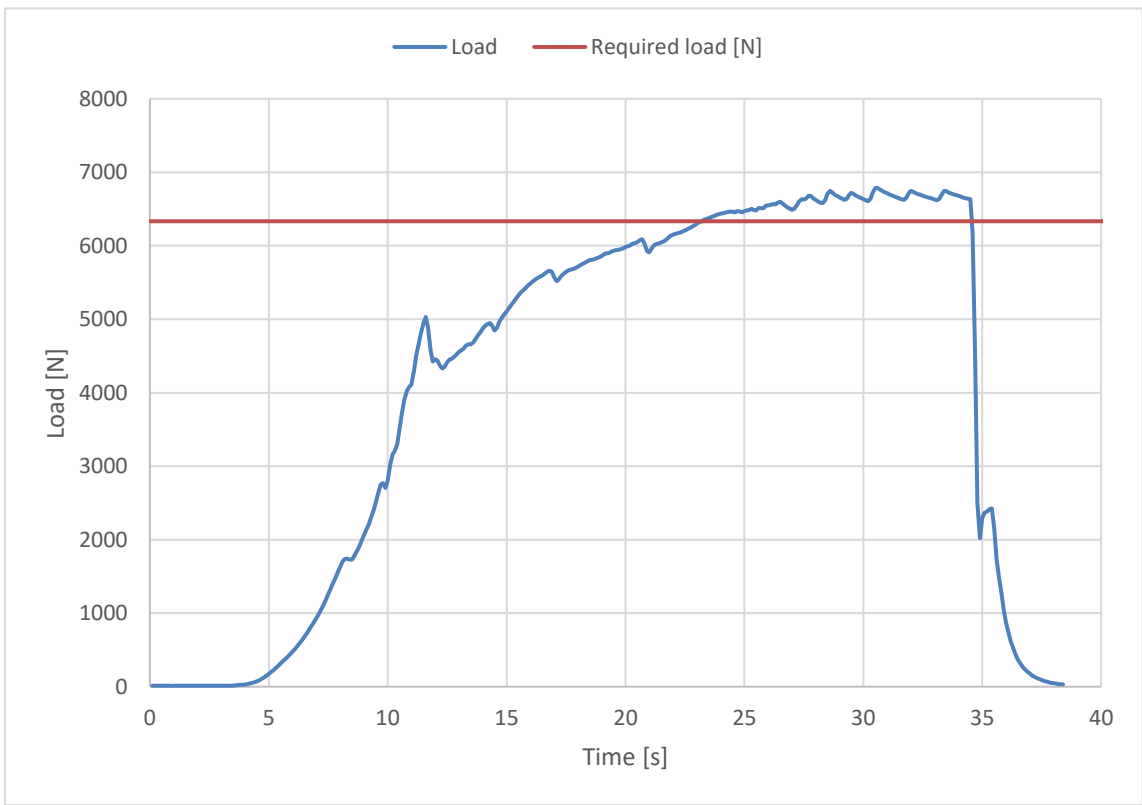
**Test ID 08**

Standard	<b>EN 1651</b>
Reference in standard	<b>5.5.1.9</b>
Test setup	<b>Anti falling-out system</b>
Attachment points	<b>Around anti falling-out system</b>
Anchor points	<b>Both main riser attachment (no dummy)</b>
Required load [g]	<b>4.5</b>
Required load [N]	<b>6300</b>
Minimum test duration [s]	<b>5</b>
<b>Result</b>	
Test duration [s]	<b>11.3</b>
Any signs of structural failure	<b>No</b>
Test results	<b>POSITIVE</b>

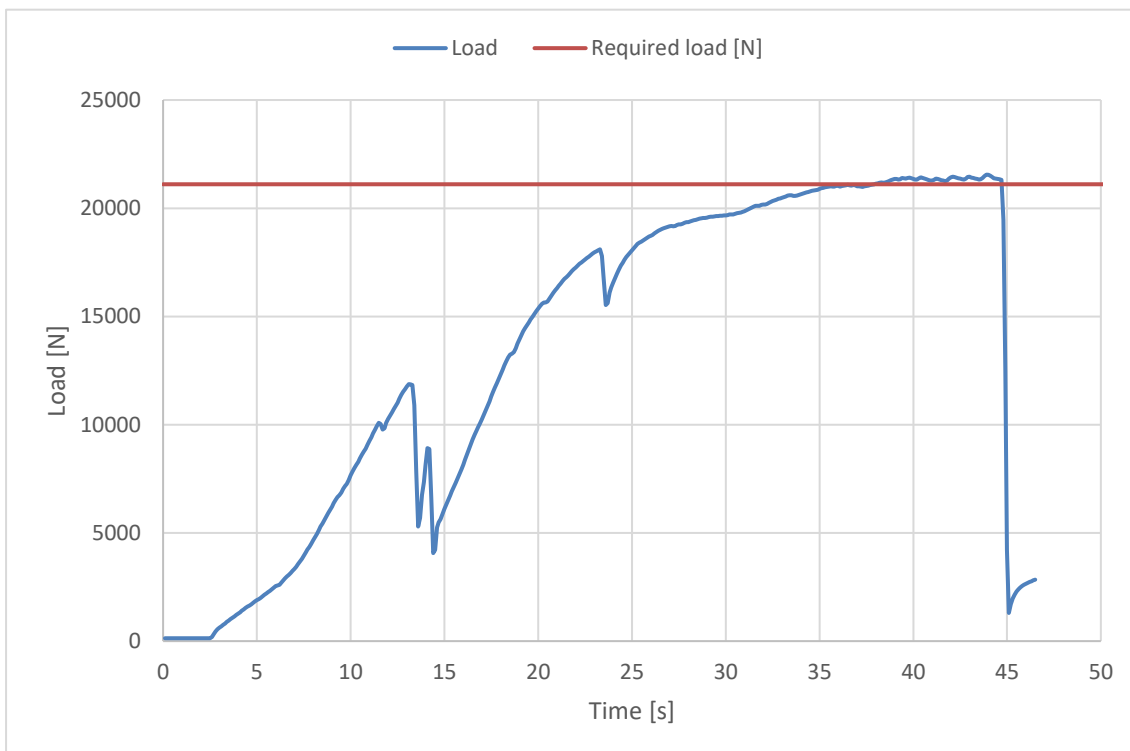
**Test ID 09**

Reference in standard	<b>5.5.1.3</b>	
Test setup	<b>Positive symmetric load rescue points</b>	
Attachment points	<b>Both main riser attachment (1,2)</b>	
Anchor points	<b>Dummy (B1,B2)</b>	
Required load [g]	<b>15</b>	
Required load [N]	<b>21000</b>	
Minimum test duration [s]	<b>5</b>	
<b>Result</b>		
Test duration [s]	<b>6.8</b>	
Any signs of structural failure	<b>No</b>	
Slippery test OK	<b>Yes</b>	
Test results	<b>POSITIVE</b>

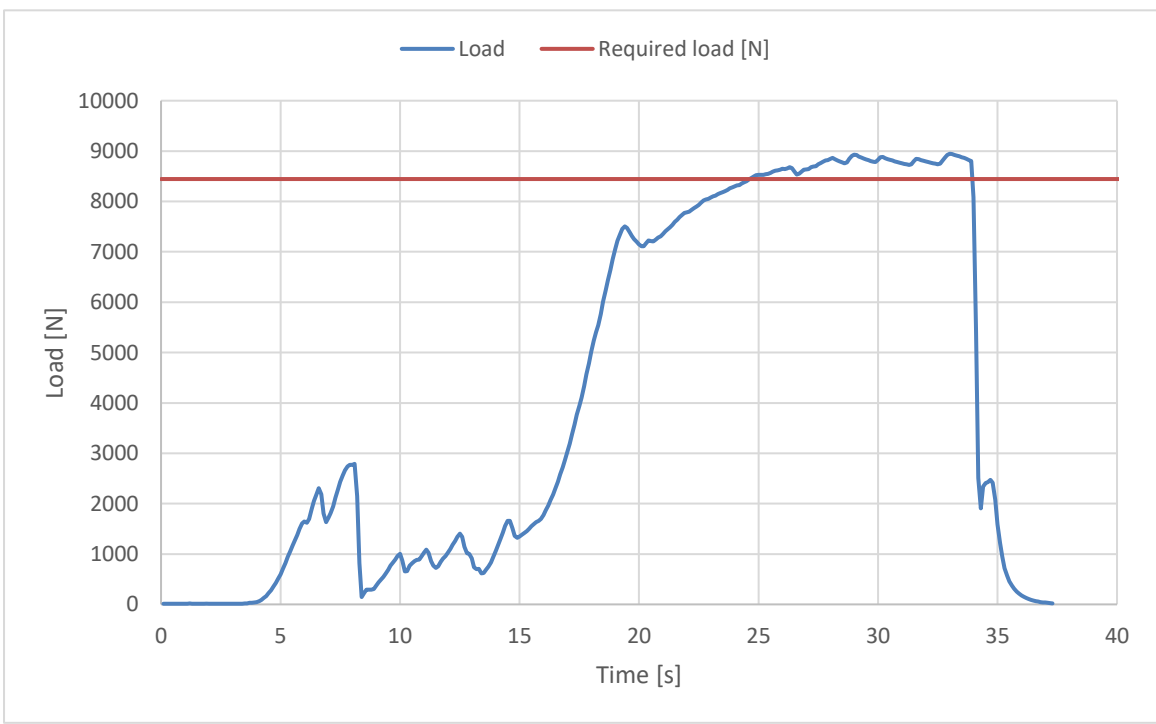
**Test ID 12**

Standard	<b>EN 1651</b>
Reference in standard	<b>5.5.1.7</b>
Test setup	<b>Upright (landing) position load</b>
Attachment points	<b>Both main riser attachment (3, 4)</b>
Anchor points	<b>Both legstrap of harness (no dummy)</b>
Required load [g]	<b>6</b>
Required load [N]	<b>8400</b>
Minimum test duration [s]	<b>5</b>
Harness type	<b>type a</b>
<b>Result</b>	
Test duration [s]	<b>9.3</b>
Any signs of structural failure	<b>No</b>
Slippery test OK	<b>Yes</b>
Test results	<b>POSITIVE</b>

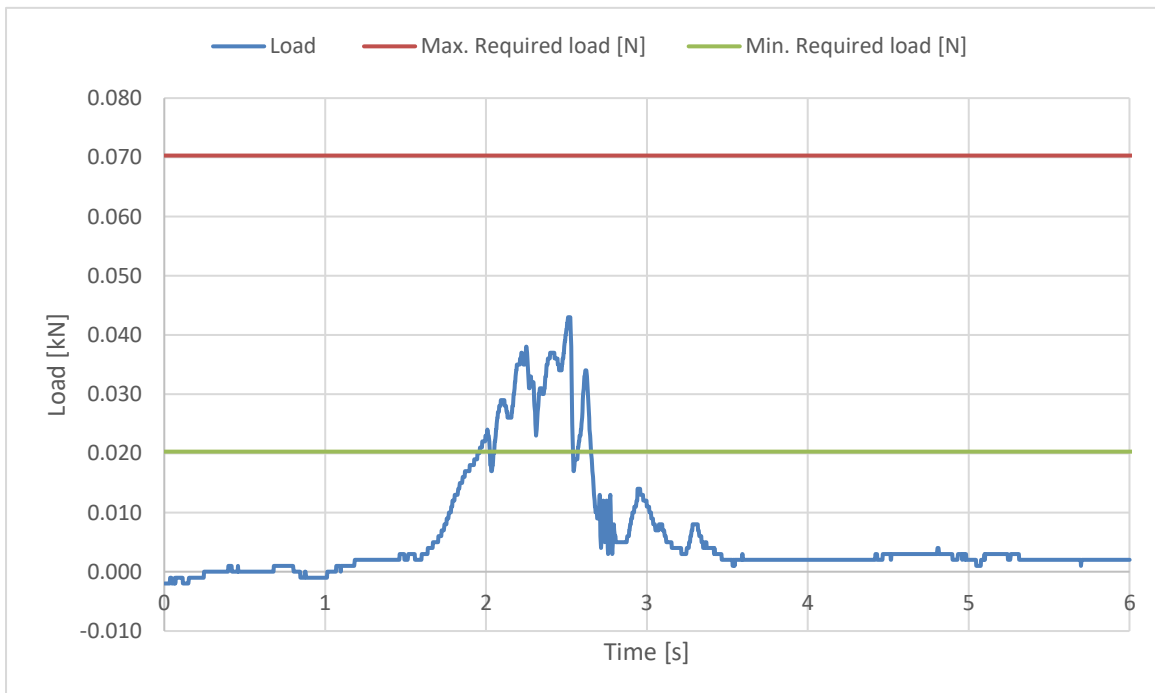
**Test ID RRDT**

Standard	<b>EN 1651</b>
Reference in standard	<b>5.5.1.11</b>
Test setup	<b>Default flying position</b>
Attachment points	<b>Sensor connect to handle, and pull in opening direction</b>
	The test is to simulate the load required to open the emergency parachute(1st action).
Min. Required load [N]	<b>20</b>
Max. Required load [N]	<b>70</b>
<b>Result</b>	
Load for first action [N]	<b>43.29</b>
Test results	<b>POSITIVE</b>

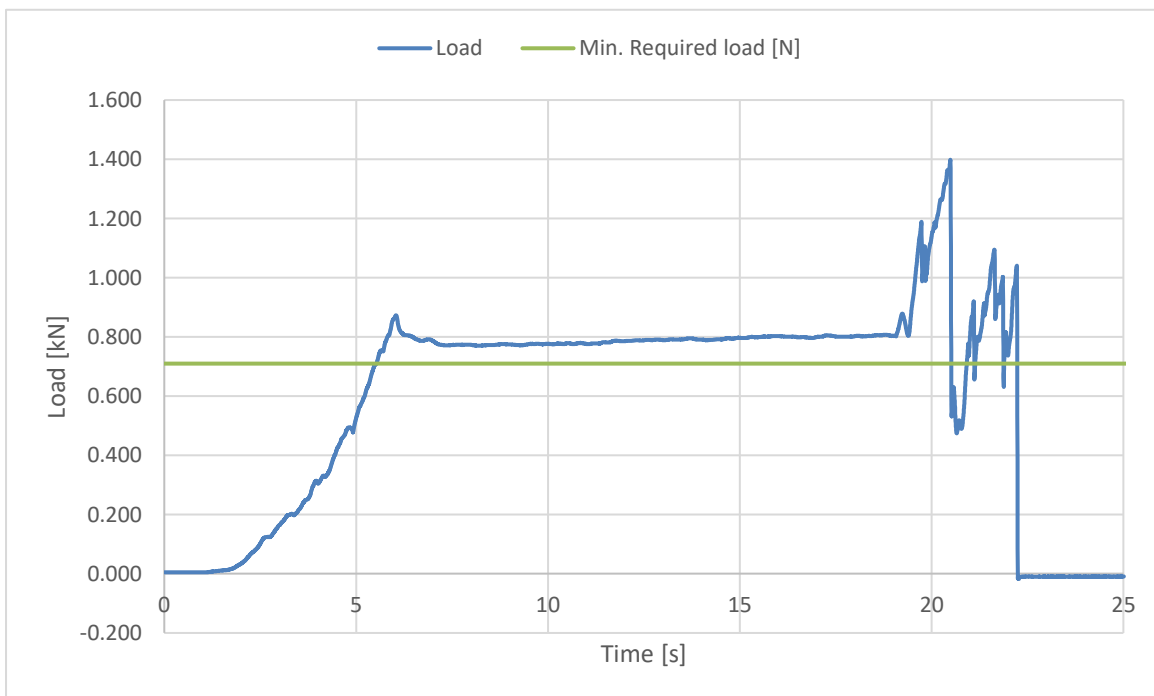
**Test ID RRST**

Standard	<b>EN 12491</b>
Reference in standard	<b>5.3.2</b>
Test setup	<b>Two end points of handle</b>
Attachment points	<b>Sensor connect to end of handle, pull on the other side</b>
	The handle must support min 700 N for 10 s, after measure breaking strength
Min. Required load [N]	<b>700</b>
Minimum test duration [s]	<b>10</b>
<b>Result</b>	
Test duration [s]:	<b>15.0</b>
Breaking strength [N]	<b>1389.71</b>
Test results	<b>POSITIVE</b>
