Harness Structural test Report

Inspection certificate number: **PH_232.2018**
Manufacturer data:

Name: **Oxygen2+**
 Type: **ABS**
 Size: **L**
 Serial number: **PRHARN-OXY2+-MK2**
 Impact pad type: ⁽¹⁾ **Foam**
 Clip-in weight [kg]: **120**

Date of test: **28.03.2018**
Atmosphere AGL:

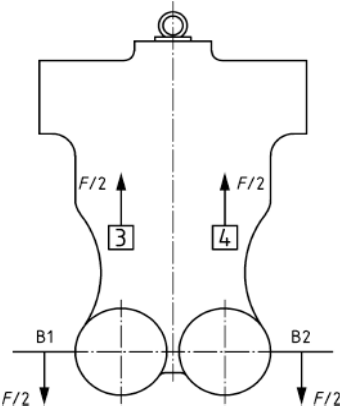
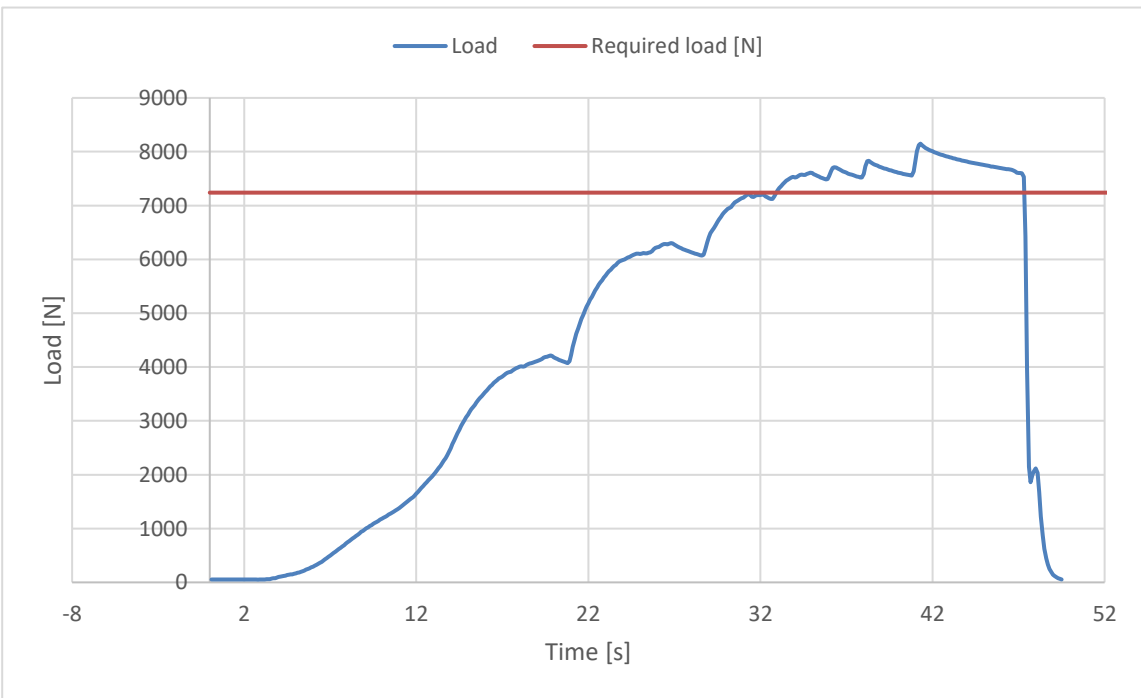
Test ID R0

Reference in standard	5.3.2.1	
Test setup	Default flying position	
Attachment points	Both main riser attachment (3,4)	
Anchor points	Dummy (B1, B2)	
Required load [g]	6	
Required load [N]	7200	
Minimum test duration [s]	10	
Result		
Test duration [s]	14.4	
Any signs of structural failure	No	
Test results	POSITIVE

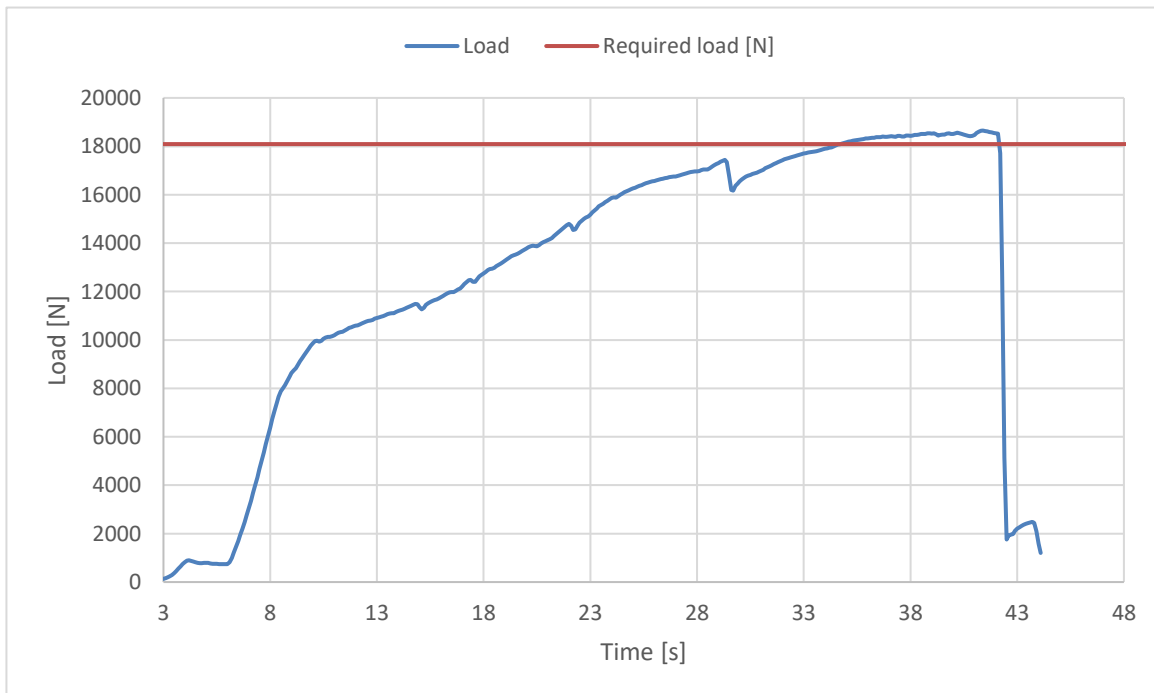
Test ID R2

Standard	EN 1651:1999
Reference in standard	5.3.2.2
Test setup	Default flying position
Attachment points	Both main riser attachment (3,4)
Anchor points	Dummy (B1, B2)
Required load [g]	15
Required load [N]	18000
Minimum test duration [s]	5
Result	
Test duration [s]	7.5
Any signs of structural failure	No
Test results	POSITIVE

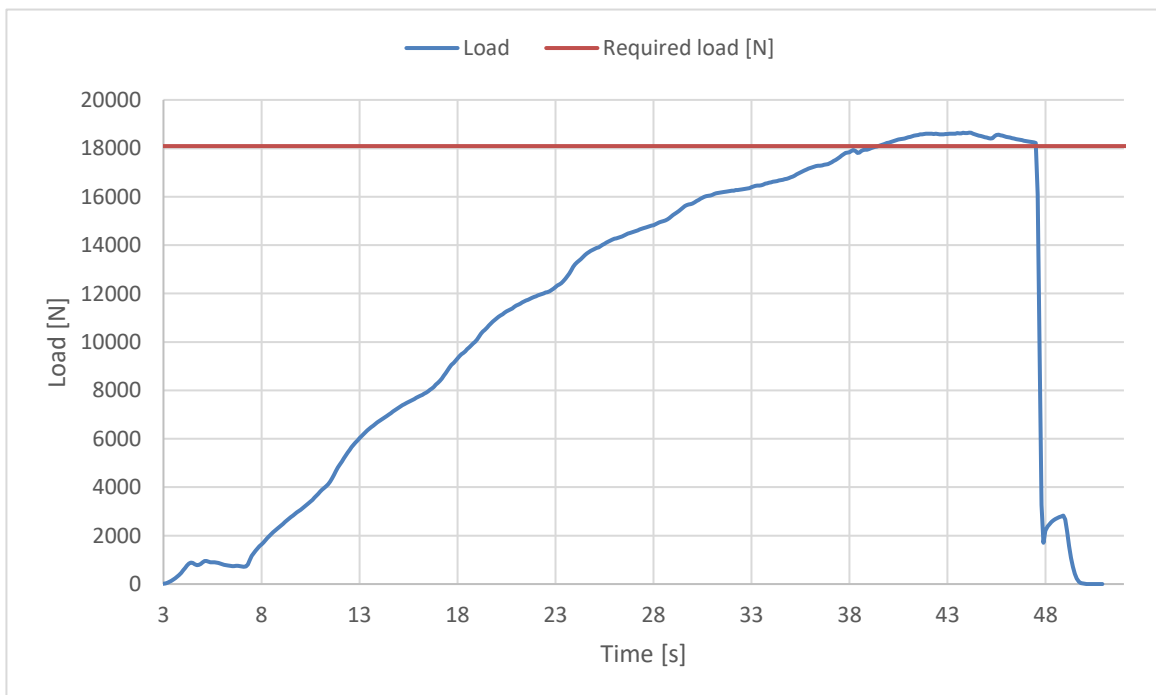
Test ID R4

Standard	EN 1651:1999
Reference in standard	5.3.2.7
Test setup	Flying position before landing
Attachment points	Both main riser attachment (3,4)
Anchor points	Dummy (7,8)
Required load [g]	15
Required load [N]	18000
Minimum test duration [s]	5
Result	
Test duration [s]	8.1
Any signs of structural failure	No
Test results	POSITIVE

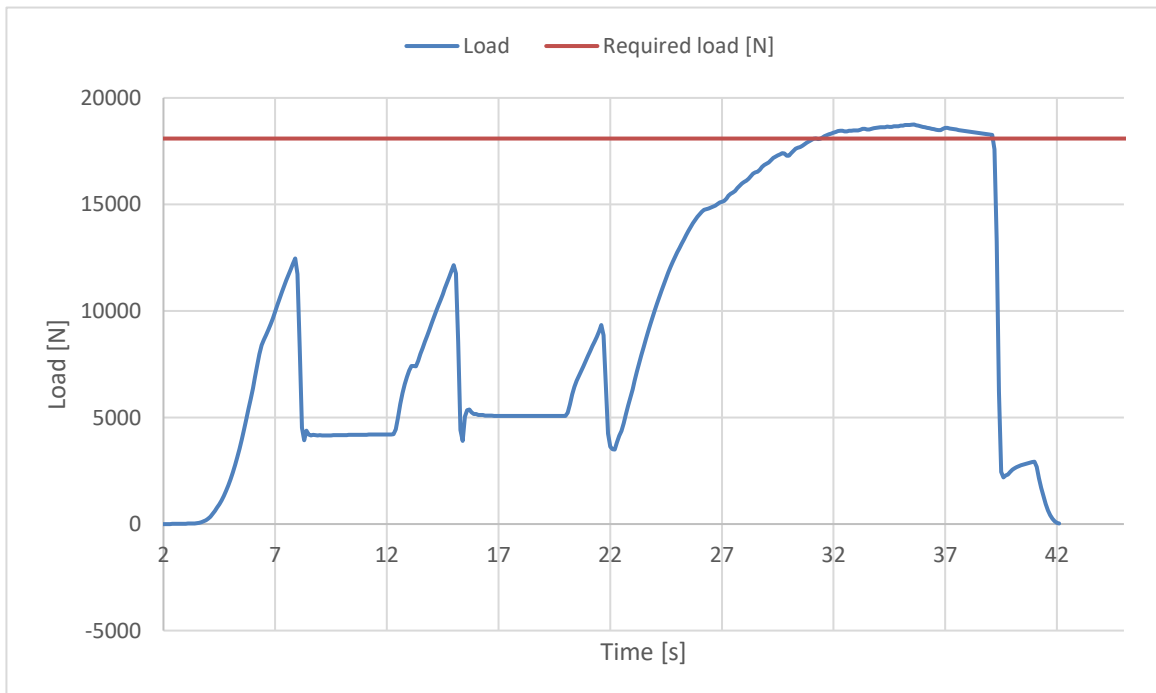
Test ID R6

Reference in standard	5.3.2.4	
Test setup	Rescue attachments	
Attachment points	Rescue riser attachment (1,2)	
Anchor points	Dummy (B1,B2)	
Required load [g]	15	
Required load [N]	18000	
Minimum test duration [s]	5	
Result		
Test duration [s]	7.7	
Any signs of structural failure	No	
Test results	POSITIVE

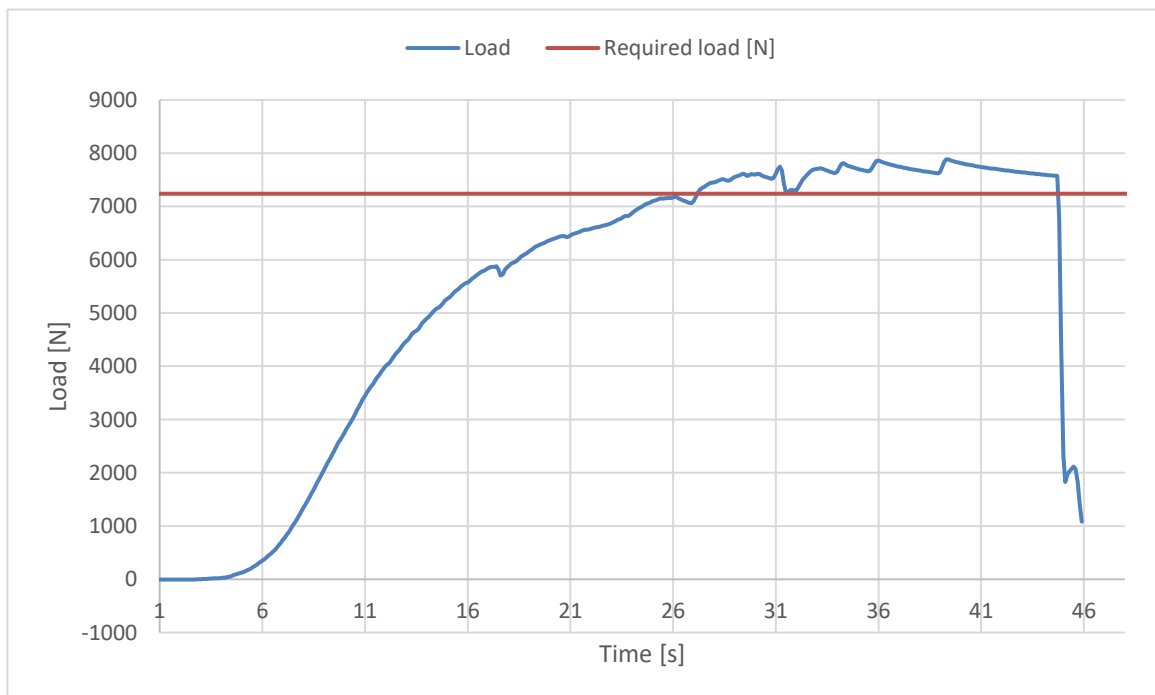
Test ID R8

Standard	EN 1651:1999
Reference in standard	5.3.2.3
Test setup	Asymmetric, one riser
Attachment points	One main riser attachment (3)
Anchor points	Dummy (B1,B2)
Required load [g]	6
Required load [N]	7200
Minimum test duration [s]	10
Result	
Test duration [s]	17.6
Any signs of structural failure	No
Test results	POSITIVE

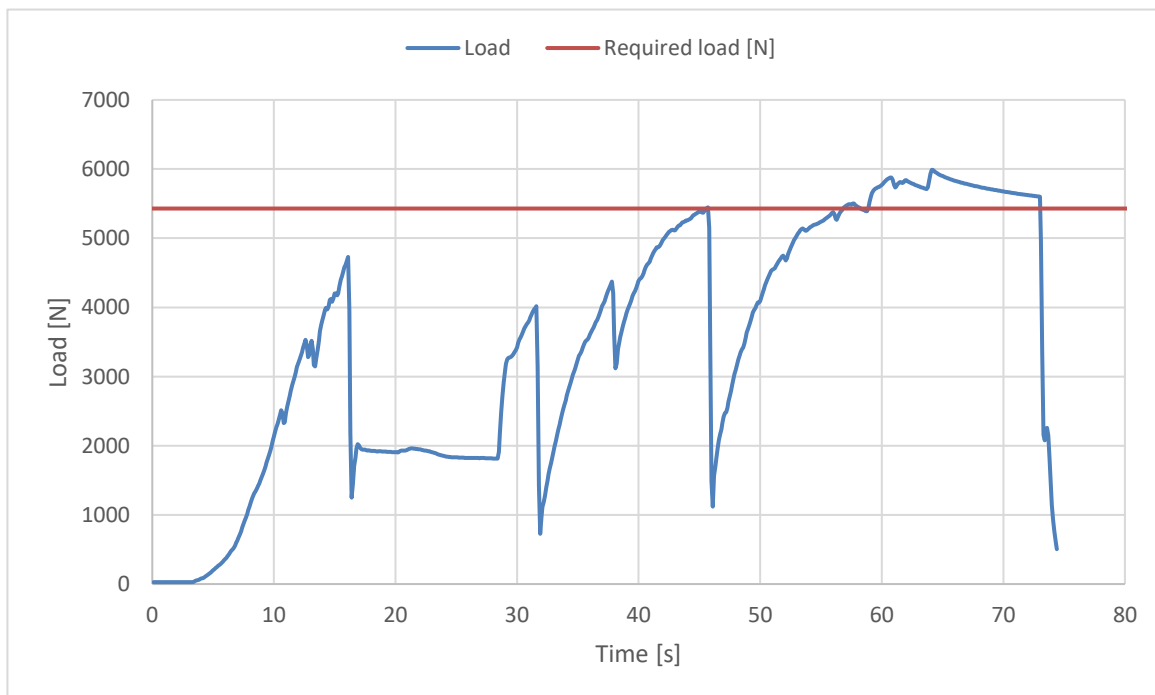
Test ID R10

Reference in standard	5.3.2.6	
Test setup	Asymmetric, negative	
Attachment points	One main riser attachment (3 or 4) downwards	
Anchor points	Dummy (9)	
Required load [g]	4.5	
Required load [N]	5400	
Minimum test duration [s]	10	
Result		
Test duration [s]	14.2	
Any signs of structural failure	No	
Test results	POSITIVE

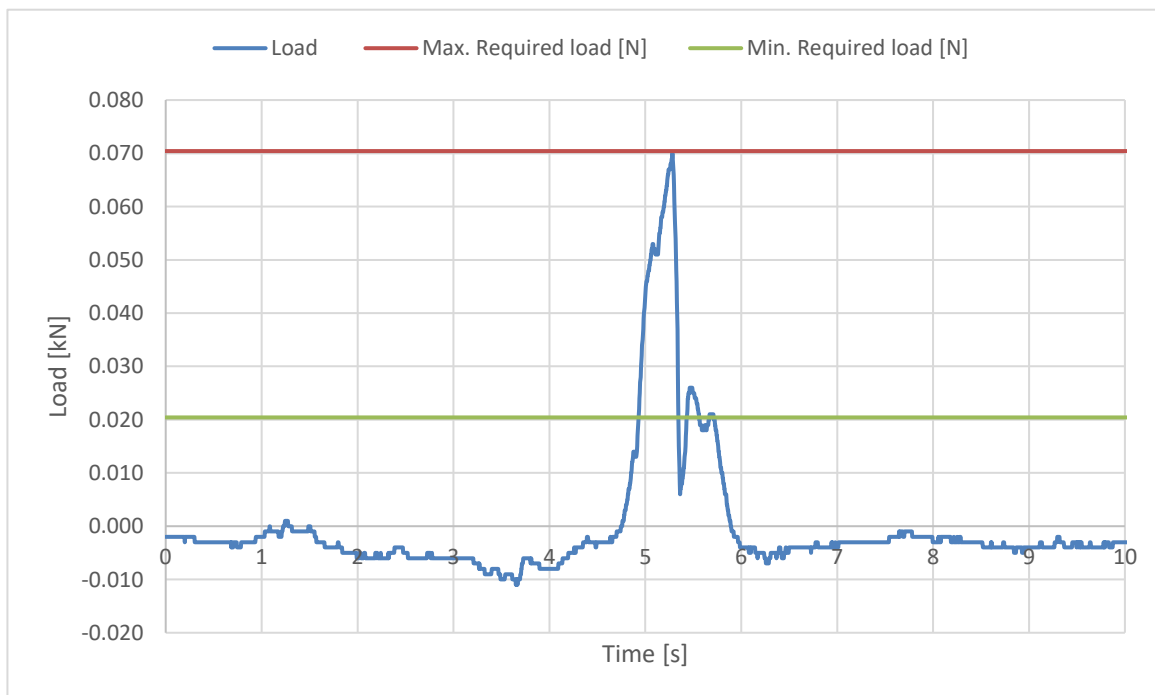
Test ID RRDT

Standard	LTF NfL II 91/09
Reference in standard	6.1.5
Test setup	Default flying position
Attachment points	Sensor connect to handle, and pull in opening direction
	The test is to simulate the load required to open the emergency parachute(1st action).
Min. Required load [N]	20
Max. Required load [N]	70
Result	
Load for first action [N]	69.58
Test results	POSITIVE

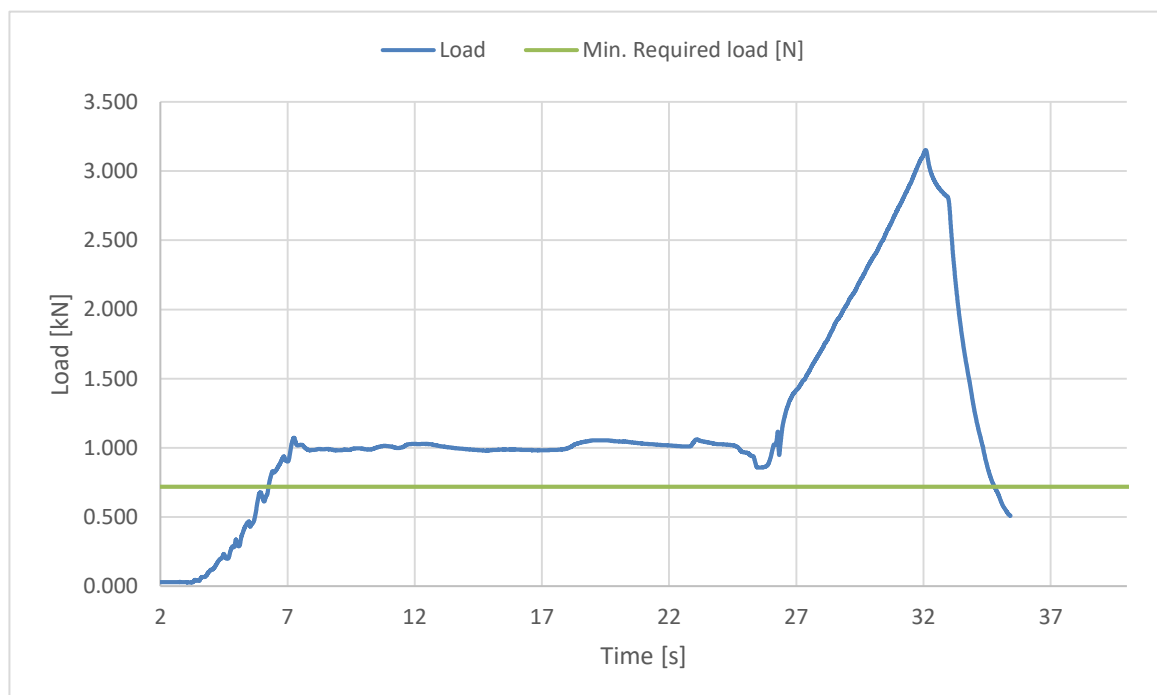
Test ID RRST

Standard	EN12491:2015
Reference in standard	5.3.2
Test setup	Two end points of handle
Attachment points	Sensor connect to end of handle, pull on the other side
	The handle must support min 700 N for 10 s, after measure breaking strength
Min. Required load [N]	700
Minimum test duration [s]	10
Result	
Test duration [s]:	28.3
Breaking strength [N]	3134.06
Test results	POSITIVE
