Harness Structural test Report - EN

Inspection certificate number: **PH_361.2022**

Name: **Ozo 2**
 Type: **ABS**
 Size: **M**
 Serial number: **OZO2 M-W-PROTO**
 Impact pad type: ⁽¹⁾ **n/a**
 Clip-in weight [kg]: **120**

model: **Ozo 2**

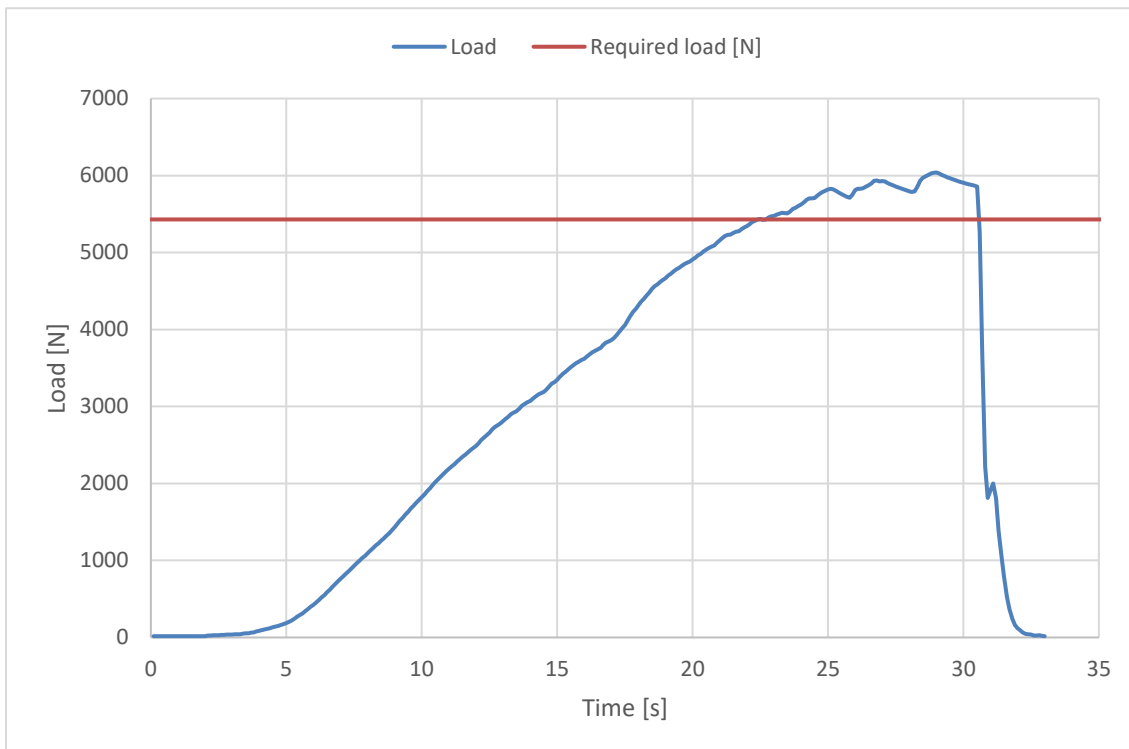
Test ID 01

Reference in standard	5.5.1.1	
Test setup	Positive symmetric load (Slippage)	
Attachment points	Both main riser attachment (3,4)	
Anchor points	Dummy (B1, B2)	
Required load [g]	4.5	
Required load [N]	5400	
Minimum test duration [s]	5	
Result		
Test duration [s]	7.8	
Any signs of structural failure	No	
Slippery test OK	Yes	
Test results	POSITIVE

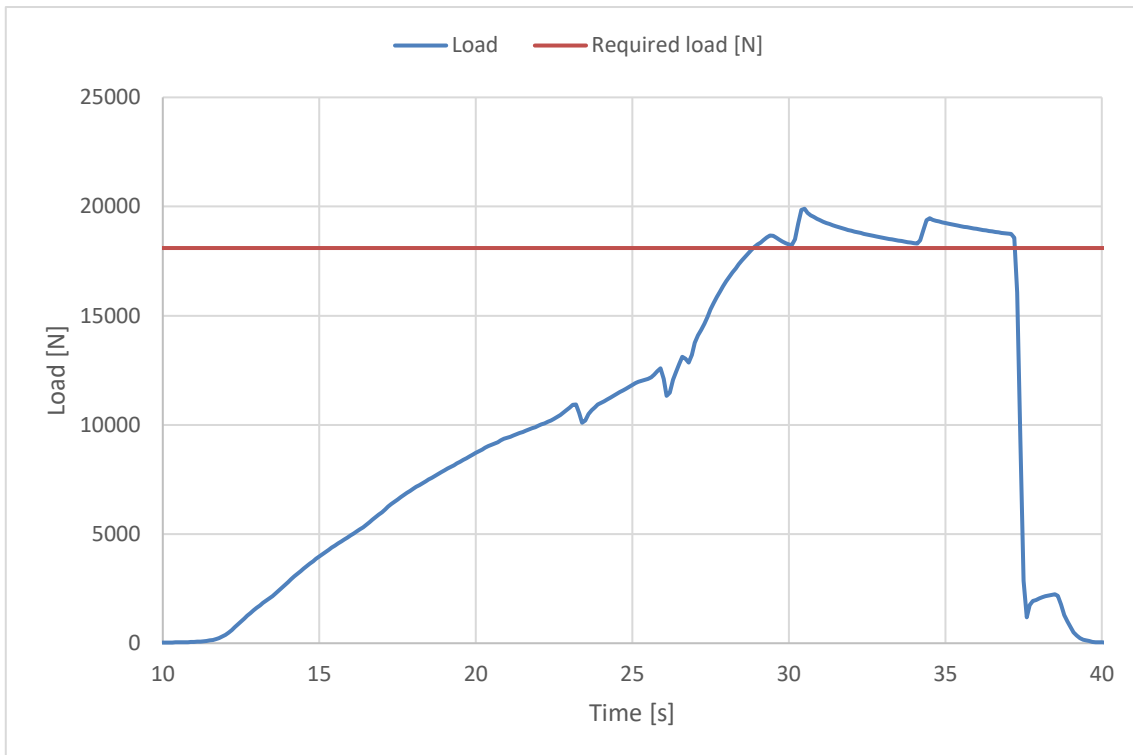
Test ID 03

Standard	EN 1651
Reference in standard	5.5.1.1b
Test setup	Positive symmetric load
Attachment points	Both main riser attachment (3,4)
Anchor points	Dummy (B1, B2)
Required load [g]	15
Required load [N]	18000
Minimum test duration [s]	5
Result	
Test duration [s]	8.4
Any signs of structural failure	No
Slippery test OK	Yes
Test results	POSITIVE

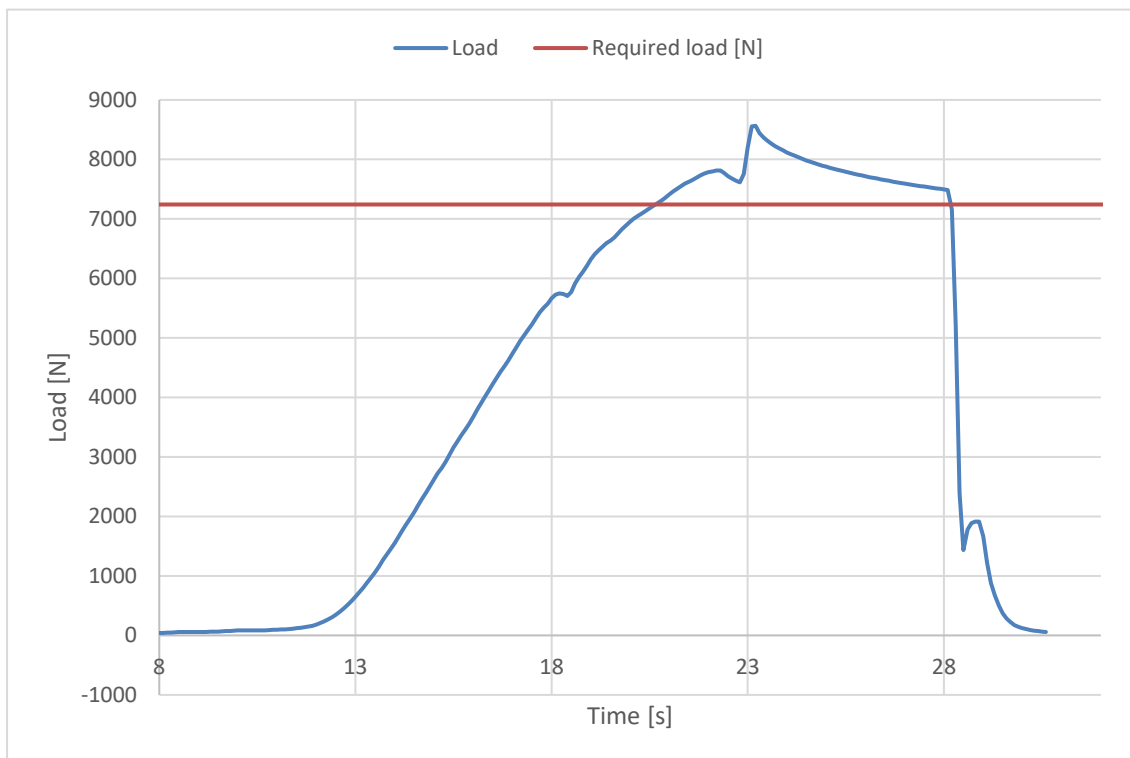
Test ID 05

Standard	EN 1651
Reference in standard	5.5.1.2
Test setup	Positive asymmetric load
Attachment points	One riser attachment (3 or 4)
Anchor points	Dummy (C)
Required load [g]	6
Required load [N]	7200
Minimum test duration [s]	5
Result	
Test duration [s]	7.5
Any signs of structural failure	No
Test results	POSITIVE

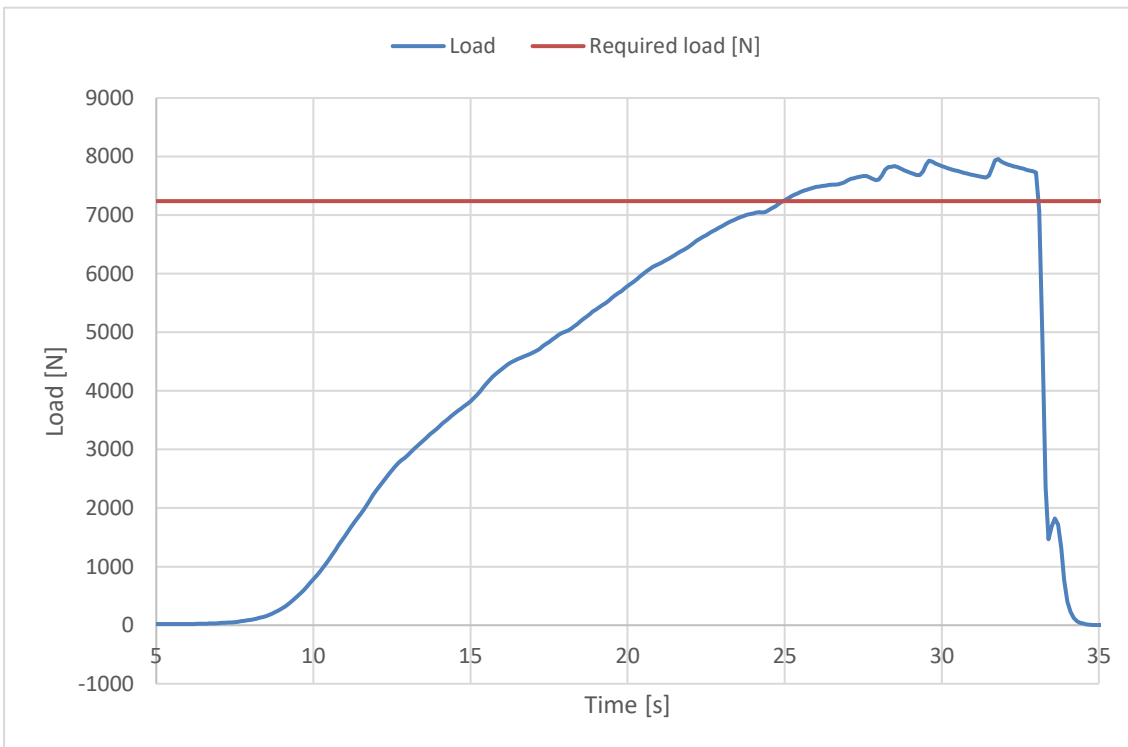
Test ID 06

Standard	EN 1651
Reference in standard	5.5.1.6
Test setup	Negative symmetric load
Attachment points	Both main riser attachment (3,4)
Anchor points	Dummy (A)
Required load [g]	6
Required load [N]	7200
Minimum test duration [s]	5
Result	
Test duration [s]	8.1
Any signs of structural failure	No
Test results	POSITIVE

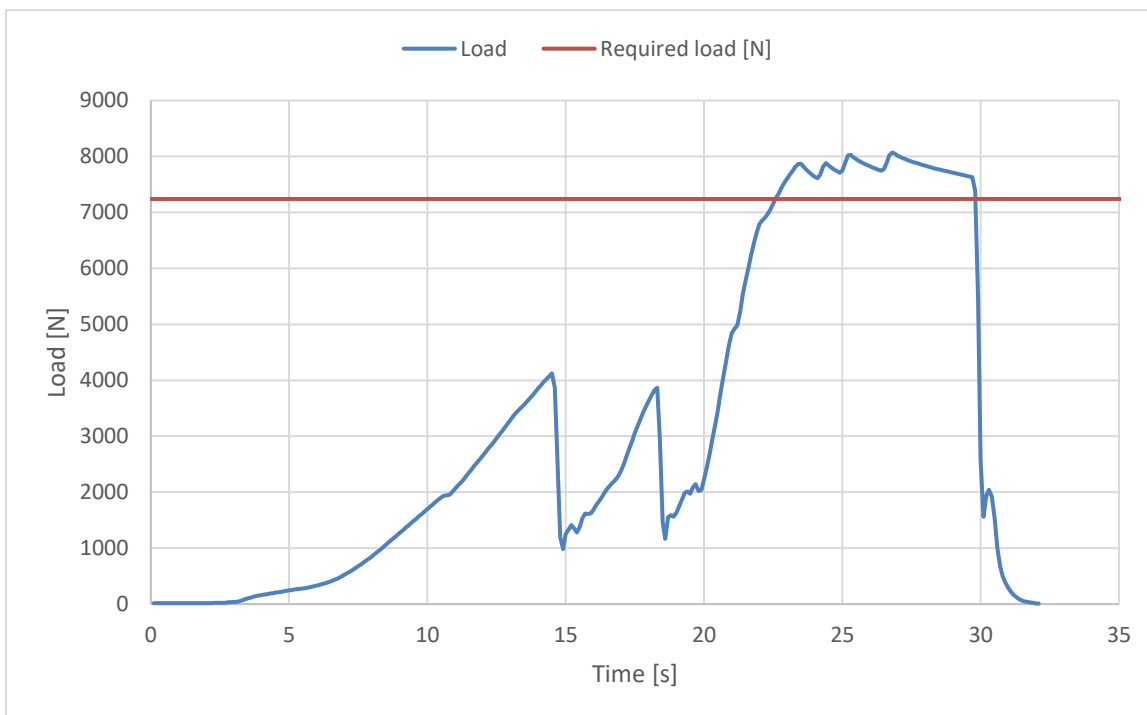
Test ID 12

Standard	EN 1651
Reference in standard	5.5.1.7
Test setup	Upright (landing) position load
Attachment points	Both main riser attachment (3, 4)
Anchor points	Both legstrap of harness (no dummy)
Required load [g]	6
Required load [N]	7200
Minimum test duration [s]	5
Harness type	type c
Result	
Test duration [s]	7.3
Any signs of structural failure	No
Slippery test OK	Yes
Test results	POSITIVE
