Harness Structural test Report - NfL

Inspection certificate number: PH_337.2021

Name: **Runa**
 Type: **ABS**
 Size: **L**
 Serial number: **55.L.4-0621-144**
 Impact pad type: ⁽¹⁾ **Inflatable**
 Clip-in weight [kg]: **120**
 Integrated container: **Yes**
 Date of test: **21.06.2021**

Summary of Structural test

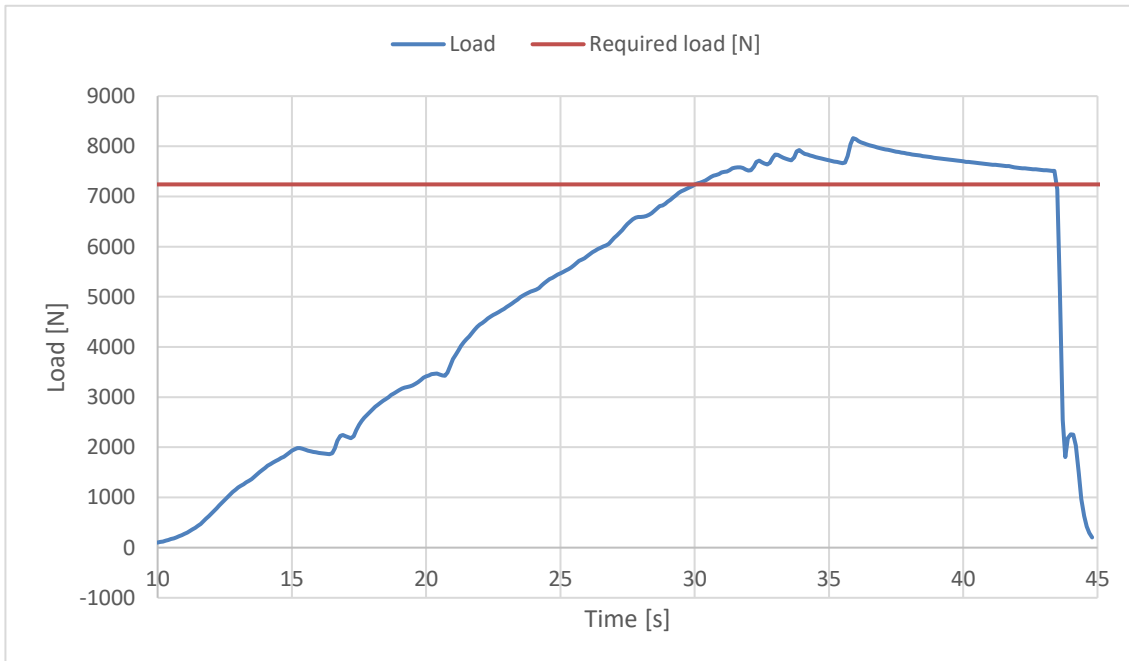
Test ID 02

Standard	NfL 2-565-20
Reference	5.3.2.1
Test setup	Default flying position
Attachment points	Both main riser attachment (3,4)
Anchor points	Dummy (B1, B2)
Required load [g]	6
Required load [N]	7200
Minimum test duration [s]	10
Result	
Test duration [s]	13.4
Any signs of structural failure	No
Test results	POSITIVE

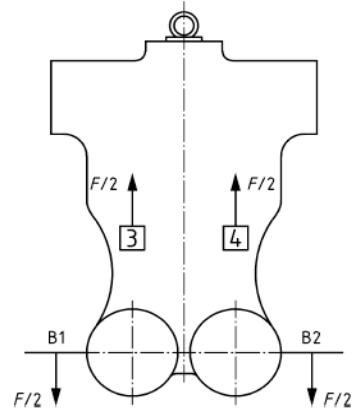
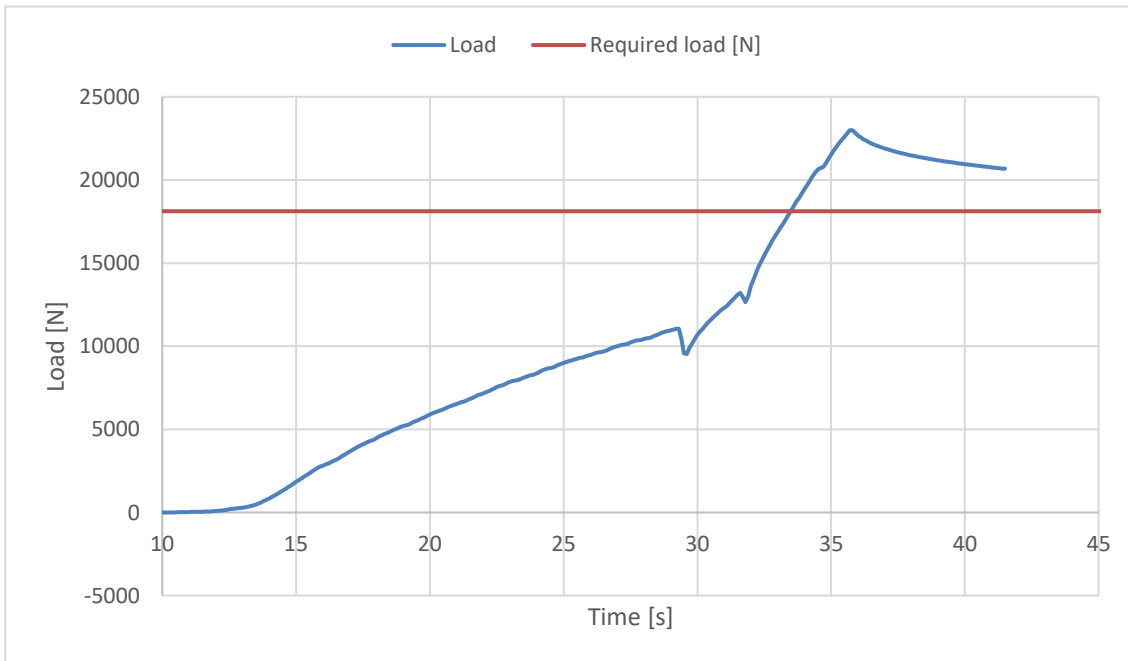
Test ID 03

Standard **NfL 2-565-20**
 Reference **5.3.2.2**
 Test setup **Default flying position**
 Attachment points **Both main riser attachment (3,4)**
 Anchor points **Dummy (B1, B2)**

Required load [g] **15**
 Required load [N] **18000**
 Minimum test duration [s] **5**

Test duration [s] **8.1**
 Any signs of structural failure **No**
 Test results **POSITIVE**

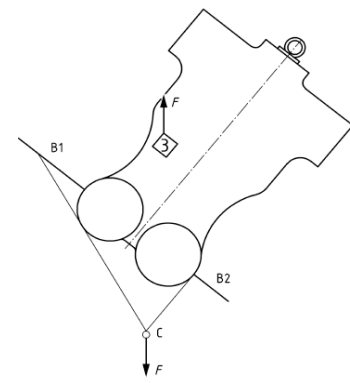
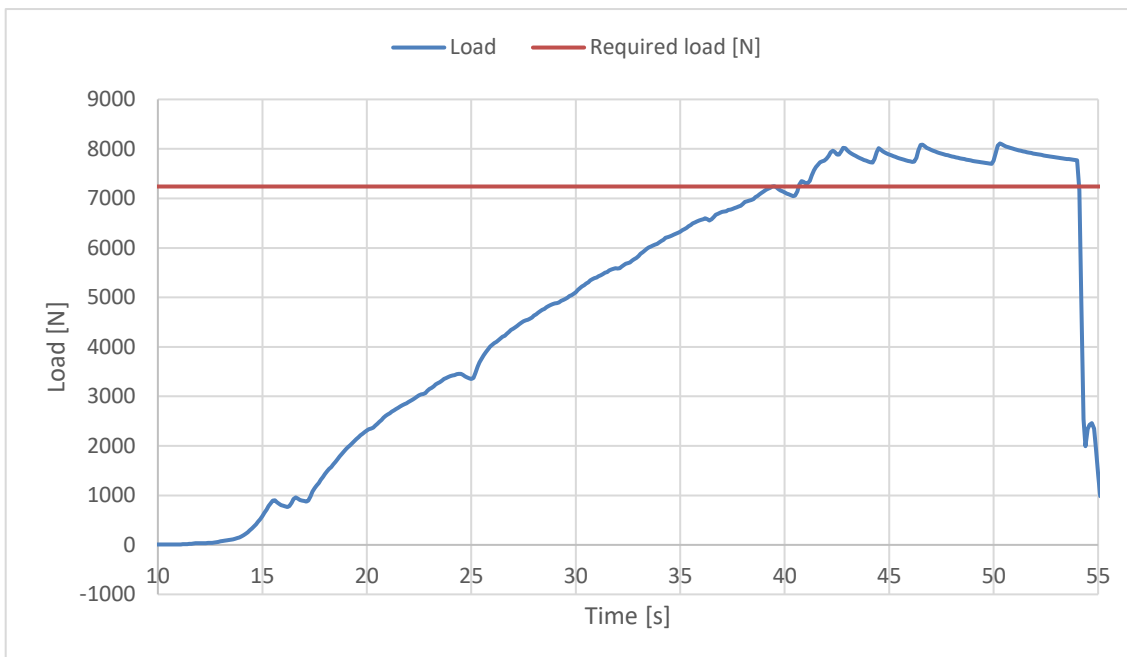
Test ID 04

Standard	NfL 2-565-20
Reference	5.3.2.3
Test setup	Asymmetric, one riser
Attachment points	One main riser attachment (3)
Anchor points	Dummy (B1,B2)
Required load [g]	6
Required load [N]	7200
Minimum test duration [s]	10
Result	
Test duration [s]	13.4
Any signs of structural failure	No
Test results	POSITIVE

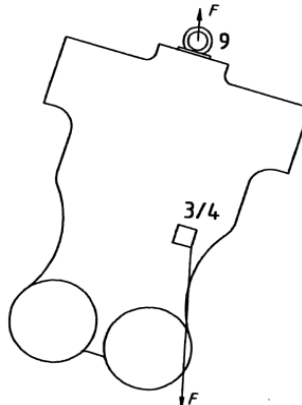
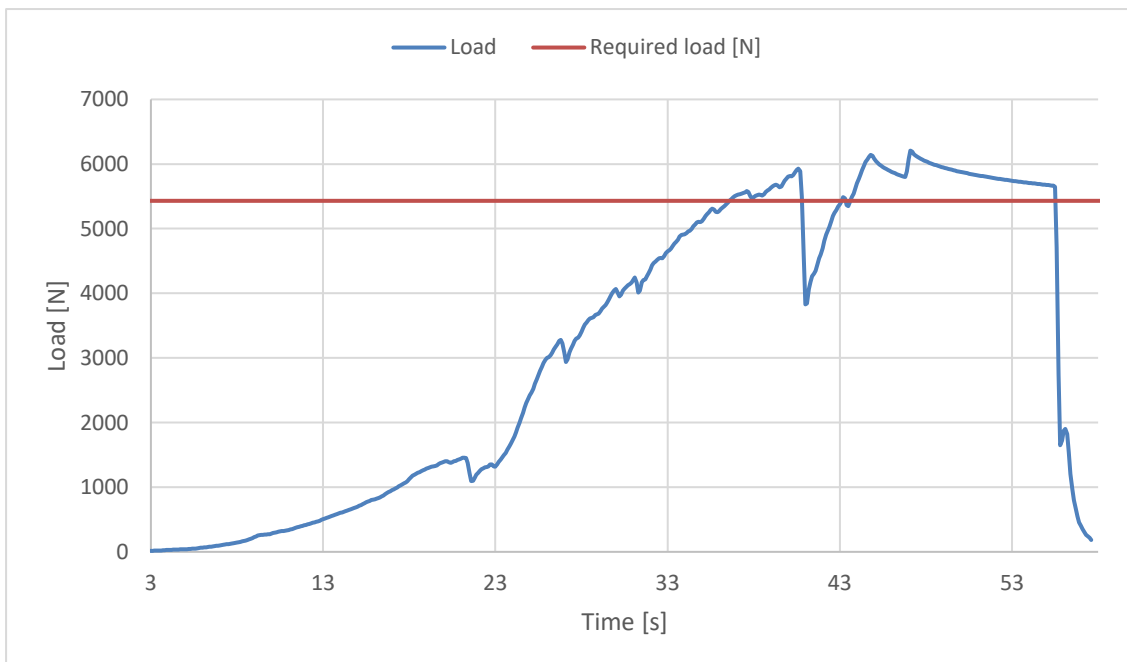
Test ID 07

Standard	NfL 2-565-20
Reference	5.3.2.6
Test setup	Asymmetric, negative
Attachment points	One main riser attachment (3 or 4) downwards
Anchor points	Dummy (9)
Required load [g]	4.5
Required load [N]	5400
Minimum test duration [s]	10
Result	
Test duration [s]	11.9
Any signs of structural failure	No
Test results	POSITIVE

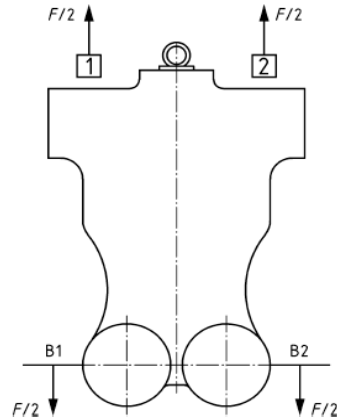
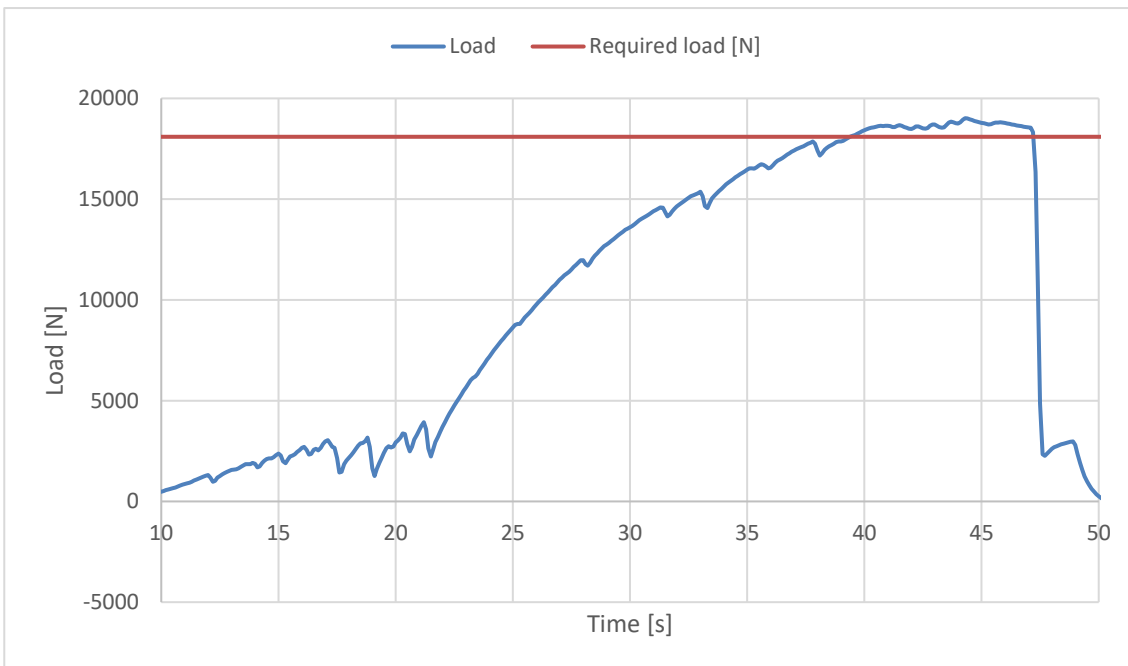
Test ID 09

Standard **NfL 2-565-20**
 Reference **5.3.2.4**
 Test setup **Rescue attachments**
 Attachment points **Rescue riser attachment (1,2)**
 Anchor points **Dummy (B1,B2)**

Required load [g] **15**
 Required load [N] **18000**
 Minimum test duration [s] **5**

Test duration [s] **7.9**
 Any signs of structural failure **No**
 Test results **POSITIVE**

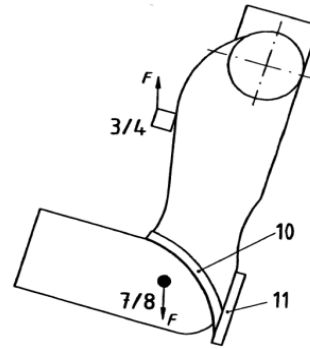
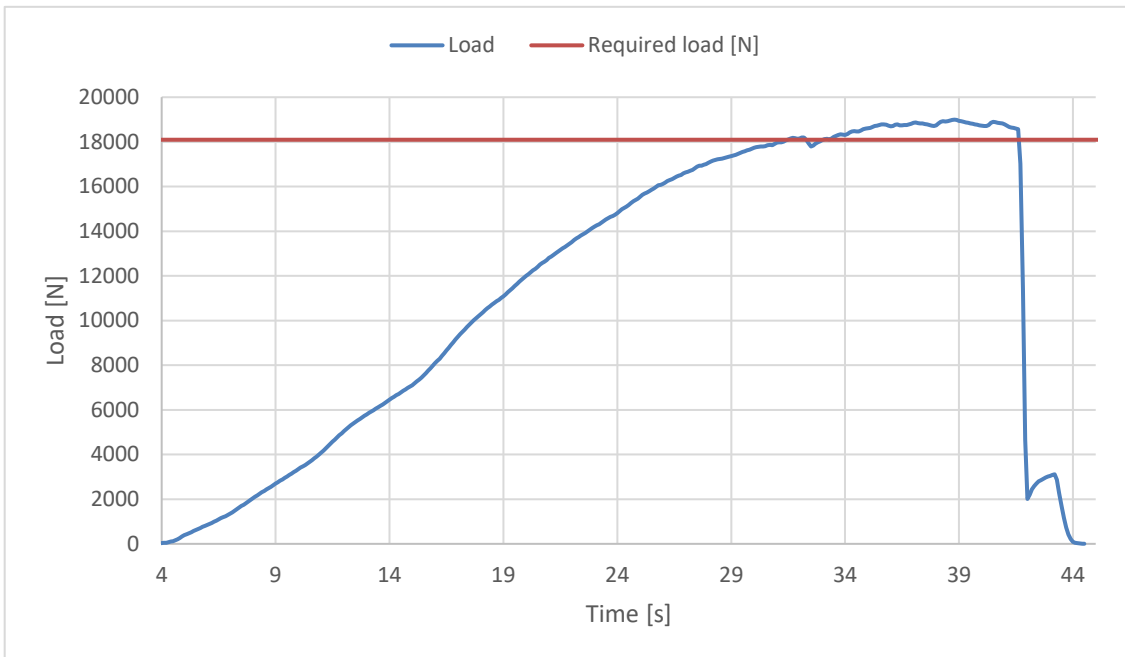
Test ID 13

Standard **NfL 2-565-20**
 Reference **5.3.2.7**
 Test setup **Flying position before landing**
 Attachment points **Both main riser attachment (3,4)**
 Anchor points **Dummy (7,8)**

Required load [g] **15**
 Required load [N] **18000**
 Minimum test duration [s] **5**

Test duration [s] **8.6**
 Any signs of structural failure **No**
 Test results **POSITIVE**

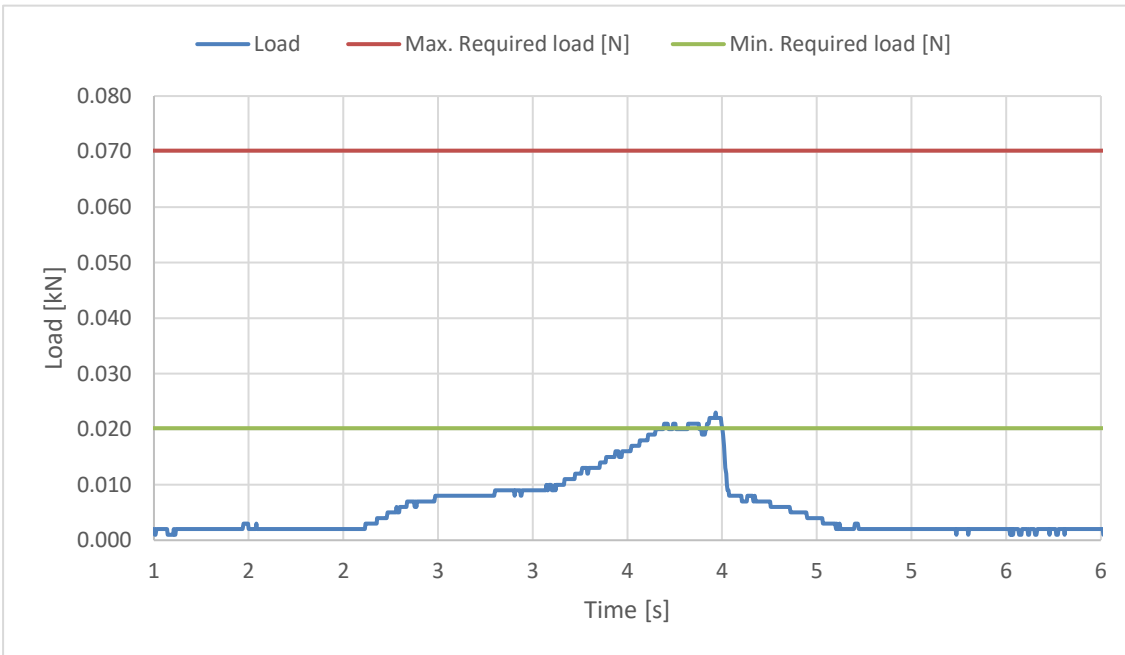
Test ID RRDT

Standard	NfL 2-565-20
Reference	6.1.5
Test setup	Default flying position
Attachment points	Sensor connect to handle, and pull in opening direction The test is to simulate the load required to open the emergency parachute(1st action).
Min. Required load [N]	20
Max. Required load [N]	70
Result	
Load for first action [N]	22.85
Test results	POSITIVE

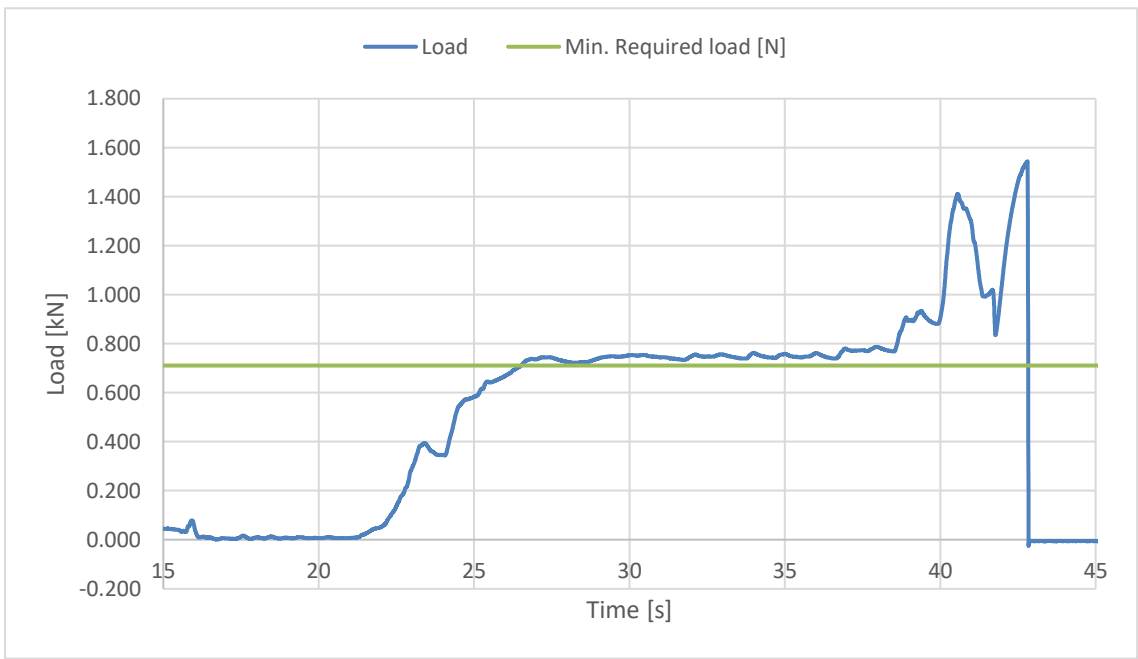
Test ID RRSST

Standard	EN12491:2015
Reference in standard	5.3.2
Test setup	Two end points of handle
Attachment points	Sensor connect to end of handle, pull on the other side The handle must support min 700 N for 10 s, after measure breaking strength
Min. Required load [N]	700
Minimum test duration [s]	10
Result	
Test duration [s]:	16.3
Breaking strength [N]	1533.74
Test results	POSITIVE
