## Harness Structural test Report - EN

Inspection certificate number: **PH\_313.2020**

Name: **Runa**  
 Type: **ABS**  
 Size: **M**  
 Serial number: **0520-038**  
 Impact pad type: <sup>(1)</sup> **Inflatable**  
 Clip-in weight [kg]: **100**

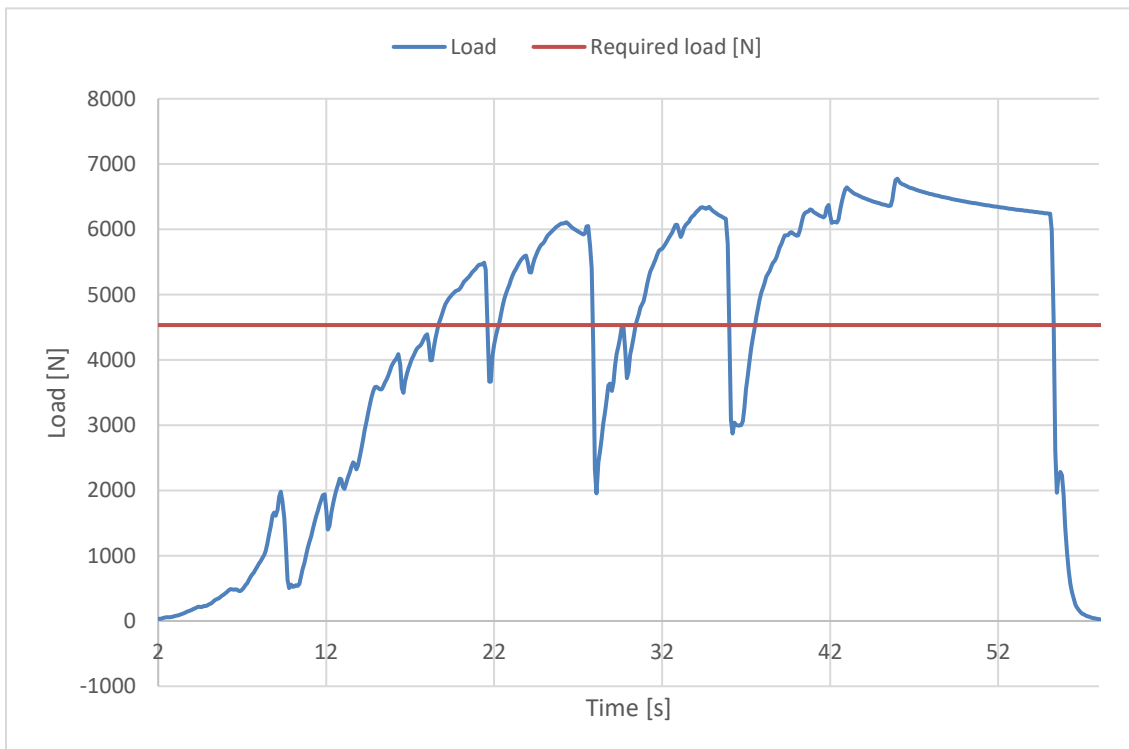
**Test ID 01**

Standard	<b>EN 1651</b>
Reference in standard	<b>5.5.1.1</b>
Test setup	<b>Positive symmetric load (Slippage)</b>
Attachment points	<b>Both main riser attachment (3,4)</b>
Anchor points	<b>Dummy (B1, B2)</b>
Required load [g]	<b>4.5</b>
Required load [N]	<b>4500</b>
Minimum test duration [s]	<b>5</b>
<b>Result</b>	
Test duration [s]	<b>17.8</b>
Any signs of structural failure	<b>No</b>
Slippery test OK	<b>Yes</b>
Test results	<b>POSITIVE</b>

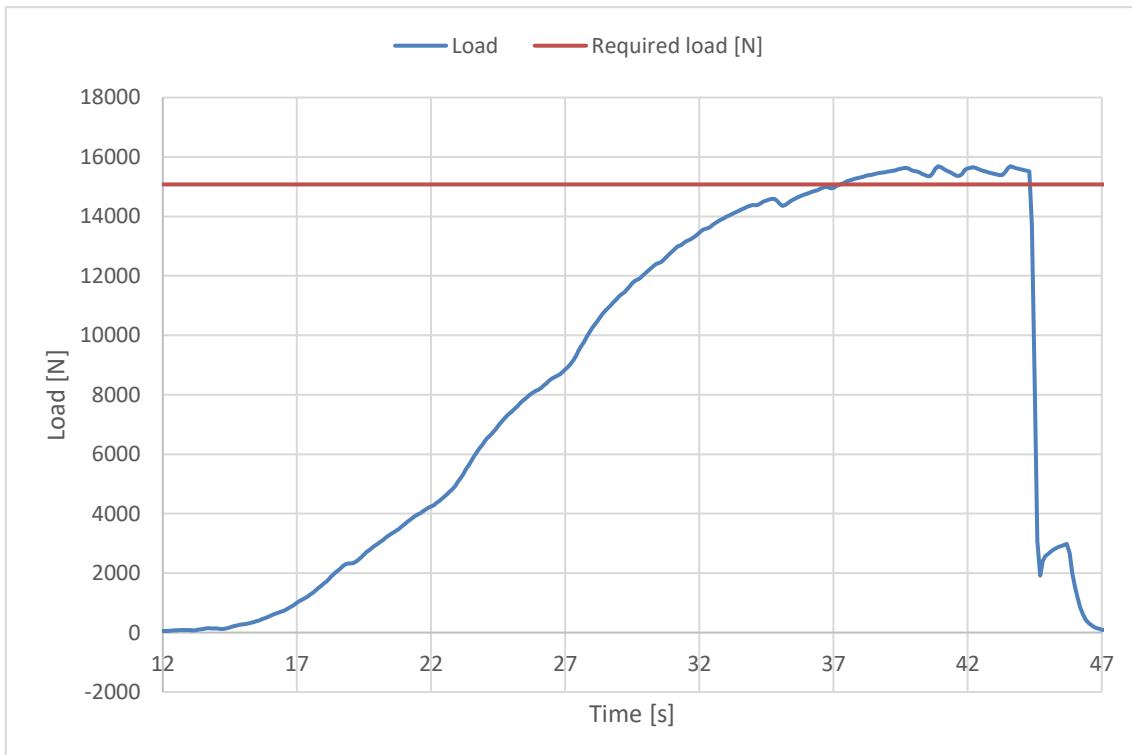
**Test ID 03**

Test duration [s] **7.1**  
 Any signs of structural failure **No**  
 Slippery test OK **Yes**  
 Test results **POSITIVE**

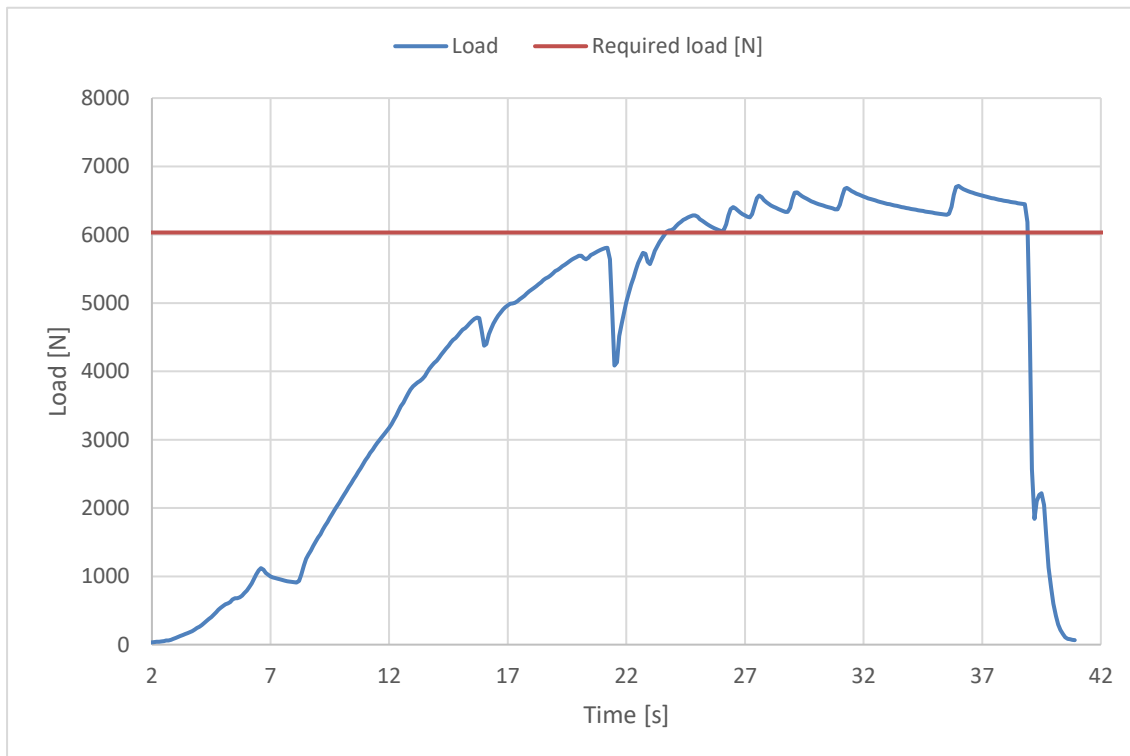
**Test ID 05**

Standard	<b>EN 1651</b>
Reference in standard	<b>5.5.1.2</b>
Test setup	<b>Positive asymmetric load</b>
Attachment points	<b>One riser attachment (3 or 4)</b>
Anchor points	<b>Dummy (C)</b>
Required load [g]	<b>6</b>
Required load [N]	<b>6000</b>
Minimum test duration [s]	<b>5</b>
<b>Result</b>	
Test duration [s]	<b>15.3</b>
Any signs of structural failure	<b>No</b>
Test results	<b>POSITIVE</b>

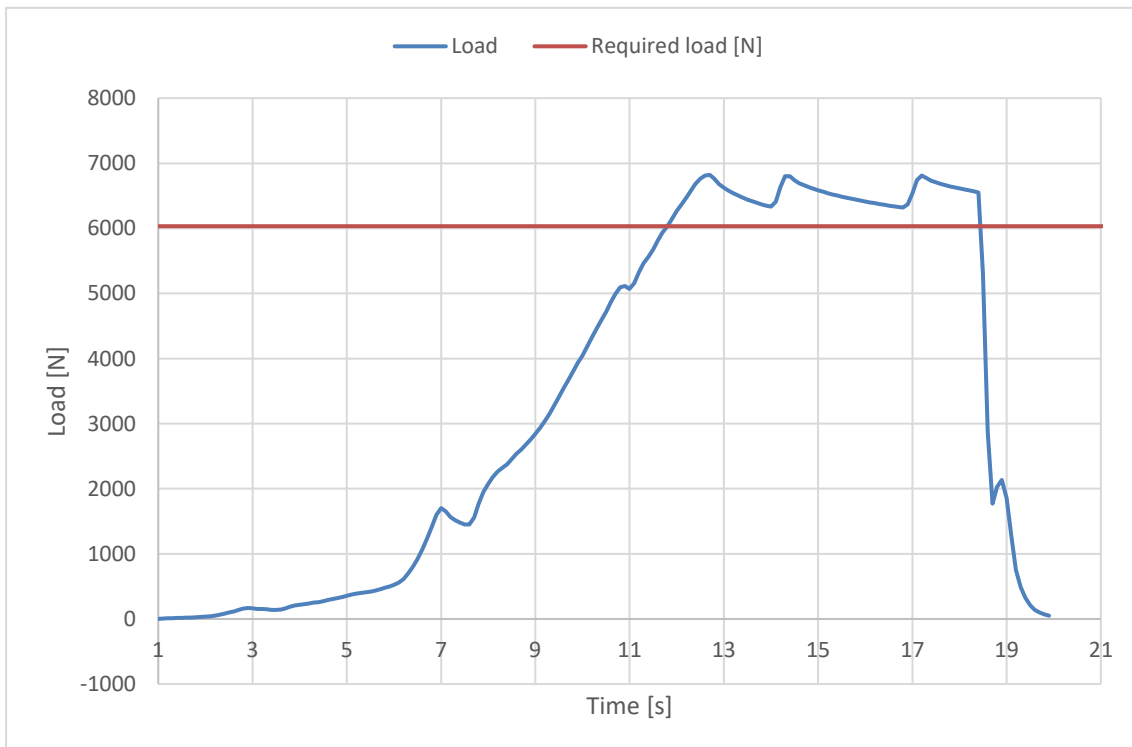
**Test ID 06**

Standard	<b>EN 1651</b>
Reference in standard	<b>5.5.1.6</b>
Test setup	<b>Negative symmetric load</b>
Attachment points	<b>Both main riser attachment (3,4)</b>
Anchor points	<b>Dummy (A)</b>
Required load [g]	<b>6</b>
Required load [N]	<b>6000</b>
Minimum test duration [s]	<b>5</b>
<b>Result</b>	
Test duration [s]	<b>6.6</b>
Any signs of structural failure	<b>No</b>
Test results	<b>POSITIVE</b>

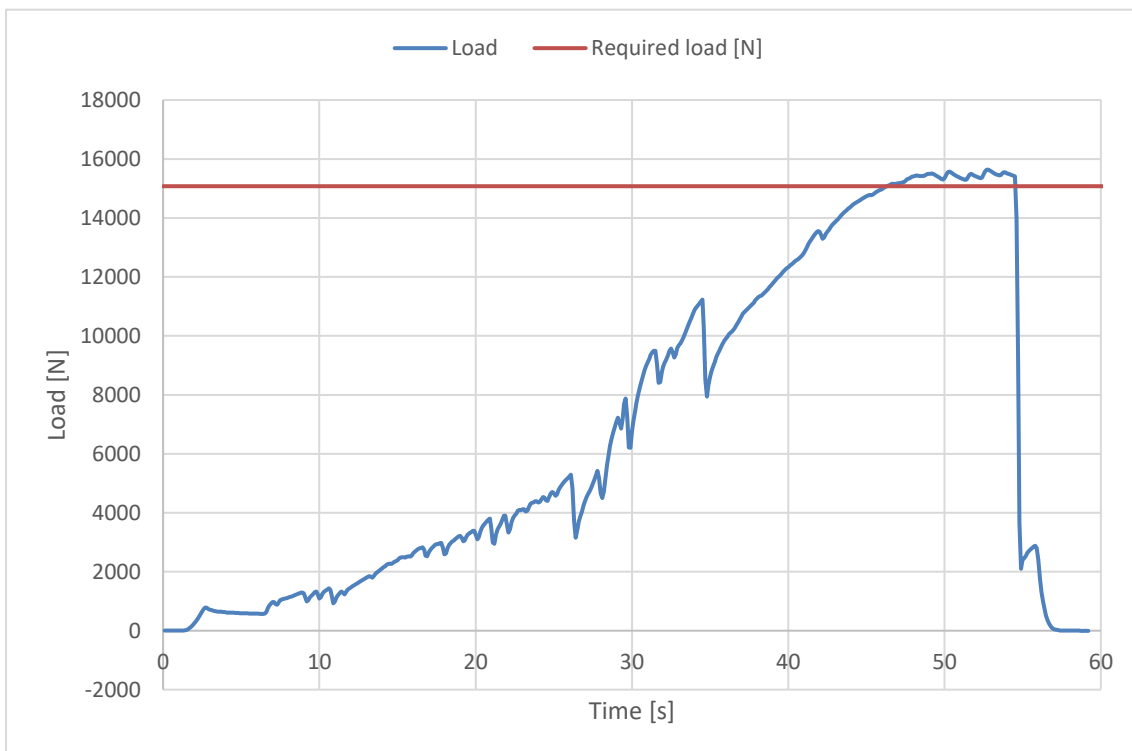
**Test ID 09**

Standard	<b>EN 1651</b>
Reference in standard	<b>5.5.1.3</b>
Test setup	<b>Positive symmetric load rescue points</b>
Attachment points	<b>Both main riser attachment (1,2)</b>
Anchor points	<b>Dummy (B1,B2)</b>
Required load [g]	<b>15</b>
Required load [N]	<b>15000</b>
Minimum test duration [s]	<b>5</b>
<b>Result</b>	
Test duration [s]	<b>8.3</b>
Any signs of structural failure	<b>No</b>
Slippery test OK	<b>Yes</b>
Test results	<b>POSITIVE</b>

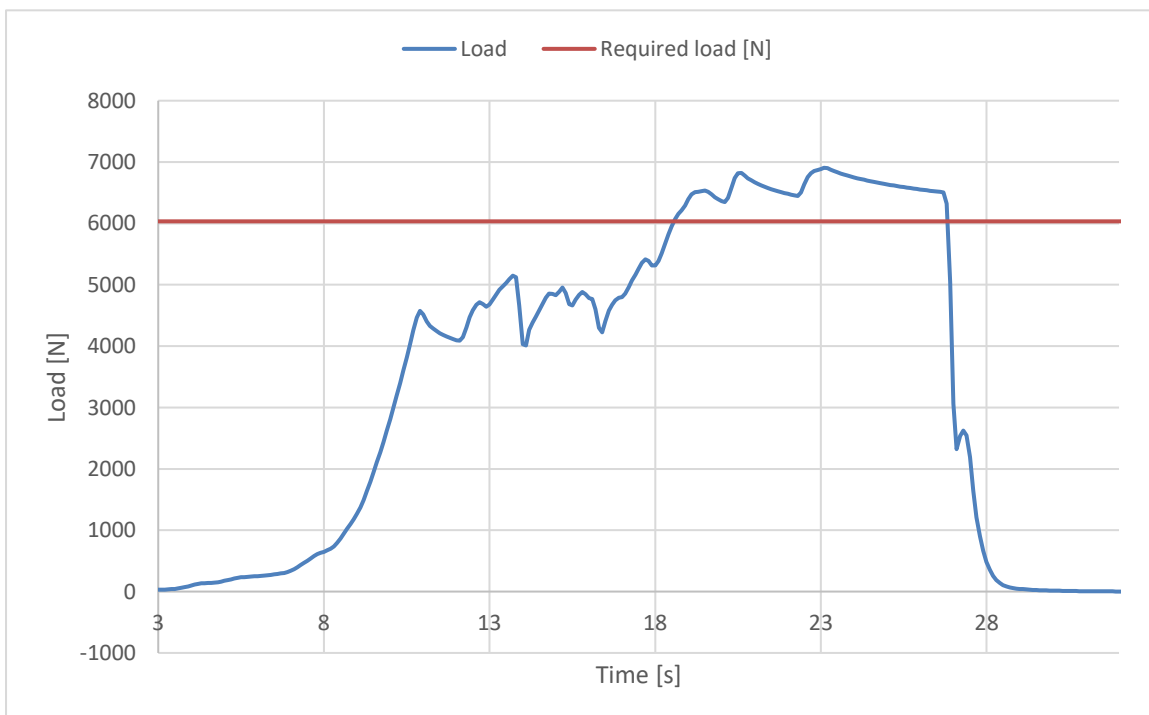
**Test ID 12**

Standard	<b>EN 1651</b>
Reference in standard	<b>5.5.1.7</b>
Test setup	<b>Upright (landing) position load</b>
Attachment points	<b>Both main riser attachment (3, 4)</b>
Anchor points	<b>Both legstrap of harness (no dummy)</b>
Required load [g]	<b>6</b>
Required load [N]	<b>6000</b>
Minimum test duration [s]	<b>5</b>
Harness type	<b>type a</b>
<b>Result</b>	
Test duration [s]	<b>8.3</b>
Any signs of structural failure	<b>No</b>
Slippery test OK	<b>Yes</b>
Test results	<b>POSITIVE</b>

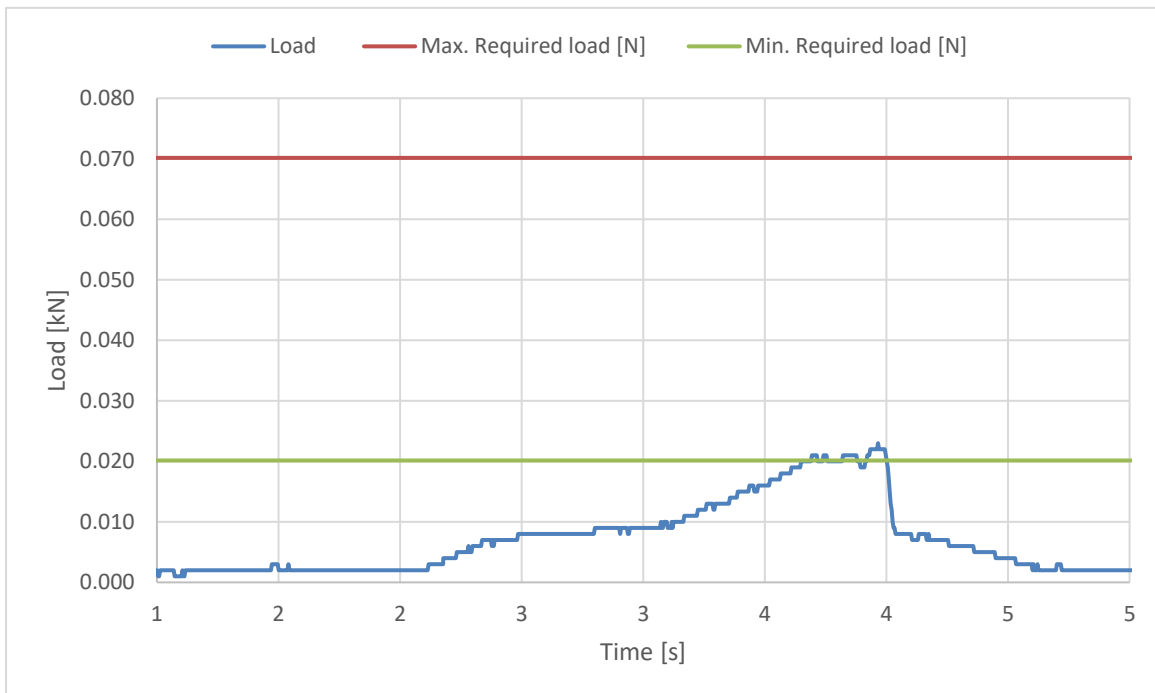
**Test ID RRDT**

Standard	<b>LTF NfL II 91/09</b>
Reference in standard	<b>6.1.5</b>
Test setup	<b>Default flying position</b>
Attachment points	<b>Sensor connect to handle, and pull in opening direction</b>
	The test is to simulate the load required to open the emergency parachute(1st action).
Min. Required load [N]	<b>20</b>
Max. Required load [N]	<b>70</b>
<b>Result</b>	
Load for first action [N]	<b>22.86</b>
Test results	<b>POSITIVE</b>

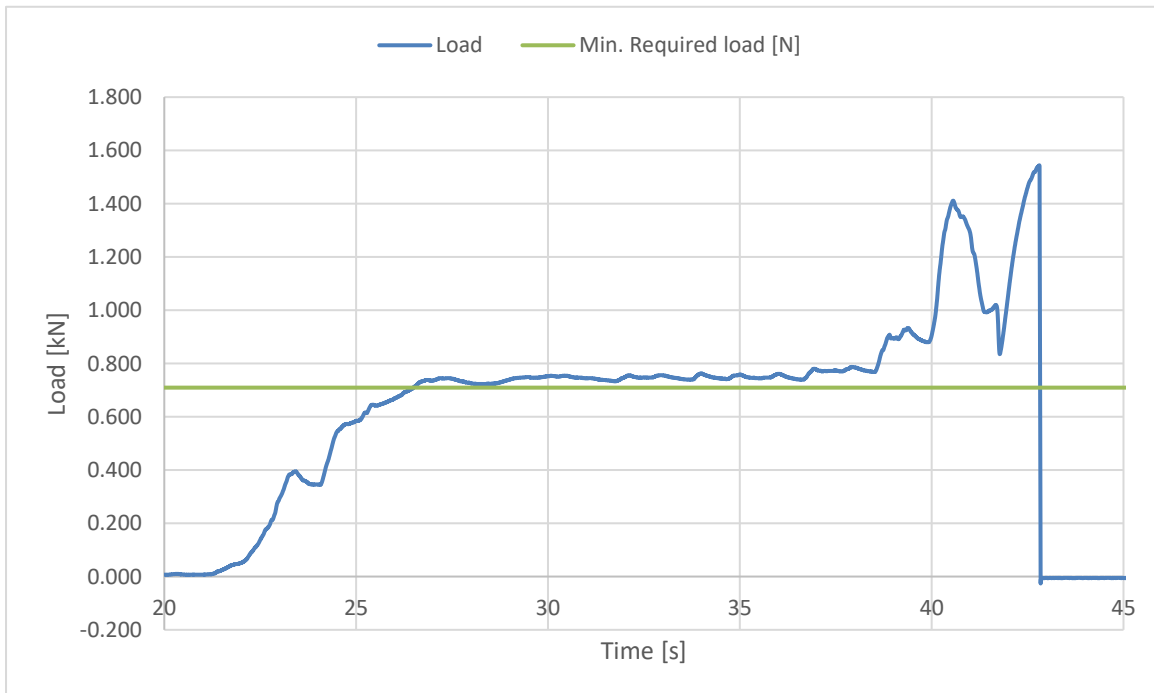
**Test ID RRST**

Standard	<b>EN12491:2015</b>
Reference in standard	<b>5.3.2</b>
Test setup	<b>Two end points of handle</b>
Attachment points	<b>Sensor connect to end of handle, pull on the other side</b>
	The handle must support min 700 N for 10 s, after measure breaking strength
Min. Required load [N]	<b>700</b>
Minimum test duration [s]	<b>10</b>
<b>Result</b>	
Test duration [s]:	<b>16.3</b>
Breaking strength [N]	<b>1534.72</b>
Test results	<b>POSITIVE</b>
