## Harness Structural test Report - LTF

Inspection certificate number: **PH\_313.2020**

Name: **Runa**  
 Type: **ABS**  
 Size: **M**  
 Serial number: **0520-038**  
 Impact pad type: <sup>(1)</sup> **Inflatable**  
 Clip-in weight [kg]: **100**

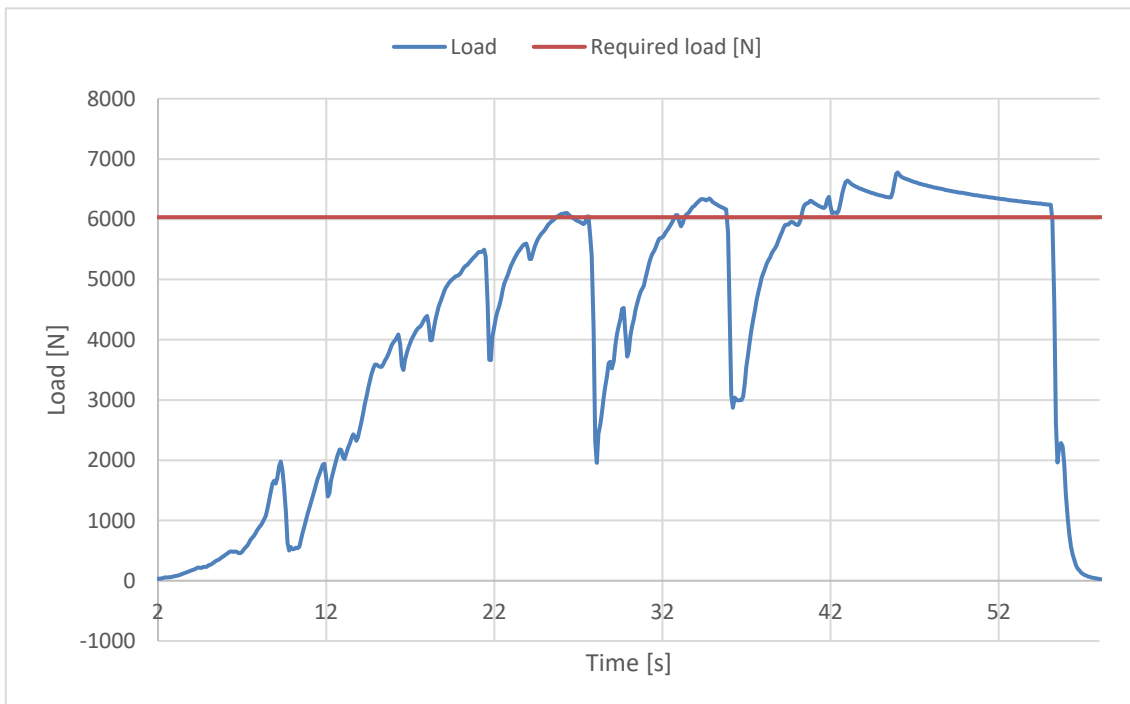
**Test ID 02**

Standard	<b>LTF NfL II 91/09</b>
Reference	<b>5.3.2.1</b>
Test setup	<b>Default flying position</b>
Attachment points	<b>Both main riser attachment (3,4)</b>
Anchor points	<b>Dummy (B1, B2)</b>
Required load [g]	<b>6</b>
Required load [N]	<b>6000</b>
Minimum test duration [s]	<b>10</b>
<b>Result</b>	
Test duration [s]	<b>14.9</b>
Any signs of structural failure	<b>No</b>
Test results	<b>POSITIVE</b>

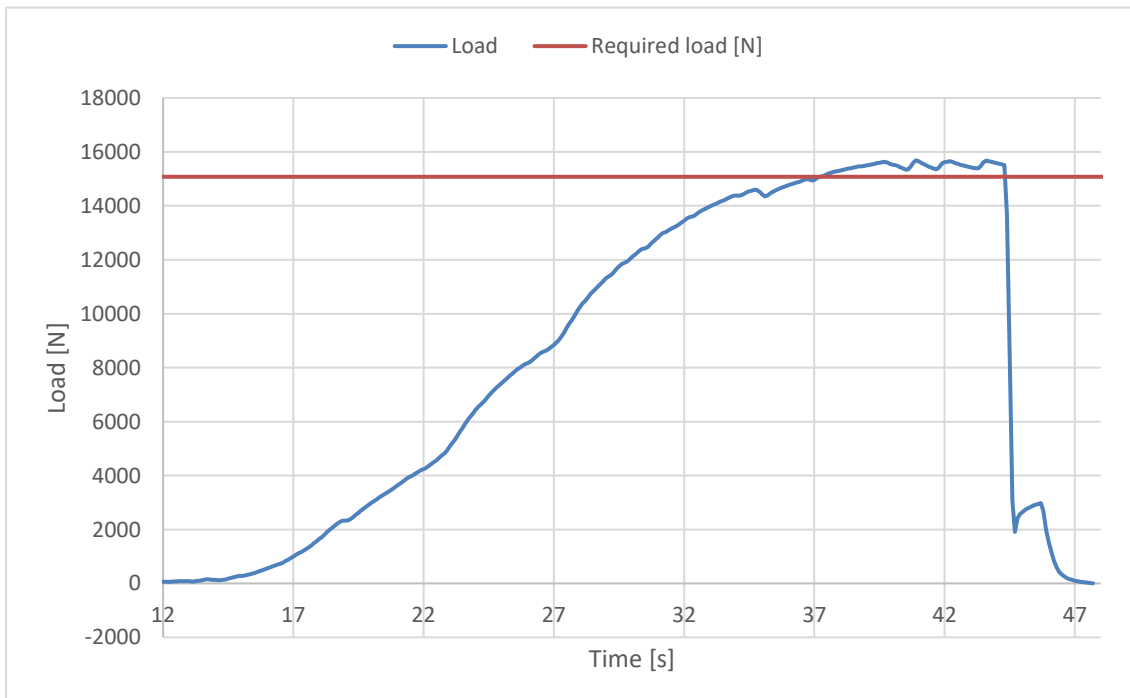
**Test ID 03**

Standard	<b>LTF NfL II 91/09</b>
Reference	<b>5.3.2.2</b>
Test setup	<b>Default flying position</b>
Attachment points	<b>Both main riser attachment (3,4)</b>
Anchor points	<b>Dummy (B1, B2)</b>
Required load [g]	<b>15</b>
Required load [N]	<b>15000</b>
Minimum test duration [s]	<b>5</b>
<b>Result</b>	
Test duration [s]	<b>7.1</b>
Any signs of structural failure	<b>No</b>
Test results	<b>POSITIVE</b>

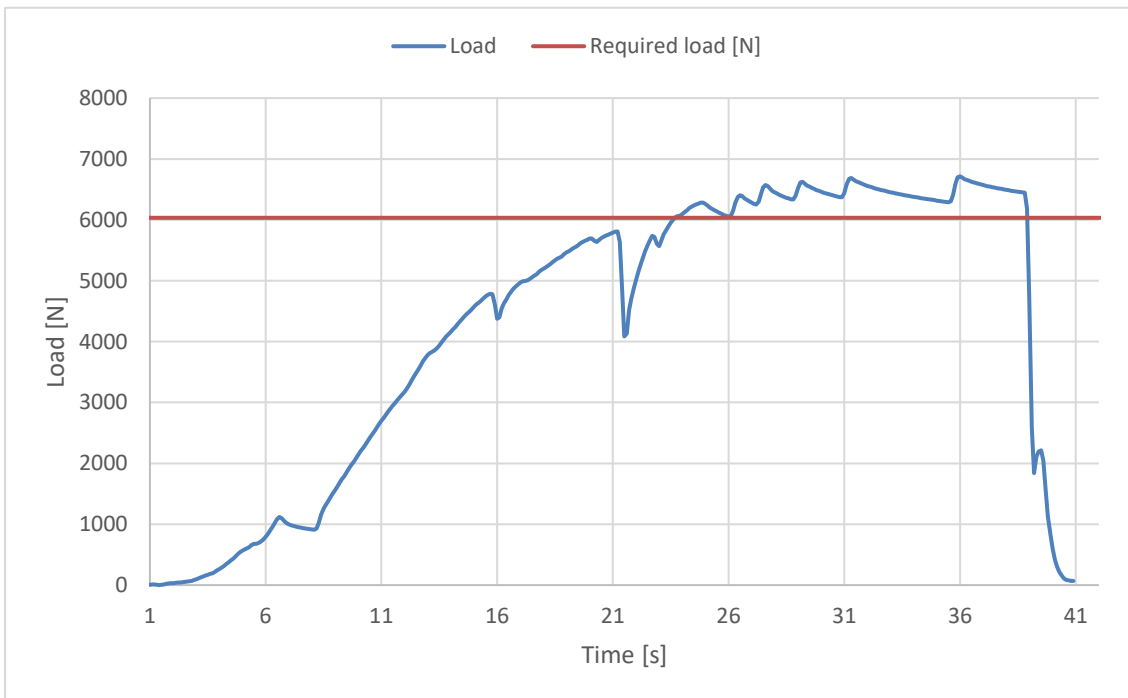
**Test ID 04**

Test duration [s] **15.3**  
 Any signs of structural failure **No**  
 Test results **POSITIVE**

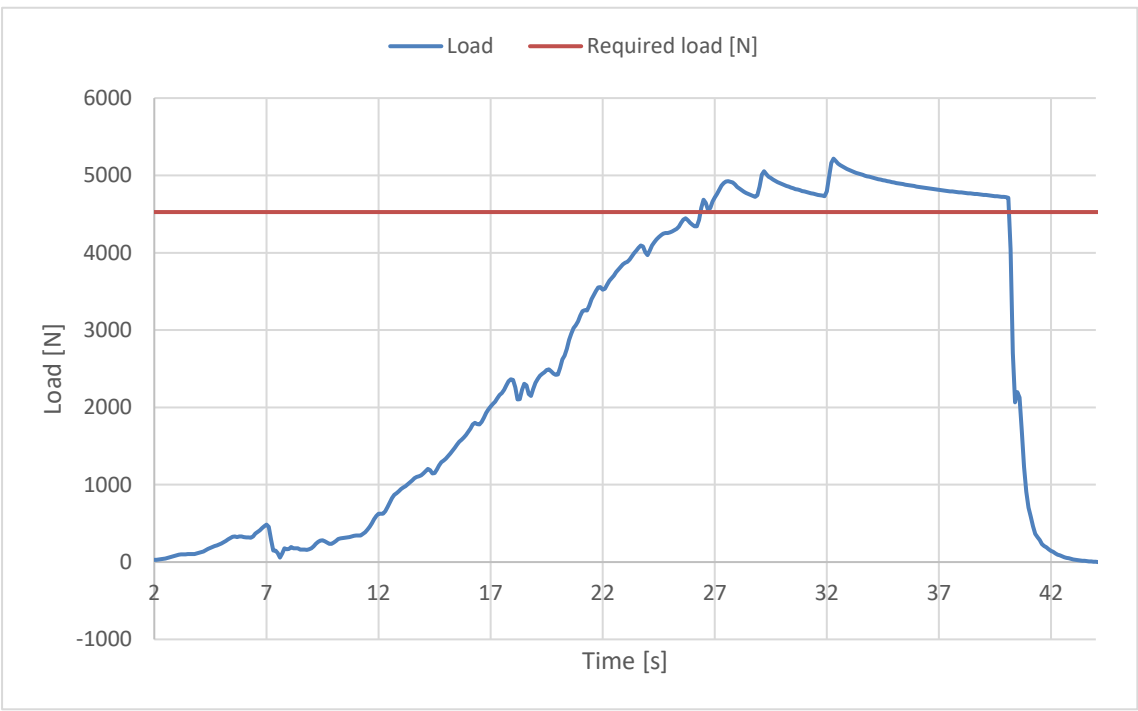
**Test ID 07**

Reference	<b>5.3.2.6</b>	
Test setup	<b>Asymmetric, negative</b>	
Attachment points	<b>One main riser attachment (3 or 4) downwards</b>	
Anchor points	<b>Dummy (9)</b>	
Required load [g]	<b>4.5</b>	
Required load [N]	<b>4500</b>	
Minimum test duration [s]	<b>10</b>	
<b>Result</b>		
Test duration [s]	<b>13.8</b>	
Any signs of structural failure	<b>No</b>	
Test results	<b>POSITIVE</b>

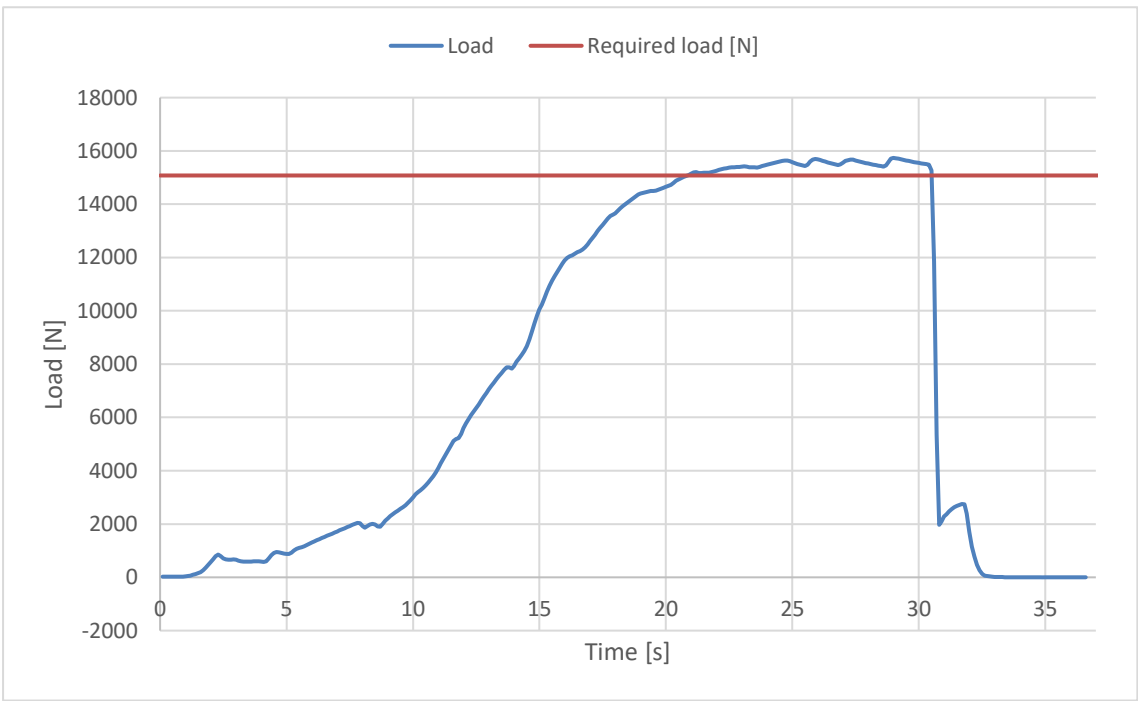
**Test ID 13**

Standard	<b>LTF NfL II 91/09</b>
Reference	<b>5.3.2.7</b>
Test setup	<b>Flying position before landing</b>
Attachment points	<b>Both main riser attachment (3,4)</b>
Anchor points	<b>Dummy (7,8)</b>
Required load [g]	<b>15</b>
Required load [N]	<b>15000</b>
Minimum test duration [s]	<b>5</b>
<b>Result</b>	
Test duration [s]	<b>9.7</b>
Any signs of structural failure	<b>No</b>
Test results	<b>POSITIVE</b>

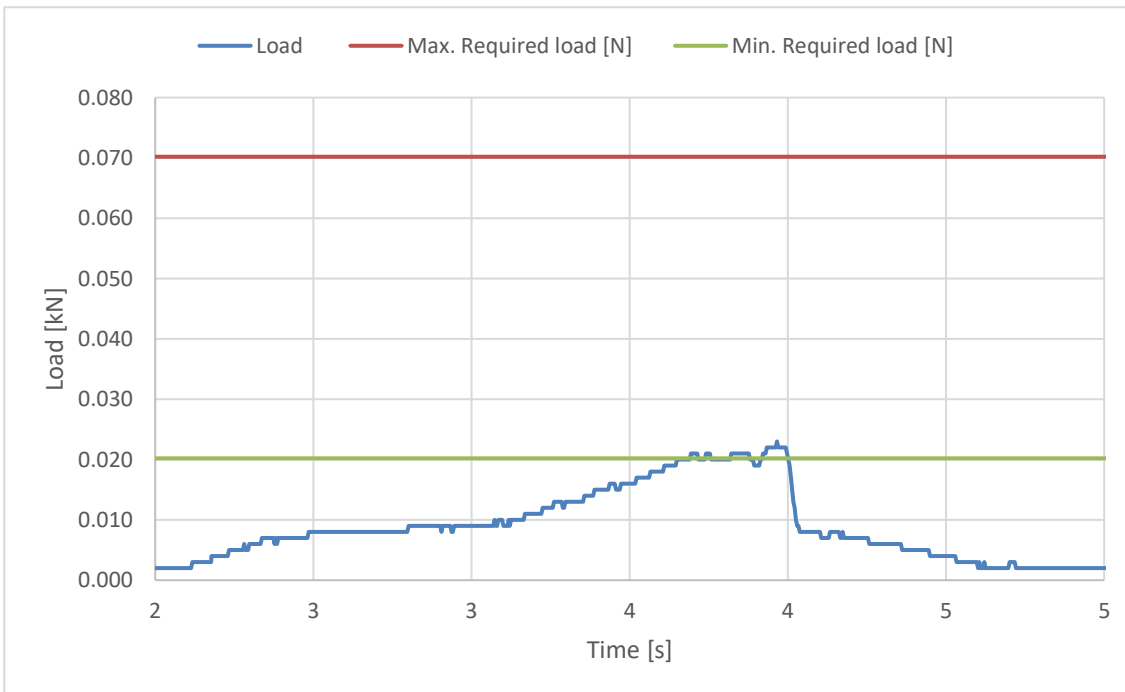
**Test ID RRDT**

Standard	<b>LTF NfL II 91/09</b>
Reference	<b>6.1.5</b>
Test setup	<b>Default flying position</b>
Attachment points	<b>Sensor connect to handle, and pull in opening direction</b>
	The test is to simulate the load required to open the emergency parachute(1st action).
Min. Required load [N]	<b>20</b>
Max. Required load [N]	<b>70</b>
<b>Result</b>	
Load for first action [N]	<b>22.80</b>
Test results	<b>POSITIVE</b>

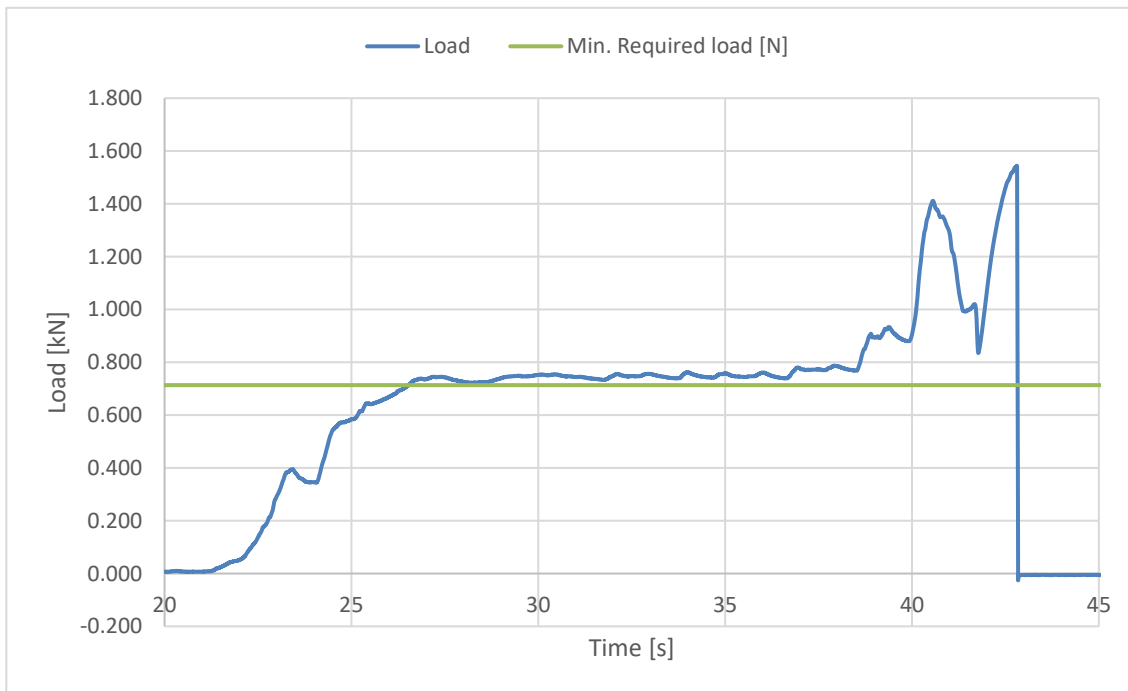
**Test ID RRST**

Standard	<b>EN12491:2015</b>
Reference in standard	<b>5.3.2</b>
Test setup	<b>Two end points of handle</b>
Attachment points	<b>Sensor connect to end of handle, pull on the other side</b>
	The handle must support min 700 N for 10 s, after measure breaking strength
Min. Required load [N]	<b>700</b>
Minimum test duration [s]	<b>10</b>
<b>Result</b>	
Test duration [s]:	<b>16.3</b>
Breaking strength [N]	<b>1530.61</b>
Test results	<b>POSITIVE</b>
