Harness Structural test Report - EN

Inspection certificate number: **PH 312.2020**

Name: **String V3**
 Type: **ABS**
 Size: **M**
 Serial number: **H13-001**
 Impact pad type: ⁽¹⁾ **Airbag**
 Clip-in weight [kg]: **120**
 Date of test: **21.09.2020**

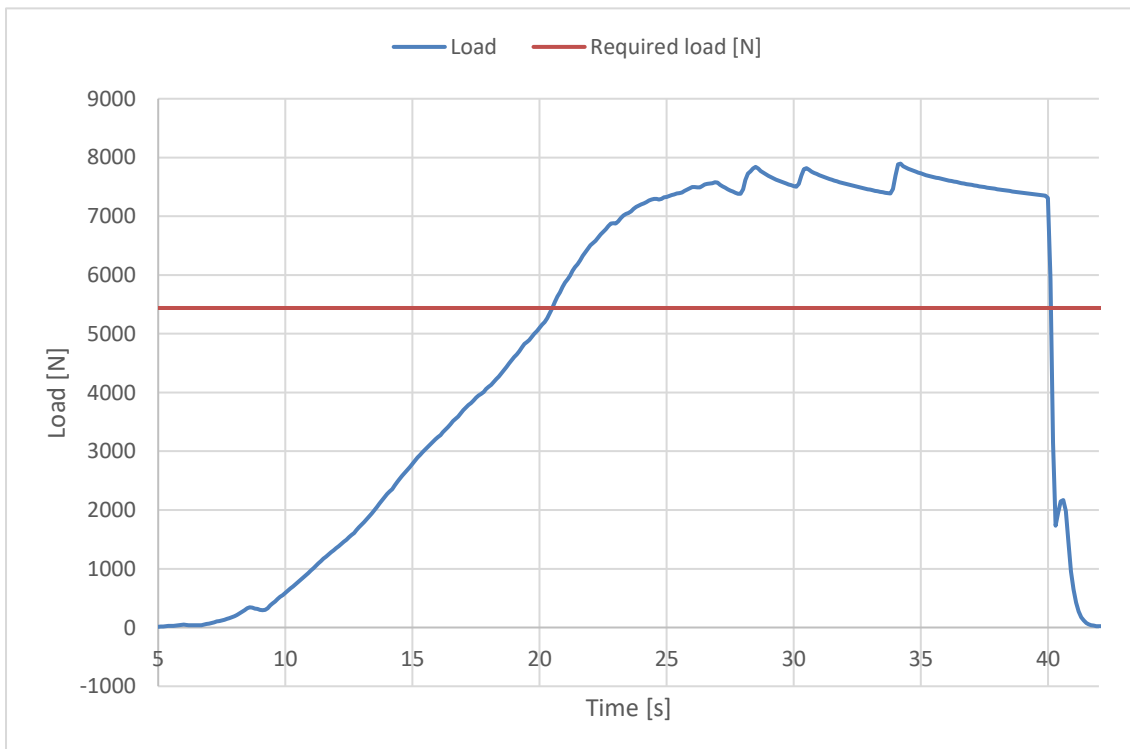
Test ID 03

Standard	EN 1651
Reference in standard	5.5.1.1
Test setup	Positive symmetric load (Slippage)
Attachment points	Both main riser attachment (3,4)
Anchor points	Dummy (B1, B2)
Required load [g]	4.5
Required load [N]	5400
Minimum test duration [s]	5
Result	
Test duration [s]	19.6
Any signs of structural failure	No
Slippery test OK	Yes
Test results	POSITIVE

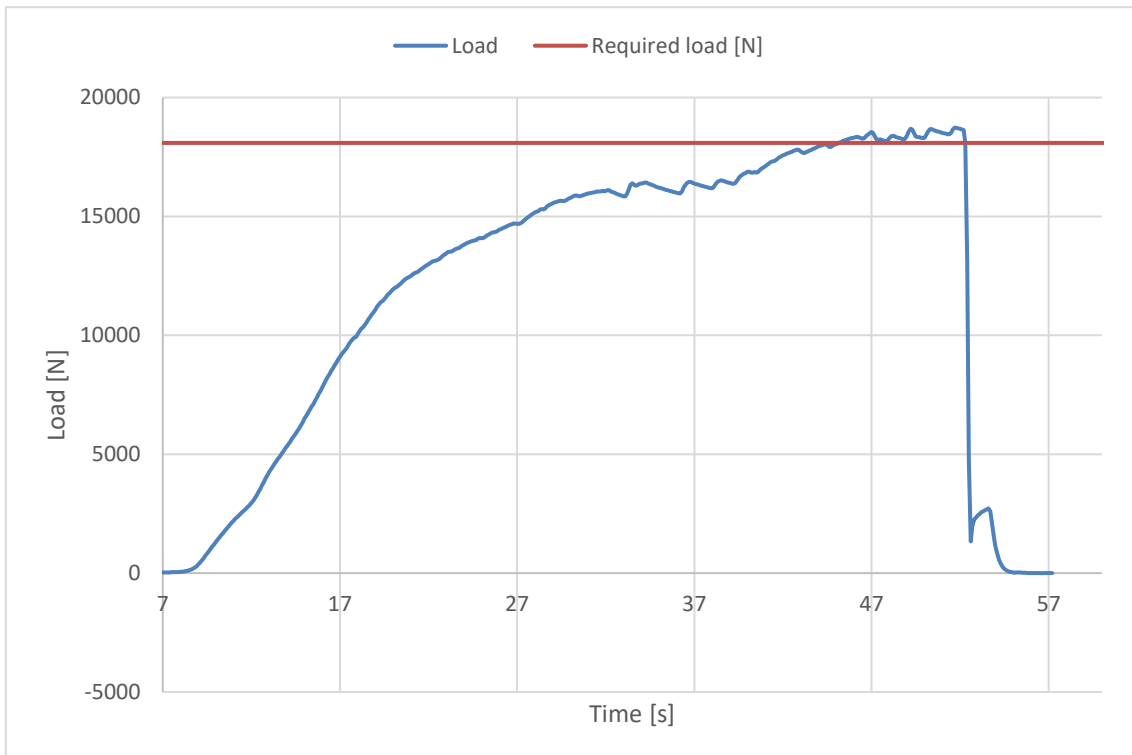
Standard **EN 1651**
 Reference in standard **5.5.1.1b**
 Test setup **Positive symmetric load**
 Attachment points **Both main riser attachment (3,4)**
 Anchor points **Dummy (B1, B2)**

Test duration [s] **7.1**
 Any signs of structural failure **No**
 Slippery test OK **Yes**
 Test results **POSITIVE**

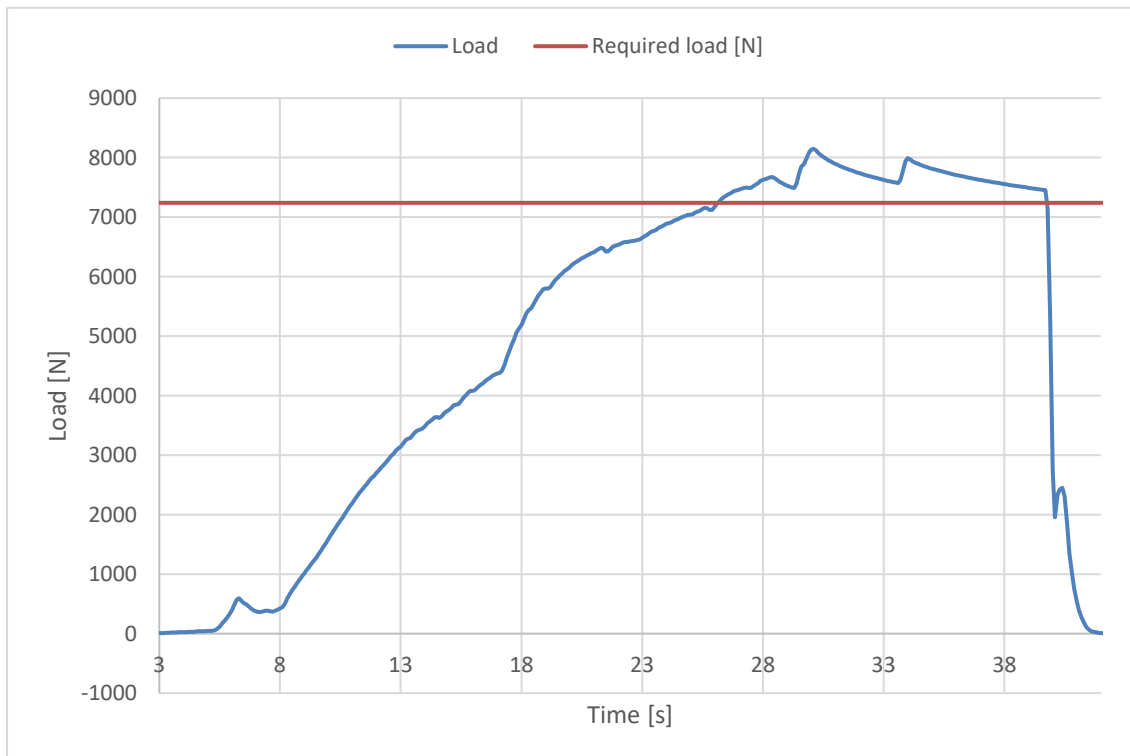
Test ID 05

Standard	EN 1651
Reference in standard	5.5.1.2
Test setup	Positive asymmetric load
Attachment points	One riser attachment (3 or 4)
Anchor points	Dummy (C)
Required load [g]	6
Required load [N]	7200
Minimum test duration [s]	5
Result	
Test duration [s]	13.6
Any signs of structural failure	No
Test results	POSITIVE

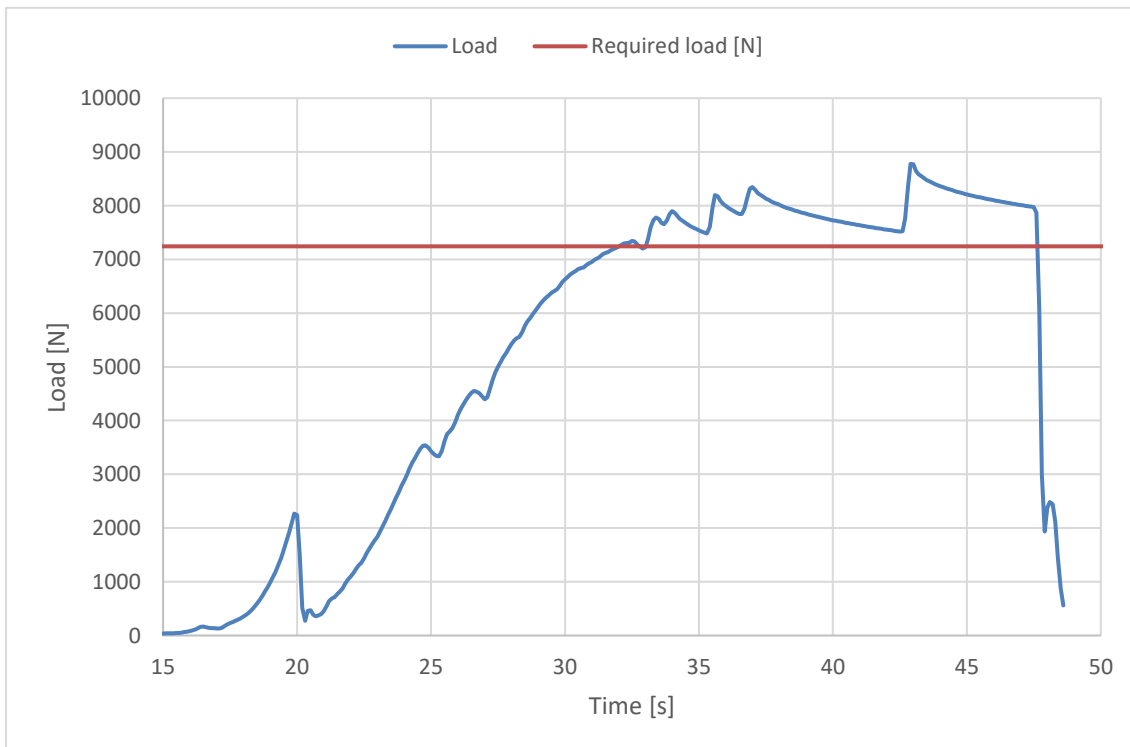
Test ID 06

Standard	EN 1651
Reference in standard	5.5.1.6
Test setup	Negative symmetric load
Attachment points	Both main riser attachment (3,4)
Anchor points	Dummy (A)
Required load [g]	6
Required load [N]	7200
Minimum test duration [s]	5
Result	
Test duration [s]	14.6
Any signs of structural failure	No
Test results	POSITIVE

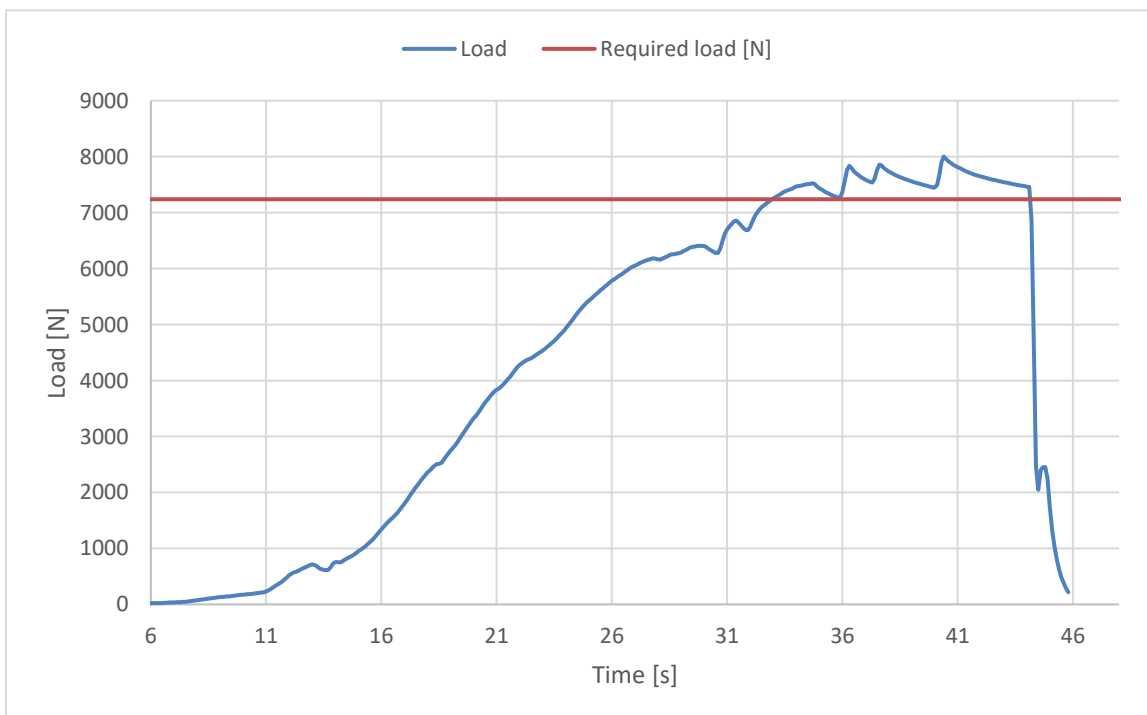
Test ID 12

Standard	EN 1651
Reference in standard	5.5.1.7
Test setup	Upright (landing) position load
Attachment points	Both main riser attachment (3, 4)
Anchor points	Both legstrap of harness (no dummy)
Required load [g]	6
Required load [N]	7200
Minimum test duration [s]	5
Harness type	type c
Result	
Test duration [s]	11.2
Any signs of structural failure	No
Slippery test OK	Yes
Test results	POSITIVE
