## Harness Structural test Report - LTF

Inspection certificate number: **PH 312.2020**

Name: **String V3**  
 Type: **ABS**  
 Size: **M**  
 Serial number: **H13-001**  
 Impact pad type: <sup>(1)</sup> **Airbag**  
 Clip-in weight [kg]: **120**

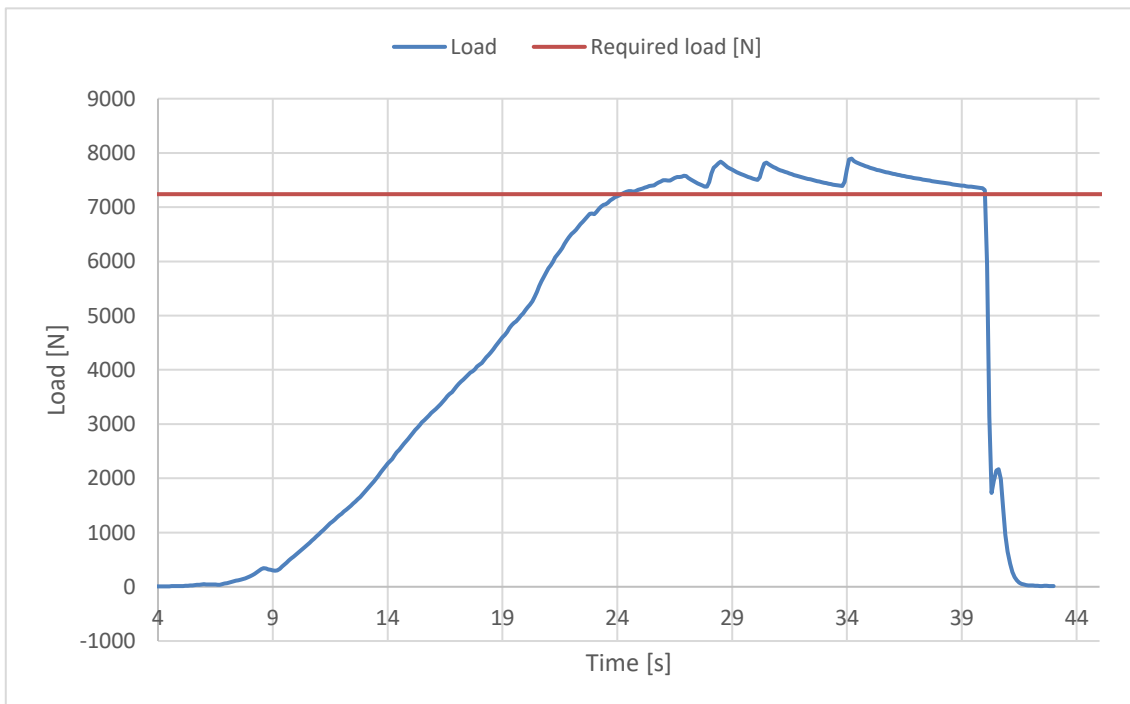
**Test ID 02**

Standard	<b>LTF NfL II 91/09</b>
Reference	<b>5.3.2.1</b>
Test setup	<b>Default flying position</b>
Attachment points	<b>Both main riser attachment (3,4)</b>
Anchor points	<b>Dummy (B1, B2)</b>
Required load [g]	<b>6</b>
Required load [N]	<b>7200</b>
Minimum test duration [s]	<b>10</b>
<b>Result</b>	
Test duration [s]	<b>15.9</b>
Any signs of structural failure	<b>No</b>
Test results	<b>POSITIVE</b>

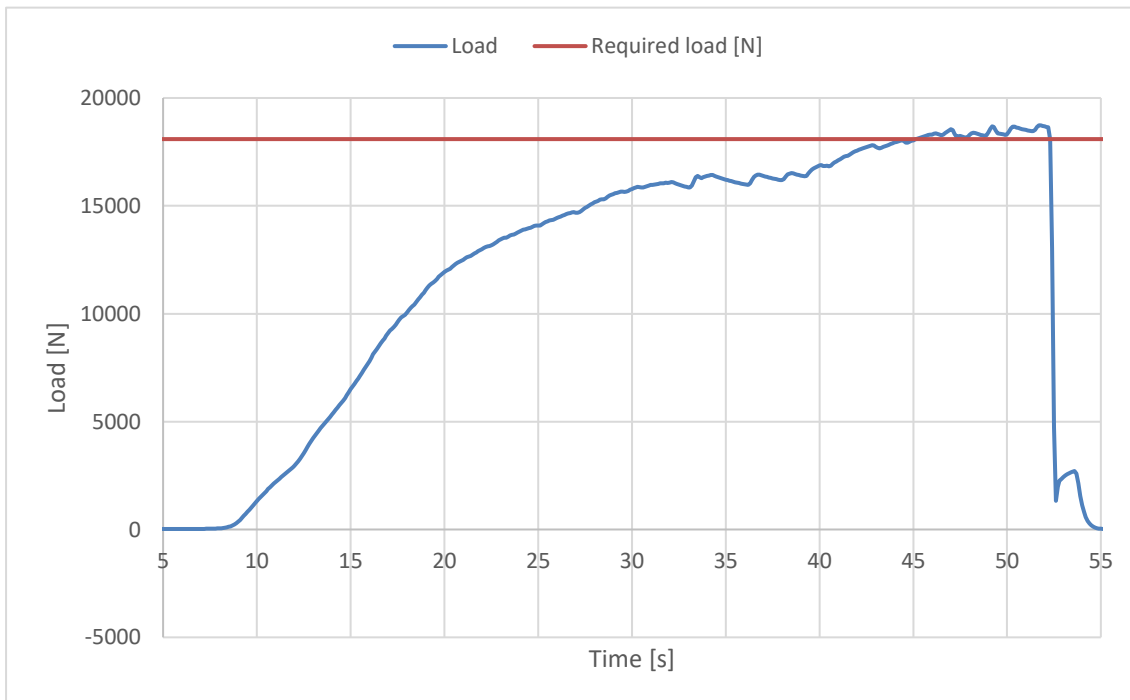
**Test ID 03**

Test duration [s] **7.1**  
 Any signs of structural failure **No**  
 Test results **POSITIVE**

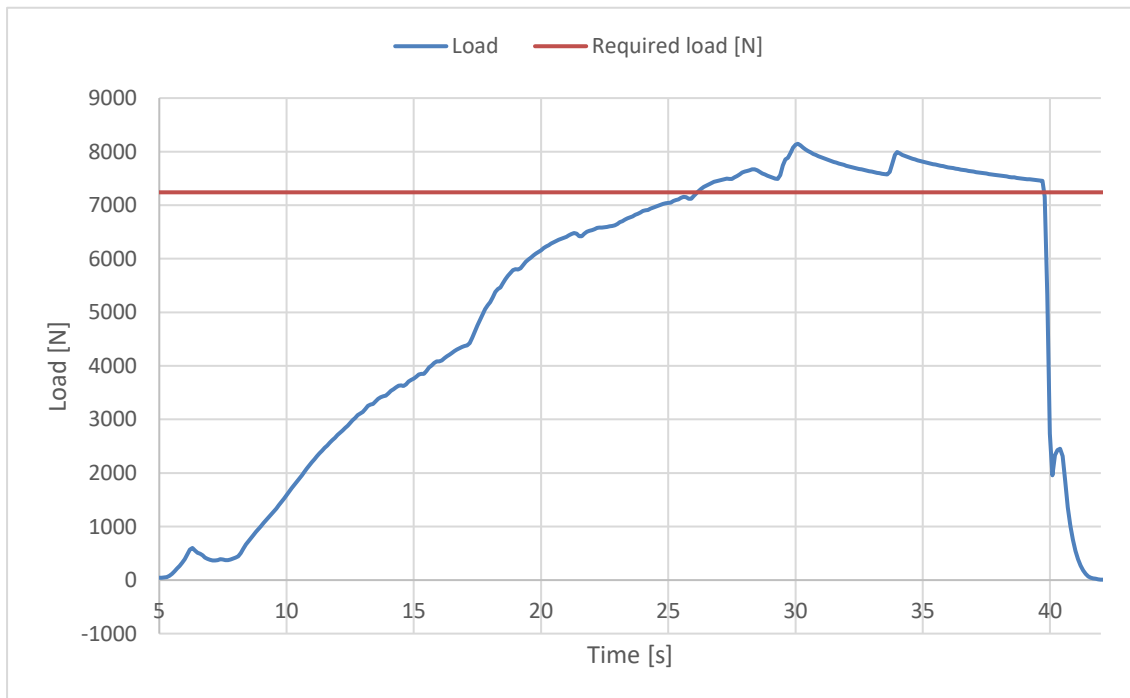
**Test ID 04**

Test duration [s] **13.6**  
 Any signs of structural failure **No**  
 Test results **POSITIVE**

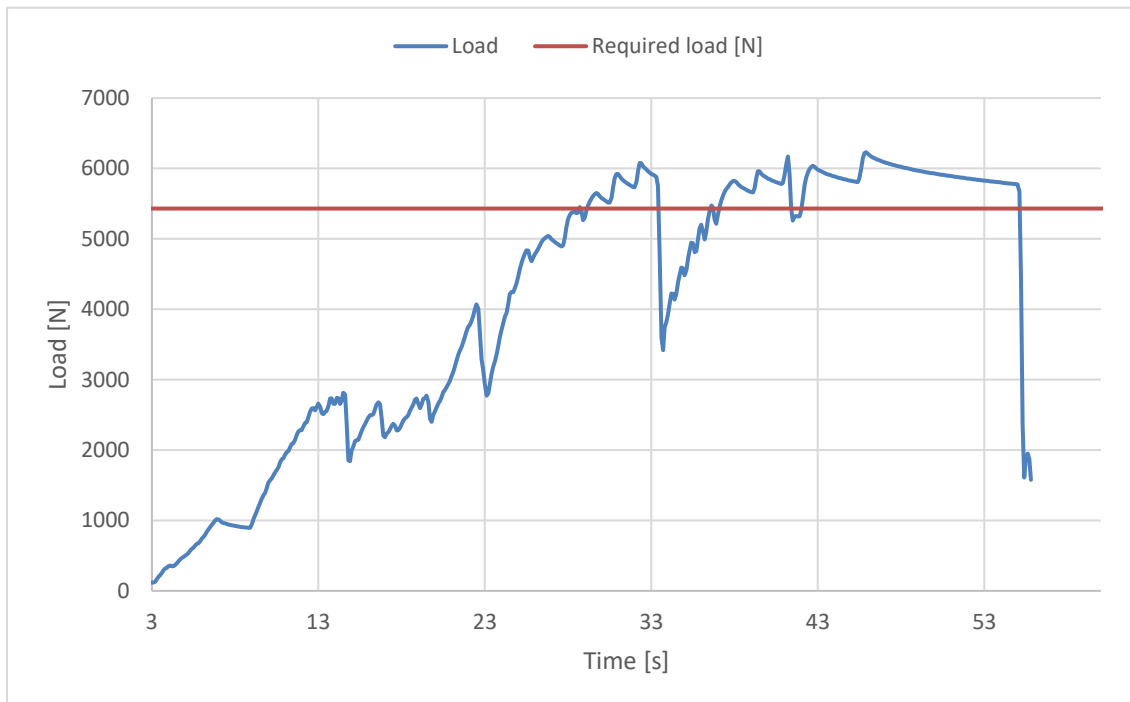
**Test ID 07**

Reference	<b>5.3.2.6</b>	
Test setup	<b>Asymmetric, negative</b>	
Attachment points	<b>One main riser attachment (3 or 4) downwards</b>	
Anchor points	<b>Dummy (9)</b>	
Required load [g]	<b>4.5</b>	
Required load [N]	<b>5400</b>	
Minimum test duration [s]	<b>10</b>	
<b>Result</b>		
Test duration [s]	<b>13.1</b>	
Any signs of structural failure	<b>No</b>	
Test results	<b>POSITIVE</b>

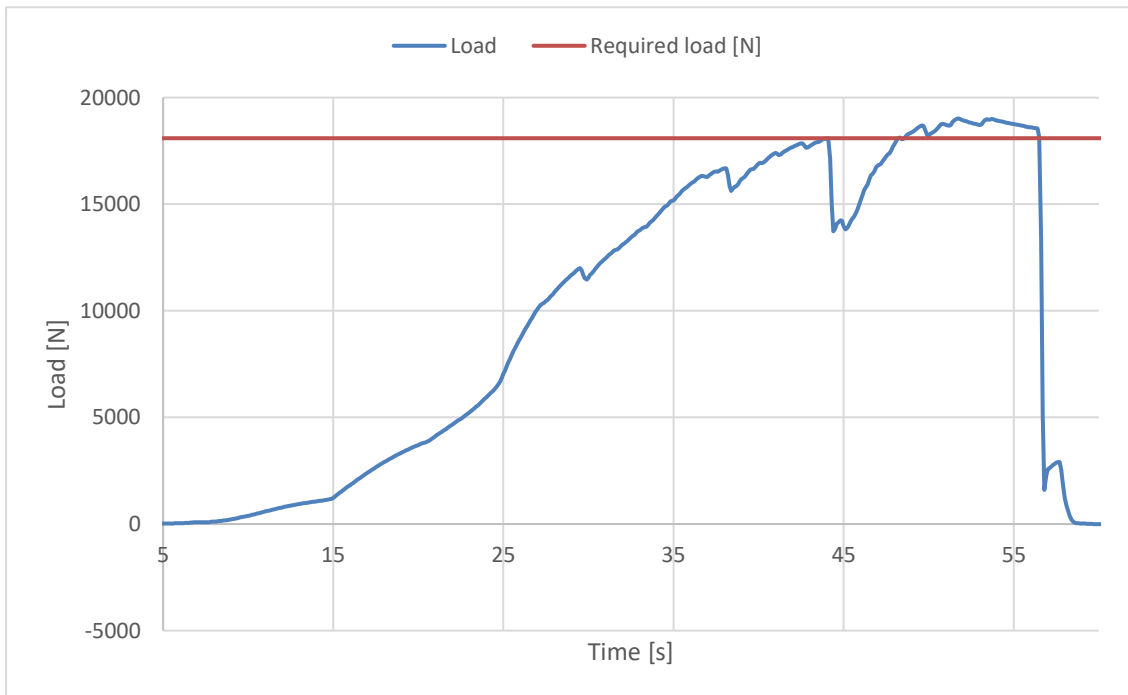
**Test ID 13**

Standard	<b>LTF NfL II 91/09</b>
Reference	<b>5.3.2.7</b>
Test setup	<b>Flying position before landing</b>
Attachment points	<b>Both main riser attachment (3,4)</b>
Anchor points	<b>Dummy (7,8)</b>
Required load [g]	<b>15</b>
Required load [N]	<b>18000</b>
Minimum test duration [s]	<b>5</b>
<b>Result</b>	
Test duration [s]	<b>8</b>
Any signs of structural failure	<b>No</b>
Test results	<b>POSITIVE</b>
