# Harness Structural test Report

Inspection certificate number: **PH\_216.2017**
**Manufacturer data:**

Name: **Crux**  
 Type: **ABS**  
 Size: **M**  
 Serial number: **2261-13-7232**  
 Impact pad type: <sup>(1)</sup> **n/a**  
 Clip-in weight [kg]: **120**

**Summary of Structural test**

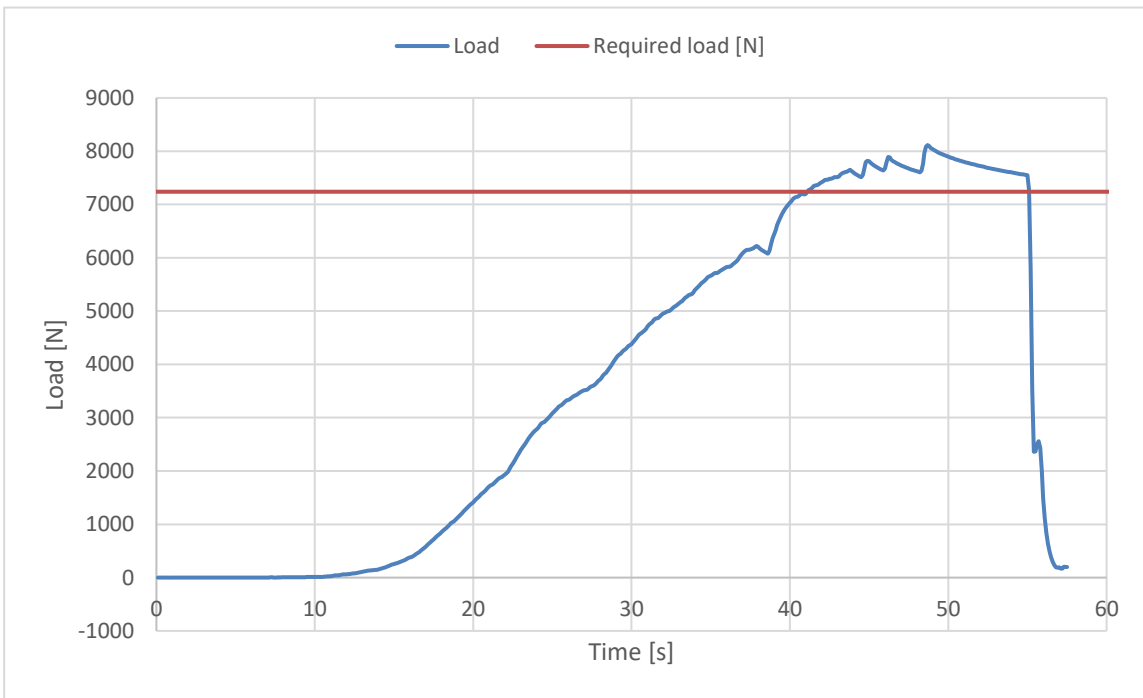
**Test ID R0**

Reference in standard	<b>5.3.2.1</b>	
Test setup	<b>Default flying position</b>	
Attachment points	<b>Both main riser attachment (3,4)</b>	
Anchor points	<b>Dummy (B1, B2)</b>	
Required load [g]	<b>6</b>	
Required load [N]	<b>7200</b>	
Minimum test duration [s]	<b>10</b>	
<b>Result</b>		
Test duration [s]	<b>14</b>	
Any signs of structural failure	<b>No</b>	
Test results	<b>POSITIVE</b>

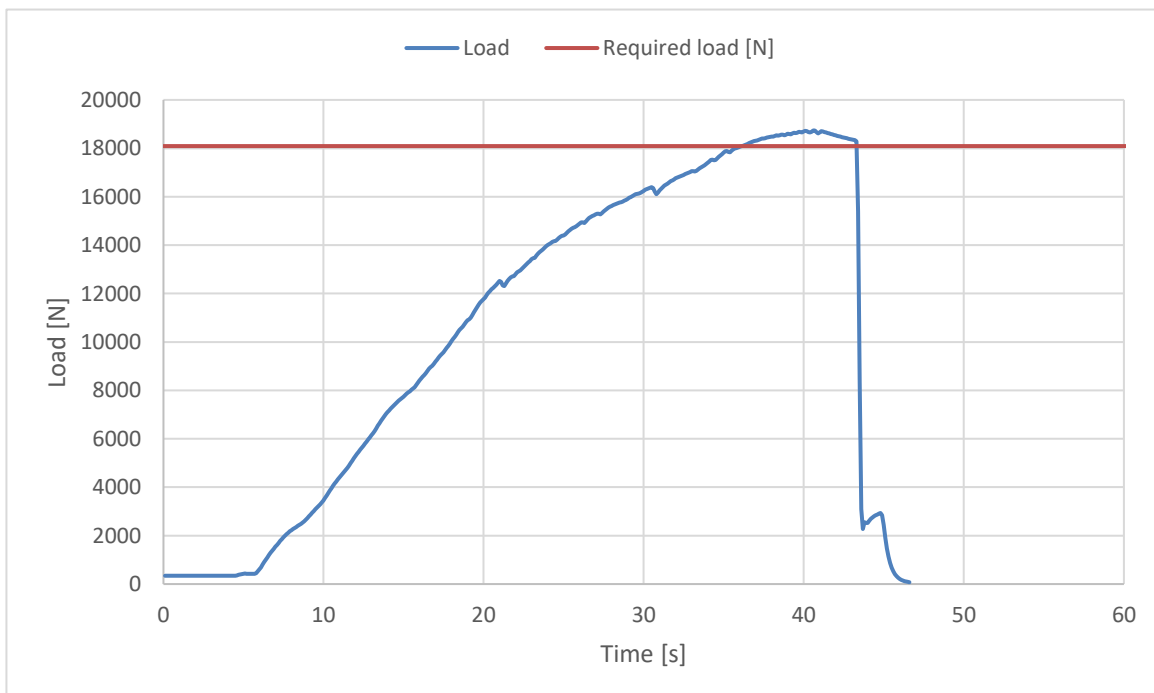
**Test ID R2**

Standard	<b>EN 1651:1999</b>	
Reference in standard	<b>5.3.2.2</b>	
Test setup	<b>Default flying position</b>	
Attachment points	<b>Both main riser attachment (3,4)</b>	
Anchor points	<b>Dummy (B1, B2)</b>	
Required load [g]	<b>15</b>	
Required load [N]	<b>18000</b>	
Minimum test duration [s]	<b>5</b>	
<b>Result</b>		
Test duration [s]	<b>7.2</b>	
Any signs of structural failure	<b>No</b>	
Test results	<b>POSITIVE</b>

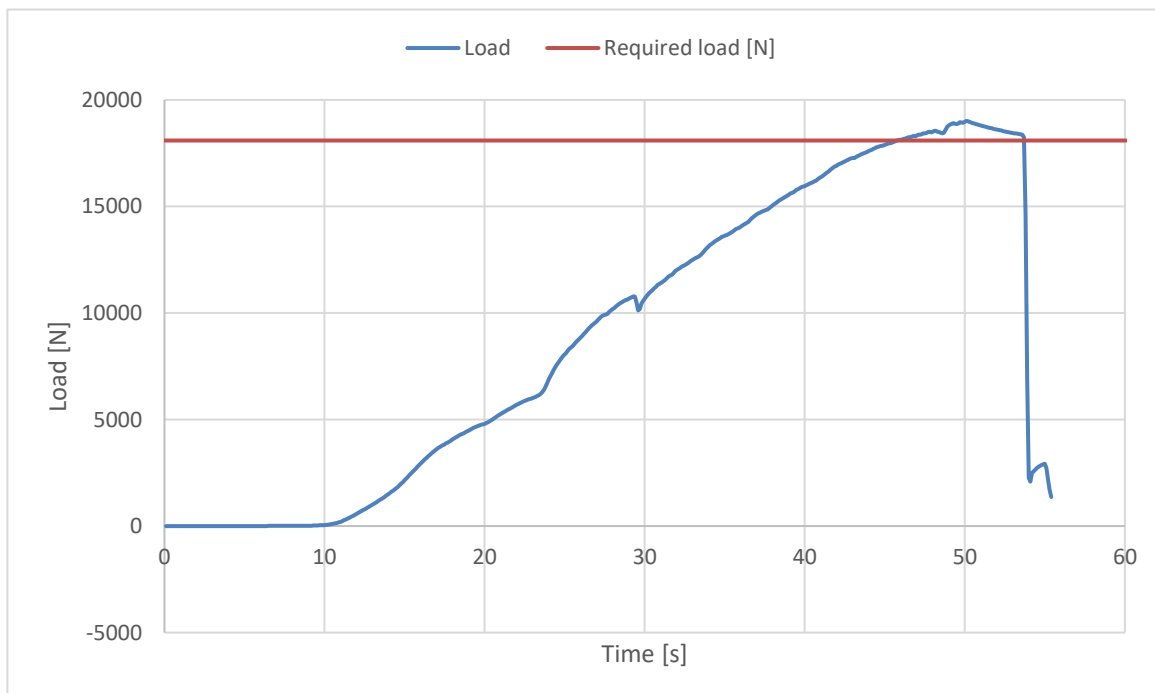
**Test ID R4**

Standard	<b>EN 1651:1999</b>
Reference in standard	<b>5.3.2.7</b>
Test setup	<b>Flying position before landing</b>
Attachment points	<b>Both main riser attachment (3,4)</b>
Anchor points	<b>Dummy (7,8)</b>
Required load [g]	<b>15</b>
Required load [N]	<b>18000</b>
Minimum test duration [s]	<b>5</b>
<b>Result</b>	
Test duration [s]	<b>8</b>
Any signs of structural failure	<b>No</b>
Test results	<b>POSITIVE</b>

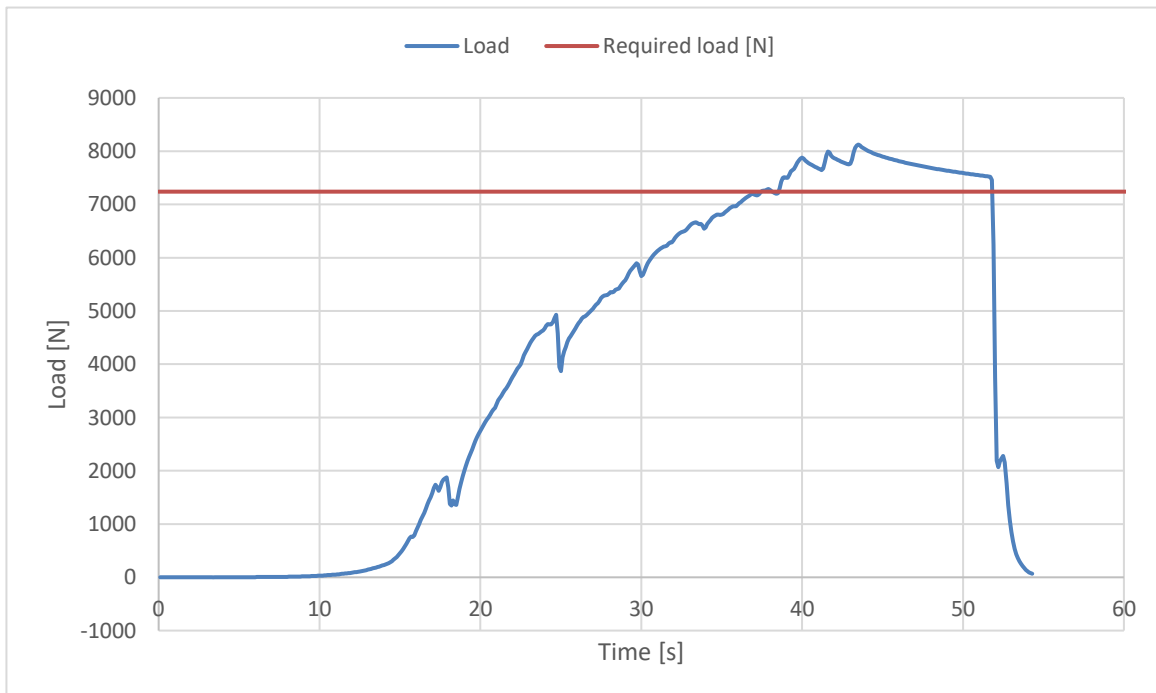
**Test ID R8**

Standard	<b>EN 1651:1999</b>
Reference in standard	<b>5.3.2.3</b>
Test setup	<b>Asymmetric, one riser</b>
Attachment points	<b>One main riser attachment (3)</b>
Anchor points	<b>Dummy (B1,B2)</b>
Required load [g]	<b>6</b>
Required load [N]	<b>7200</b>
Minimum test duration [s]	<b>10</b>
<b>Result</b>	
Test duration [s]	<b>13.3</b>
Any signs of structural failure	<b>No</b>
Test results	<b>POSITIVE</b>

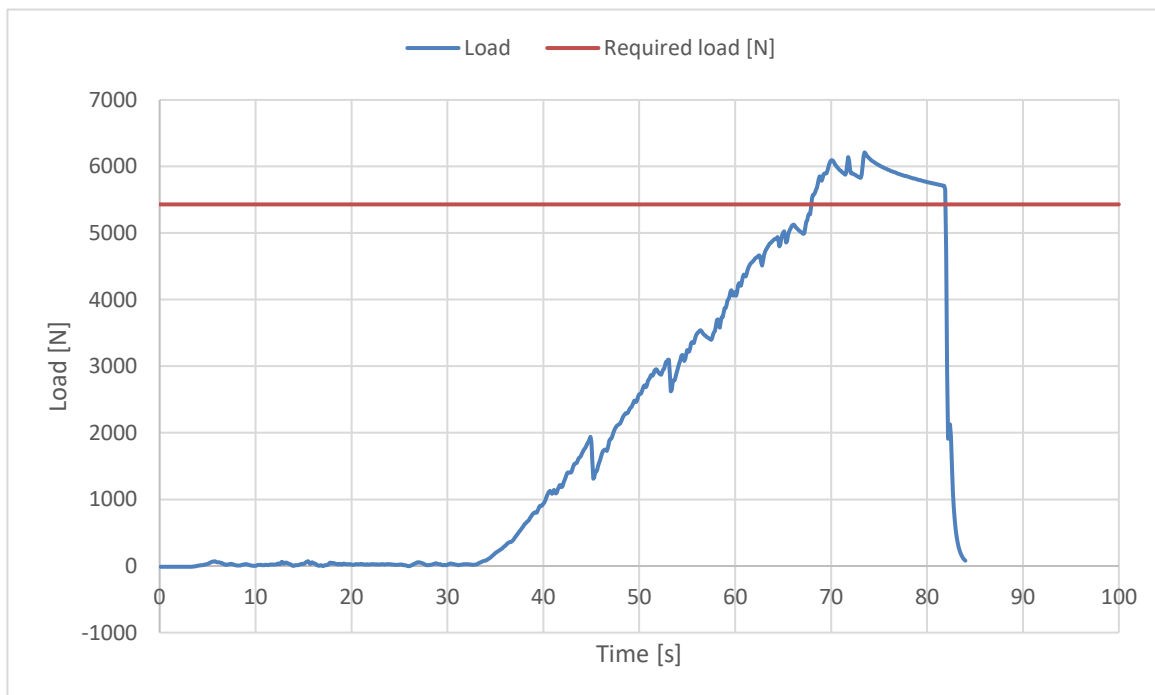
**Test ID R10**

Reference in standard	<b>5.3.2.6</b>	
Test setup	<b>Asymmetric, negative</b>	
Attachment points	<b>One main riser attachment (3 or 4) downwards</b>	
Anchor points	<b>Dummy (9)</b>	
Required load [g]	<b>4.5</b>	
Required load [N]	<b>5400</b>	
Minimum test duration [s]	<b>10</b>	
<b>Result</b>		
Test duration [s]	<b>14</b>	
Any signs of structural failure	<b>No</b>	
Test results	<b>POSITIVE</b>
