# Harness Structural test Report

Inspection certificate number: **PH\_270.2019****Manufacturer data:**

Name: **Gii 4 ALPHA**  
 Type: **ABS**  
 Size: **L**  
 Serial number: **2453-13-5688**  
 Impact pad type: <sup>(1)</sup> **Foam**  
 Clip-in weight [kg]: **120**

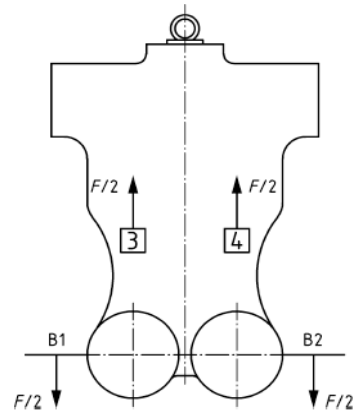
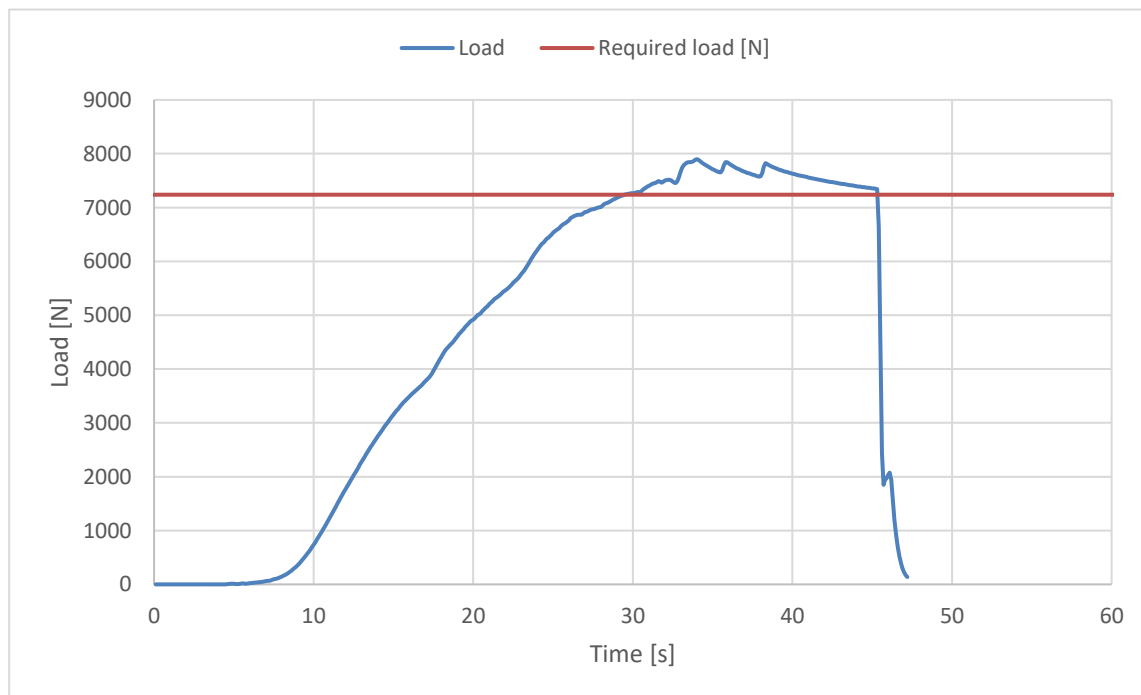
Test ID R0

Test duration [s] **15.9**  
Any signs of structural failure **No**  
Test results **POSITIVE**

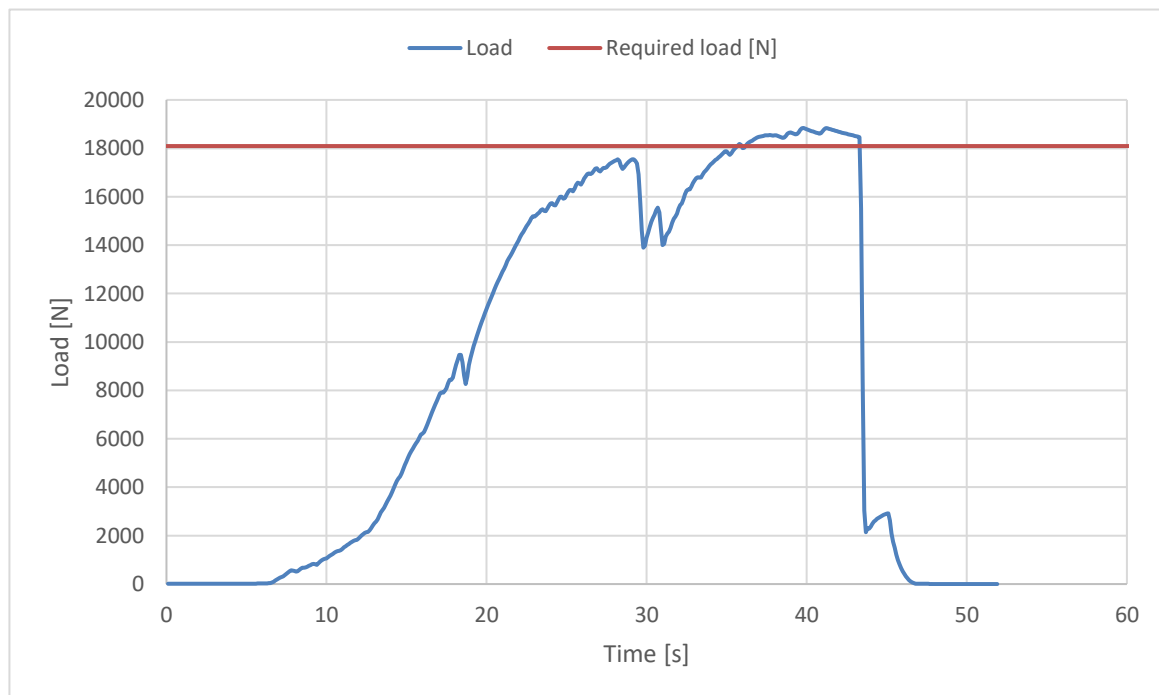
Test ID R4

Test duration [s] **7.2**  
Any signs of structural failure **No**  
Test results **POSITIVE**

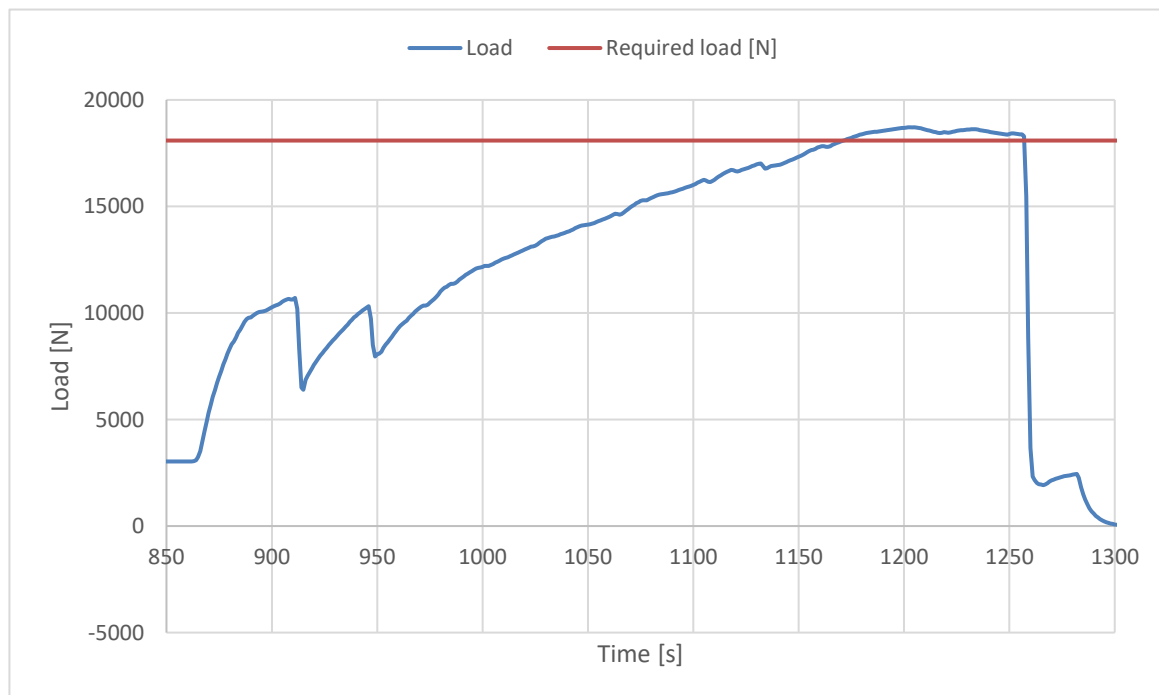
Test ID R6

Test duration [s] **8.6**  
Any signs of structural failure **No**  
Test results **POSITIVE**

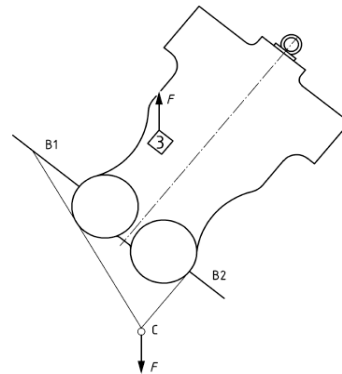
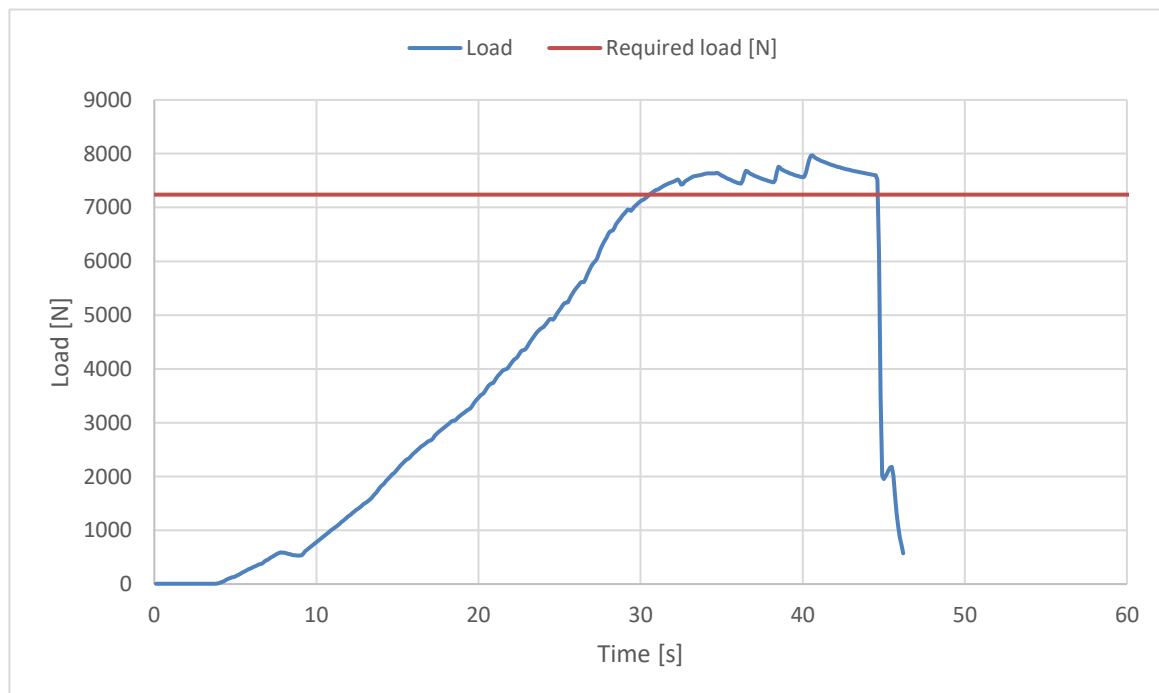
Test ID R8

Test duration [s] **14.1**  
Any signs of structural failure **No**  
Test results **POSITIVE**

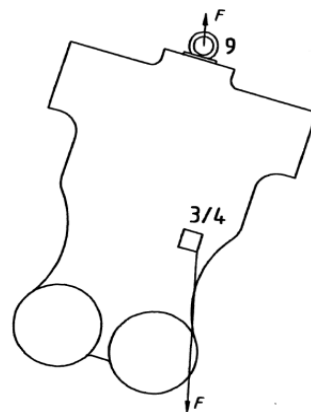
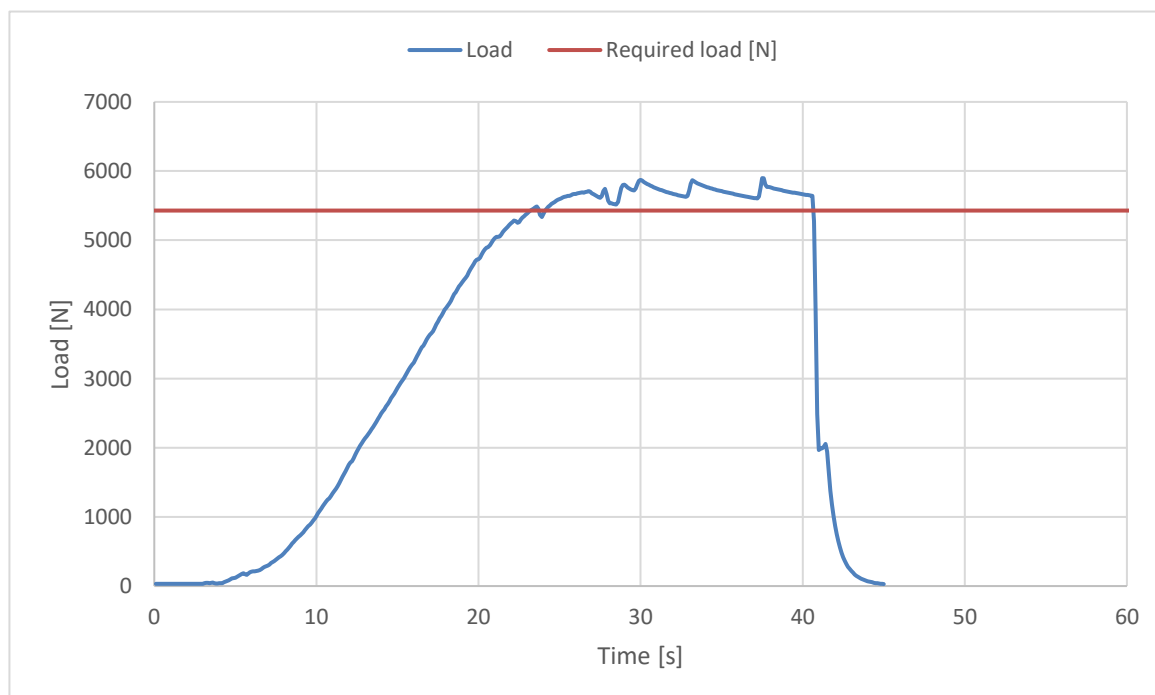
Test ID R10

Test duration [s] **16.5**  
Any signs of structural failure **No**  
Test results **POSITIVE**

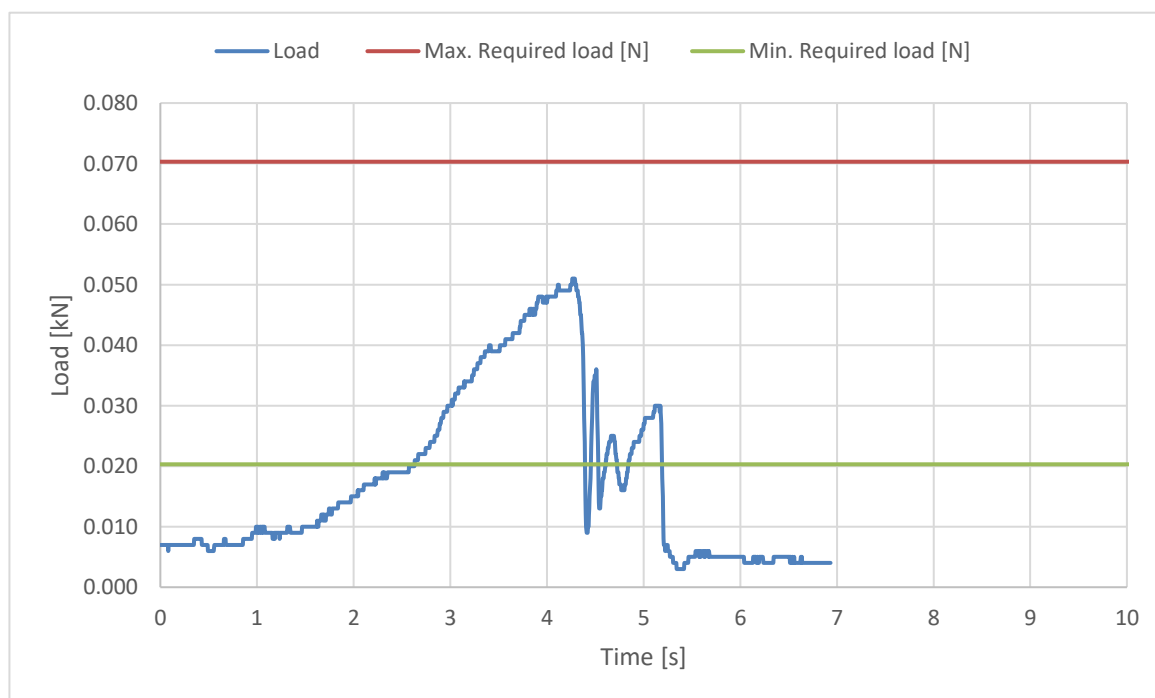
| Load for first action [N] | <b>50.69</b> |
| Test results | <b>POSITIVE</b> |
