# Harness Structural test Report

Inspection certificate number: **PH\_268.2019**

Name: **Gii 4**  
 Type: **ABS**  
 Size: **L**  
 Serial number: **2453-13-5688**  
 Impact pad type: <sup>(1)</sup> **Airbag**  
 Clip-in weight [kg]: **120**

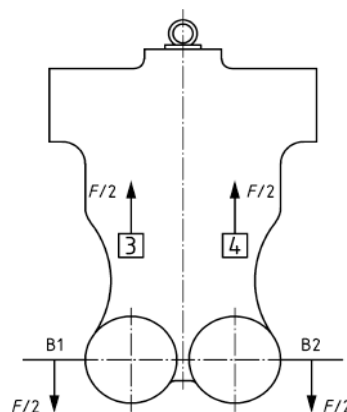
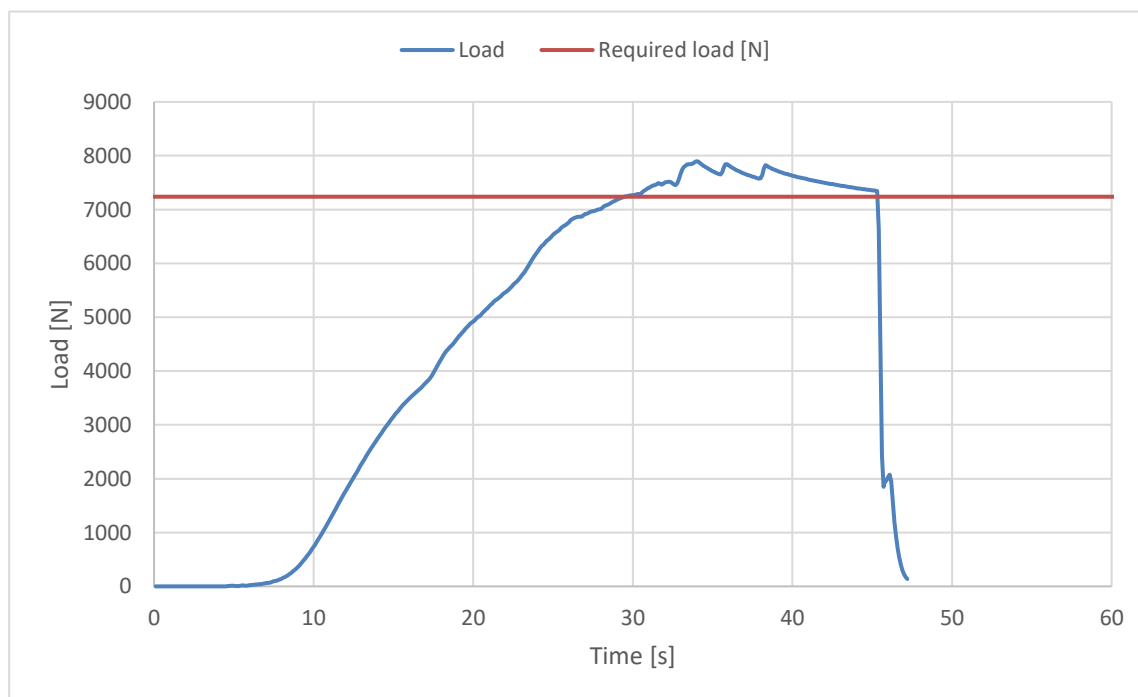
Test ID R0

Test duration [s] **15.9**  
Any signs of structural failure **No**  
Test results **POSITIVE**

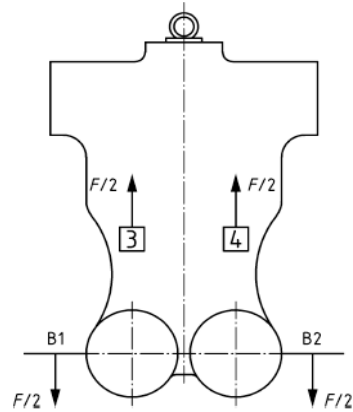
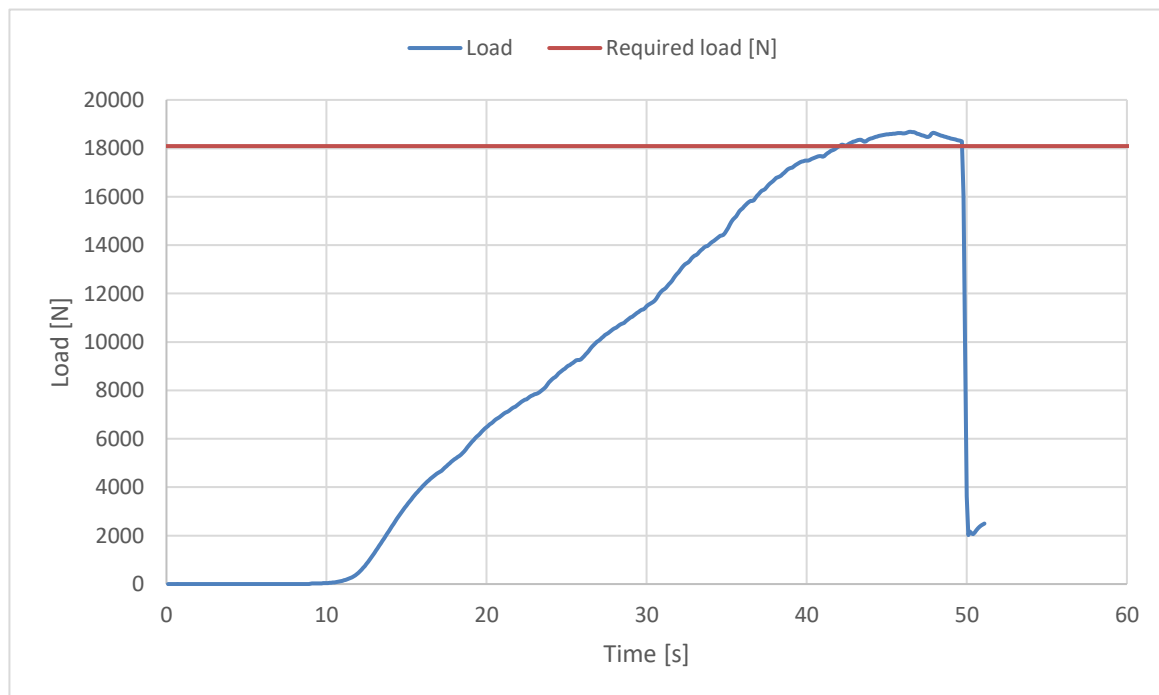
Test ID R2

Test duration [s] **7.7**  
Any signs of structural failure **No**  
Test results **POSITIVE**

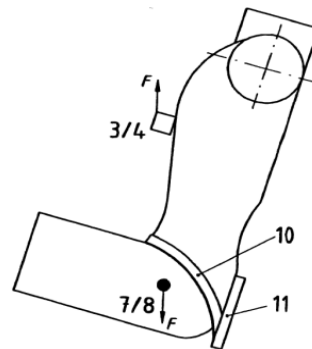
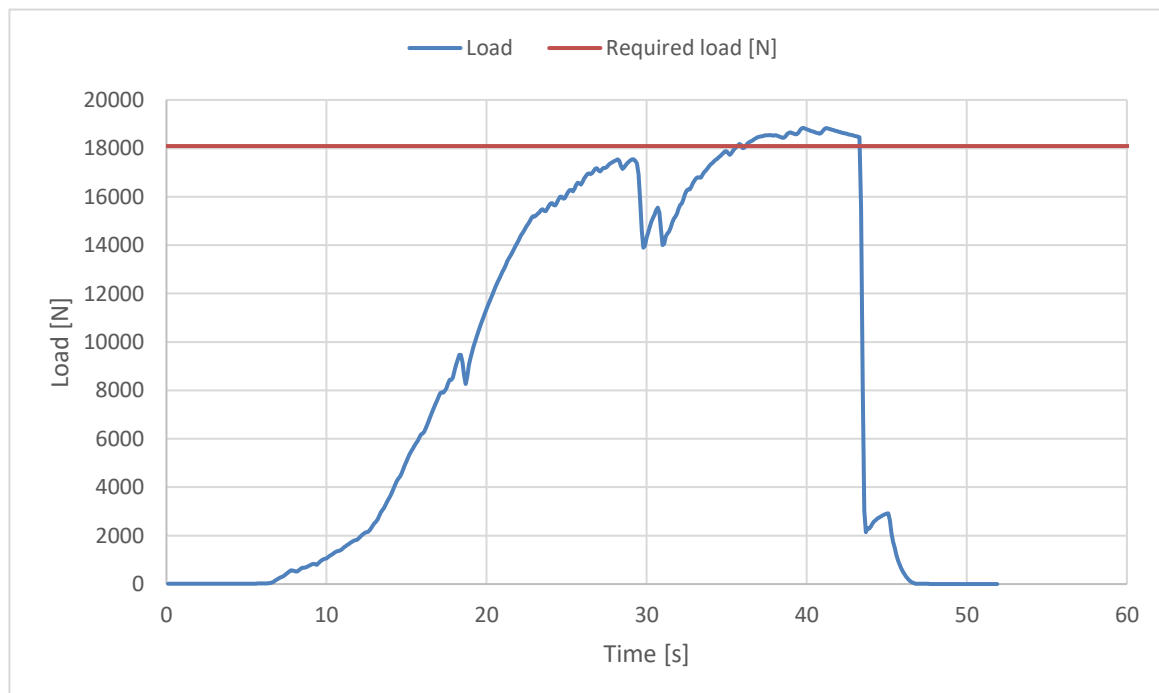
Test ID R4

Test duration [s] **7.2**  
Any signs of structural failure **No**  
Test results **POSITIVE**

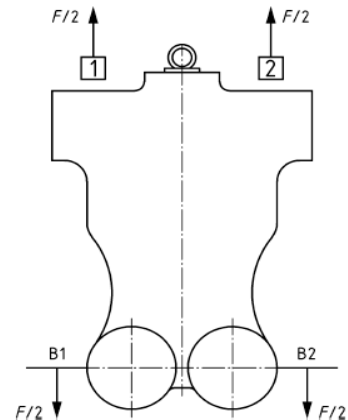
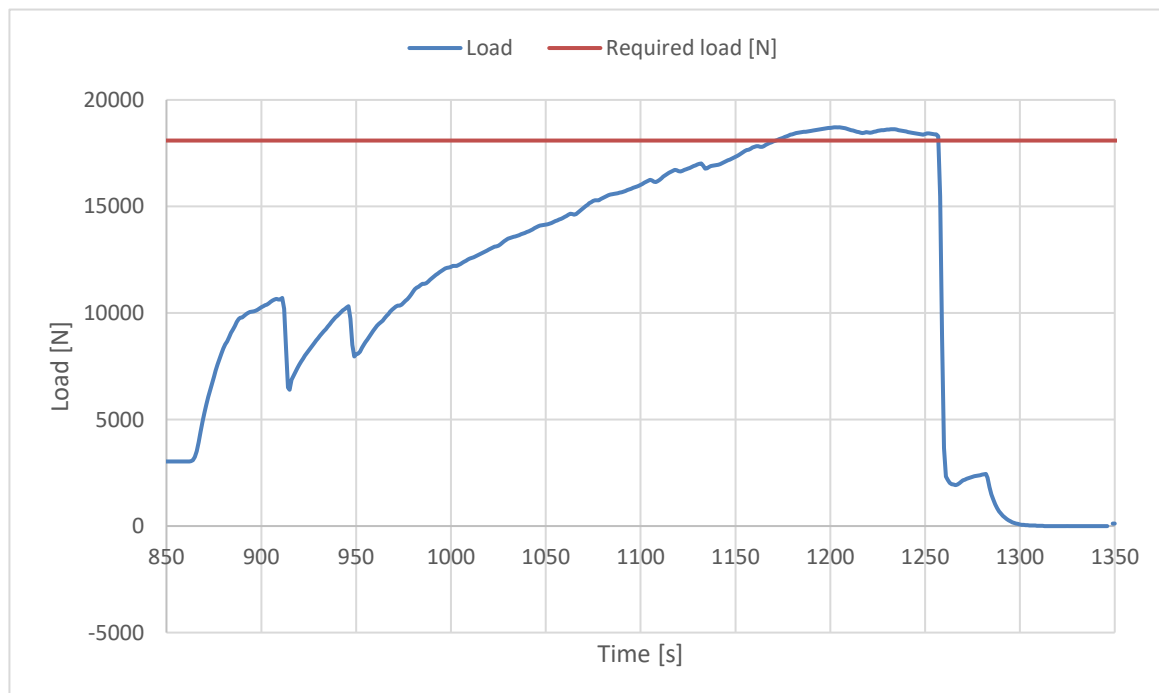
Test ID R6

Test duration [s] **8.6**  
Any signs of structural failure **No**  
Test results **POSITIVE**

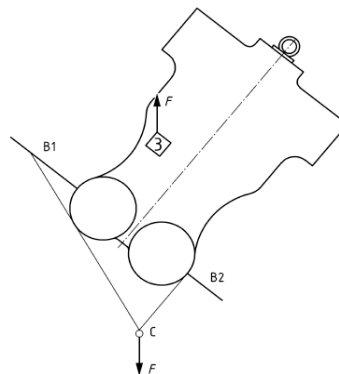
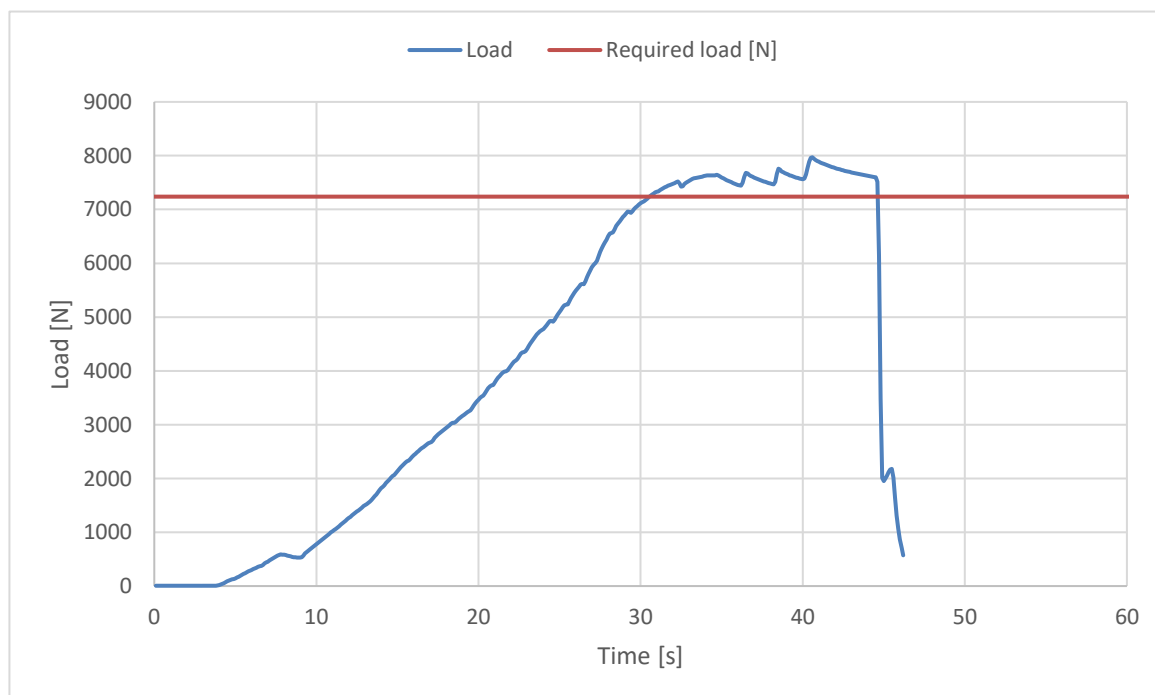
Test ID R8

Test duration [s] **14.1**  
Any signs of structural failure **No**  
Test results **POSITIVE**

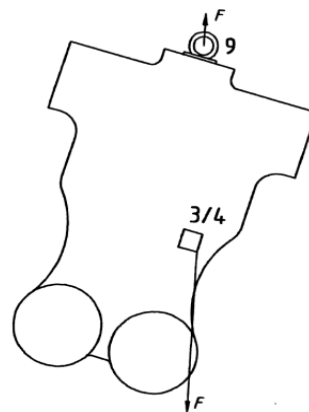
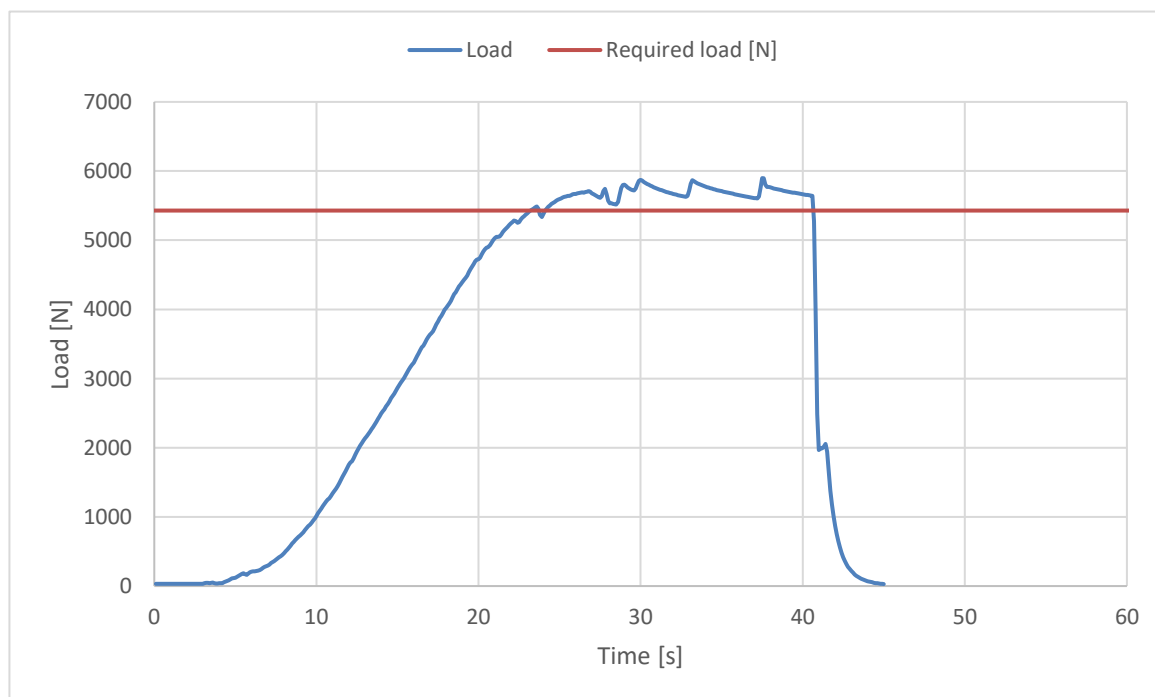
Test ID R10

Test duration [s] **16.5**  
Any signs of structural failure **No**  
Test results **POSITIVE**

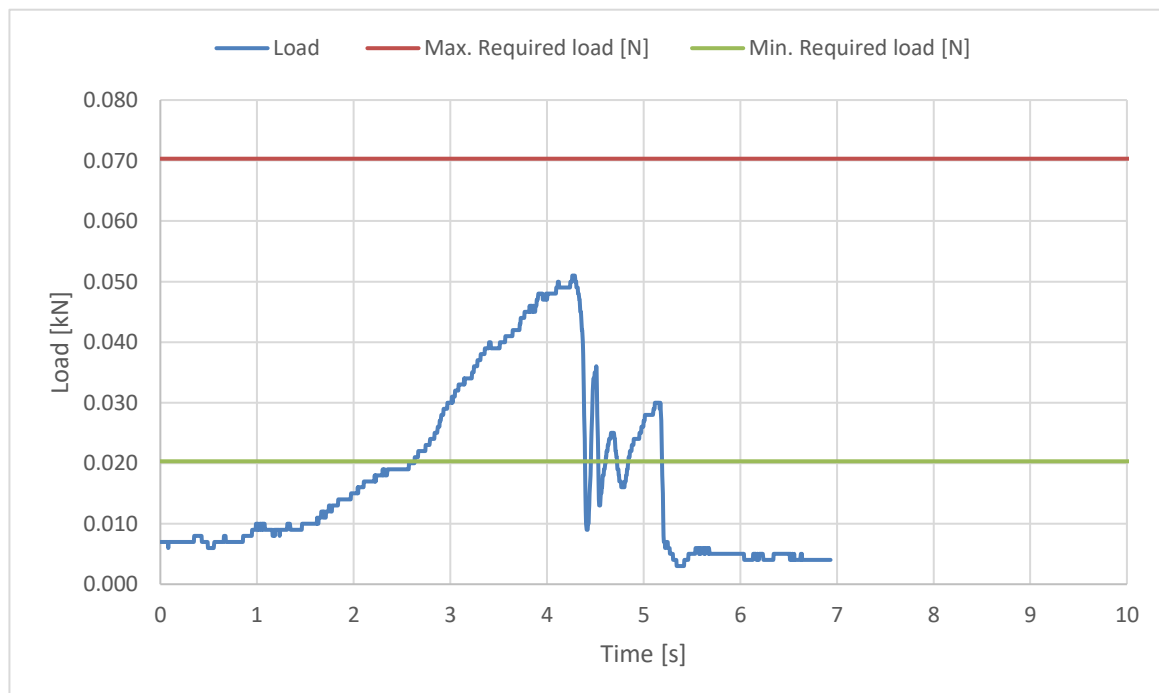
Test ID RRDT

Load for first action [N] **50.69**  
Test results **POSITIVE**

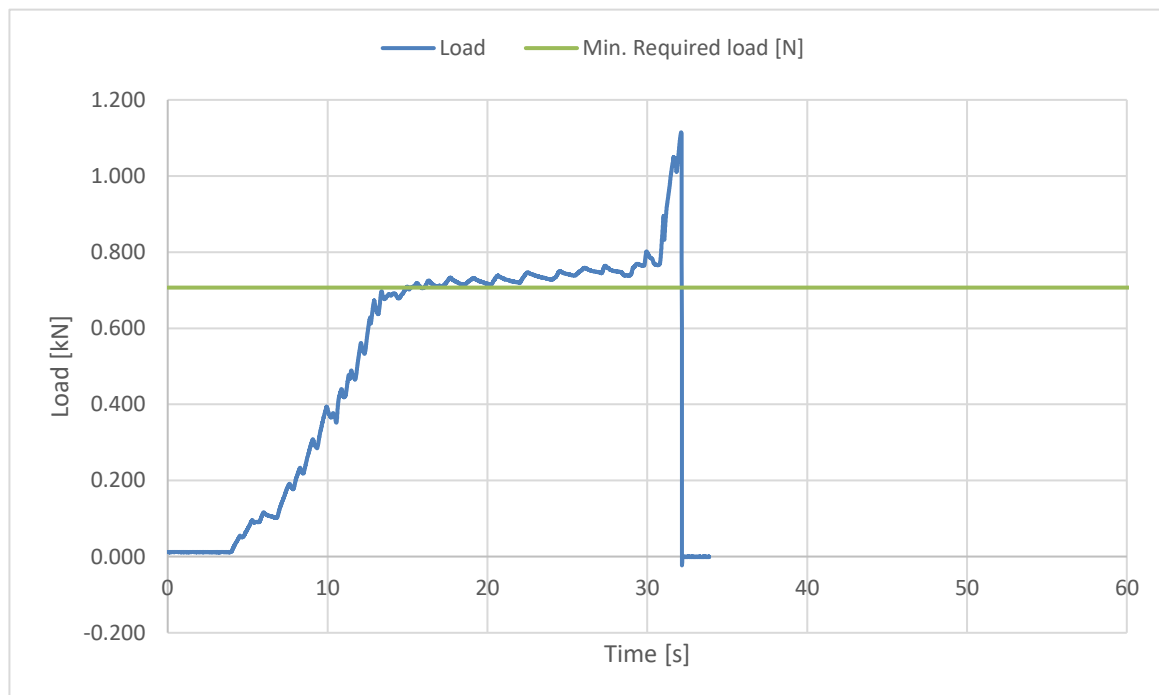
Test ID RRST

| Breaking strength [N] | <b>1108.30</b> |
| Test results | <b>POSITIVE</b> |
