# Harness Structural test Report

Inspection certificate number: **PH\_214.2017**
**Manufacturer data:**

Name: **Pax**  
 Type: **ABS**  
 Size: **unique size**  
 Serial number: **2259-13-7019**  
 Impact pad type: <sup>(1)</sup> **Airbag**  
 Clip-in weight [kg]: **120**

Date of test: **24.11.2017**
**Atmosphere AGL:**

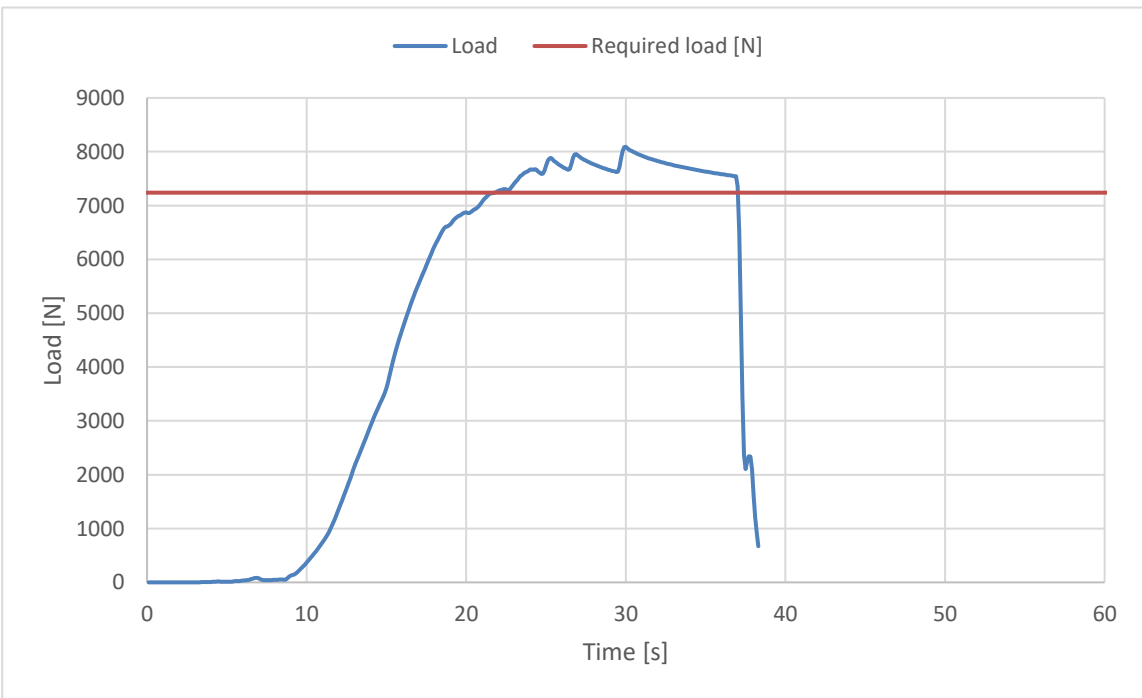
**Test ID R0**

Standard	<b>EN 1651:1999</b>
Reference in standard	<b>5.3.2.1</b>
Test setup	<b>Default flying position</b>
Attachment points	<b>Both main riser attachment (3,4)</b>
Anchor points	<b>Dummy (B1, B2)</b>
Required load [g]	<b>6</b>
Required load [N]	<b>7200</b>
Minimum test duration [s]	<b>10</b>
<b>Result</b>	
Test duration [s]	<b>15.2</b>
Any signs of structural failure	<b>No</b>
Test results	<b>POSITIVE</b>

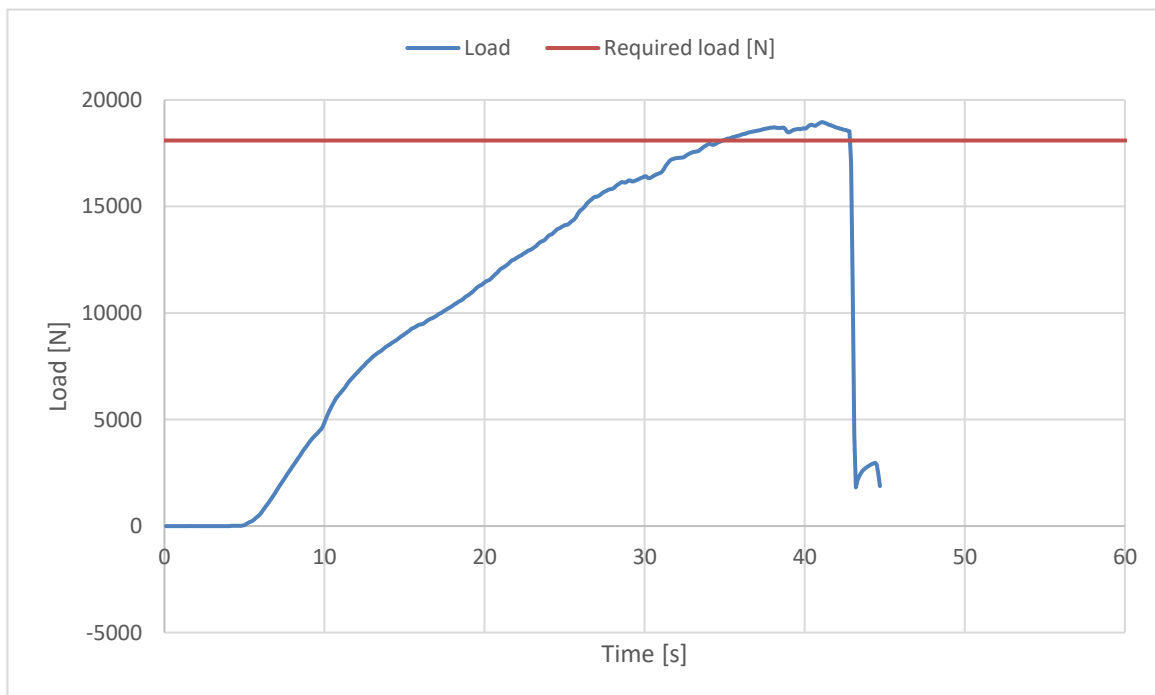
**Test ID R2**

Standard	<b>EN 1651:1999</b>	
Reference in standard	<b>5.3.2.2</b>	
Test setup	<b>Default flying position</b>	
Attachment points	<b>Both main riser attachment (3,4)</b>	
Anchor points	<b>Dummy (B1, B2)</b>	
Required load [g]	<b>15</b>	
Required load [N]	<b>18000</b>	
Minimum test duration [s]	<b>5</b>	
<b>Result</b>		
Test duration [s]	<b>8</b>	
Any signs of structural failure	<b>No</b>	
Test results	<b>POSITIVE</b>

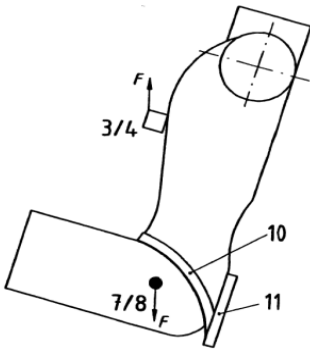
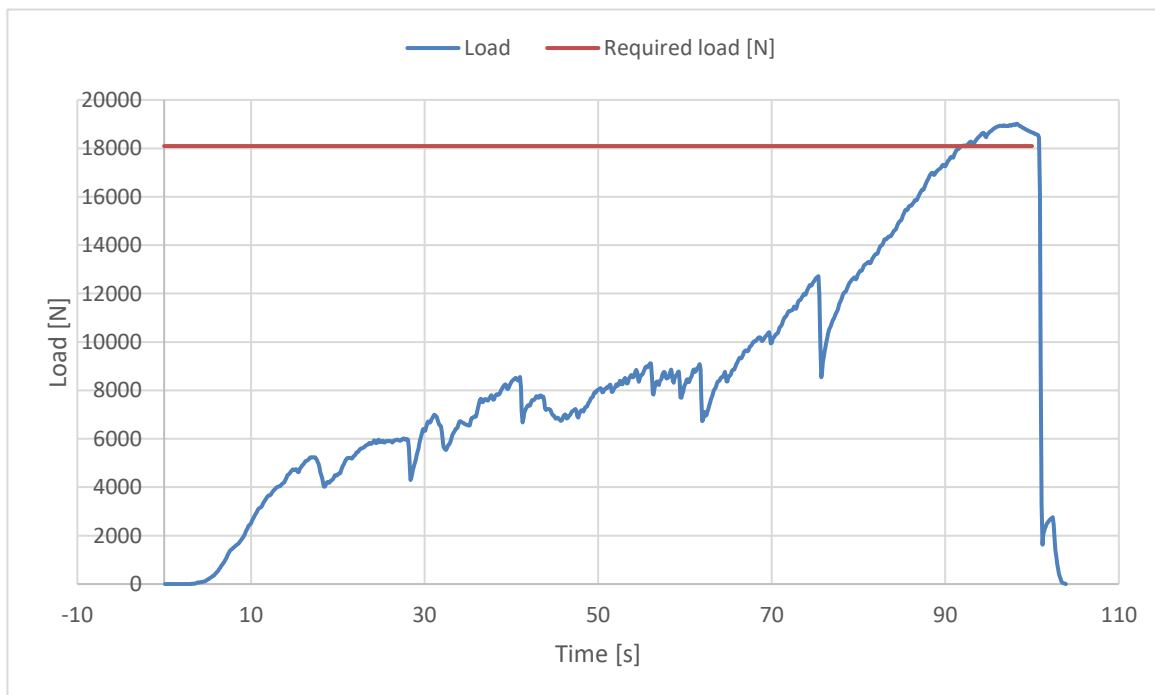
**Test ID R4**

Standard	<b>EN 1651:1999</b>
Reference in standard	<b>5.3.2.7</b>
Test setup	<b>Flying position before landing</b>
Attachment points	<b>Both main riser attachment (3,4)</b>
Anchor points	<b>Dummy (7,8)</b>
Required load [g]	<b>15</b>
Required load [N]	<b>18000</b>
Minimum test duration [s]	<b>5</b>
<b>Result</b>	
Test duration [s]	<b>8.4</b>
Any signs of structural failure	<b>No</b>
Test results	<b>POSITIVE</b>

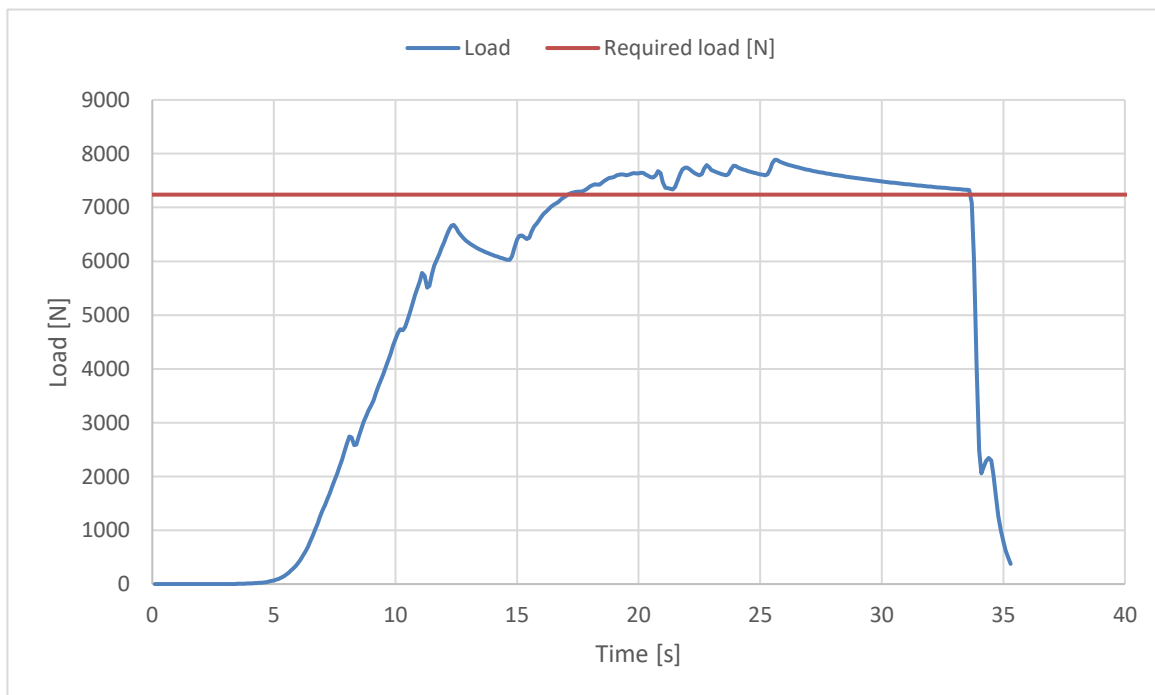
**Test ID R8**

Standard	<b>EN 1651:1999</b>	
Reference in standard	<b>5.3.2.3</b>	
Test setup	<b>Asymmetric, one riser</b>	
Attachment points	<b>One main riser attachment (3)</b>	
Anchor points	<b>Dummy (B1,B2)</b>	
Required load [g]	<b>6</b>	
Required load [N]	<b>7200</b>	
Minimum test duration [s]	<b>10</b>	
<b>Result</b>		
Test duration [s]	<b>16.6</b>	
Any signs of structural failure	<b>No</b>	
Test results	<b>POSITIVE</b>

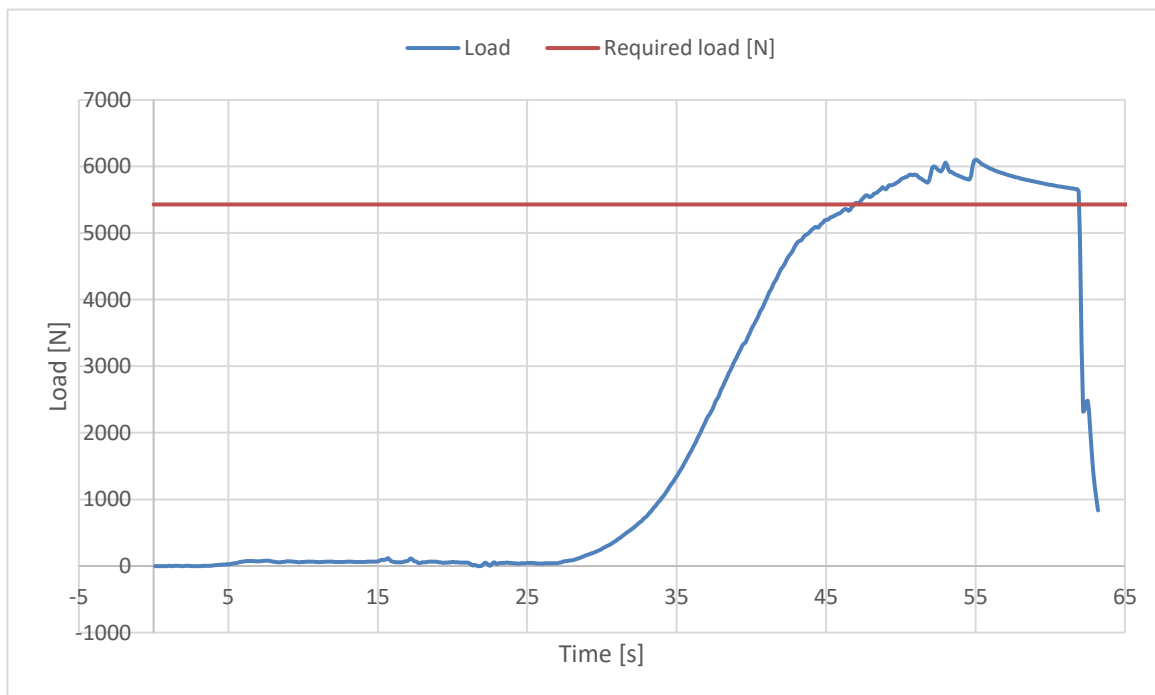
**Test ID R10**

Reference in standard	<b>5.3.2.6</b>	
Test setup	<b>Asymmetric, negative</b>	
Attachment points	<b>One main riser attachment (3 or 4) downwards</b>	
Anchor points	<b>Dummy (9)</b>	
Required load [g]	<b>4.5</b>	
Required load [N]	<b>5400</b>	
Minimum test duration [s]	<b>10</b>	
<b>Result</b>		
Test duration [s]	<b>15.1</b>	
Any signs of structural failure	<b>No</b>	
Test results	<b>POSITIVE</b>
