## Harness Structural test Report - NfL

Inspection certificate number: **PH\_359.2022**

Name: **Twin 2**  
 Type: **ABS**  
 Size: **L**  
 Serial number: **2752-13-5715**  
 Impact pad type: <sup>(1)</sup> **Foam**  
 Clip-in weight [kg]: **120**  
 Integrated container: **Yes**  
 Date of test: **03.05.2022**

**NfL 2-565-20, EN12491:2015 and EN1651:1999**

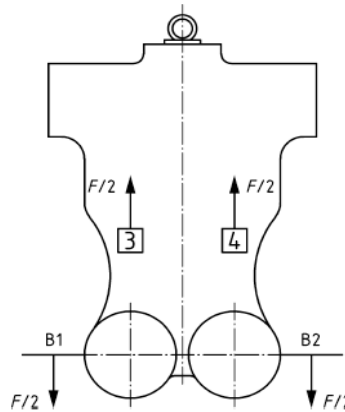
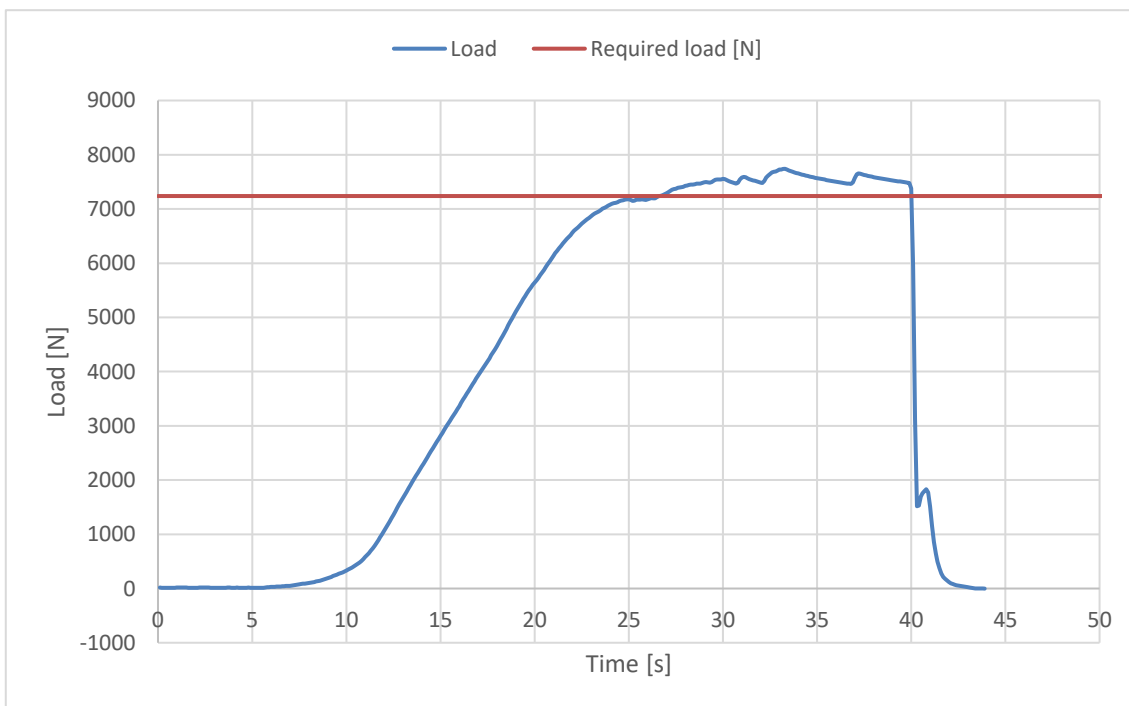
**Test ID 02**

Test duration [s] **13.5**  
 Any signs of structural failure **No**  
 Test results **POSITIVE**

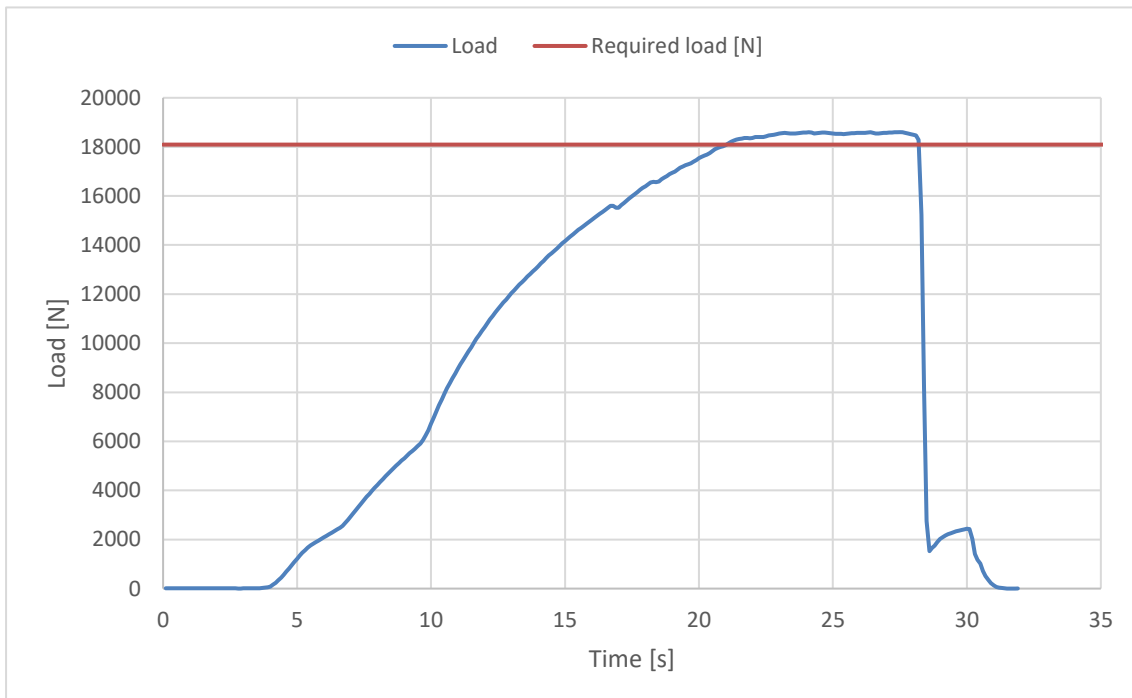
**Test ID 03**

Reference	<b>5.3.2.2</b>	
Test setup	<b>Default flying position</b>	
Attachment points	<b>Both main riser attachment (3,4)</b>	
Anchor points	<b>Dummy (B1, B2)</b>	
Required load [g]	<b>15</b>	
Required load [N]	<b>18000</b>	
Minimum test duration [s]	<b>5</b>	
<b>Result</b>		
Test duration [s]	<b>7.2</b>	
Any signs of structural failure	<b>No</b>	
Test results	<b>POSITIVE</b>

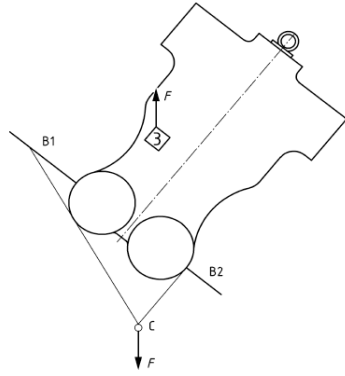
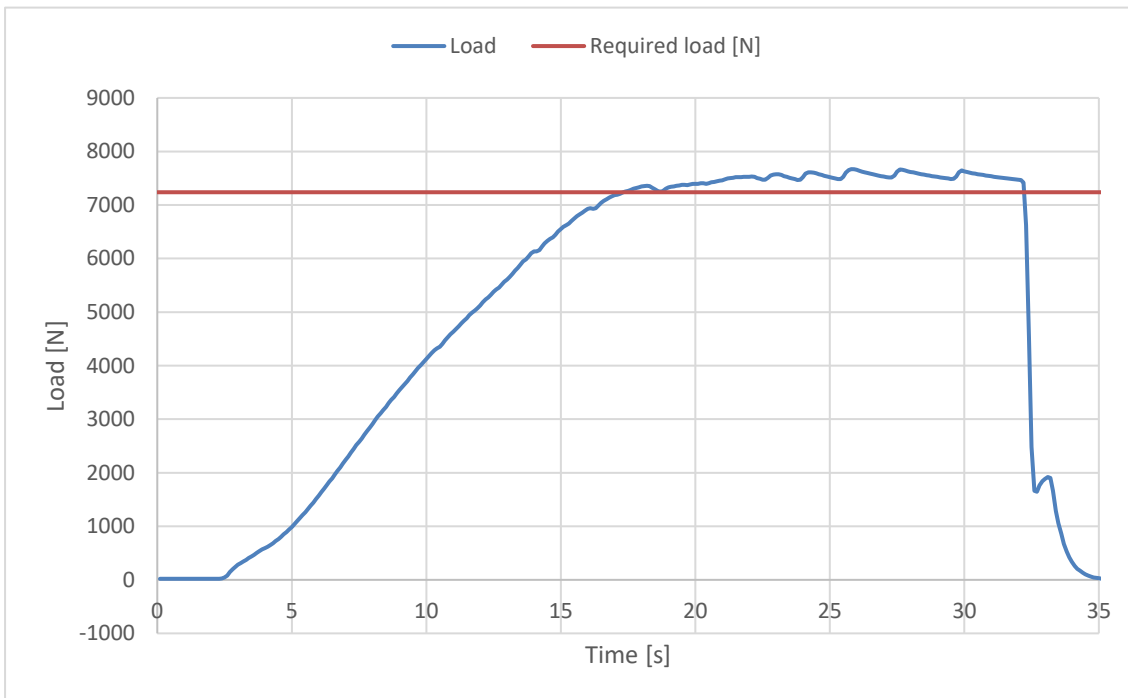
**Test ID 04**

Reference	<b>5.3.2.3</b>	
Test setup	<b>Asymmetric, one riser</b>	
Attachment points	<b>One main riser attachment (3)</b>	
Anchor points	<b>Dummy (B1,B2)</b>	
Required load [g]	<b>6</b>	
Required load [N]	<b>7200</b>	
Minimum test duration [s]	<b>10</b>	
<b>Result</b>		
Test duration [s]	<b>14.9</b>	
Any signs of structural failure	<b>No</b>	
Test results	<b>POSITIVE</b>

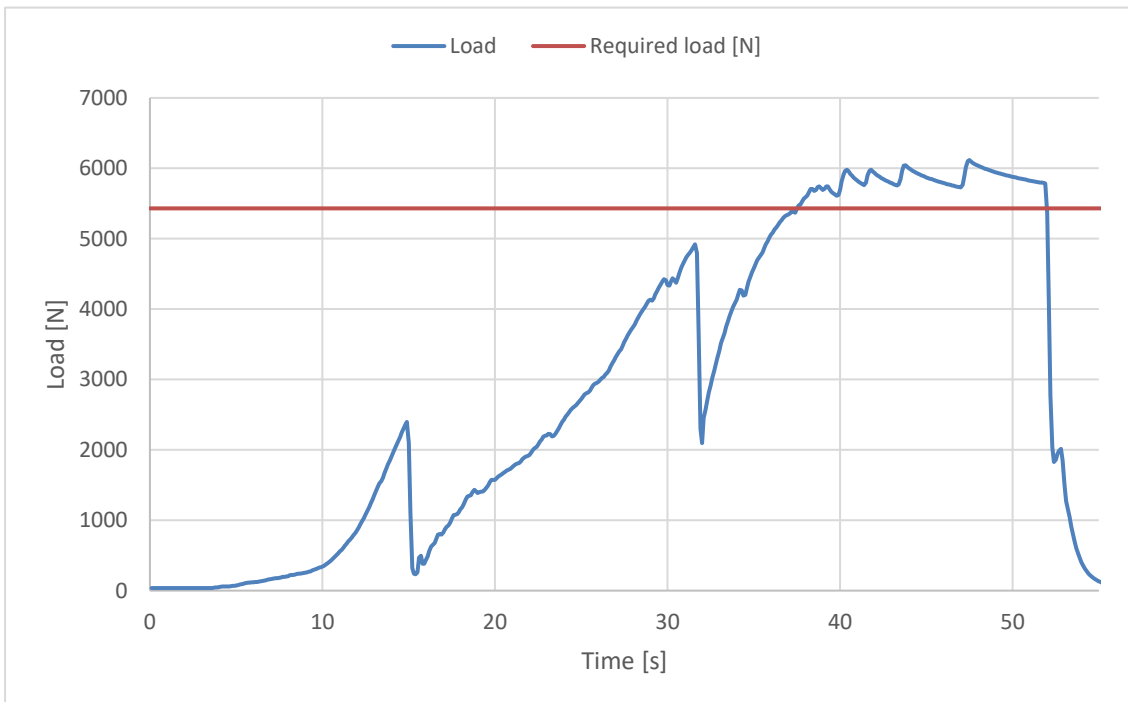
**Test ID 07**

Reference	<b>5.3.2.6</b>	
Test setup	<b>Asymmetric, negative</b>	
Attachment points	<b>One main riser attachment (3 or 4) downwards</b>	
Anchor points	<b>Dummy (9)</b>	
Required load [g]	<b>4.5</b>	
Required load [N]	<b>5400</b>	
Minimum test duration [s]	<b>10</b>	
<b>Result</b>		
Test duration [s]	<b>14.4</b>	
Any signs of structural failure	<b>No</b>	
Test results	<b>POSITIVE</b>

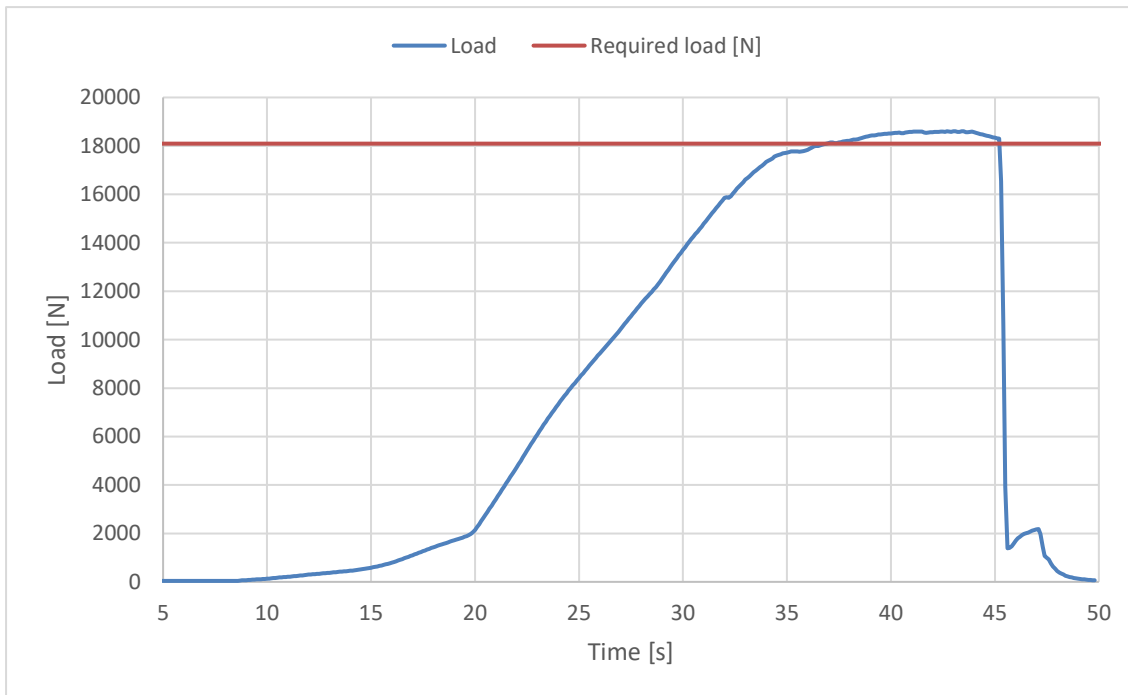
**Test ID 13**

Standard	<b>EN 1651:1999</b>
Reference	<b>5.3.2.7</b>
Test setup	<b>Flying position before landing</b>
Attachment points	<b>Both main riser attachment (3,4)</b>
Anchor points	<b>Dummy (7,8)</b>
Required load [g]	<b>15</b>
Required load [N]	<b>18000</b>
Minimum test duration [s]	<b>5</b>
<b>Result</b>	
Test duration [s]	<b>8.4</b>
Any signs of structural failure	<b>No</b>
Test results	<b>POSITIVE</b>

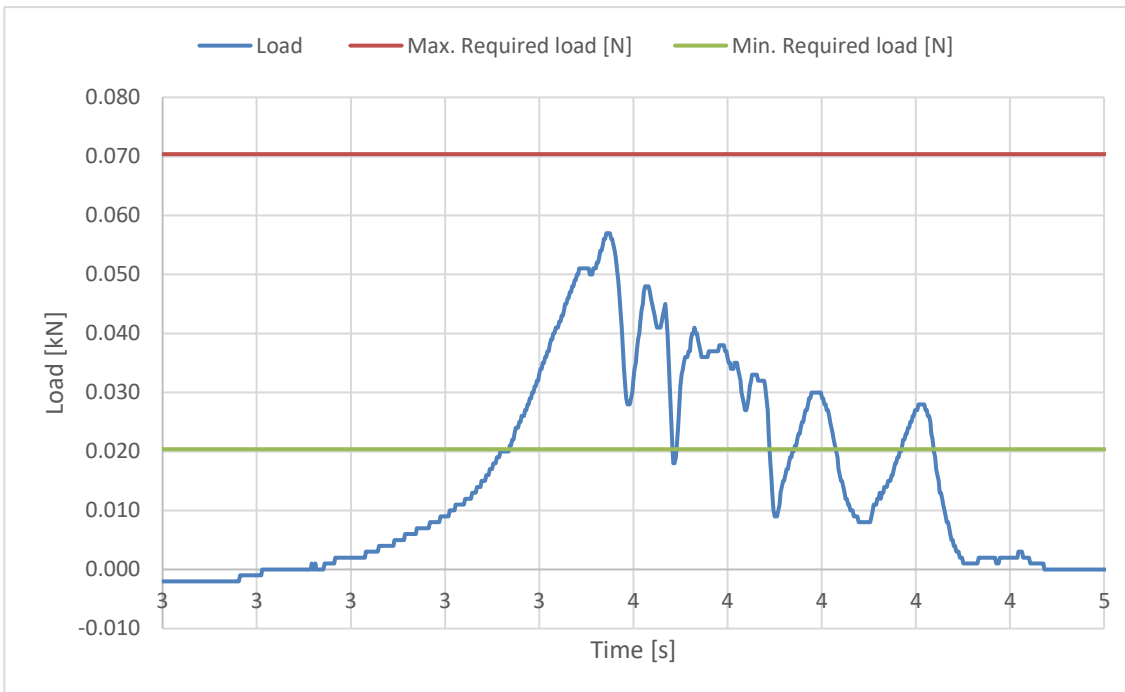
**Test ID RRDT**

Standard	<b>NfL 2-565-20</b>
Reference	<b>6.1.5</b>
Test setup	<b>Default flying position</b>
Attachment points	<b>Sensor connect to handle, and pull in opening direction</b>
	The test is to simulate the load required to open the emergency parachute(1st action).
Min. Required load [N]	<b>20</b>
Max. Required load [N]	<b>70</b>
<b>Result</b>	
Load for first action [N]	<b>56.62</b>
Test results	<b>POSITIVE</b>

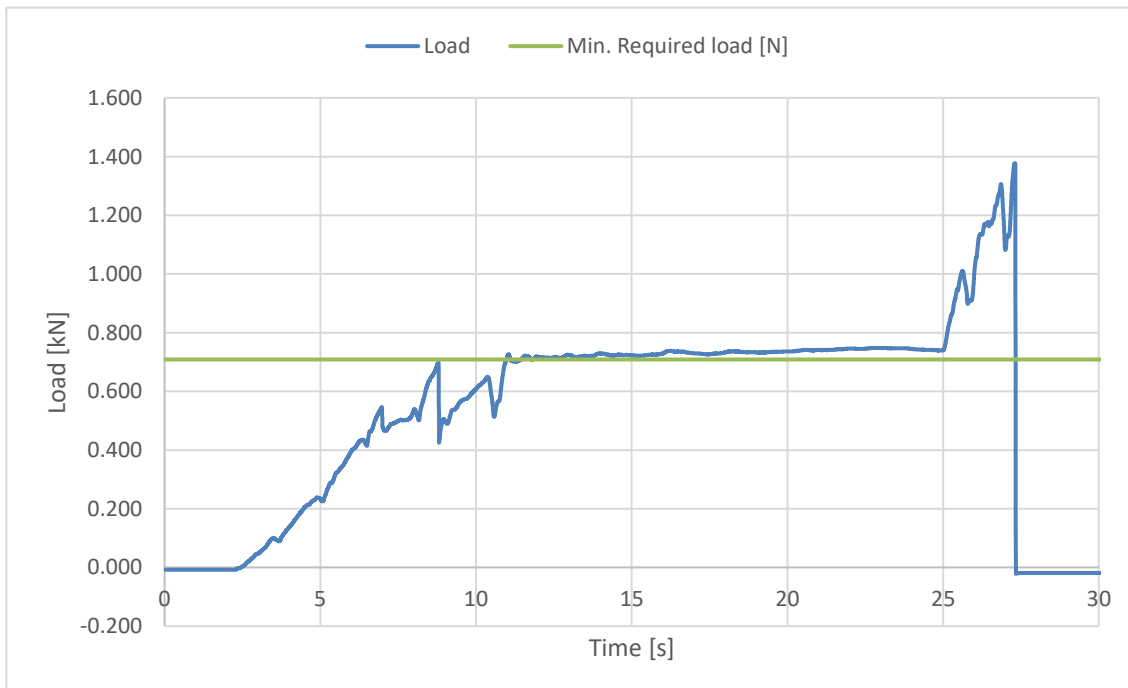
**Test ID RRST**

Standard	<b>EN 12491</b>
Reference in standard	<b>5.3.2</b>
Test setup	<b>Two end points of handle</b>
Attachment points	<b>Sensor connect to end of handle, pull on the other side</b>
	The handle must support min 700 N for 10 s, after measure breaking strength
Min. Required load [N]	<b>700</b>
Minimum test duration [s]	<b>10</b>
<b>Result</b>	
Test duration [s]:	<b>15.5</b>
Breaking strength [N]	<b>1367.85</b>
Test results	<b>POSITIVE</b>
