Harness Structural test Report - NfL

Inspection certificate number: **PH_305.2020**

Name: **Cruise**
 Type: **ABS**
 Size: **M**
 Serial number: **SPHERE01-4020-00001**
 Impact pad type: ⁽¹⁾ **Inflatable**
 Clip-in weight [kg]: **120**
 Integrated container: **Yes**
 Date of test: **28.09.2020**

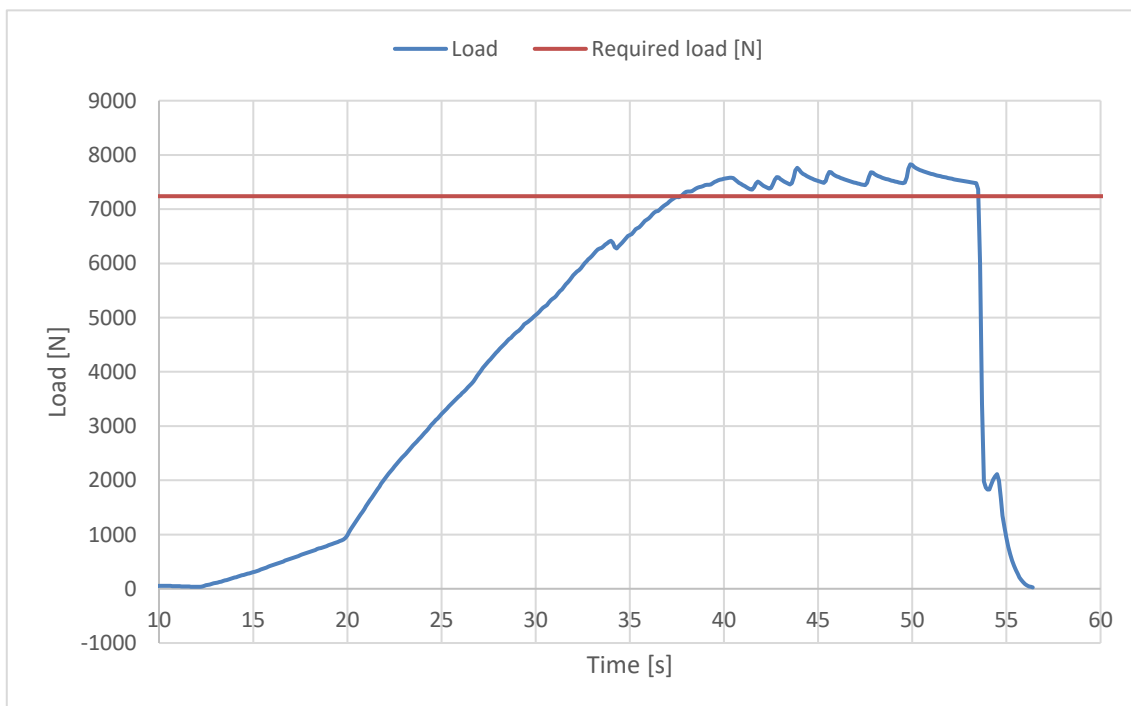
Test ID 02

Test duration [s] **15.8**
 Any signs of structural failure **No**
 Test results **POSITIVE**

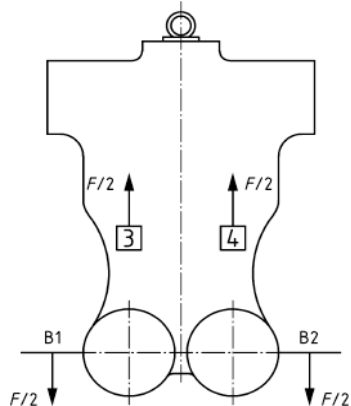
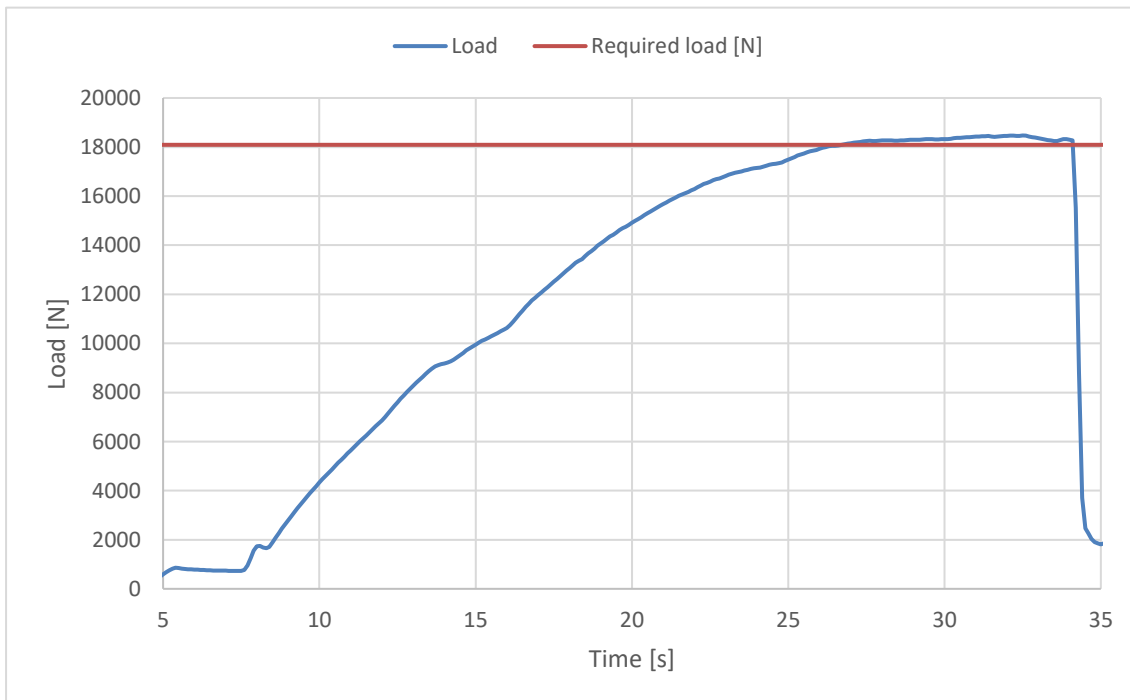
Test ID 03

Standard	NfL 2-565-20
Reference	5.3.2.2
Test setup	Default flying position
Attachment points	Both main riser attachment (3,4)
Anchor points	Dummy (B1, B2)
Required load [g]	15
Required load [N]	18000
Minimum test duration [s]	5
Result	
Test duration [s]	7.5
Any signs of structural failure	No
Test results	POSITIVE

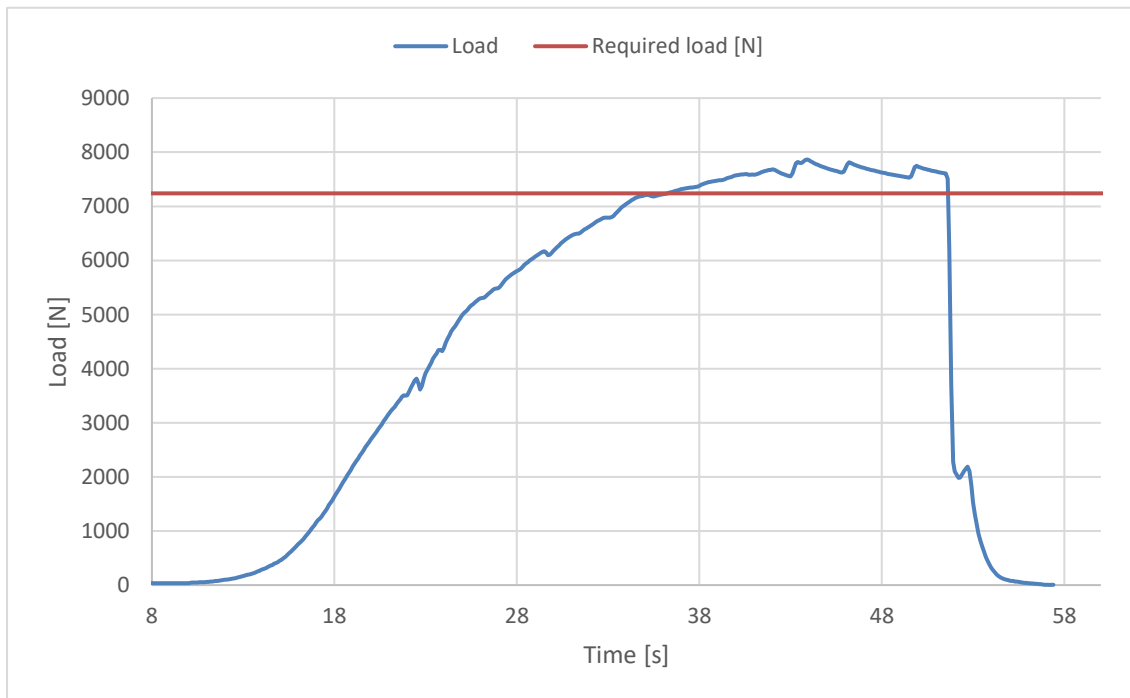
Test ID 04

Test duration [s] **15.4**
 Any signs of structural failure **No**
 Test results **POSITIVE**

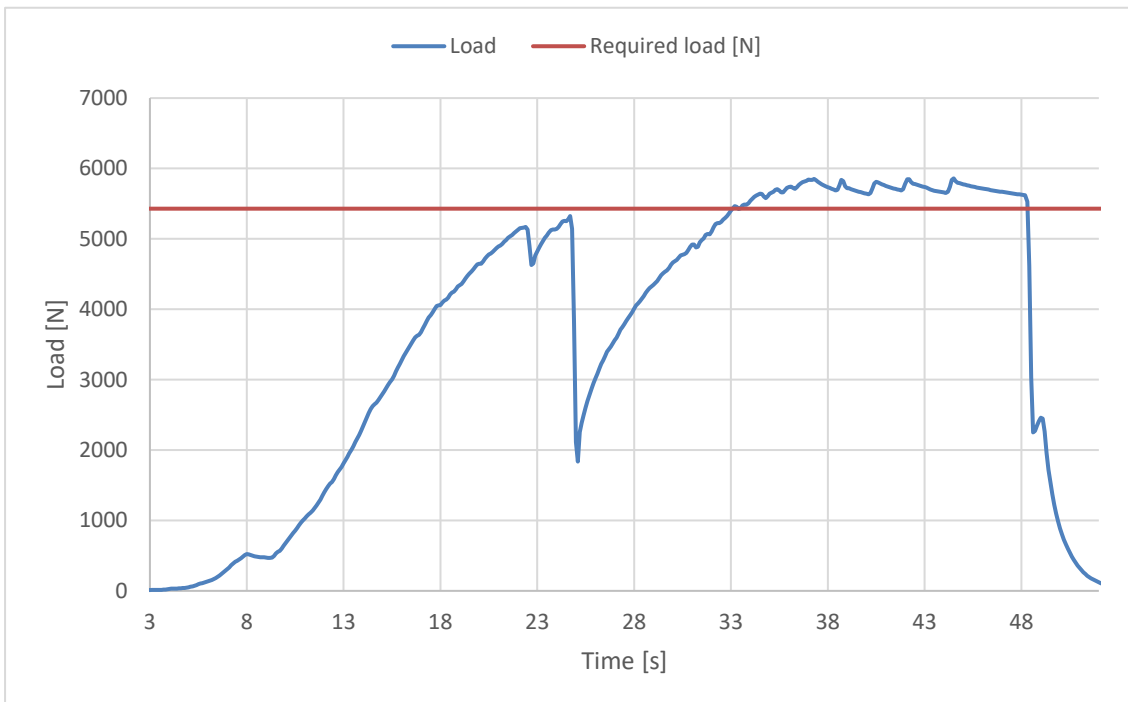
Test ID 07

Standard	NfL 2-565-20
Reference	5.3.2.6
Test setup	Asymmetric, negative
Attachment points	One main riser attachment (3 or 4) downwards
Anchor points	Dummy (9)
Required load [g]	4.5
Required load [N]	5400
Minimum test duration [s]	10
Result	
Test duration [s]	14.9
Any signs of structural failure	No
Test results	POSITIVE

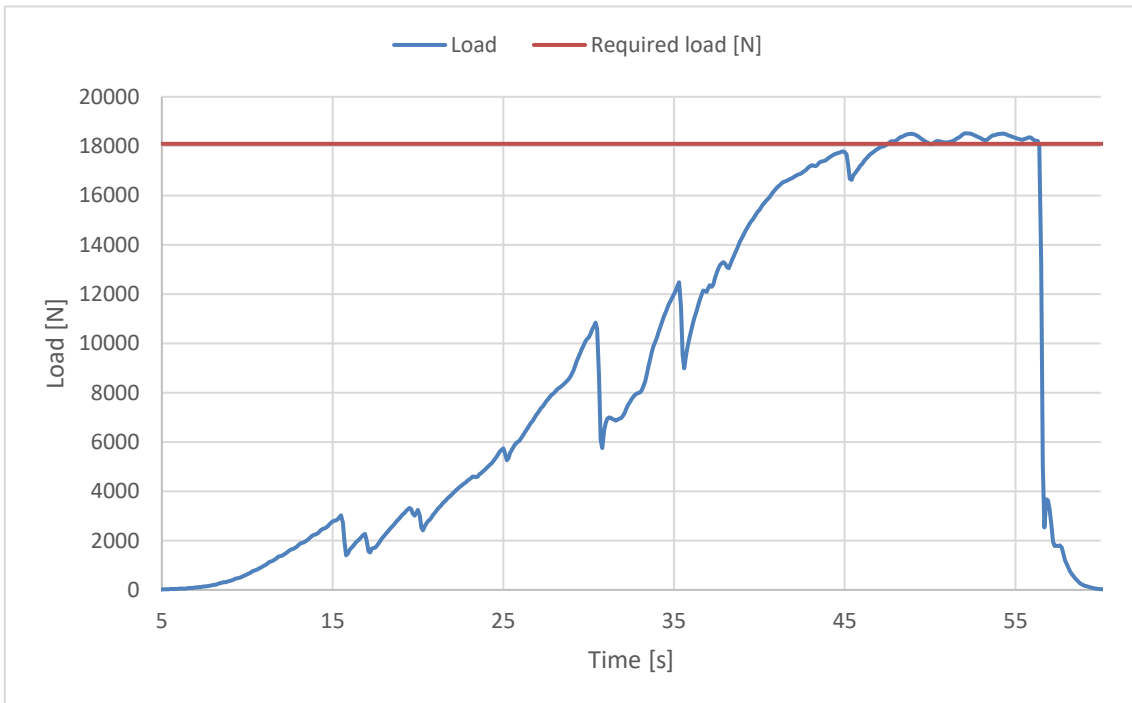
Test ID 09

Reference	5.3.2.4	
Test setup	Rescue attachments	
Attachment points	Rescue riser attachment (1,2)	
Anchor points	Dummy (B1,B2)	
Required load [g]	15	
Required load [N]	18000	
Minimum test duration [s]	5	
Result		
Test duration [s]	6.2	
Any signs of structural failure	No	
Test results	POSITIVE

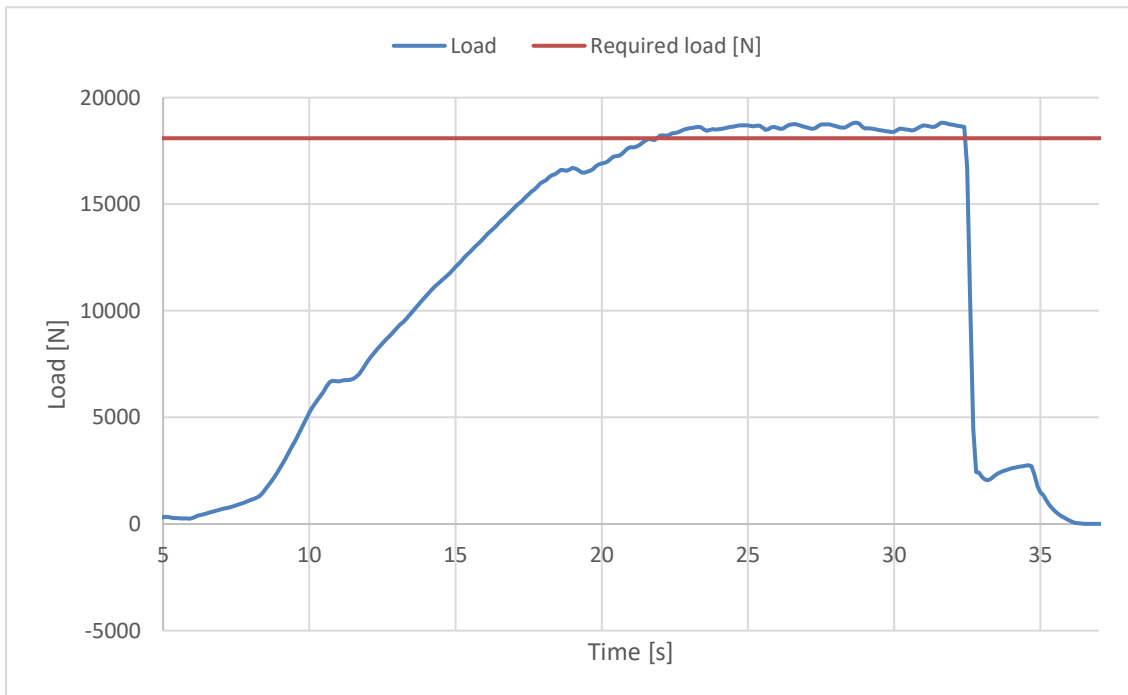
Test ID 13

Standard	NfL 2-565-20
Reference	5.3.2.7
Test setup	Flying position before landing
Attachment points	Both main riser attachment (3,4)
Anchor points	Dummy (7,8)
Required load [g]	15
Required load [N]	18000
Minimum test duration [s]	5
Result	
Test duration [s]	10.5
Any signs of structural failure	No
Test results	POSITIVE

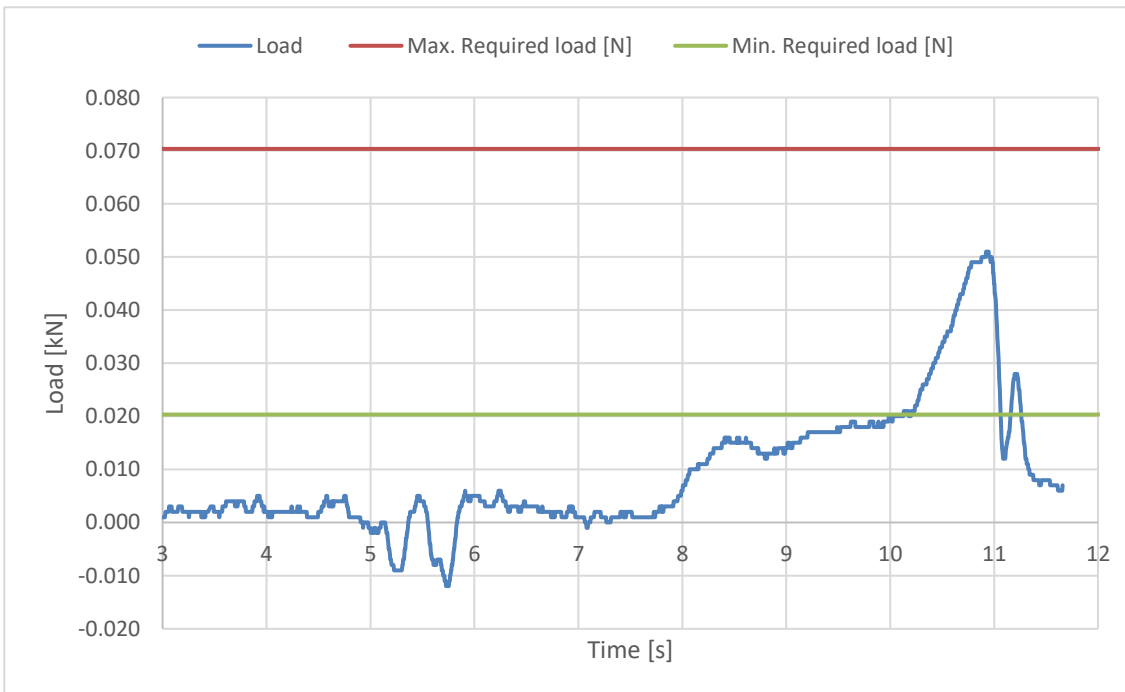
Test ID RRDT

Load for first action [N] **50.66**
 Test results **POSITIVE**

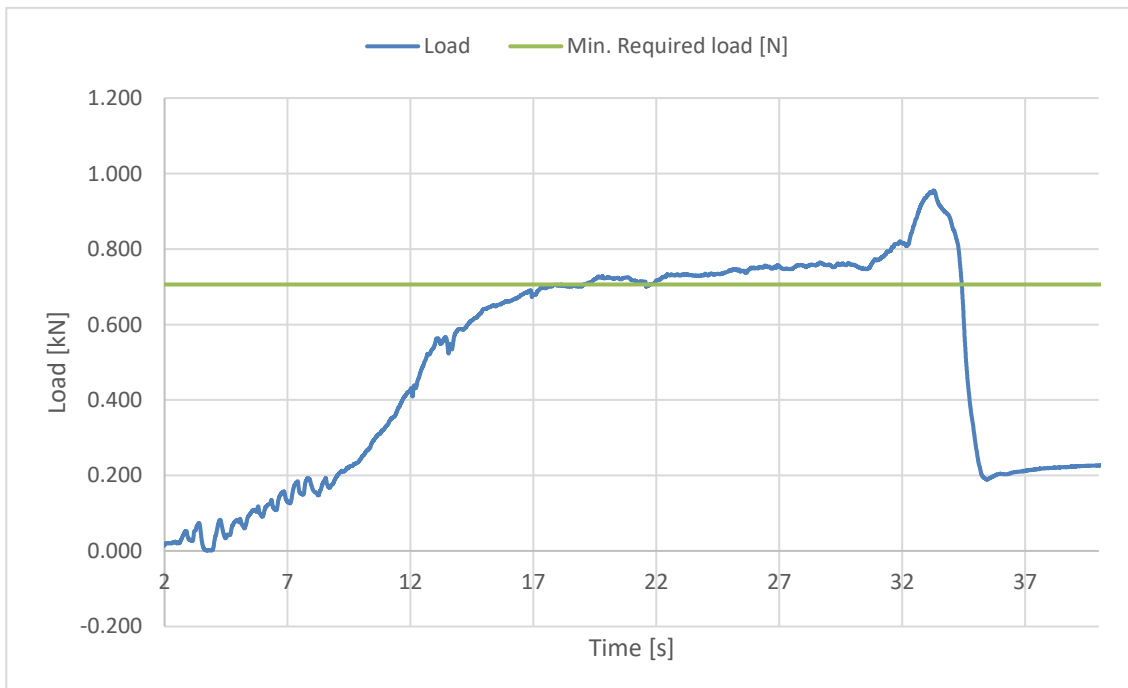
Test ID RRST

Standard	EN12491:2015
Reference in standard	5.3.2
Test setup	Two end points of handle
Attachment points	Sensor connect to end of handle, pull on the other side
	The handle must support min 700 N for 10 s, after measure breaking strength
Min. Required load [N]	700
Minimum test duration [s]	10
Result	
Test duration [s]:	7.9
Breaking strength [N]	949.65
Test results	POSITIVE
