Harness Structural test Report - EN

Inspection certificate number: **PH_369.2022**

Name: **GUEST**
 Type: **ABS**
 Size: **M**
 Serial number: **SKH-0122-PA-01**
 Impact pad type: ⁽¹⁾ **Inflatable**
 Clip-in weight [kg]: **120**
 Date of test: **25.04.2022**

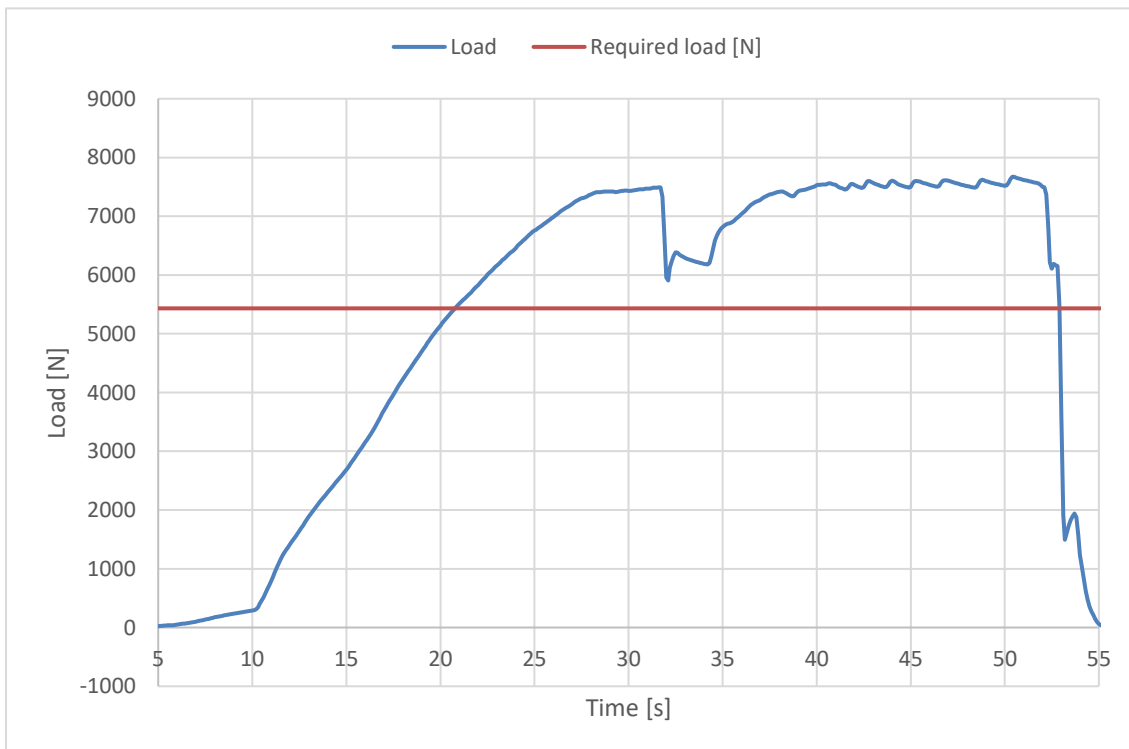
Test ID 01

| Any signs of structural failure | No |
| Slippery test OK | Yes |
| Test results | POSITIVE |

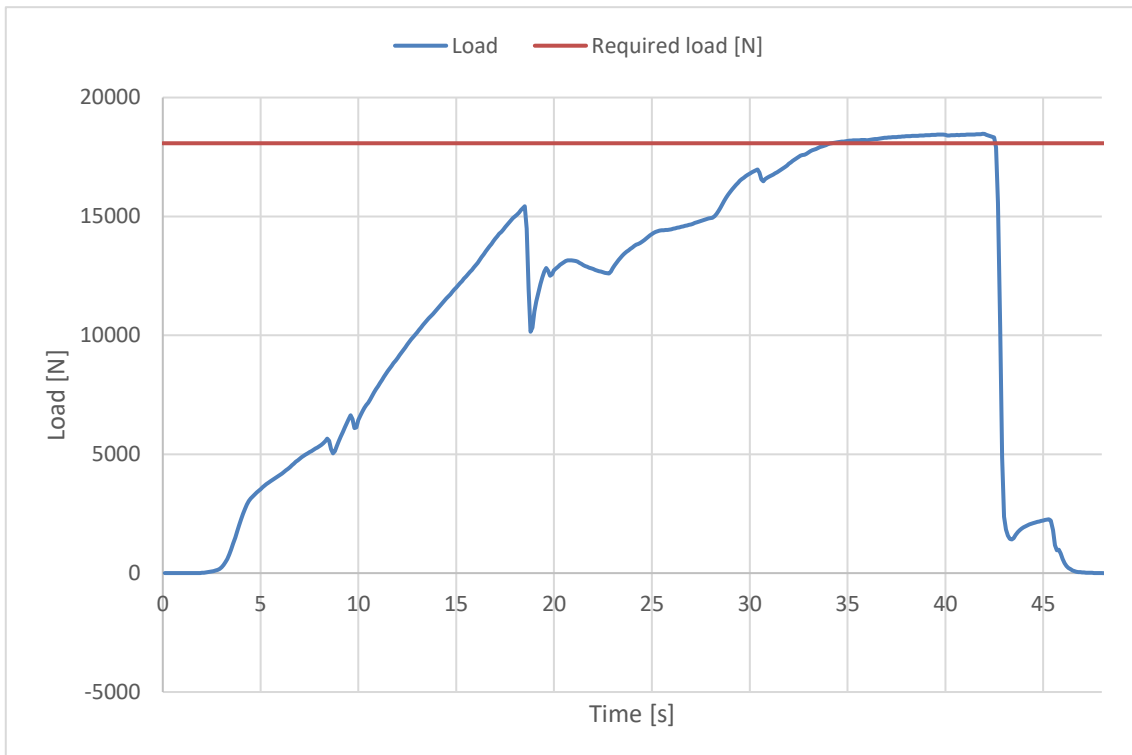
Test ID 03

Test duration [s] **8.4**
 Any signs of structural failure **No**
 Slippery test OK **Yes**
 Test results **POSITIVE**

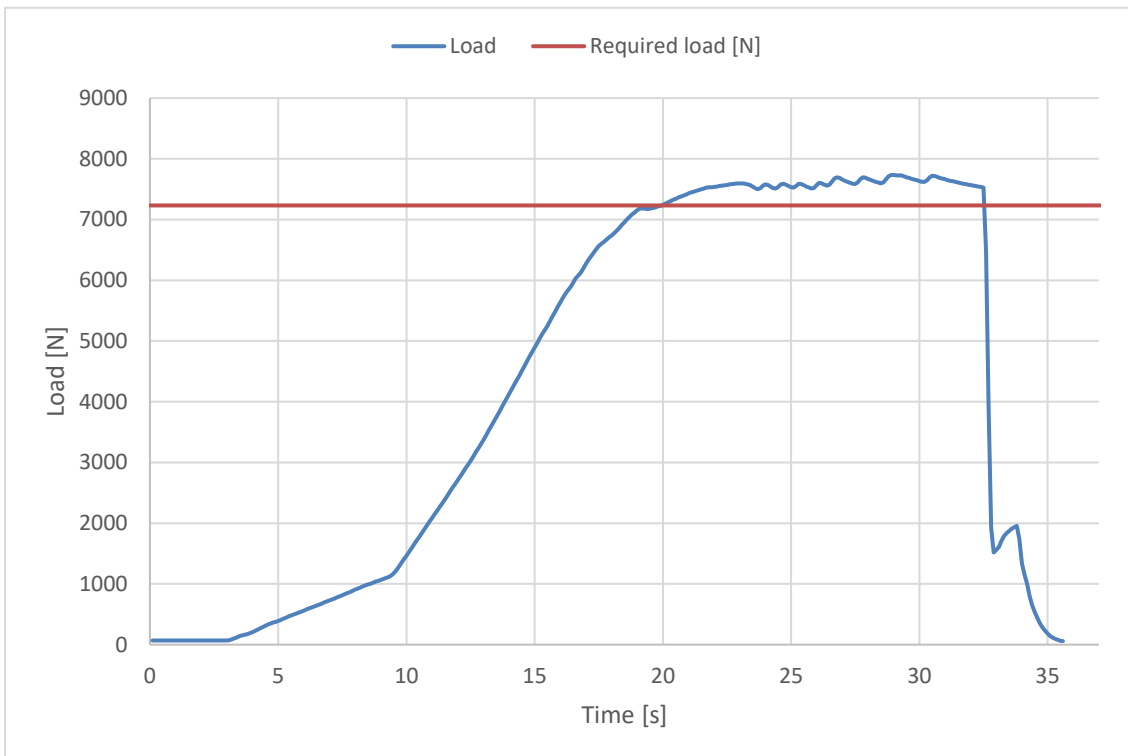
Test ID 05

| Any signs of structural failure | No |
| Test results | POSITIVE |

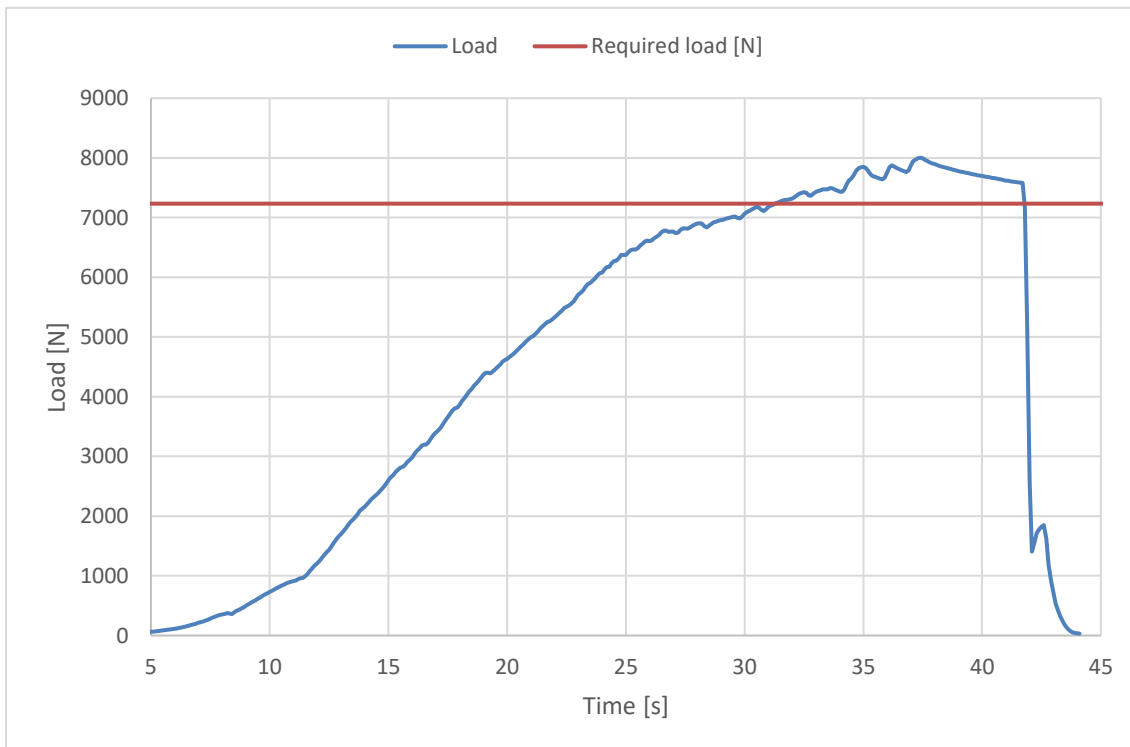
Test ID 06

Test duration [s] **10.5**
 Any signs of structural failure **No**
 Test results **POSITIVE**

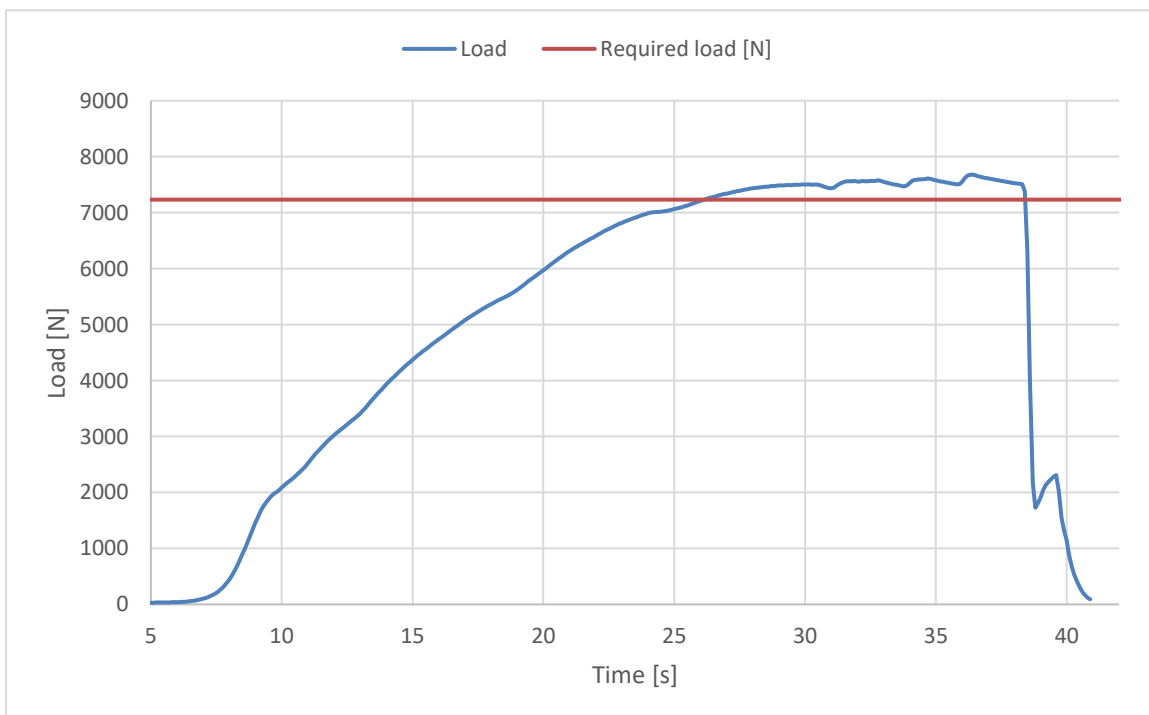
Test ID 12

| Any signs of structural failure | No |
| Slippery test OK | Yes |
| Test results | POSITIVE |
