Harness Structural test Report - NfL

Inspection certificate number: **PH_369.2022**

Name: **GUEST**
 Type: **ABS**
 Size: **M**
 Serial number: **SKH-0122-PA-01**
 Impact pad type: ⁽¹⁾ **Inflatable**
 Clip-in weight [kg]: **120**
 Integrated container: **No**
 Date of test: **25.04.2022**

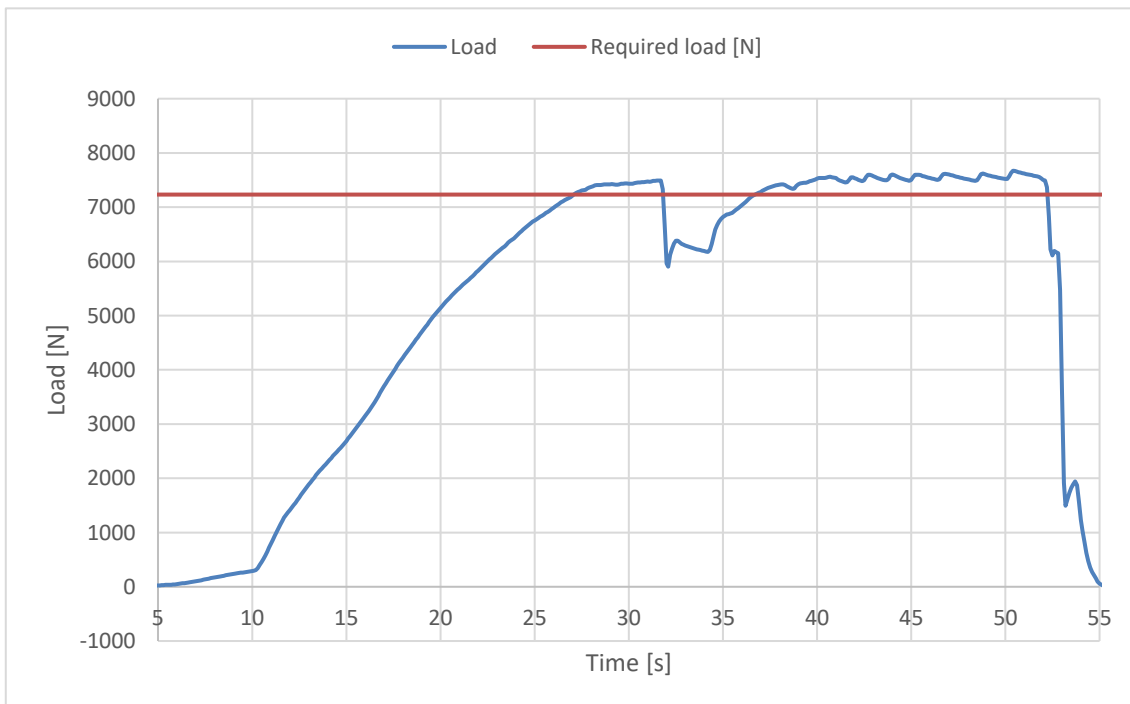
Test ID 02

Standard **EN 1651:1999**
 Reference **5.3.2.1**
 Test setup **Default flying position**
 Attachment points **Both main riser attachment (3,4)**
 Anchor points **Dummy (B1, B2)**

Required load [g] **6**
 Required load [N] **7200**
 Minimum test duration [s] **10**

Test duration [s] **15.6**
 Any signs of structural failure **No**
 Test results **POSITIVE**

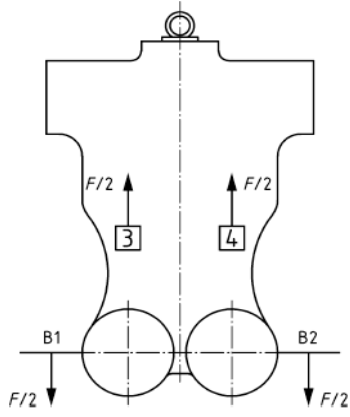
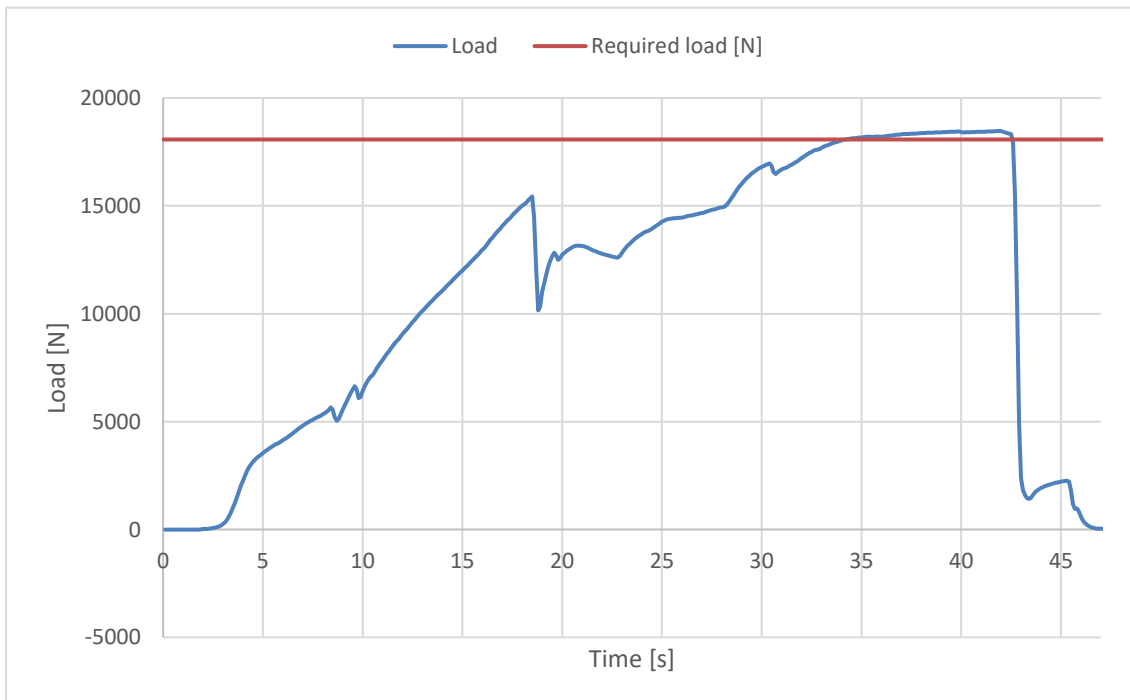
Test ID 03

Standard	EN 1651:1999
Reference	5.3.2.2
Test setup	Default flying position
Attachment points	Both main riser attachment (3,4)
Anchor points	Dummy (B1, B2)
Required load [g]	15
Required load [N]	18000
Minimum test duration [s]	5
Result	
Test duration [s]	8.4
Any signs of structural failure	No
Test results	POSITIVE

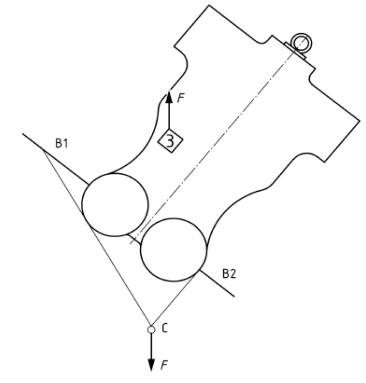
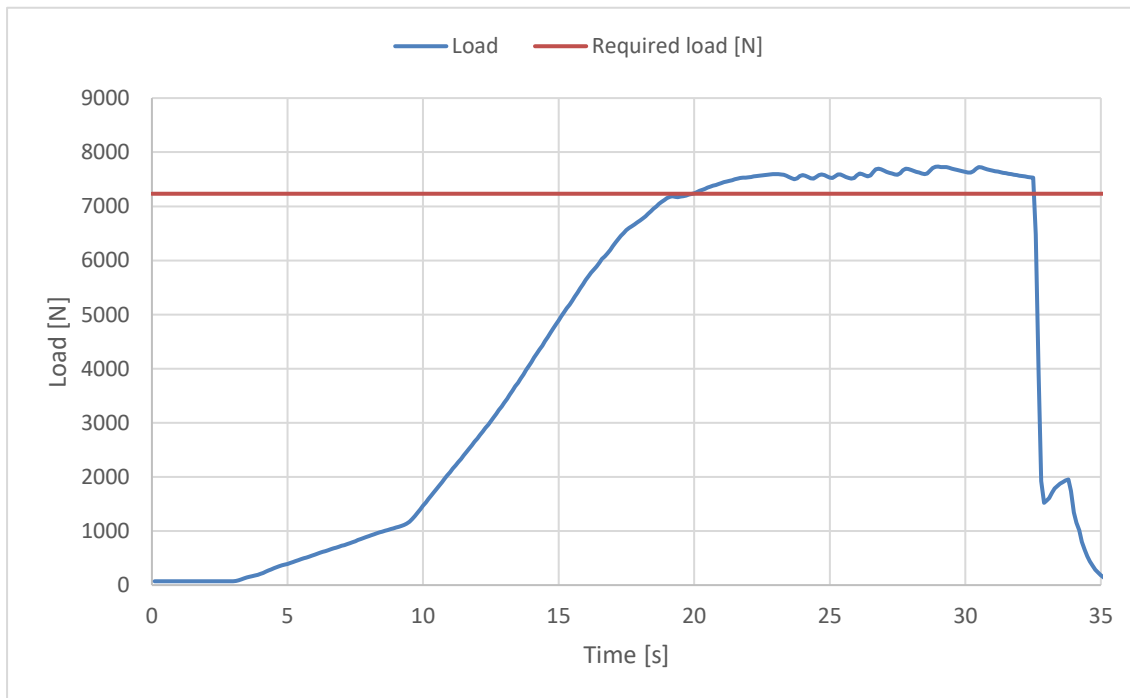
Test ID 04

Standard	EN 1651:1999
Reference	5.3.2.3
Test setup	Asymmetric, one riser
Attachment points	One main riser attachment (3)
Anchor points	Dummy (B1,B2)
Required load [g]	6
Required load [N]	7200
Minimum test duration [s]	10
Result	
Test duration [s]	12.6
Any signs of structural failure	No
Test results	POSITIVE

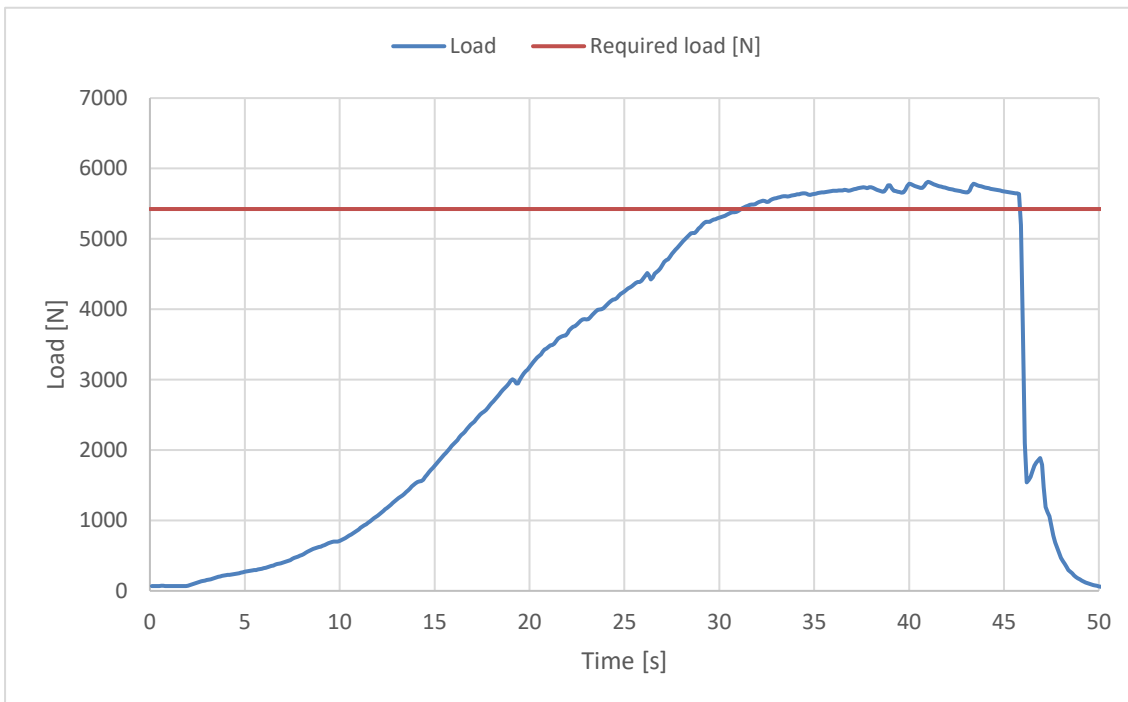
Test ID 07

Standard	EN 1651:1999
Reference	5.3.2.6
Test setup	Asymmetric, negative
Attachment points	One main riser attachment (3 or 4) downwards
Anchor points	Dummy (9)
Required load [g]	4.5
Required load [N]	5400
Minimum test duration [s]	10
Result	
Test duration [s]	14.7
Any signs of structural failure	No
Test results	POSITIVE

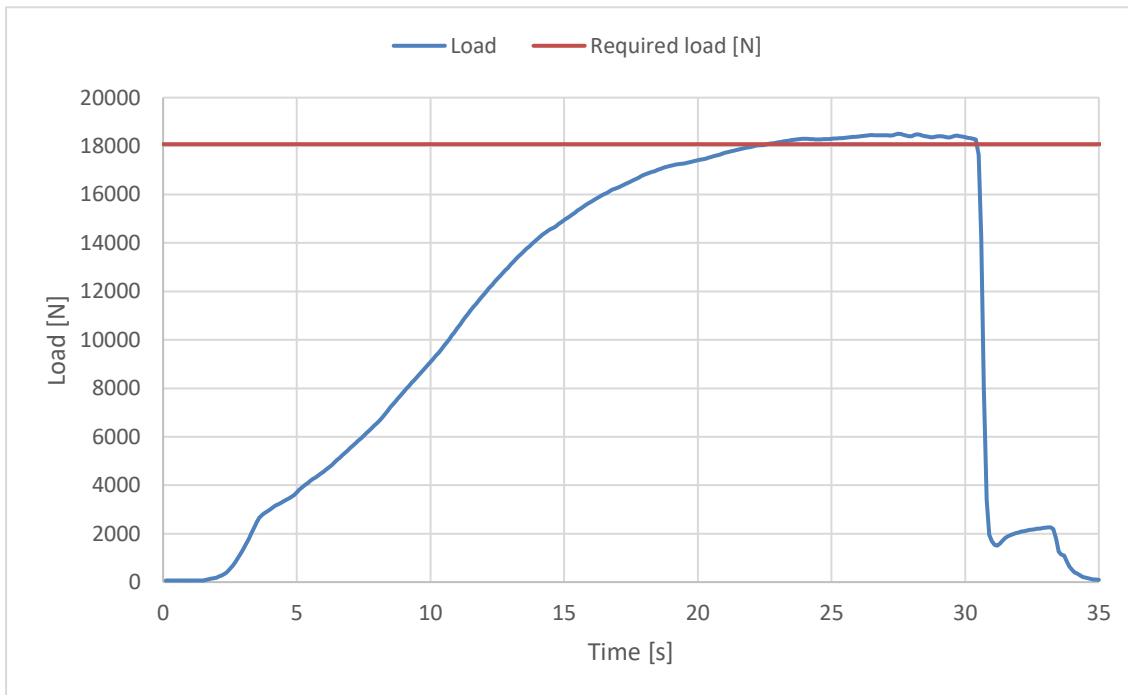
Test ID 13

Standard	EN 1651:1999
Reference	5.3.2.7
Test setup	Flying position before landing
Attachment points	Both main riser attachment (3,4)
Anchor points	Dummy (7,8)
Required load [g]	15
Required load [N]	18000
Minimum test duration [s]	5
Result	
Test duration [s]	7.9
Any signs of structural failure	No
Test results	POSITIVE
