Harness Structural test Report - NfL

Inspection certificate number: **PH_449.2024**

Name: **ROOKIE**
 Type: **ABS**
 Size: **M**
 Serial number: **SKH-0122-PA-01**
 Impact pad type: ⁽¹⁾ **Inflatable**
 Clip-in weight [kg]: **120**
 Integrated container: **No**
 Date of test: **25.04.2022**

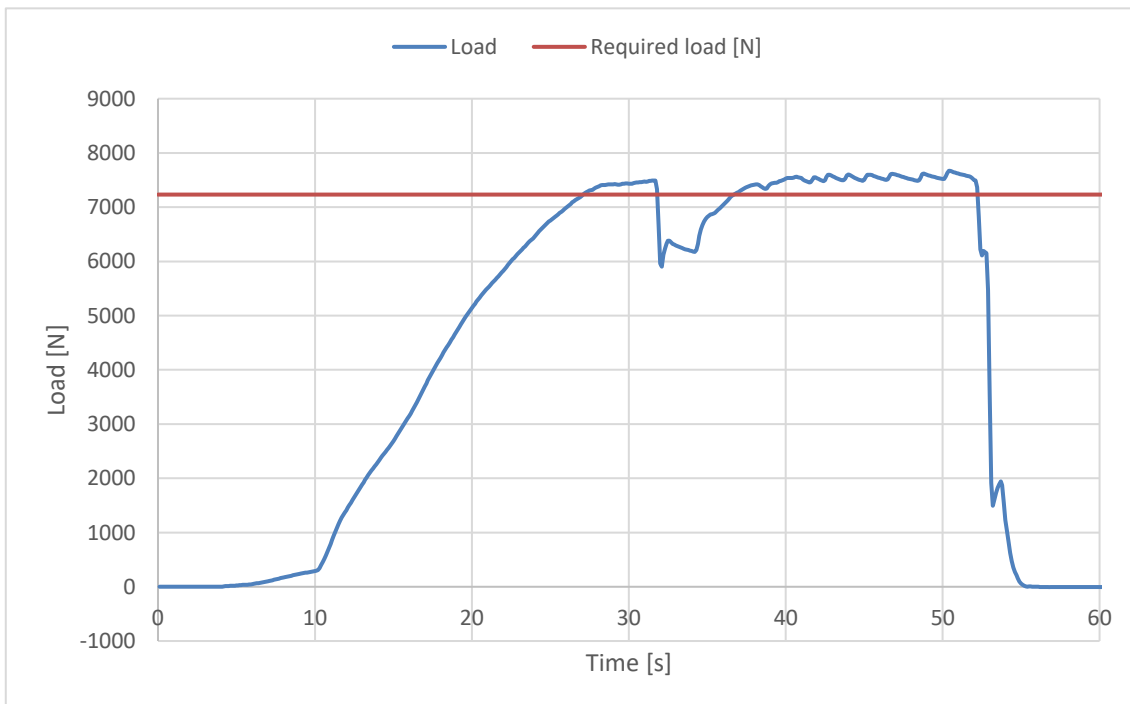
Test ID 02

Standard	EN 1651:1999
Reference	5.3.2.1
Test setup	Default flying position
Attachment points	Both main riser attachment (3,4)
Anchor points	Dummy (B1, B2)
Required load [g]	6
Required load [N]	7200
Minimum test duration [s]	10
Result	
Test duration [s]	15.6
Any signs of structural failure	No
Test results	POSITIVE

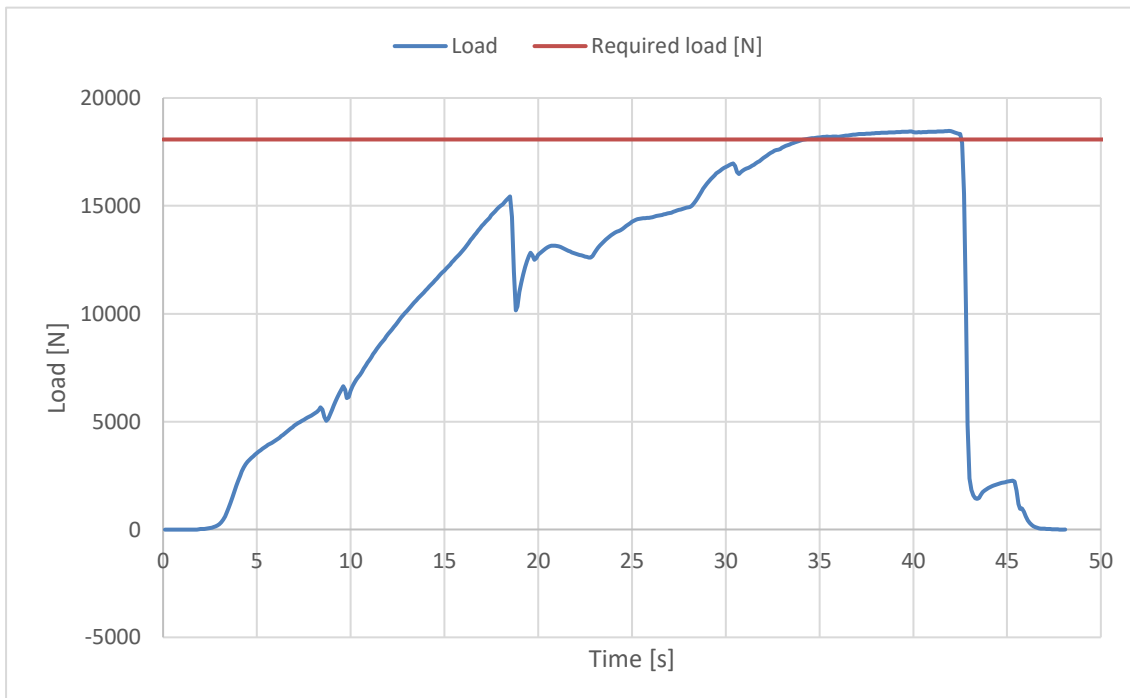
Test ID 03

Standard	EN 1651:1999
Reference	5.3.2.2
Test setup	Default flying position
Attachment points	Both main riser attachment (3,4)
Anchor points	Dummy (B1, B2)
Required load [g]	15
Required load [N]	18000
Minimum test duration [s]	5
Result	
Test duration [s]	8.4
Any signs of structural failure	No
Test results	POSITIVE

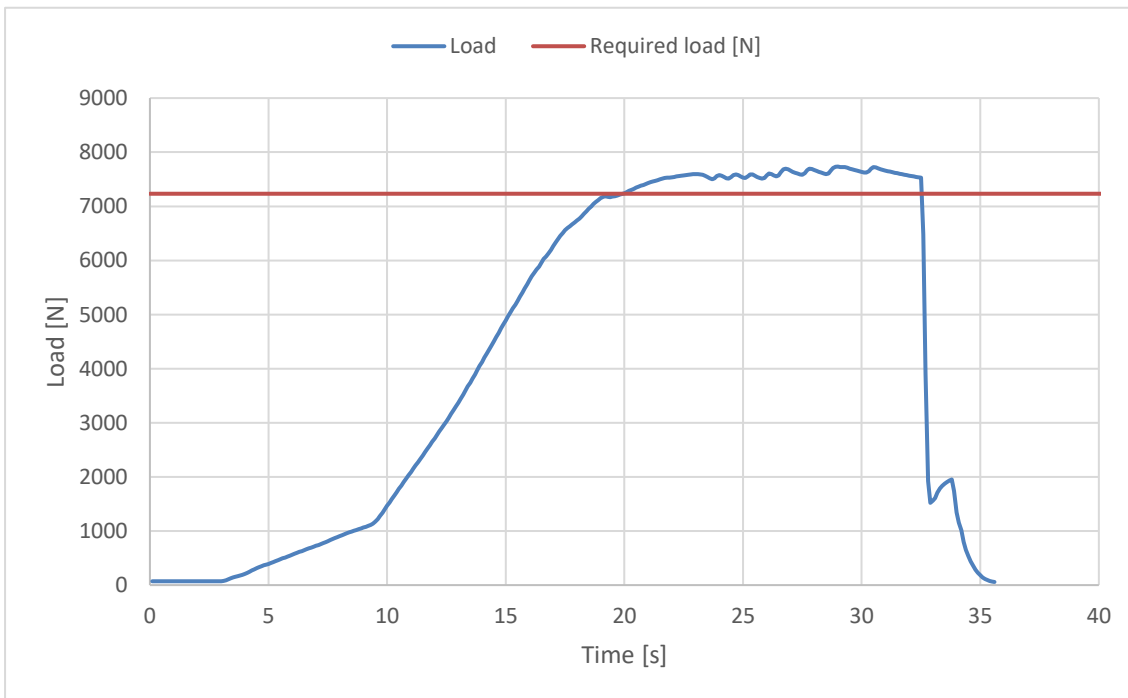
Test ID 04

Reference	5.3.2.3	
Test setup	Asymmetric, one riser	
Attachment points	One main riser attachment (3)	
Anchor points	Dummy (B1,B2)	
Required load [g]	6	
Required load [N]	7200	
Minimum test duration [s]	10	
Result		
Test duration [s]	12.6	
Any signs of structural failure	No	
Test results	POSITIVE

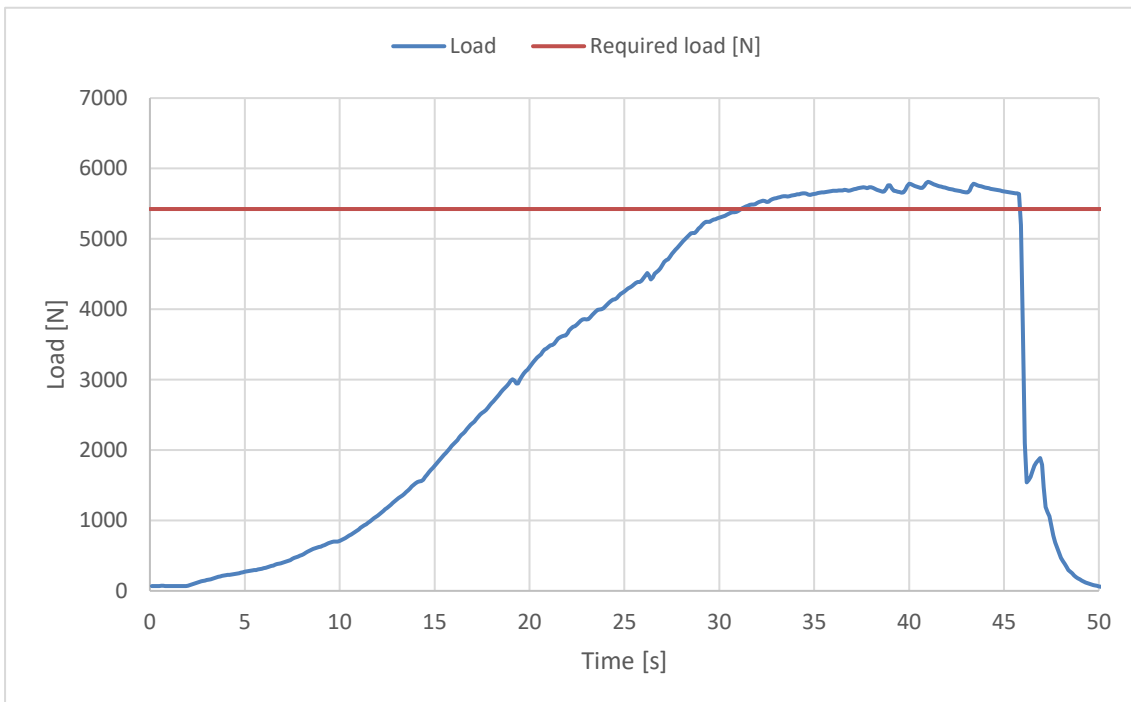
Test ID 07

Standard	EN 1651:1999
Reference	5.3.2.6
Test setup	Asymmetric, negative
Attachment points	One main riser attachment (3 or 4) downwards
Anchor points	Dummy (9)
Required load [g]	4.5
Required load [N]	5400
Minimum test duration [s]	10
Result	
Test duration [s]	14.7
Any signs of structural failure	No
Test results	POSITIVE

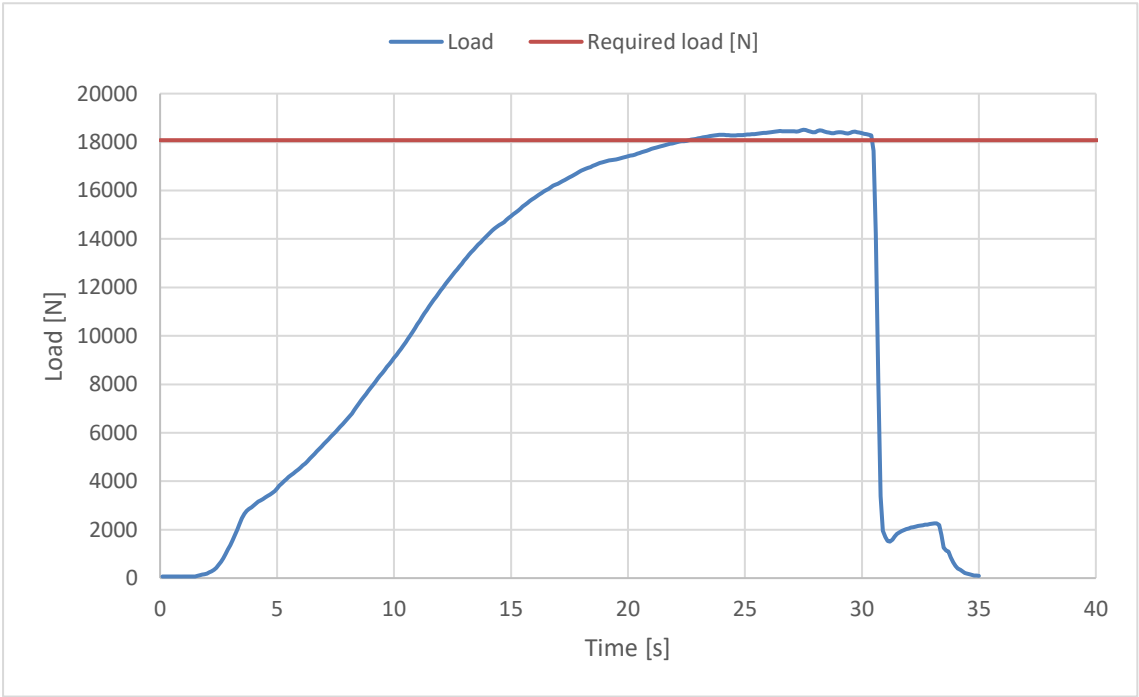
Test ID 13

Standard	EN 1651:1999
Reference	5.3.2.7
Test setup	Flying position before landing
Attachment points	Both main riser attachment (3,4)
Anchor points	Dummy (7,8)
Required load [g]	15
Required load [N]	18000
Minimum test duration [s]	5
Result	
Test duration [s]	7.9
Any signs of structural failure	No
Test results	POSITIVE
