## Harness Structural test Report

Inspection certificate number: **PH\_233.2018**

Name: **Acro 4**  
 Type: **ABS**  
 Size: **M**  
 Serial number: **2168MM**  
 Impact pad type: <sup>(1)</sup> **Foam**  
 Clip-in weight [kg]: **120**

model: **Acro 4 M**

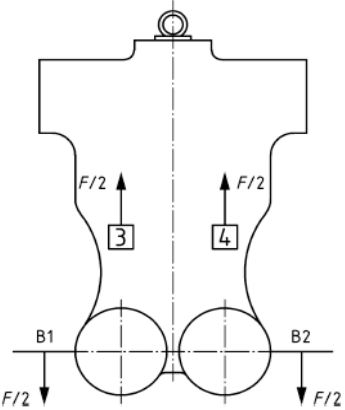
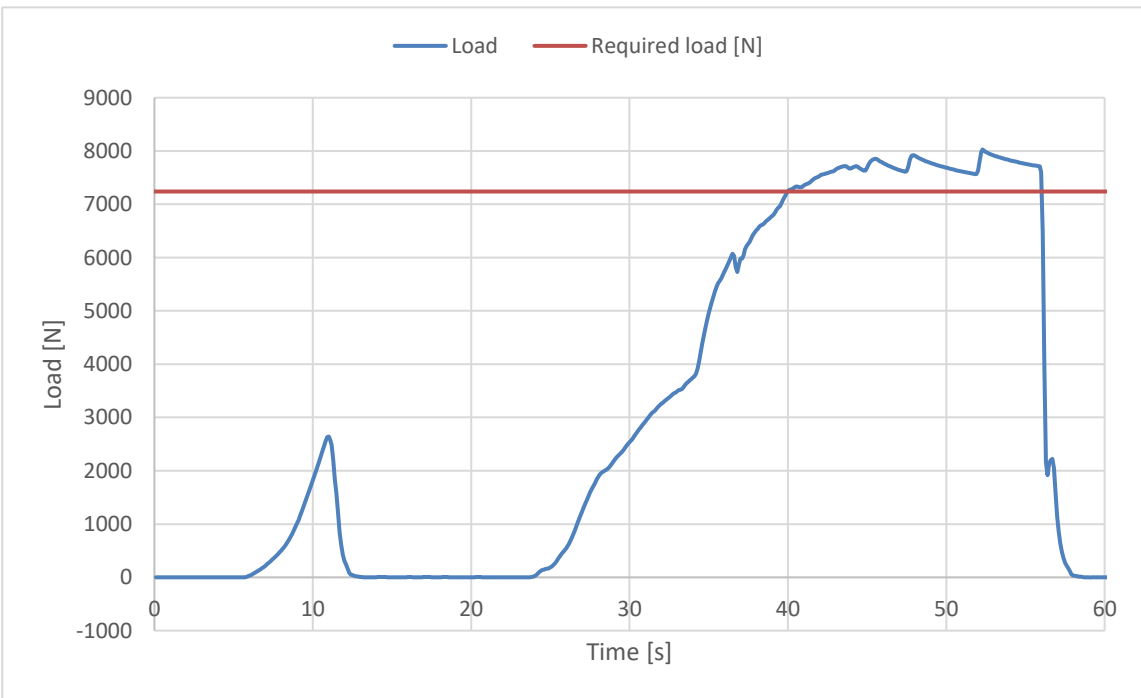
**Test ID R0**

Reference in standard	<b>5.3.2.1</b>	
Test setup	<b>Default flying position</b>	
Attachment points	<b>Both main riser attachment (3,4)</b>	
Anchor points	<b>Dummy (B1, B2)</b>	
Required load [g]	<b>6</b>	
Required load [N]	<b>7200</b>	
Minimum test duration [s]	<b>10</b>	
<b>Result</b>		
Test duration [s]	<b>16.1</b>	
Any signs of structural failure	<b>No</b>	
Test results	<b>POSITIVE</b>

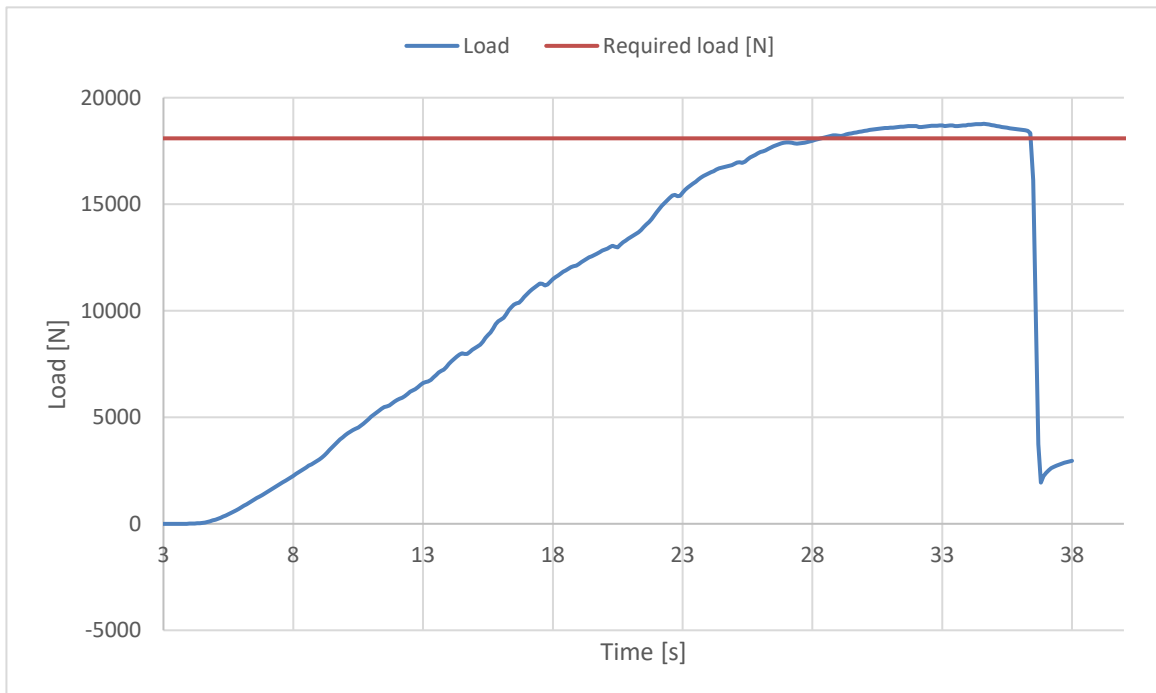
**Test ID R2**

Reference in standard	<b>5.3.2.2</b>	
Test setup	<b>Default flying position</b>	
Attachment points	<b>Both main riser attachment (3,4)</b>	
Anchor points	<b>Dummy (B1, B2)</b>	
Required load [g]	<b>15</b>	
Required load [N]	<b>18000</b>	
Minimum test duration [s]	<b>5</b>	
<b>Result</b>		
Test duration [s]	<b>8.1</b>	
Any signs of structural failure	<b>No</b>	
Test results	<b>POSITIVE</b>

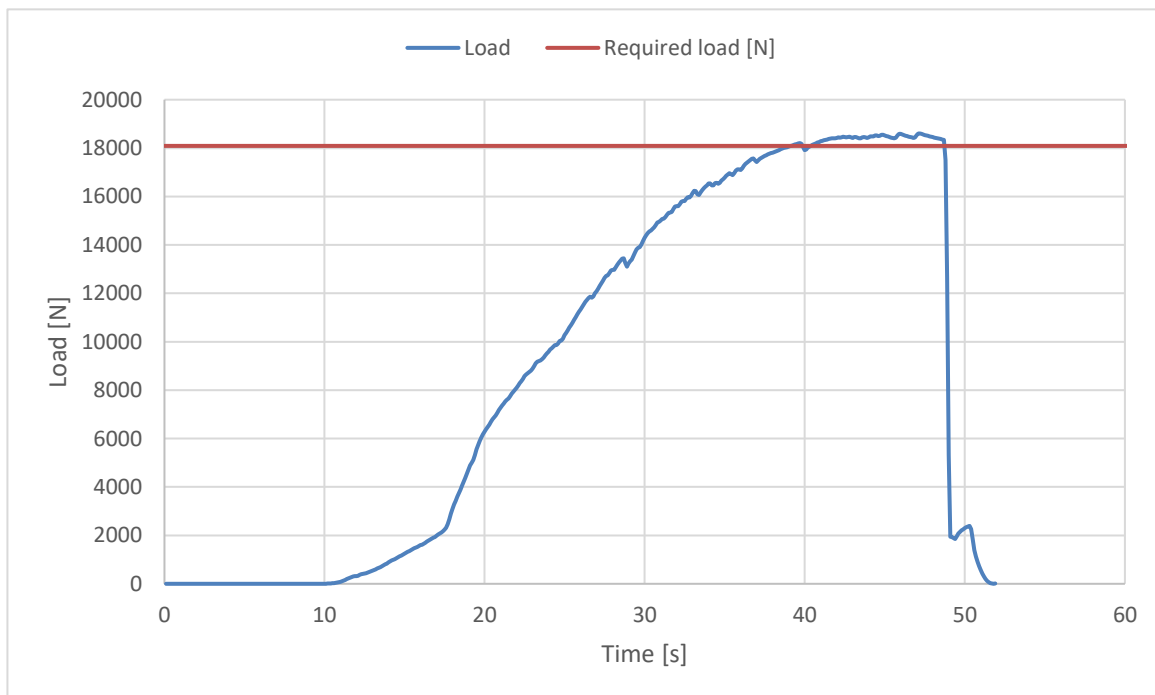
**Test ID R4**

Standard	<b>EN 1651:1999</b>
Reference in standard	<b>5.3.2.7</b>
Test setup	<b>Flying position before landing</b>
Attachment points	<b>Both main riser attachment (3,4)</b>
Anchor points	<b>Dummy (7,8)</b>
Required load [g]	<b>15</b>
Required load [N]	<b>18000</b>
Minimum test duration [s]	<b>5</b>
<b>Result</b>	
Test duration [s]	<b>8.4</b>
Any signs of structural failure	<b>No</b>
Test results	<b>POSITIVE</b>

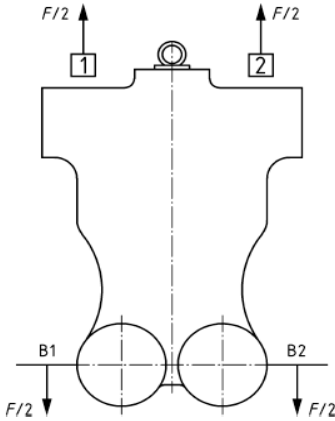
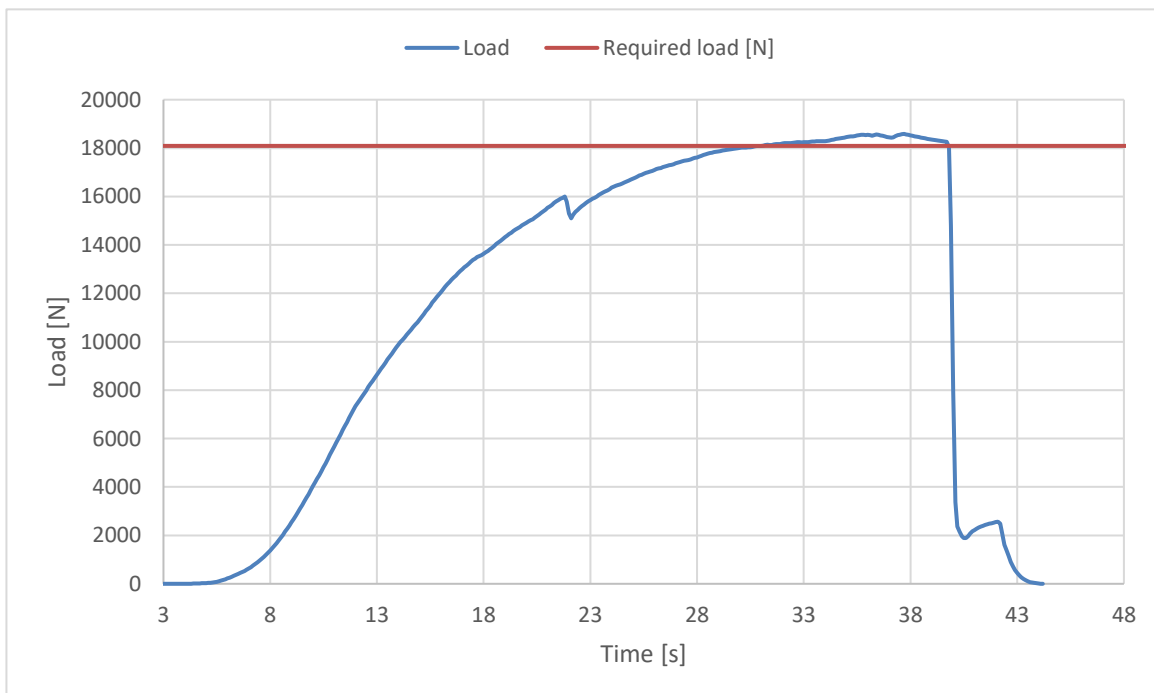
**Test ID R6**

Reference in standard	<b>5.3.2.4</b>	
Test setup	<b>Rescue attachments</b>	
Attachment points	<b>Rescue riser attachment (1,2)</b>	
Anchor points	<b>Dummy (B1,B2)</b>	
Required load [g]	<b>15</b>	
Required load [N]	<b>18000</b>	
Minimum test duration [s]	<b>5</b>	
<b>Result</b>		
Test duration [s]	<b>8.7</b>	
Any signs of structural failure	<b>No</b>	
Test results	<b>POSITIVE</b>

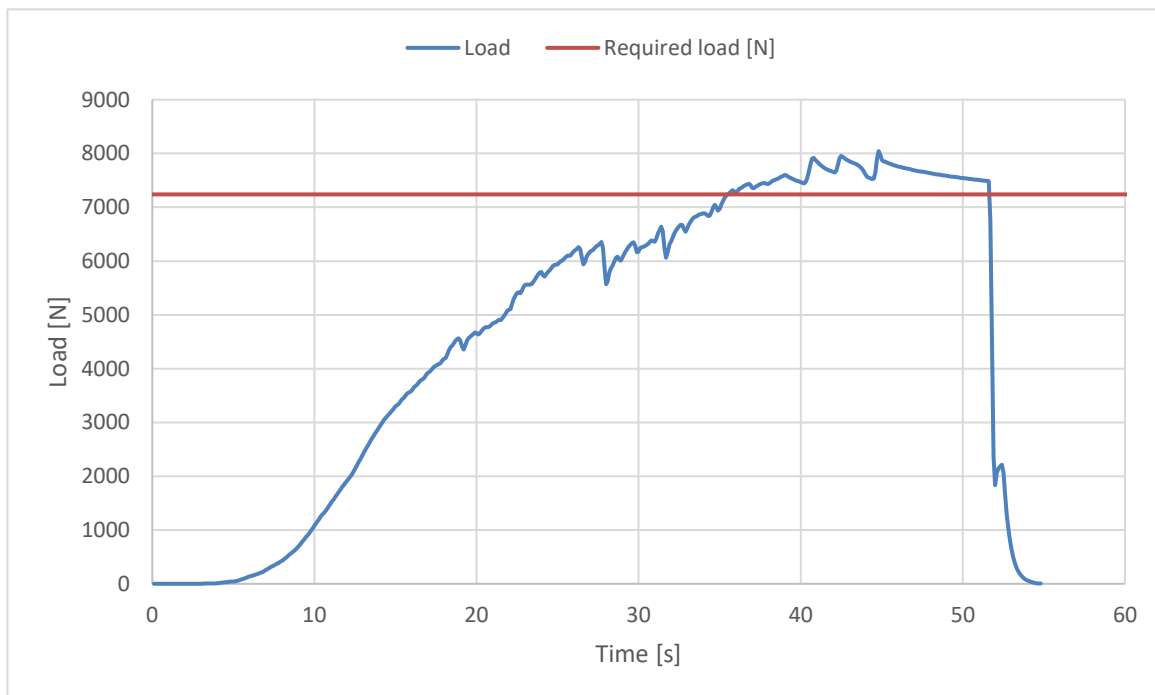
**Test ID R8**

Standard	<b>EN 1651:1999</b>	
Reference in standard	<b>5.3.2.3</b>	
Test setup	<b>Asymmetric, one riser</b>	
Attachment points	<b>One main riser attachment (3)</b>	
Anchor points	<b>Dummy (B1,B2)</b>	
Required load [g]	<b>6</b>	
Required load [N]	<b>7200</b>	
Minimum test duration [s]	<b>10</b>	
<b>Result</b>		
Test duration [s]	<b>16.2</b>	
Any signs of structural failure	<b>No</b>	
Test results	<b>POSITIVE</b>

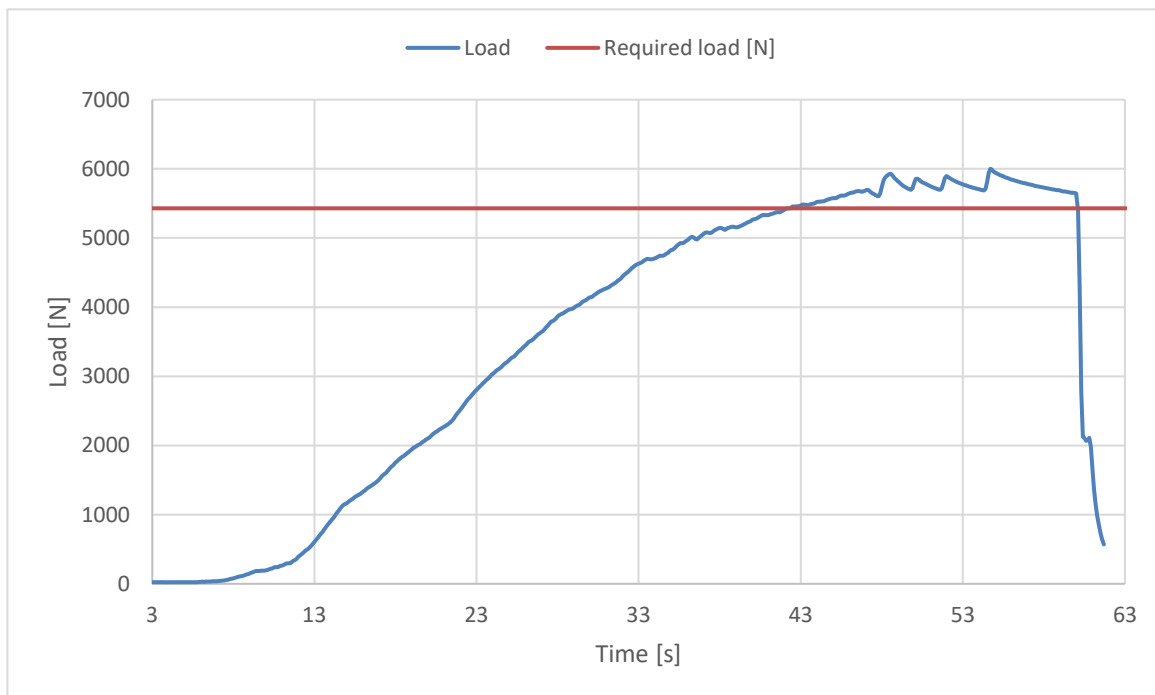
**Test ID R10**

Reference in standard	<b>5.3.2.6</b>	
Test setup	<b>Asymmetric, negative</b>	
Attachment points	<b>One main riser attachment (3 or 4) downwards</b>	
Anchor points	<b>Dummy (9)</b>	
Required load [g]	<b>4.5</b>	
Required load [N]	<b>5400</b>	
Minimum test duration [s]	<b>10</b>	
<b>Result</b>		
Test duration [s]	<b>17.7</b>	
Any signs of structural failure	<b>No</b>	
Test results	<b>POSITIVE</b>

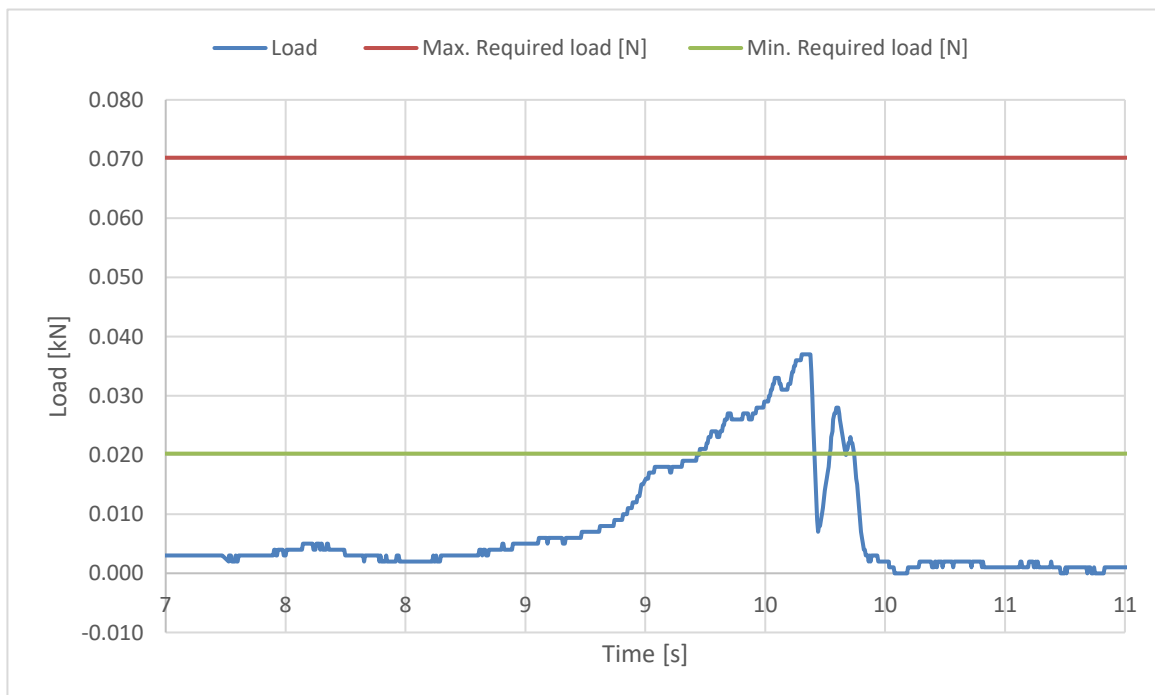
**Test ID RRDT**

Standard	<b>LTF NfL II 91/09</b>
Reference in standard	<b>6.1.5</b>
Test setup	<b>Default flying position</b>
Attachment points	<b>Sensor connect to handle, and pull in opening direction</b>
	The test is to simulate the load required to open the emergency parachute(1st action).
Min. Required load [N]	<b>20</b>
Max. Required load [N]	<b>70</b>
<b>Result</b>	
Load for first action [N]	<b>36.78</b>
Test results	<b>POSITIVE</b>

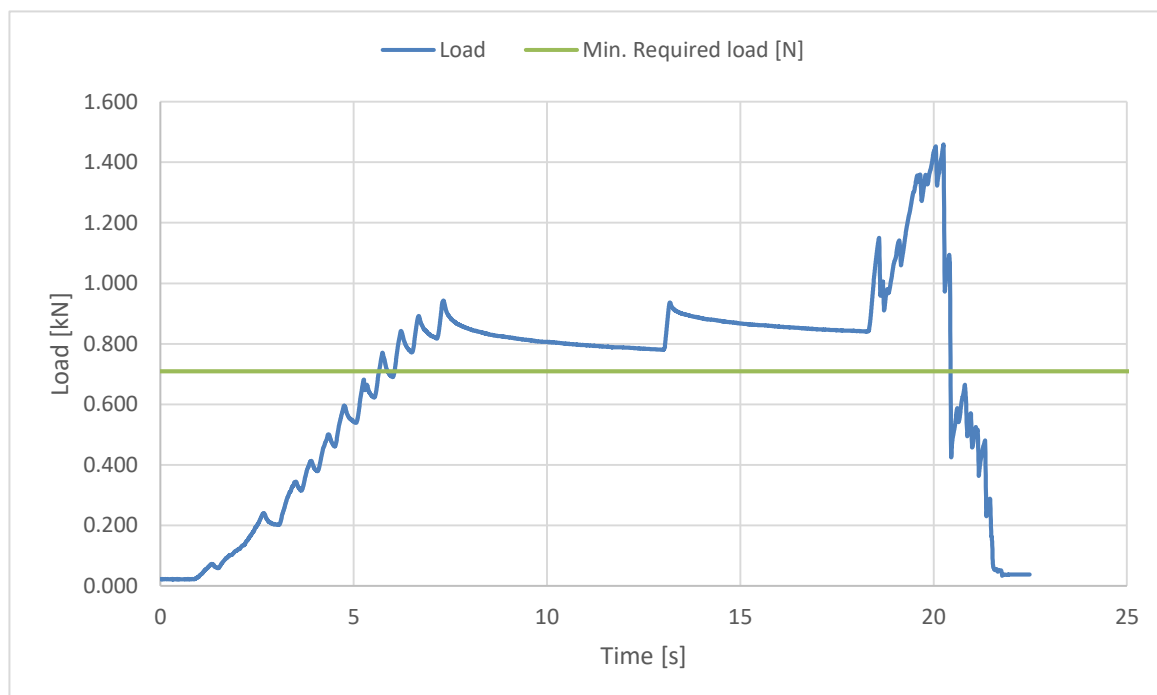
**Test ID RRST**

Standard	<b>EN12491:2015</b>
Reference in standard	<b>5.3.2</b>
Test setup	<b>Two end points of handle</b>
Attachment points	<b>Sensor connect to end of handle, pull on the other side</b>
	The handle must support min 700 N for 10 s, after measure breaking strength
Min. Required load [N]	<b>700</b>
Minimum test duration [s]	<b>10</b>
<b>Result</b>	
Test duration [s]:	<b>14.2</b>
Breaking strength [N]	<b>1450.23</b>
Test results	<b>POSITIVE</b>
