# Harness Structural test Report - EN

Inspection certificate number: **PH\_380.2022**

Name: **Altirando Lite 2**  
 Type: **ABS**  
 Size: **L**  
 Serial number: **ATL2\_L\_V2.5**  
 Impact pad type: <sup>(1)</sup> **Airbag**  
 Clip-in weight [kg]: **120**

**Harness Structural test**

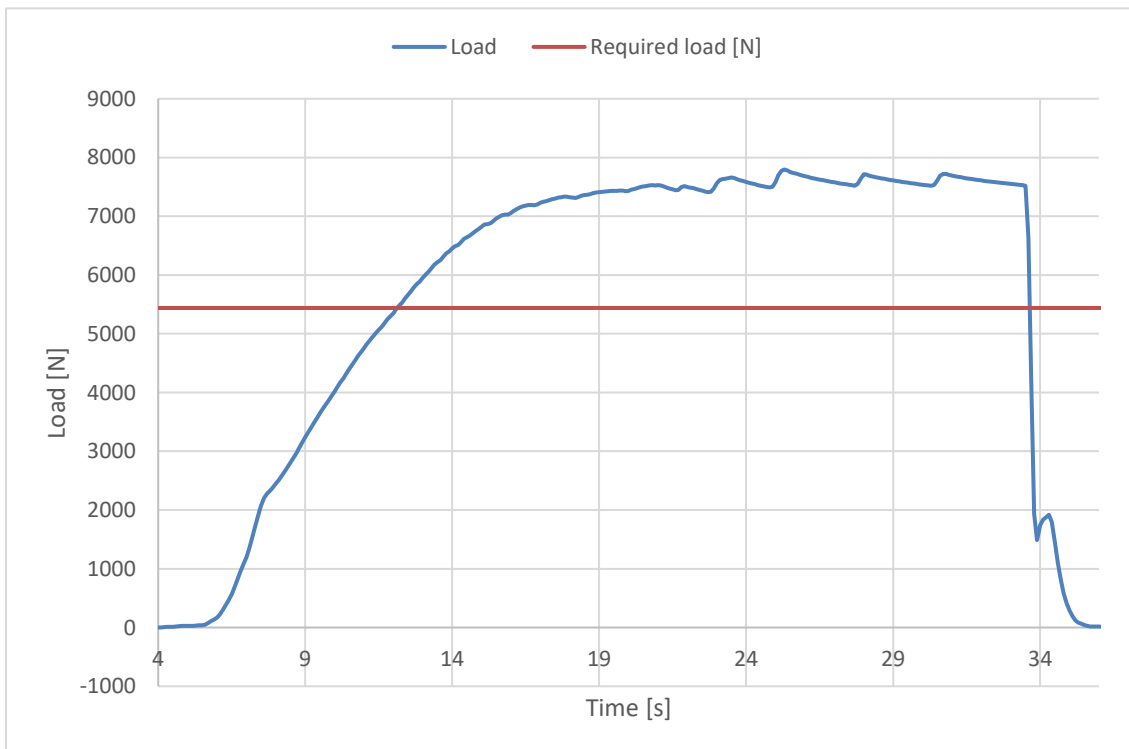
**Test ID 01**

Standard	<b>EN 1651</b>
Reference in standard	<b>5.5.1.1</b>
Test setup	<b>Positive symmetric load (Slippage)</b>
Attachment points	<b>Both main riser attachment (3,4)</b>
Anchor points	<b>Dummy (B1, B2)</b>
Required load [g]	<b>4.5</b>
Required load [N]	<b>5400</b>
Minimum test duration [s]	<b>5</b>
<b>Result</b>	
Test duration [s]	<b>21.5</b>
Any signs of structural failure	<b>No</b>
Slippery test OK	<b>Yes</b>
Test results	<b>POSITIVE</b>

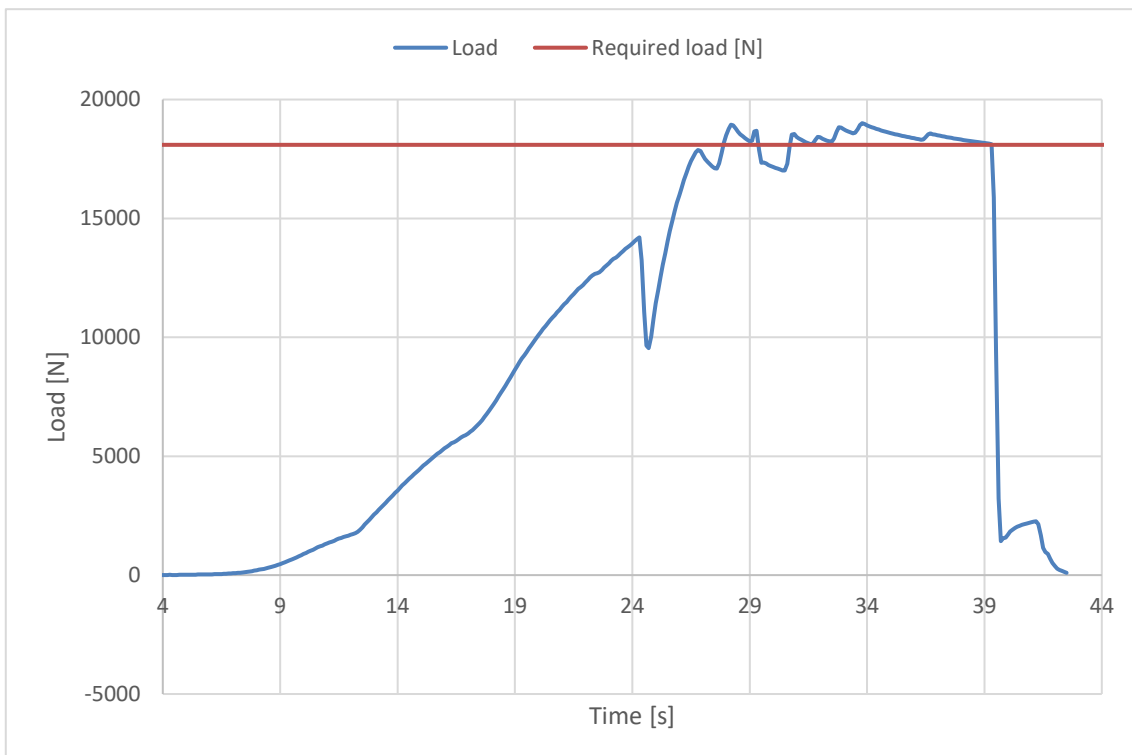
**Test ID 03**

Standard	<b>EN 1651</b>
Reference in standard	<b>5.5.1.1b</b>
Test setup	<b>Positive symmetric load</b>
Attachment points	<b>Both main riser attachment (3,4)</b>
Anchor points	<b>Dummy (B1, B2)</b>
Required load [g]	<b>15</b>
Required load [N]	<b>18000</b>
Minimum test duration [s]	<b>5</b>
<b>Result</b>	
Test duration [s]	<b>8.6</b>
Any signs of structural failure	<b>No</b>
Slippery test OK	<b>Yes</b>
Test results	<b>POSITIVE</b>

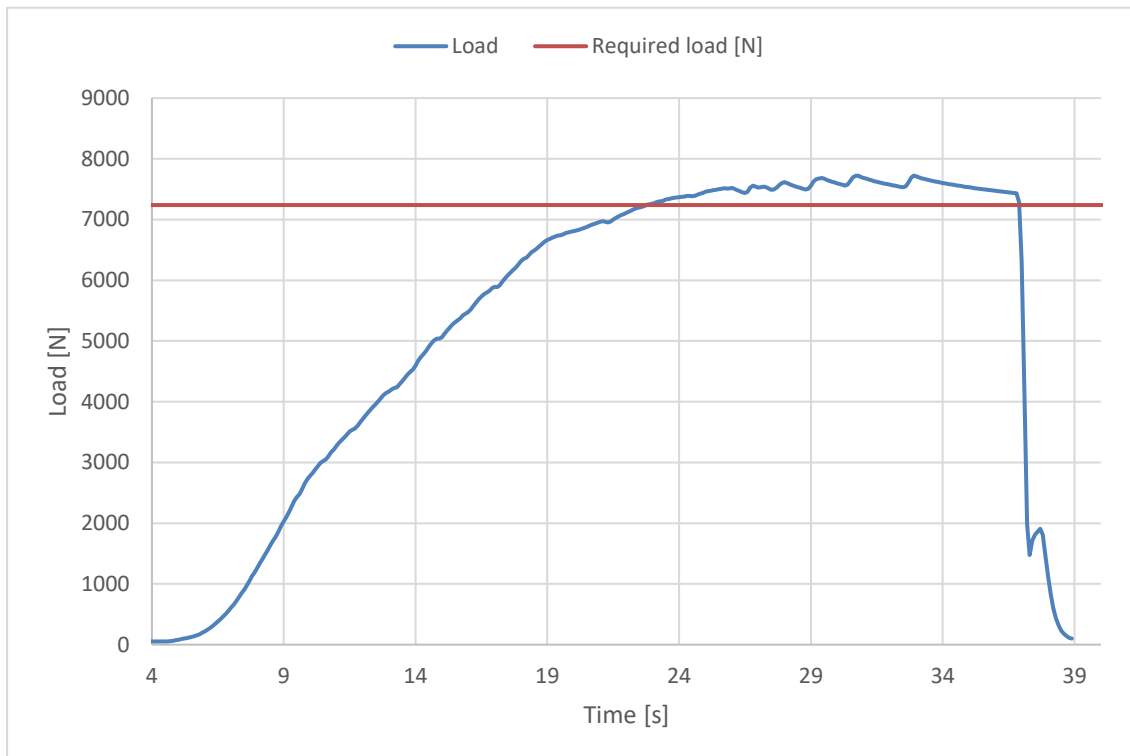
**Test ID 05**

Standard	<b>EN 1651</b>
Reference in standard	<b>5.5.1.2</b>
Test setup	<b>Positive asymmetric load</b>
Attachment points	<b>One riser attachment (3 or 4)</b>
Anchor points	<b>Dummy (C)</b>
Required load [g]	<b>6</b>
Required load [N]	<b>7200</b>
Minimum test duration [s]	<b>5</b>
<b>Result</b>	
Test duration [s]	<b>14.2</b>
Any signs of structural failure	<b>No</b>
Test results	<b>POSITIVE</b>

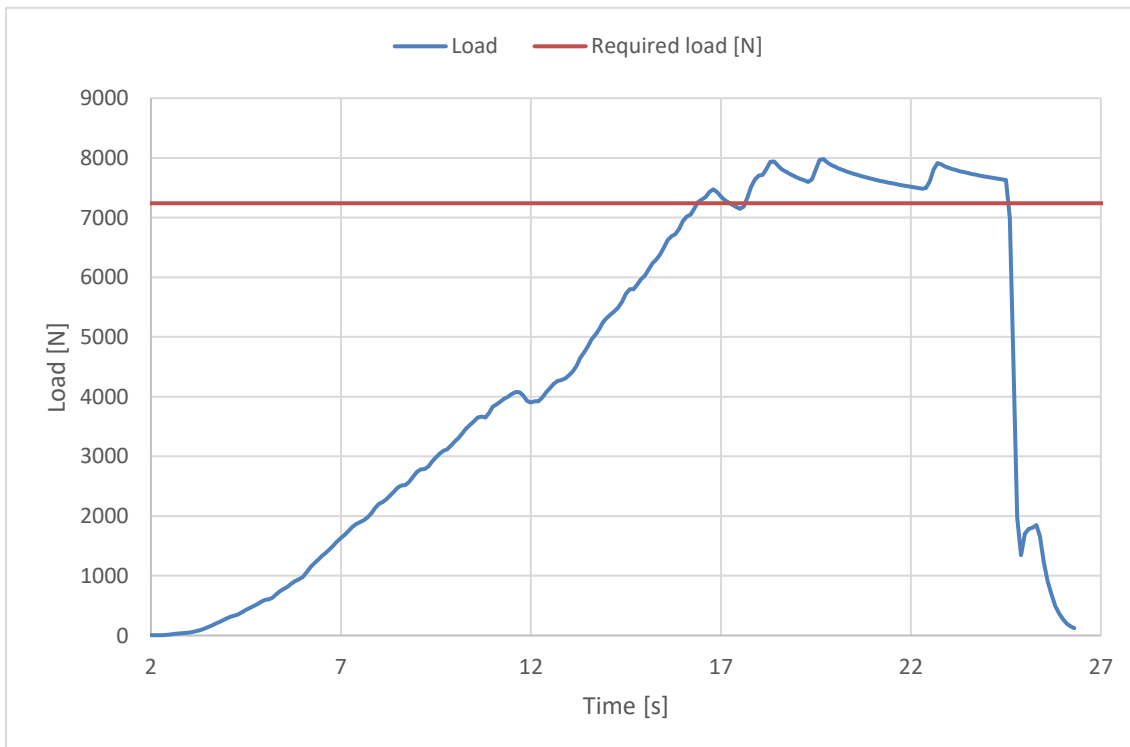
**Test ID 06**

Standard	<b>EN 1651</b>
Reference in standard	<b>5.5.1.6</b>
Test setup	<b>Negative symmetric load</b>
Attachment points	<b>Both main riser attachment (3,4)</b>
Anchor points	<b>Dummy (A)</b>
Required load [g]	<b>6</b>
Required load [N]	<b>7200</b>
Minimum test duration [s]	<b>5</b>
<b>Result</b>	
Test duration [s]	<b>6.9</b>
Any signs of structural failure	<b>No</b>
Test results	<b>POSITIVE</b>

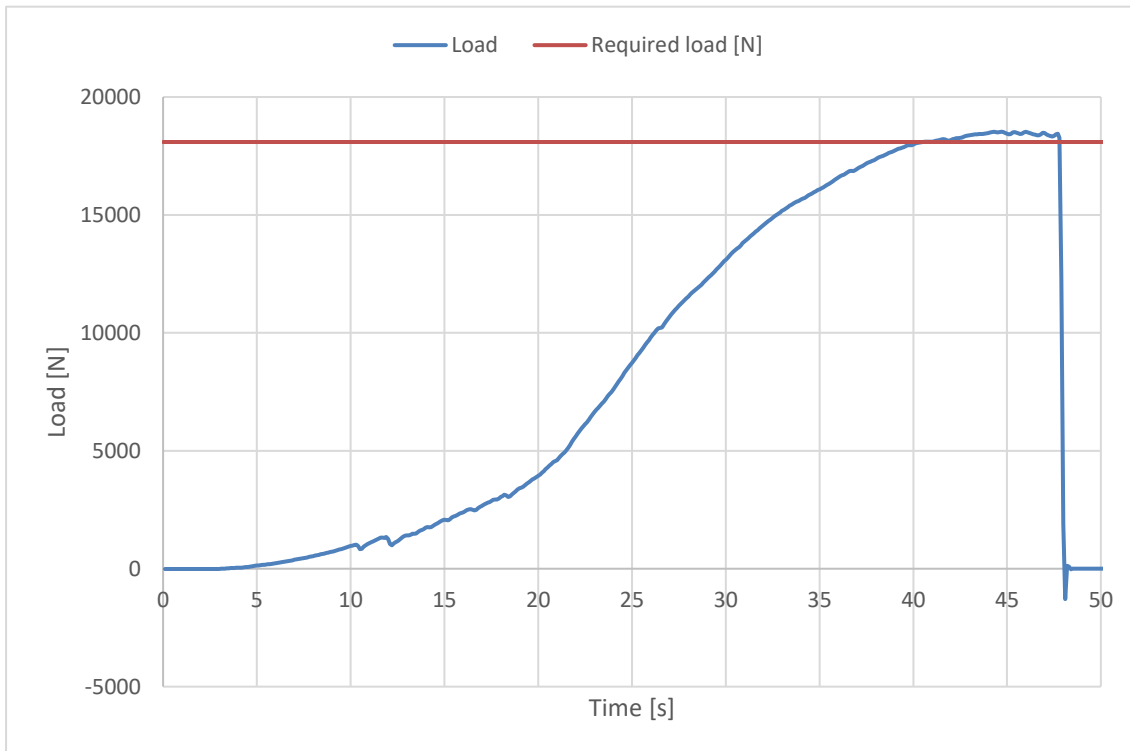
**Test ID 09**

Standard	<b>EN 1651</b>
Reference in standard	<b>5.5.1.3</b>
Test setup	<b>Positive symmetric load rescue points</b>
Attachment points	<b>Both main riser attachment (1,2)</b>
Anchor points	<b>Dummy (B1,B2)</b>
Required load [g]	<b>15</b>
Required load [N]	<b>18000</b>
Minimum test duration [s]	<b>5</b>
<b>Result</b>	
Test duration [s]	<b>7.4</b>
Any signs of structural failure	<b>No</b>
Slippery test OK	<b>Yes</b>
Test results	<b>POSITIVE</b>

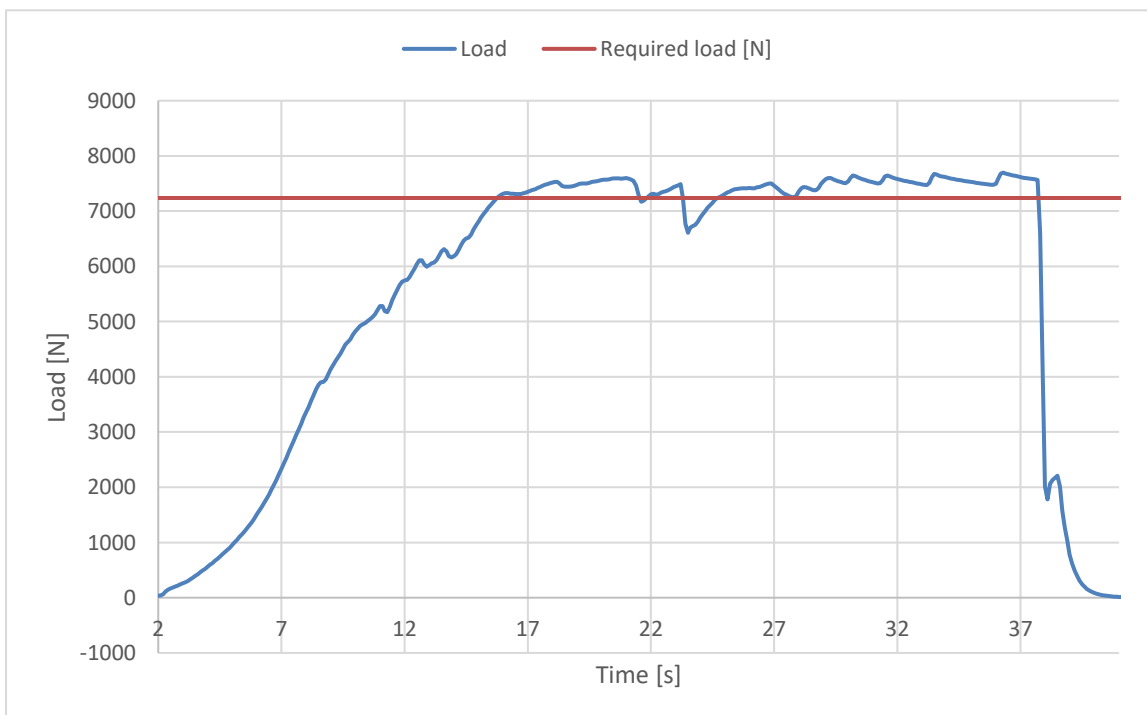
**Test ID 12**

Standard	<b>EN 1651</b>
Reference in standard	<b>5.5.1.7</b>
Test setup	<b>Upright (landing) position load</b>
Attachment points	<b>Both main riser attachment (3, 4)</b>
Anchor points	<b>Both legstrap of harness (no dummy)</b>
Required load [g]	<b>6</b>
Required load [N]	<b>7200</b>
Minimum test duration [s]	<b>5</b>
Harness type	<b>type c</b>
<b>Result</b>	
Test duration [s]	<b>13</b>
Any signs of structural failure	<b>No</b>
Slippery test OK	<b>Yes</b>
Test results	<b>POSITIVE</b>

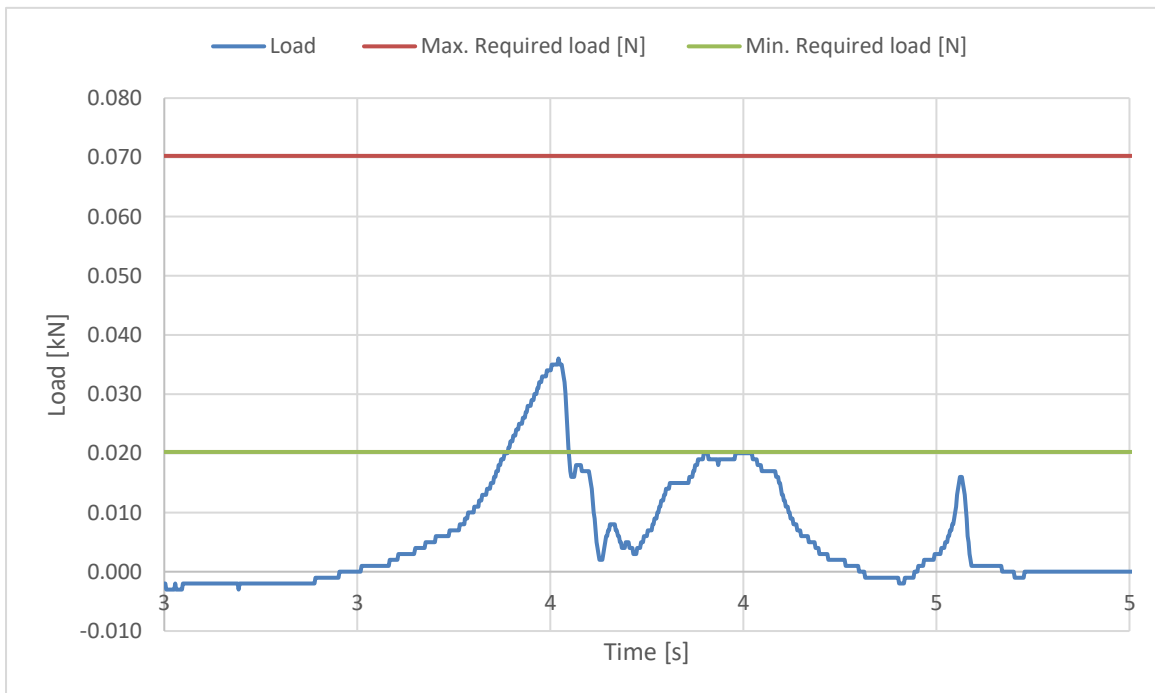
**Test ID RRDT**

Standard	<b>EN 1651</b>
Reference in standard	<b>5.5.1.11</b>
Test setup	<b>Default flying position</b>
Attachment points	<b>Sensor connect to handle, and pull in opening direction</b>
	The test is to simulate the load required to open the emergency parachute(1st action).
Min. Required load [N]	<b>20</b>
Max. Required load [N]	<b>70</b>
<b>Result</b>	
Load for first action [N]	<b>36.24</b>
Test results	<b>POSITIVE</b>

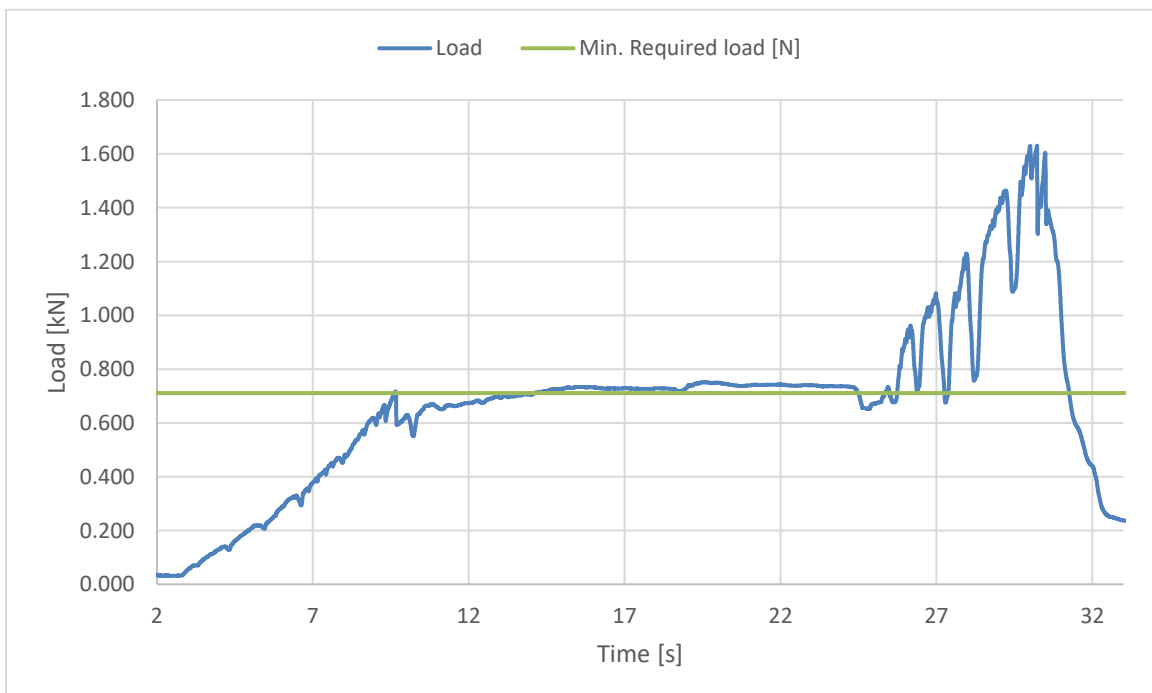
**Test ID RRST**

Standard	<b>EN 12491</b>
Reference in standard	<b>5.3.2</b>
Test setup	<b>Two end points of handle</b>
Attachment points	<b>Sensor connect to end of handle, pull on the other side</b>
	The handle must support min 700 N for 10 s, after measure breaking strength
Min. Required load [N]	<b>700</b>
Minimum test duration [s]	<b>10</b>
<b>Result</b>	
Test duration [s]:	<b>10.4</b>
Breaking strength [N]	<b>1620.17</b>
Test results	<b>POSITIVE</b>
