Harness Structural test Report - NfL

Inspection certificate number: **PH_380.2022**

Name: **Altirando Lite 2**
 Type: **ABS**
 Size: **L**
 Serial number: **ATL2_L_V2.5**
 Impact pad type: ⁽¹⁾ **Airbag**
 Clip-in weight [kg]: **120**
 Integrated container: **Yes**
 Date of test: **02.11.2022**

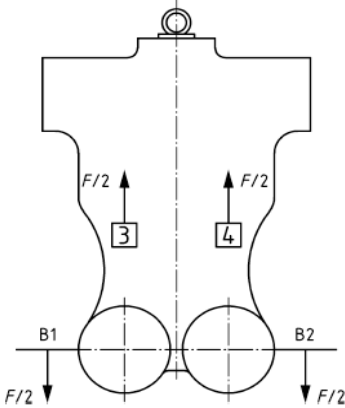
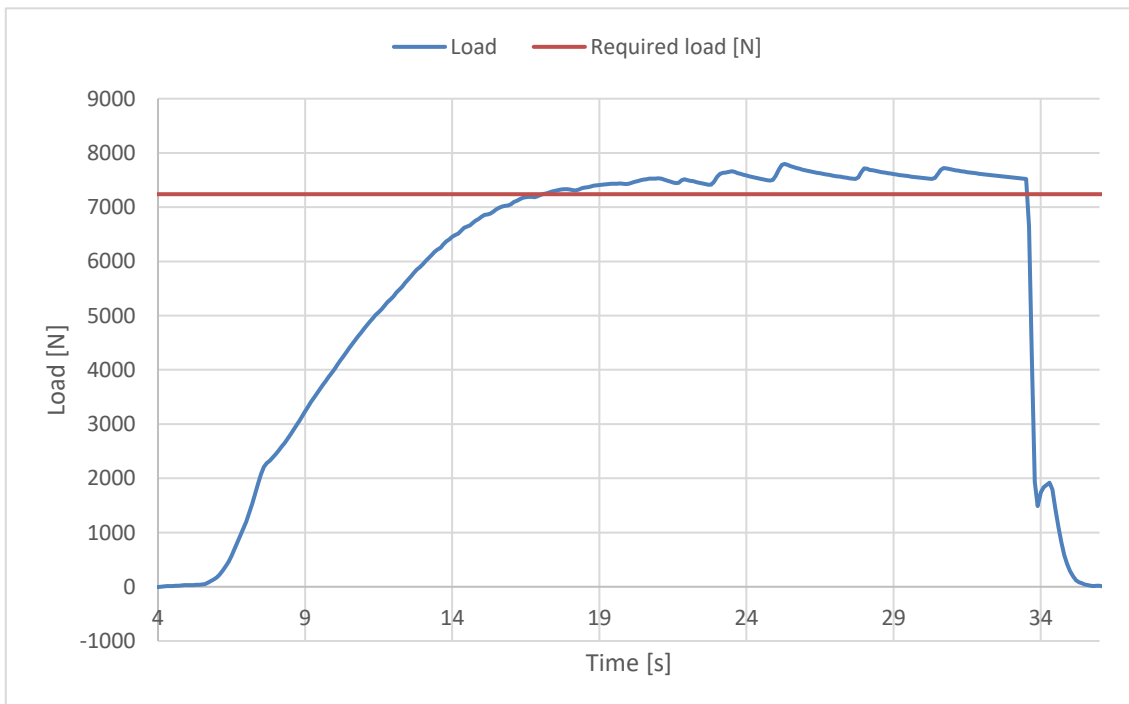
Test ID 02

Standard	EN 1651:1999
Reference	5.3.2.1
Test setup	Default flying position
Attachment points	Both main riser attachment (3,4)
Anchor points	Dummy (B1, B2)
Required load [g]	6
Required load [N]	7200
Minimum test duration [s]	10
Result	
Test duration [s]	16.5
Any signs of structural failure	No
Test results	POSITIVE

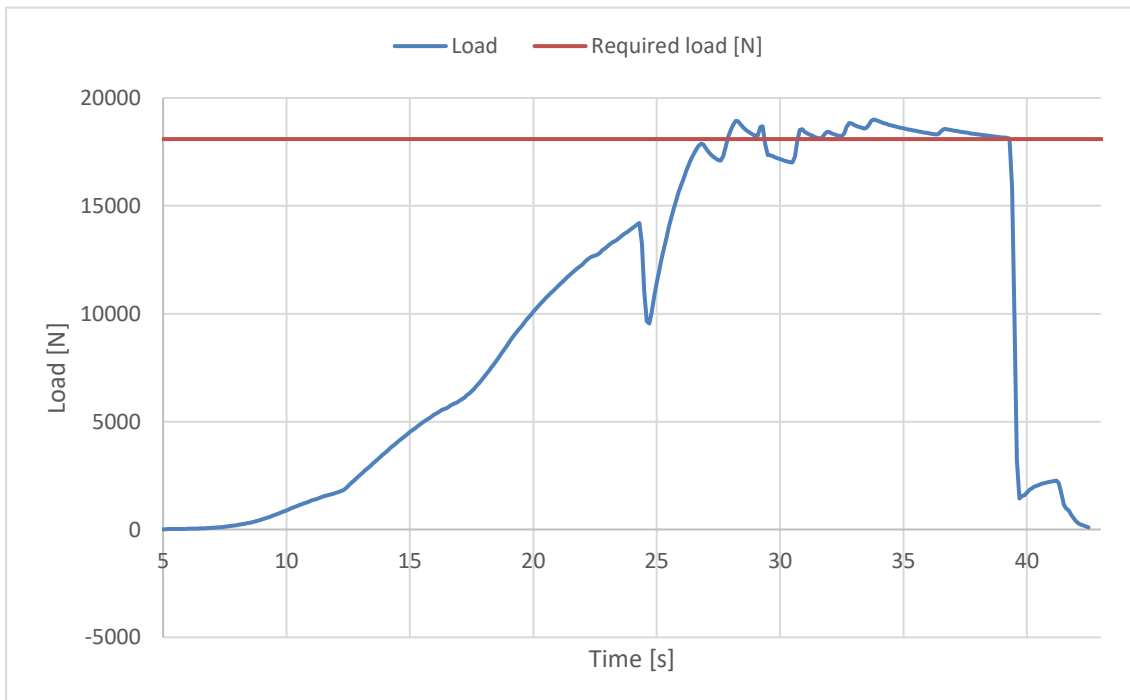
Test ID 03

Standard **EN 1651:1999**
 Reference **5.3.2.2**
 Test setup **Default flying position**
 Attachment points **Both main riser attachment (3,4)**
 Anchor points **Dummy (B1, B2)**

Test duration [s] **8.6**
 Any signs of structural failure **No**
 Test results **POSITIVE**

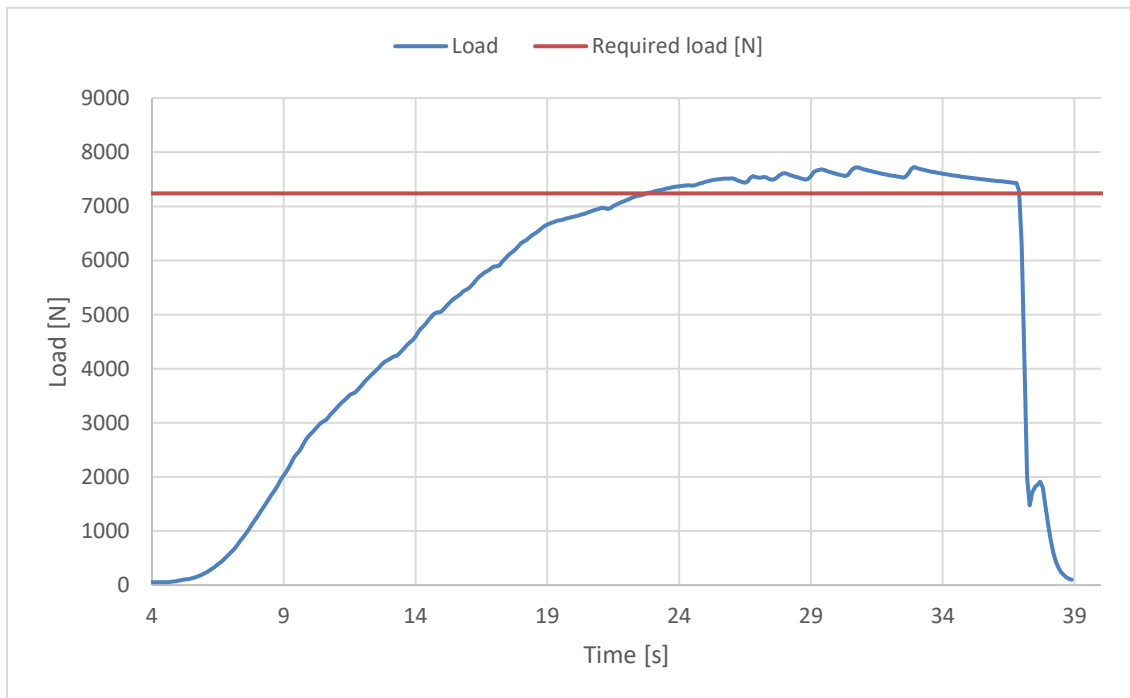
Test ID 04

Standard **EN 1651:1999**
 Reference **5.3.2.3**
 Test setup **Asymmetric, one riser**
 Attachment points **One main riser attachment (3)**
 Anchor points **Dummy (B1,B2)**

Test duration [s] **14.2**
 Any signs of structural failure **No**
 Test results **POSITIVE**

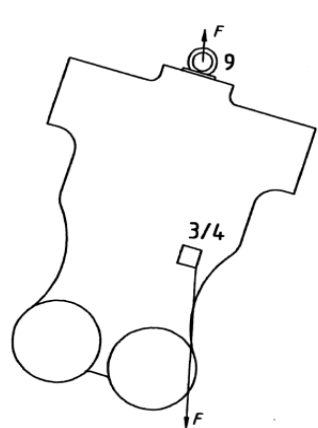
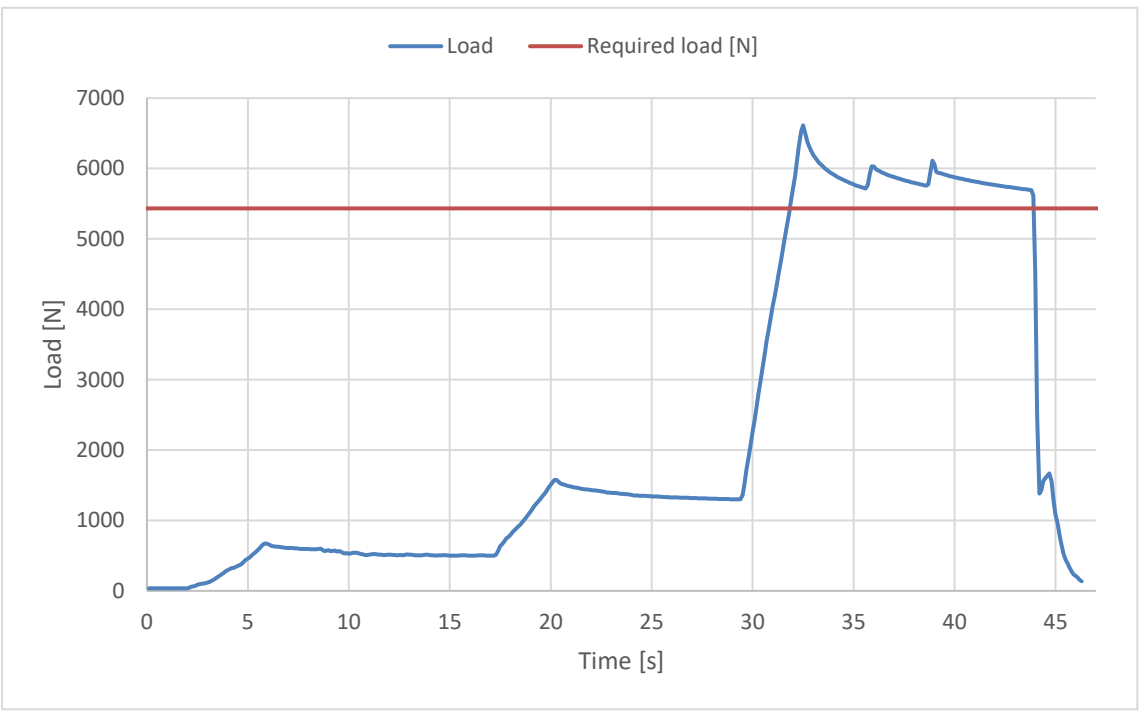
Test ID 07

Reference	5.3.2.6	
Test setup	Asymmetric, negative	
Attachment points	One main riser attachment (3 or 4) downwards	
Anchor points	Dummy (9)	
Required load [g]	4.5	
Required load [N]	5400	
Minimum test duration [s]	10	
Result		
Test duration [s]	12.1	
Any signs of structural failure	No	
Test results	POSITIVE

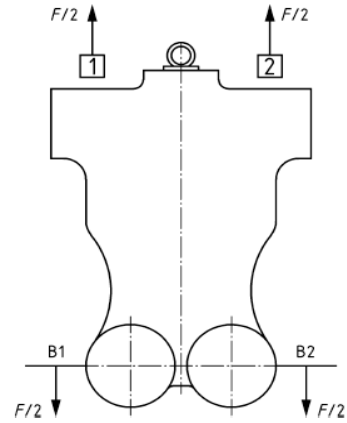
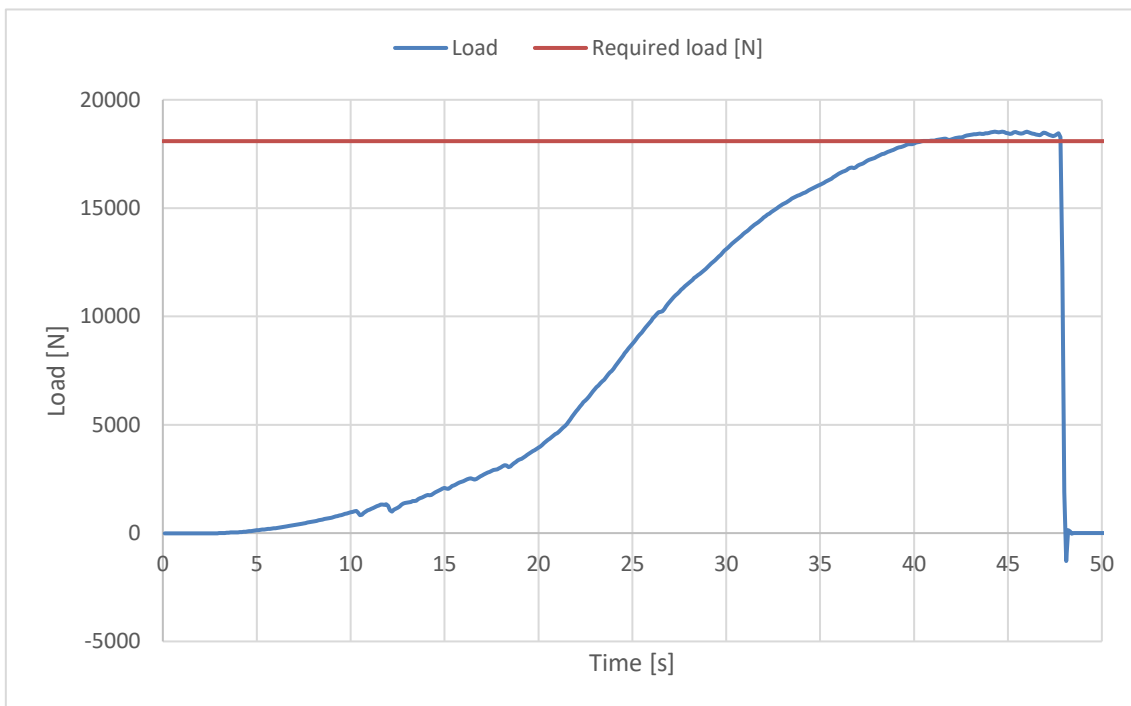
Test ID 09

Standard **EN 1651:1999**
 Reference **5.3.2.4**
 Test setup **Rescue attachments**
 Attachment points **Rescue riser attachment (1,2)**
 Anchor points **Dummy (B1,B2)**

Test duration [s] **7.4**
 Any signs of structural failure **No**
 Test results **POSITIVE**

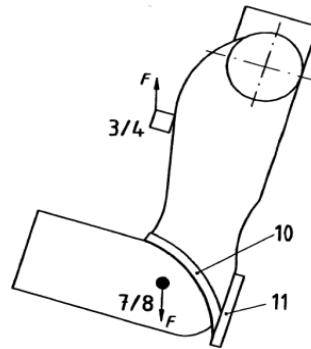
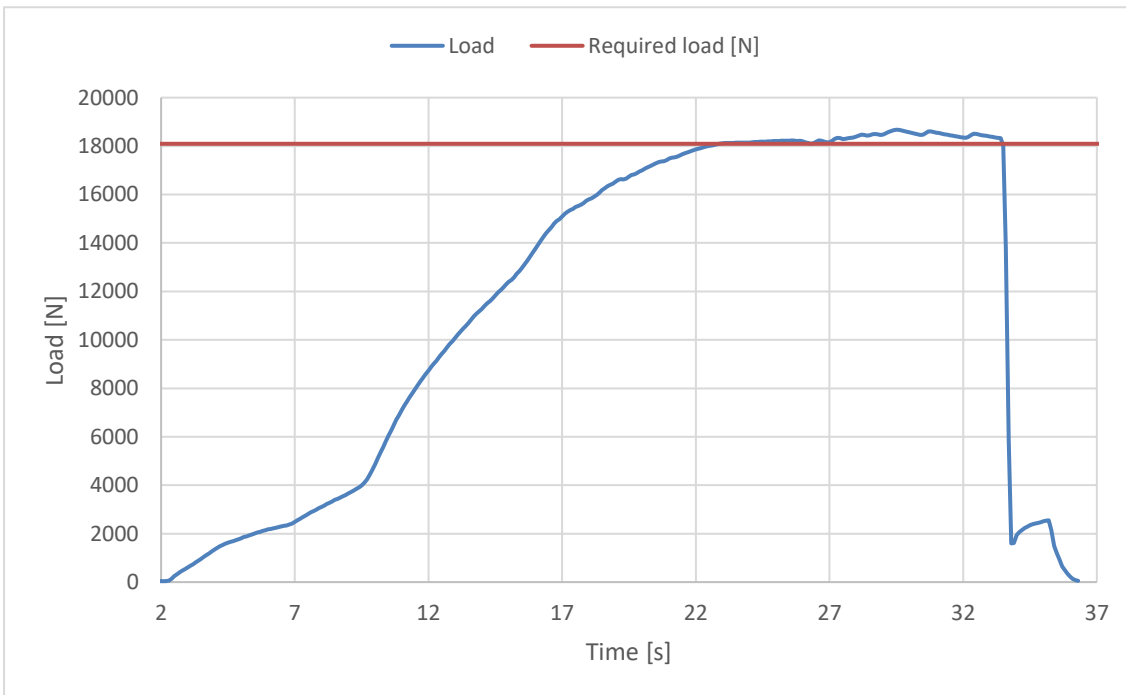
Test ID 13

Standard **EN 1651:1999**
 Reference **5.3.2.7**
 Test setup **Flying position before landing**
 Attachment points **Both main riser attachment (3,4)**
 Anchor points **Dummy (7,8)**

Test duration [s] **10.6**
 Any signs of structural failure **No**
 Test results **POSITIVE**

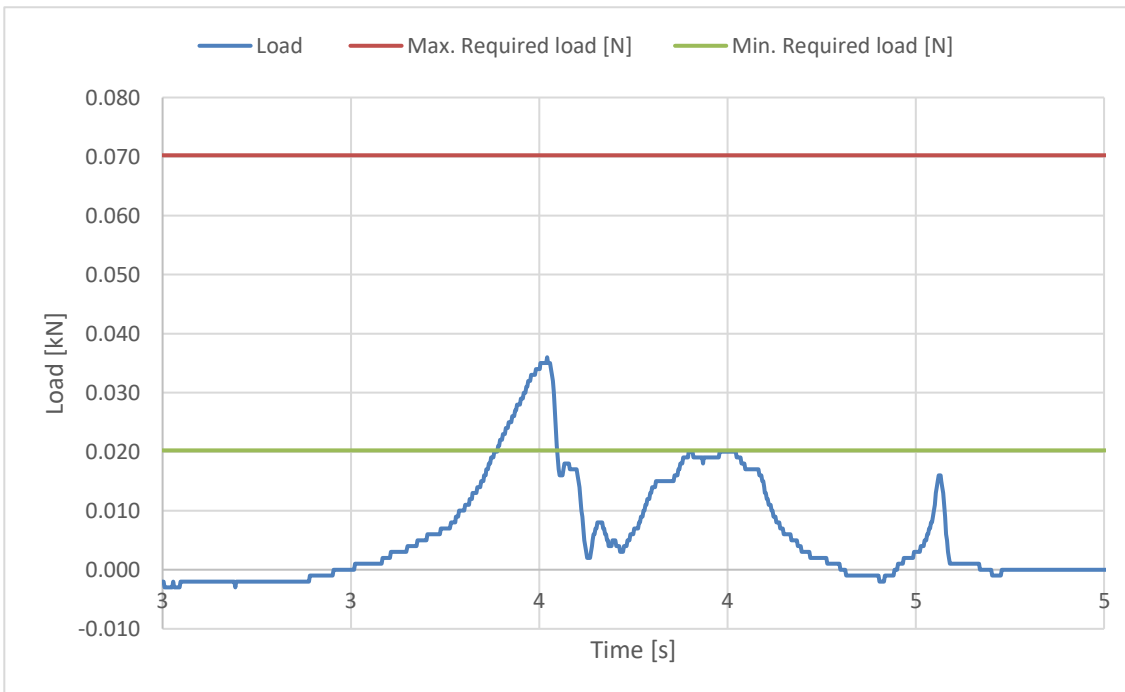
Test ID RRDT

Standard	NfL 2-565-20
Reference	6.1.5
Test setup	Default flying position
Attachment points	Sensor connect to handle, and pull in opening direction
	The test is to simulate the load required to open the emergency parachute(1st action).
Min. Required load [N]	20
Max. Required load [N]	70
Result	
Load for first action [N]	35.76
Test results	POSITIVE

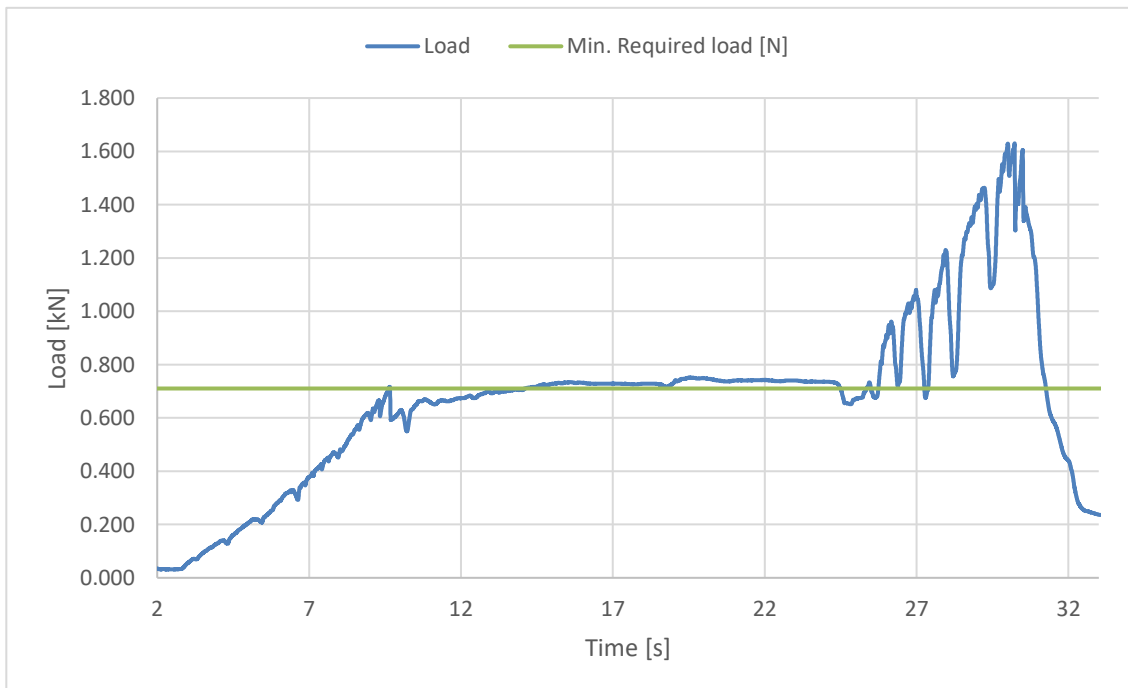
Test ID RRST

Standard	EN 12491
Reference in standard	5.3.2
Test setup	Two end points of handle
Attachment points	Sensor connect to end of handle, pull on the other side
	The handle must support min 700 N for 10 s, after measure breaking strength
Min. Required load [N]	700
Minimum test duration [s]	10
Result	
Test duration [s]:	10.4
Breaking strength [N]	1620.17
Test results	POSITIVE
