Harness Structural test Report - LTF

Inspection certificate number: **PH_296.2020**

Name: **Minimax3**
 Type: **ABS**
 Size: **Unique**
 Serial number: **MM3-V-V1.6**
 Impact pad type: ⁽¹⁾ **Airbag**
 Clip-in weight [kg]: **120**

Harness Structural test

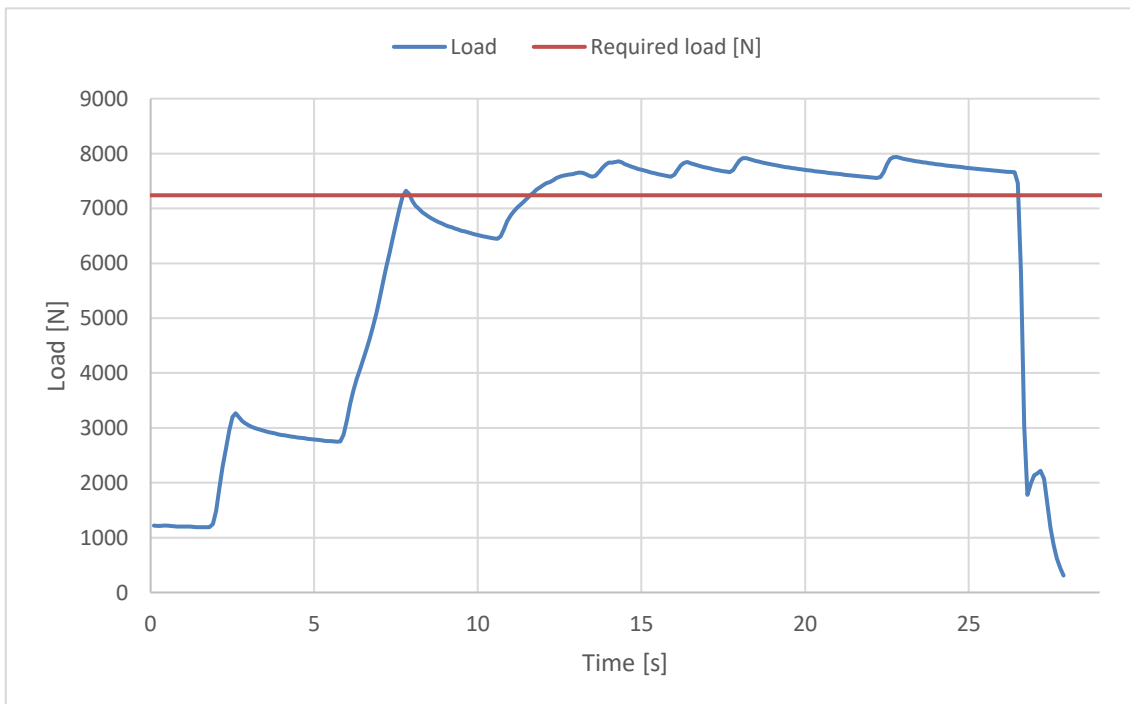
Test ID 02

Test duration [s] **14.9**
 Any signs of structural failure **No**
 Test results **POSITIVE**

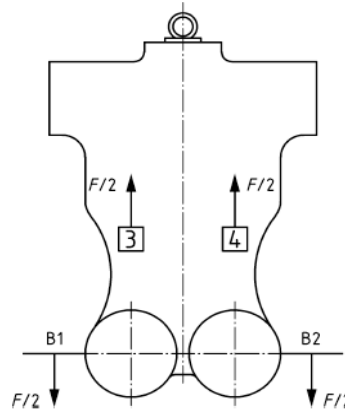
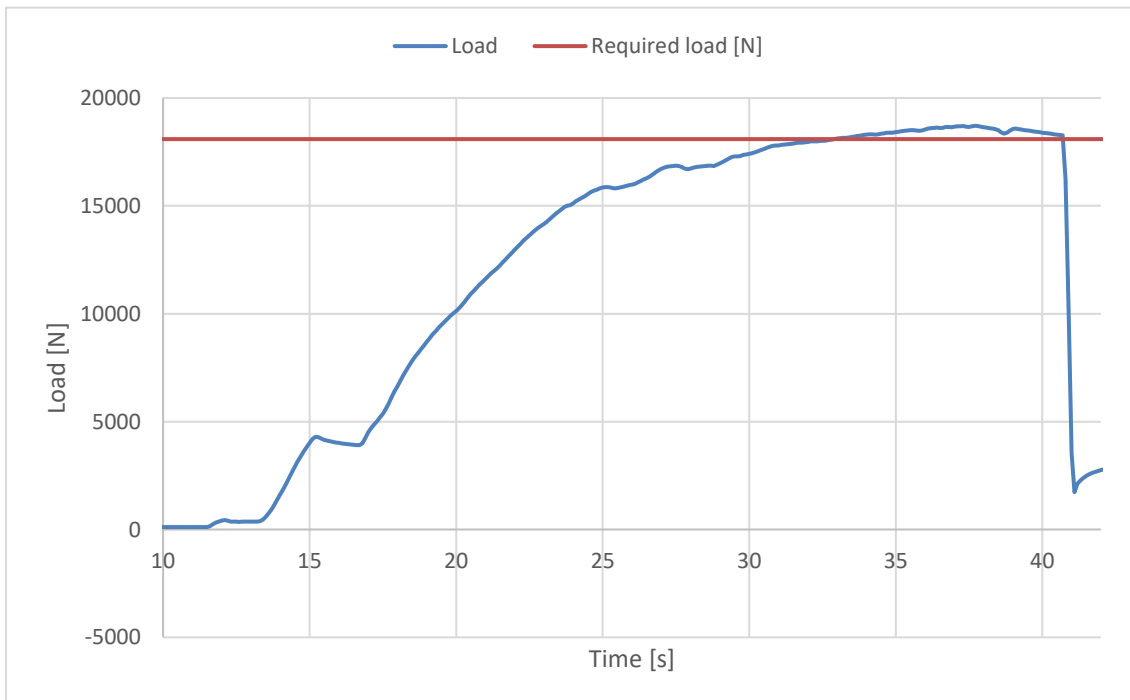
Test ID 03

Test duration [s] **7.8**
 Any signs of structural failure **No**
 Test results **POSITIVE**

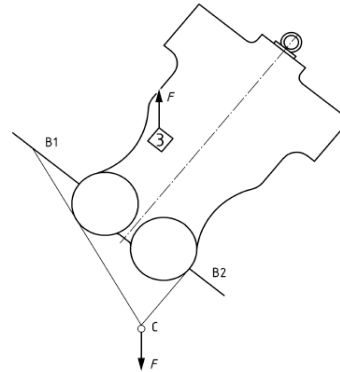
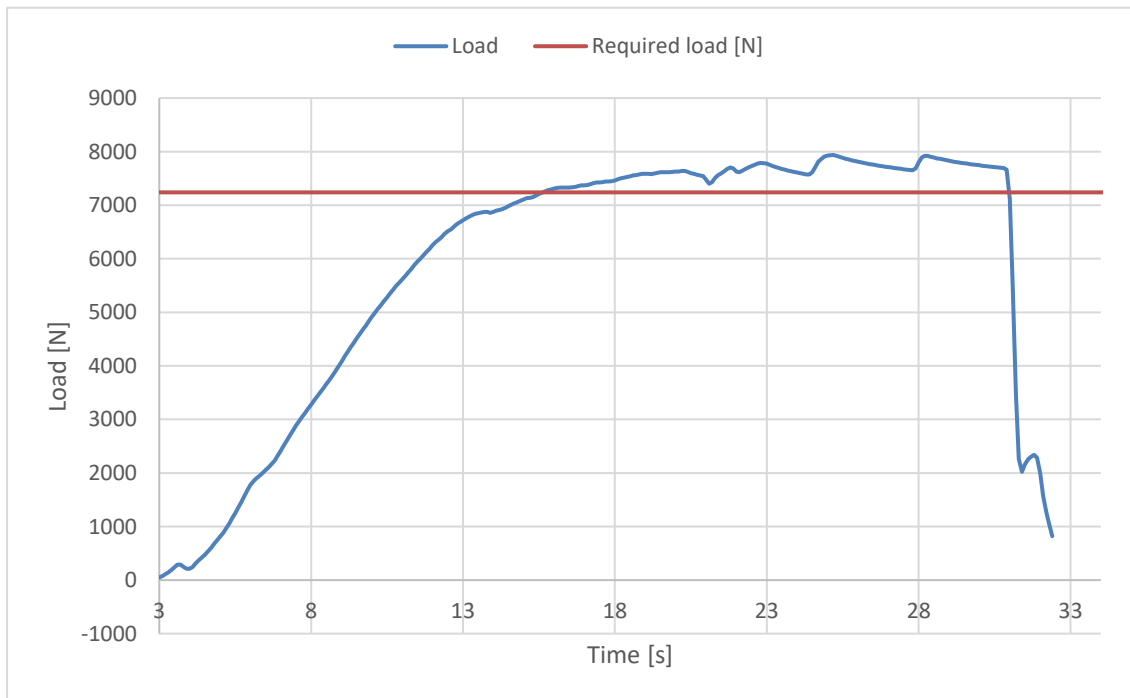
Test ID 04

Test duration [s] **15.3**
 Any signs of structural failure **No**
 Test results **POSITIVE**

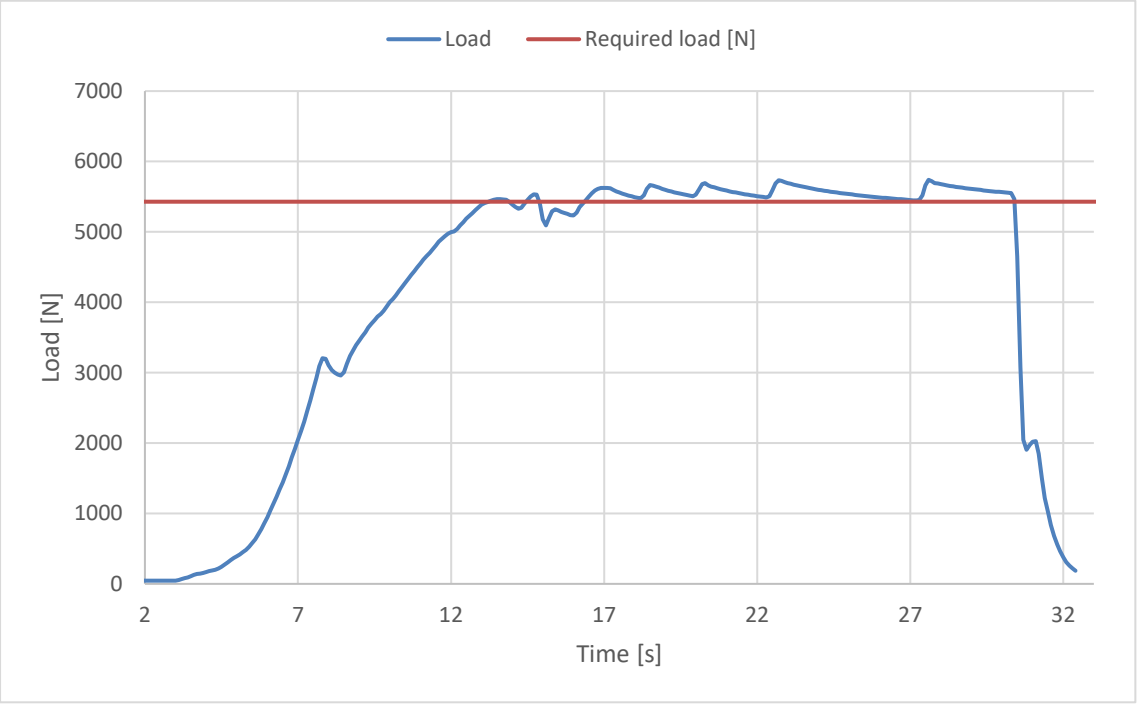
Test ID 07

Reference	5.3.2.6	
Test setup	Asymmetric, negative	
Attachment points	One main riser attachment (3 or 4) downwards	
Anchor points	Dummy (9)	
Required load [g]	4.5	
Required load [N]	5400	
Minimum test duration [s]	10	
Result		
Test duration [s]	14.1	
Any signs of structural failure	No	
Test results	POSITIVE

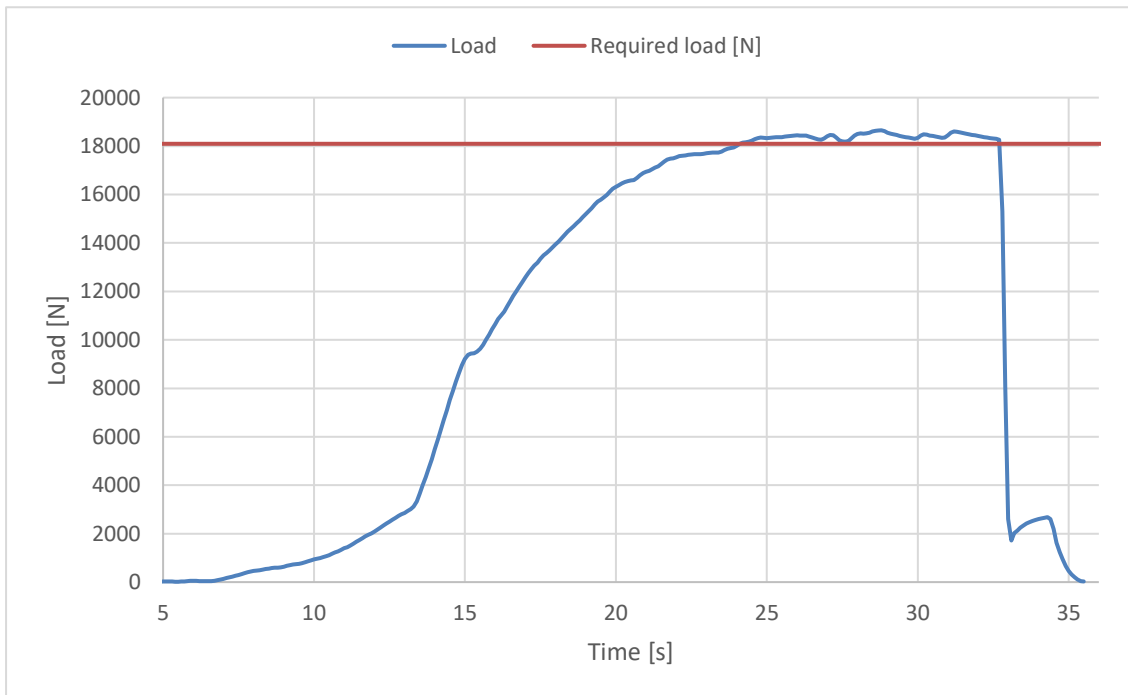
Test ID 13

Test duration [s] **8.6**
 Any signs of structural failure **No**
 Test results **POSITIVE**
