# Harness Structural test Report - EN

Inspection certificate number: **PH\_412.2023**

Name: **PAP LIGHT**  
 Type: **ABS**  
 Size: **M**  
 Serial number: **2173MM0508RO**  
 Impact pad type: <sup>(1)</sup> **Airbag**  
 Clip-in weight [kg]: **120**

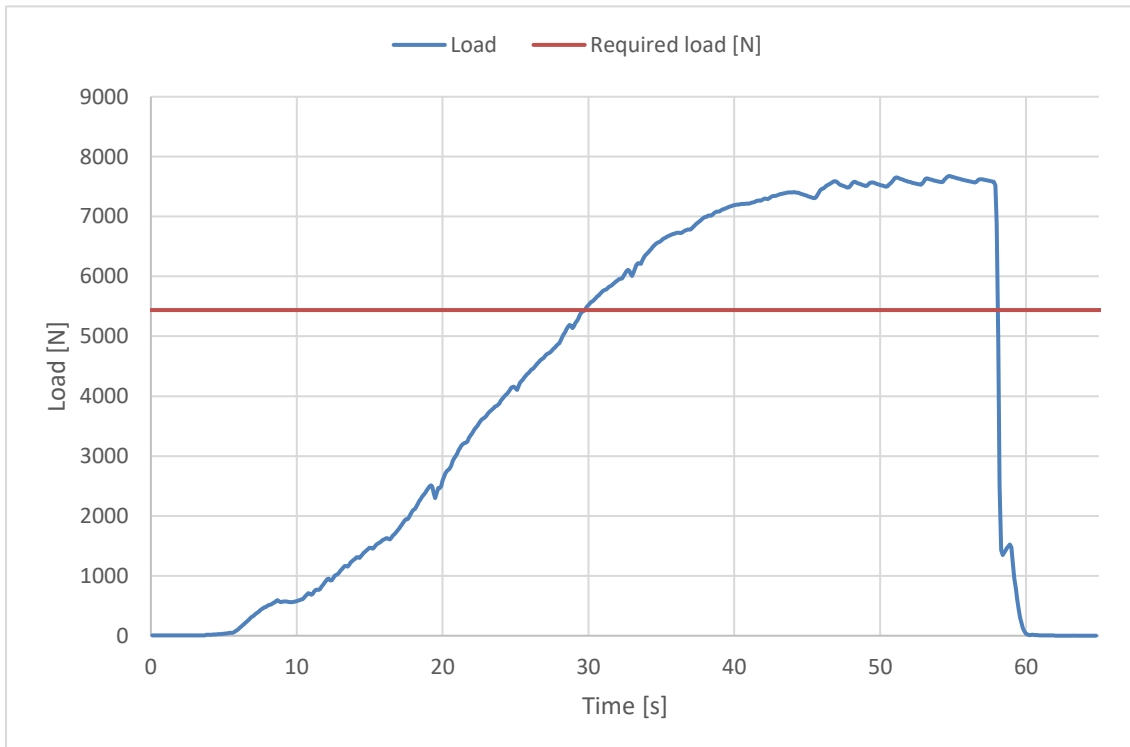
**Test ID 01**

Standard **EN 1651**  
 Reference in standard **5.5.1.1**  
 Test setup **Positive symmetric load (Slippage)**  
 Attachment points **Both main riser attachment (3,4)**  
 Anchor points **Dummy (B1, B2)**

Test duration [s] **28.3**  
 Any signs of structural failure **No**  
 Slippery test OK **Yes**  
 Test results **POSITIVE**

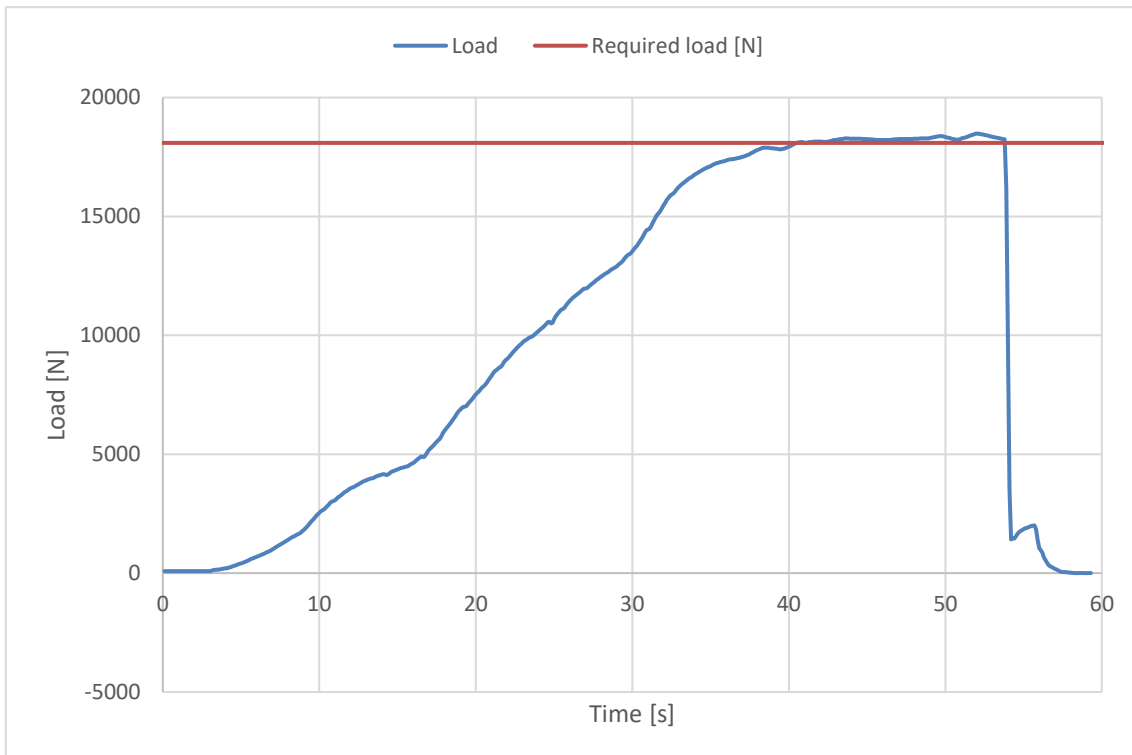
**Test ID 03**

Standard **EN 1651**  
 Reference in standard **5.5.1.1b**  
 Test setup **Positive symmetric load**  
 Attachment points **Both main riser attachment (3,4)**  
 Anchor points **Dummy (B1, B2)**

Test duration [s] **13.3**  
 Any signs of structural failure **No**  
 Slippery test OK **Yes**  
 Test results **POSITIVE**

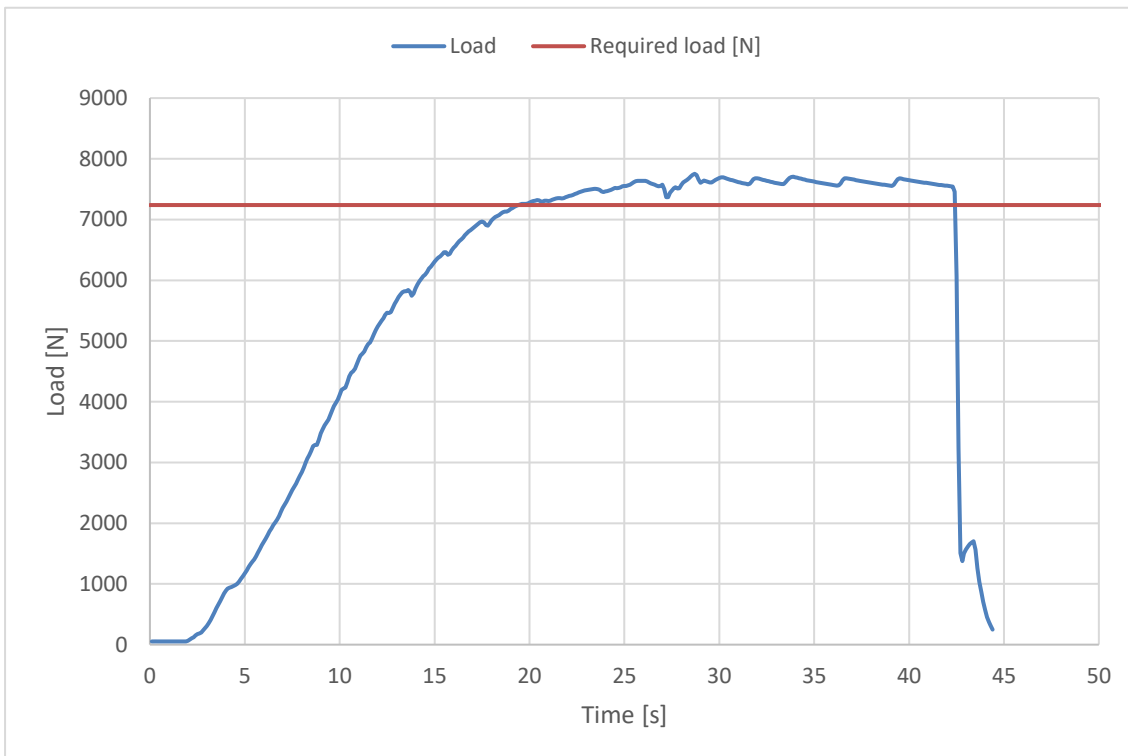
**Test ID 05**

Standard	<b>EN 1651</b>
Reference in standard	<b>5.5.1.2</b>
Test setup	<b>Positive asymmetric load</b>
Attachment points	<b>One riser attachment (3 or 4)</b>
Anchor points	<b>Dummy (C)</b>
Required load [g]	<b>6</b>
Required load [N]	<b>7200</b>
Minimum test duration [s]	<b>5</b>
<b>Result</b>	
Test duration [s]	<b>23</b>
Any signs of structural failure	<b>No</b>
Test results	<b>POSITIVE</b>

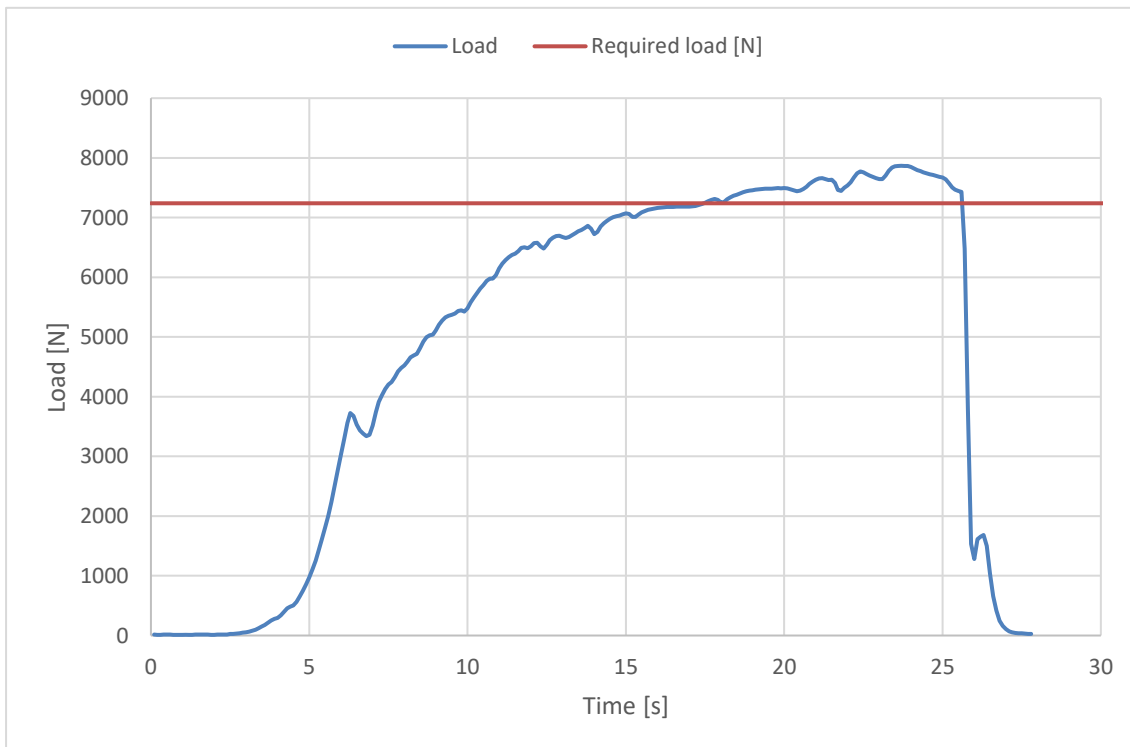
**Test ID 06**

Standard	<b>EN 1651</b>
Reference in standard	<b>5.5.1.6</b>
Test setup	<b>Negative symmetric load</b>
Attachment points	<b>Both main riser attachment (3,4)</b>
Anchor points	<b>Dummy (A)</b>
Required load [g]	<b>6</b>
Required load [N]	<b>7200</b>
Minimum test duration [s]	<b>5</b>
<b>Result</b>	
Test duration [s]	<b>8.2</b>
Any signs of structural failure	<b>No</b>
Test results	<b>POSITIVE</b>

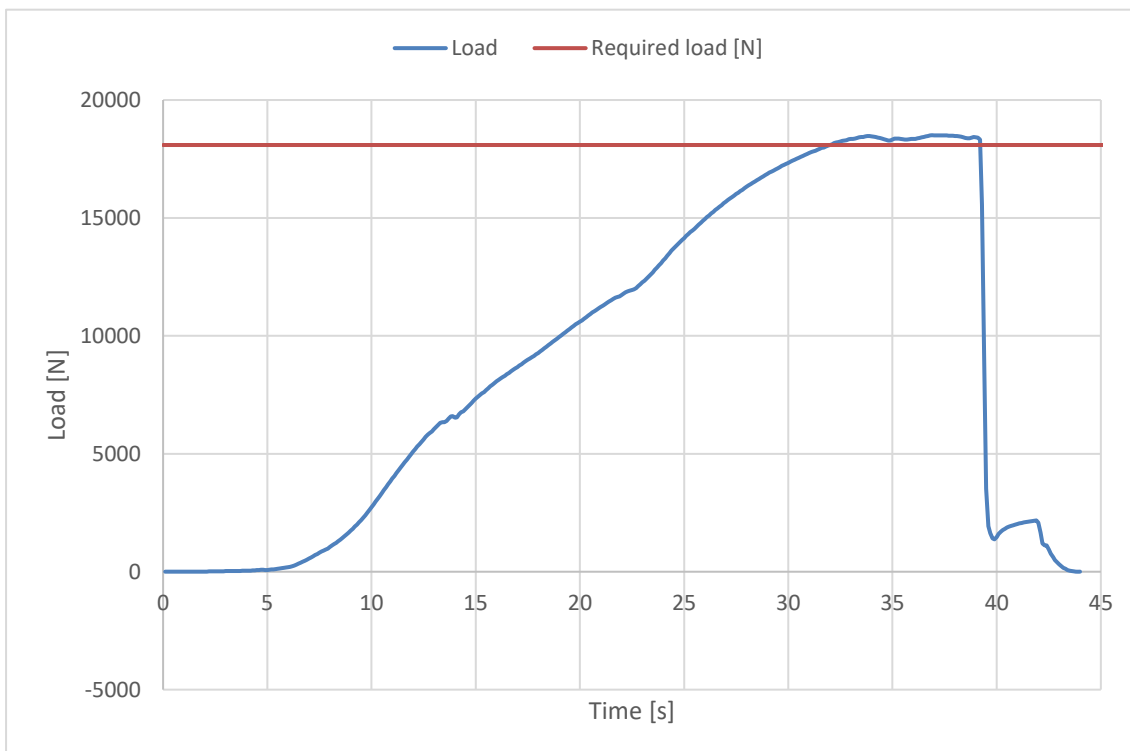
**Test ID 09**

Standard	<b>EN 1651</b>
Reference in standard	<b>5.5.1.3</b>
Test setup	<b>Positive symmetric load rescue points</b>
Attachment points	<b>Both main riser attachment (1,2)</b>
Anchor points	<b>Dummy (B1,B2)</b>
Required load [g]	<b>15</b>
Required load [N]	<b>18000</b>
Minimum test duration [s]	<b>5</b>
<b>Result</b>	
Test duration [s]	<b>7.3</b>
Any signs of structural failure	<b>No</b>
Slippery test OK	<b>Yes</b>
Test results	<b>POSITIVE</b>

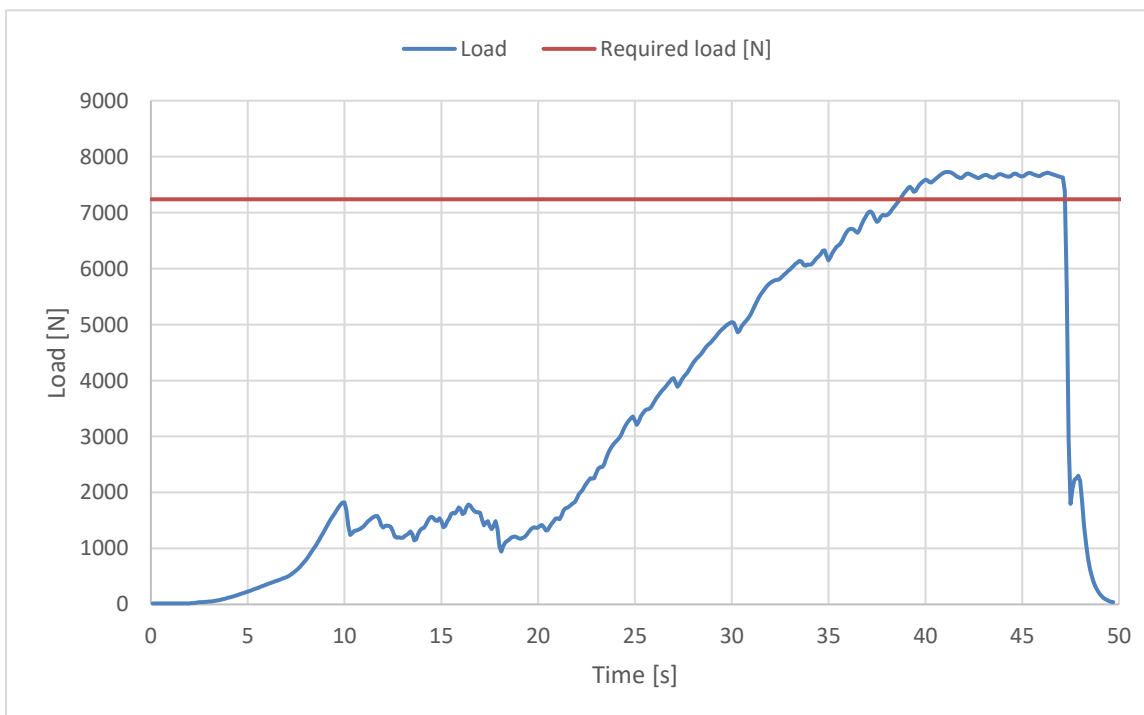
**Test ID 12**

Standard	<b>EN 1651</b>
Reference in standard	<b>5.5.1.7</b>
Test setup	<b>Upright (landing) position load</b>
Attachment points	<b>Both main riser attachment (3, 4)</b>
Anchor points	<b>Both legstrap of harness (no dummy)</b>
Required load [g]	<b>6</b>
Required load [N]	<b>7200</b>
Minimum test duration [s]	<b>5</b>
Harness type	<b>type a</b>
<b>Result</b>	
Test duration [s]	<b>8.6</b>
Any signs of structural failure	<b>No</b>
Slippery test OK	<b>Yes</b>
Test results	<b>POSITIVE</b>
