Harness Structural test Report - NfL

Inspection certificate number: **PH_412.2023**

Name: **PAP LIGHT**
 Type: **ABS**
 Size: **M**
 Serial number: **2173MM0508RO**
 Impact pad type: ⁽¹⁾ **Airbag**
 Clip-in weight [kg]: **120**
 Integrated container: **No**
 Date of test: **23.05.2023**

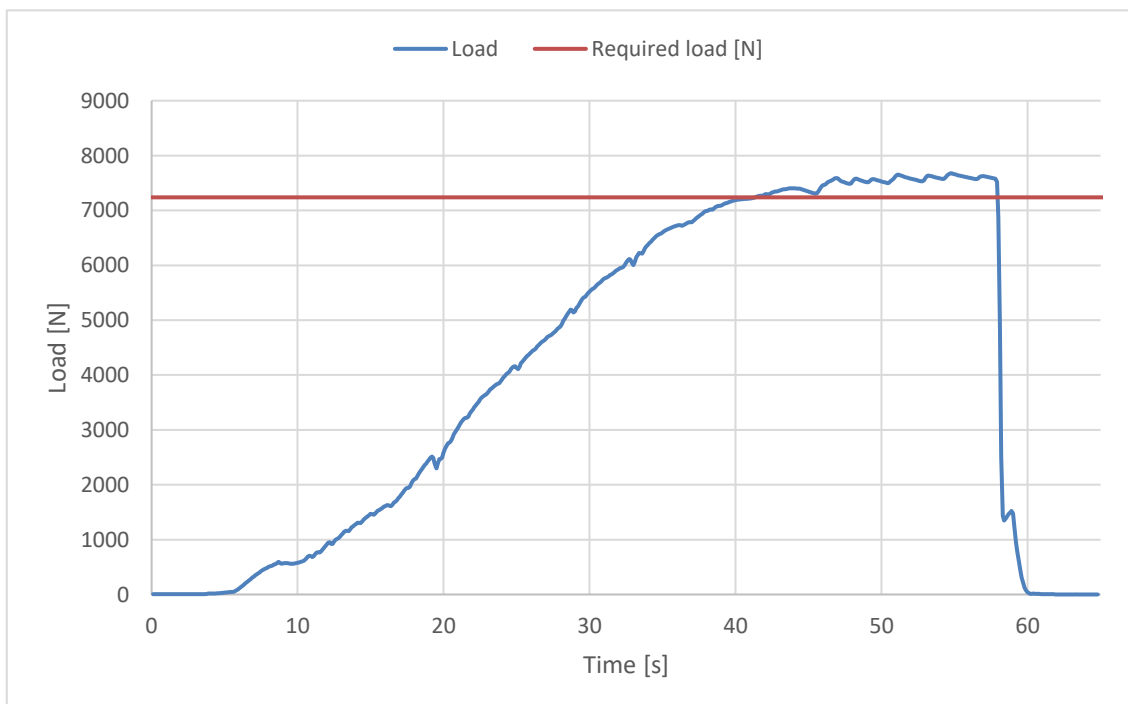
Test ID 02

Standard	EN 1651:1999
Reference	5.3.2.1
Test setup	Default flying position
Attachment points	Both main riser attachment (3,4)
Anchor points	Dummy (B1, B2)
Required load [g]	6
Required load [N]	7200
Minimum test duration [s]	10
Result	
Test duration [s]	16.6
Any signs of structural failure	No
Test results	POSITIVE

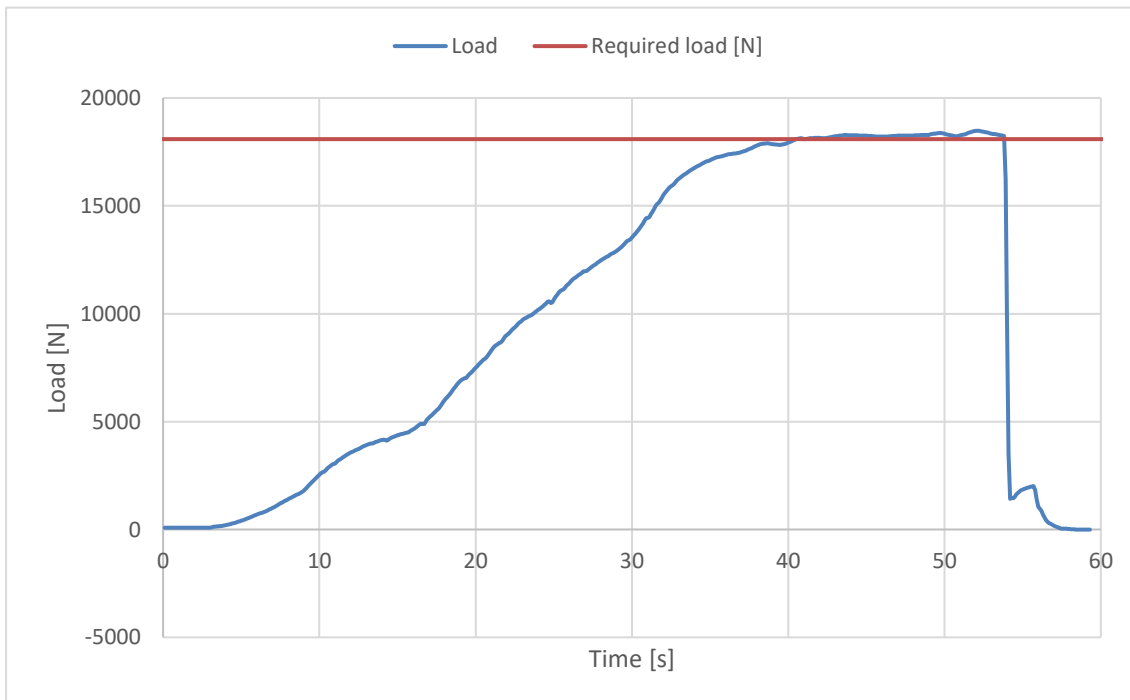
Test ID 03

Reference	5.3.2.2	
Test setup	Default flying position	
Attachment points	Both main riser attachment (3,4)	
Anchor points	Dummy (B1, B2)	
Required load [g]	15	
Required load [N]	18000	
Minimum test duration [s]	5	
Result		
Test duration [s]	13.3	
Any signs of structural failure	No	
Test results	POSITIVE

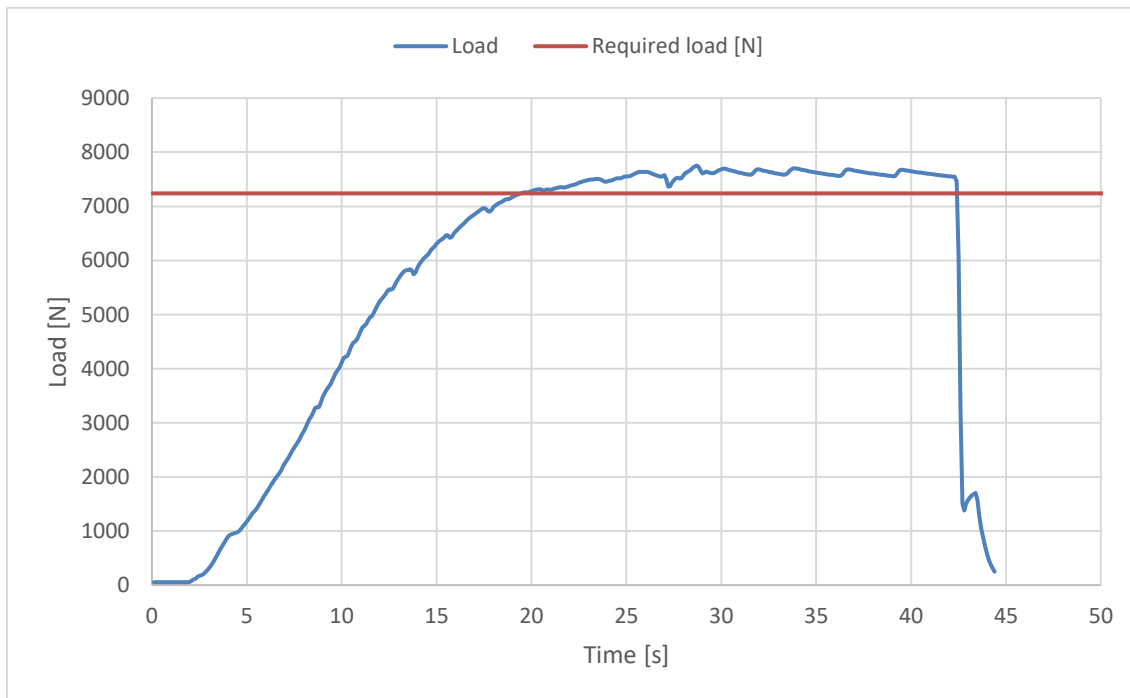
Test ID 04

Standard **EN 1651:1999**
 Reference **5.3.2.3**
 Test setup **Asymmetric, one riser**
 Attachment points **One main riser attachment (3)**
 Anchor points **Dummy (B1,B2)**

Test duration [s] **23**
 Any signs of structural failure **No**
 Test results **POSITIVE**

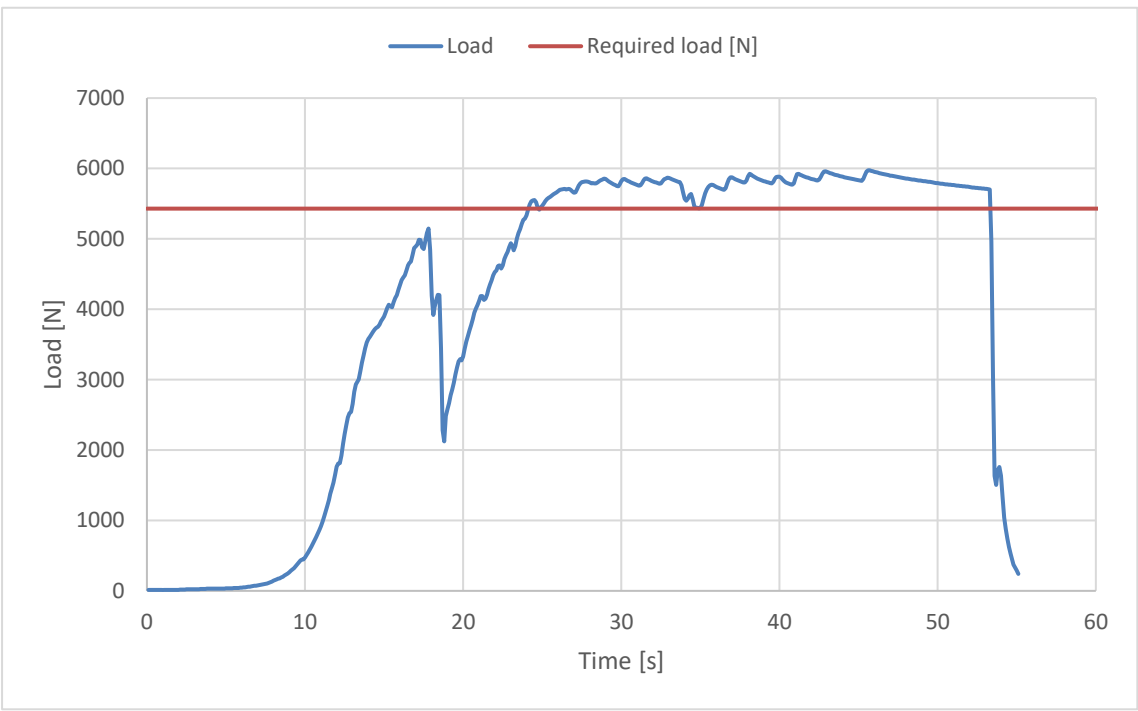
Test ID 07

Reference	5.3.2.6	
Test setup	Asymmetric, negative	
Attachment points	One main riser attachment (3 or 4) downwards	
Anchor points	Dummy (9)	
Required load [g]	4.5	
Required load [N]	5400	
Minimum test duration [s]	10	
Result		
Test duration [s]	28.5	
Any signs of structural failure	No	
Test results	POSITIVE

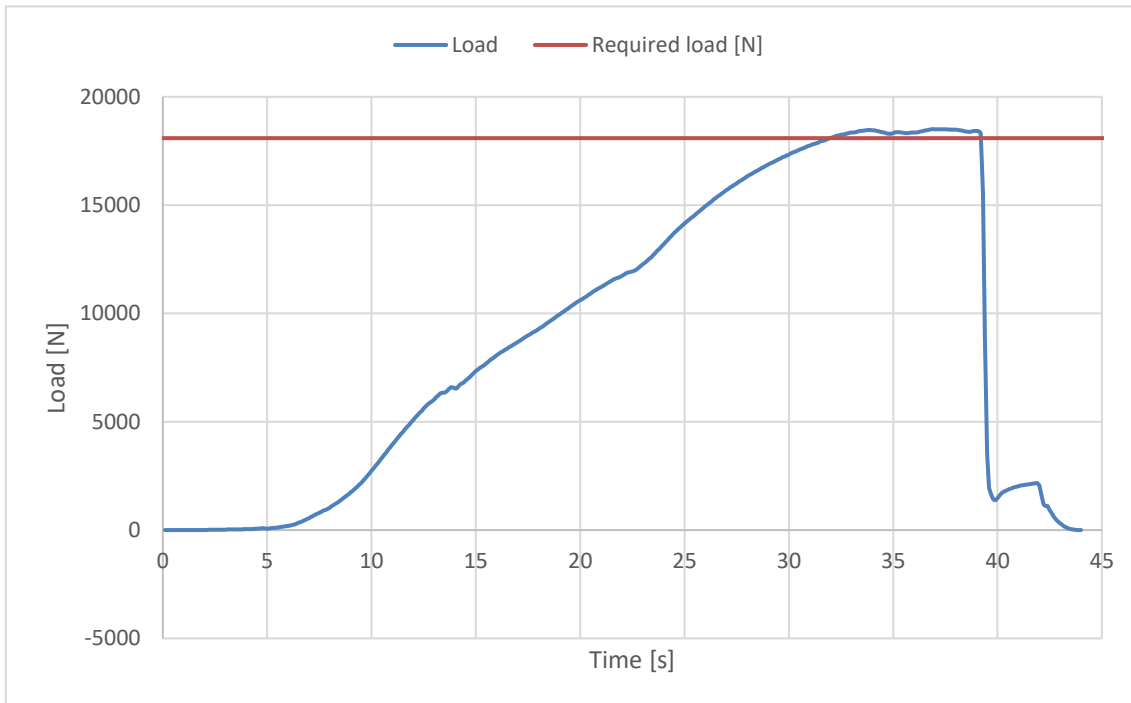
Test ID 09

Reference	5.3.2.4	
Test setup	Rescue attachments	
Attachment points	Rescue riser attachment (1,2)	
Anchor points	Dummy (B1,B2)	
Required load [g]	15	
Required load [N]	18000	
Minimum test duration [s]	5	
Result		
Test duration [s]	7.3	
Any signs of structural failure	No	
Test results	POSITIVE

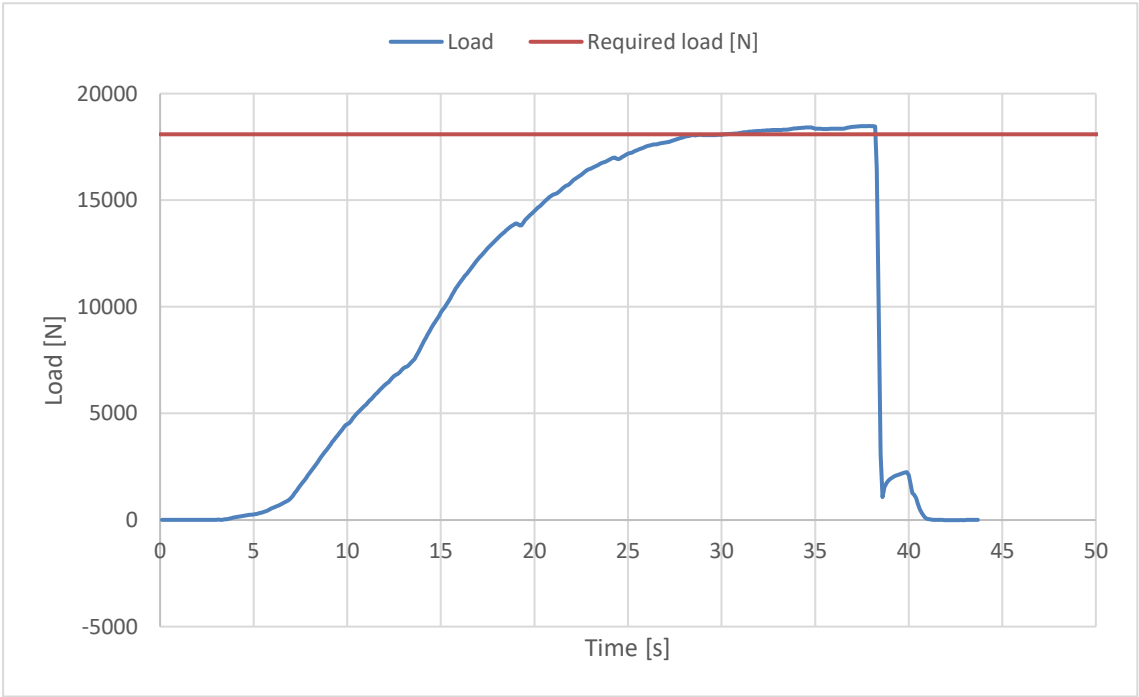
Test ID 13

Standard	EN 1651:1999
Reference	5.3.2.7
Test setup	Flying position before landing
Attachment points	Both main riser attachment (3,4)
Anchor points	Dummy (7,8)
Required load [g]	15
Required load [N]	18000
Minimum test duration [s]	5
Result	
Test duration [s]	8
Any signs of structural failure	No
Test results	POSITIVE
