Harness Structural test Report - NfL

Inspection certificate number: **PH_447.2024**

Name: **THRONE**
 Type: **ABS**
 Size: **M**
 Serial number: **096 0014 0002**
 Impact pad type: ⁽¹⁾ **Airbag**
 Clip-in weight [kg]: **120**
 Integrated container: **Yes**
 Date of test: **17.09.2019**

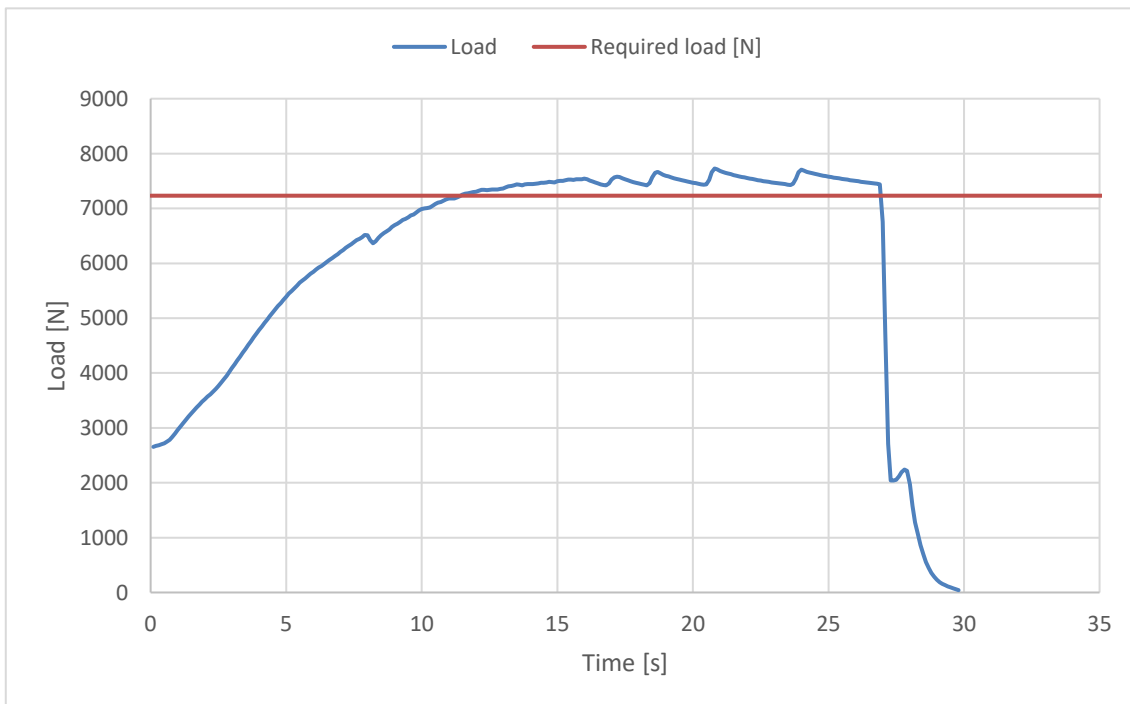
Test ID 02

Standard	EN 1651:1999
Reference	5.3.2.1
Test setup	Default flying position
Attachment points	Both main riser attachment (3,4)
Anchor points	Dummy (B1, B2)
Required load [g]	6
Required load [N]	7200
Minimum test duration [s]	10
Result	
Test duration [s]	15.5
Any signs of structural failure	No
Test results	POSITIVE

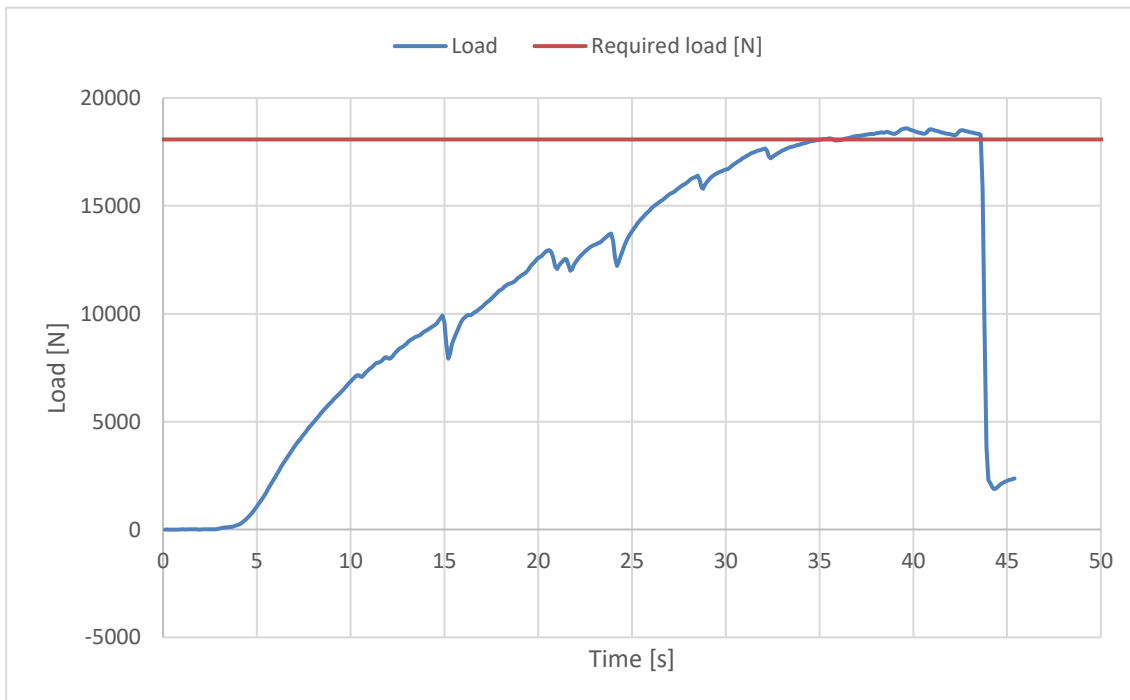
Test ID 03

Test duration [s] **7.4**
 Any signs of structural failure **No**
 Test results **POSITIVE**

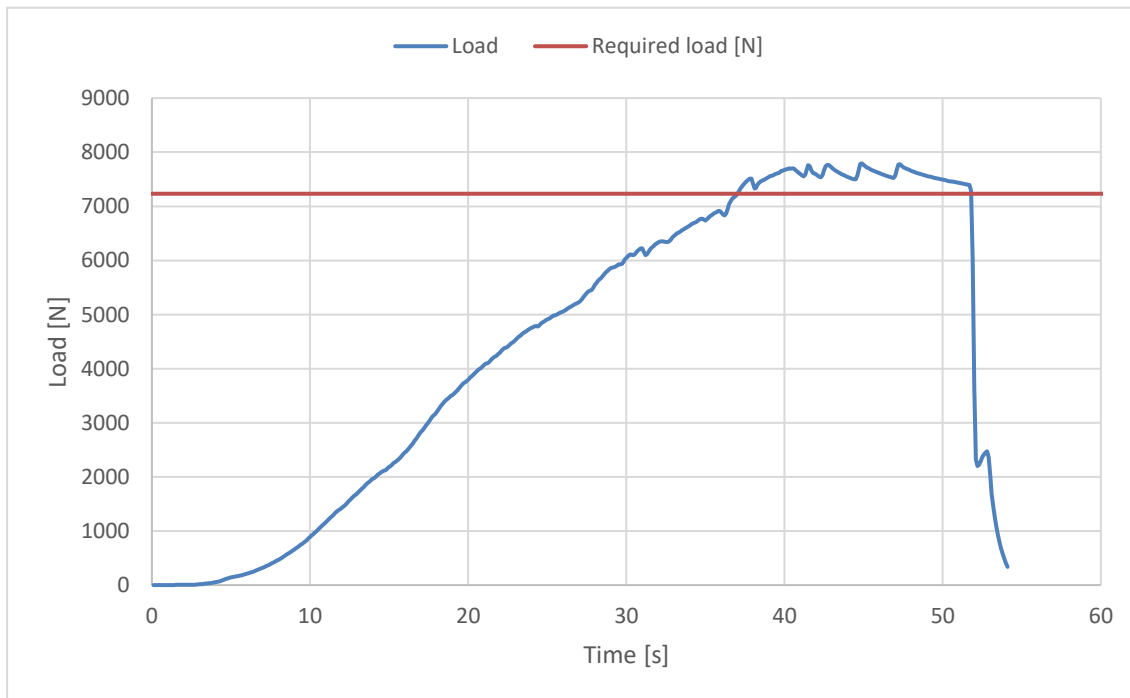
Test ID 04

Standard	EN 1651:1999
Reference	5.3.2.3
Test setup	Asymmetric, one riser
Attachment points	One main riser attachment (3)
Anchor points	Dummy (B1,B2)
Required load [g]	6
Required load [N]	7200
Minimum test duration [s]	10
Result	
Test duration [s]	14.8
Any signs of structural failure	No
Test results	POSITIVE

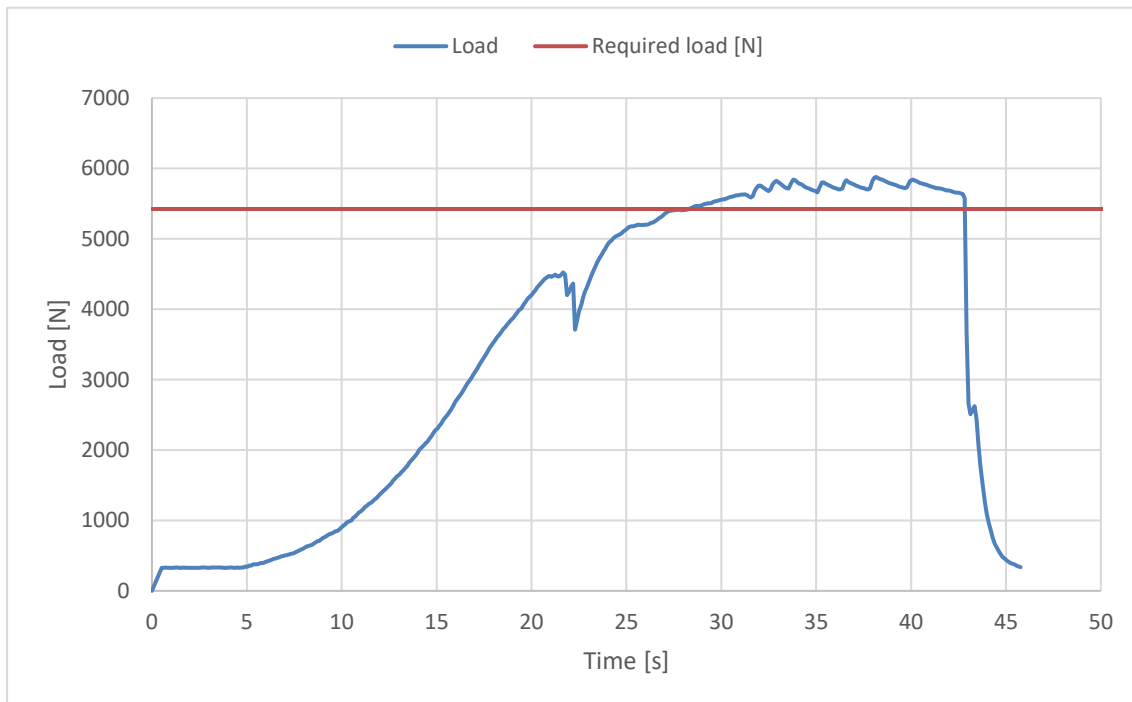
Test ID 07

Reference	5.3.2.6	
Test setup	Asymmetric, negative	
Attachment points	One main riser attachment (3 or 4) downwards	
Anchor points	Dummy (9)	
Required load [g]	4.5	
Required load [N]	5400	
Minimum test duration [s]	10	
Result		
Test duration [s]	13.7	
Any signs of structural failure	No	
Test results	POSITIVE

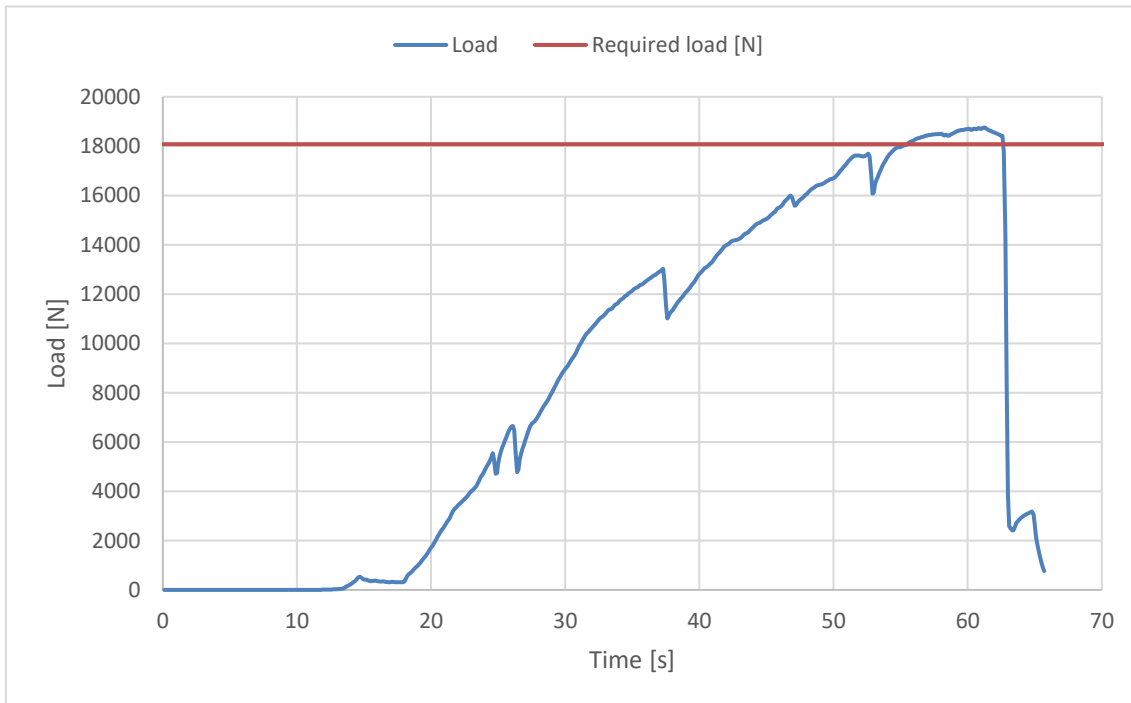
Test ID 09

Test duration [s] **7.2**
 Any signs of structural failure **No**
 Test results **POSITIVE**

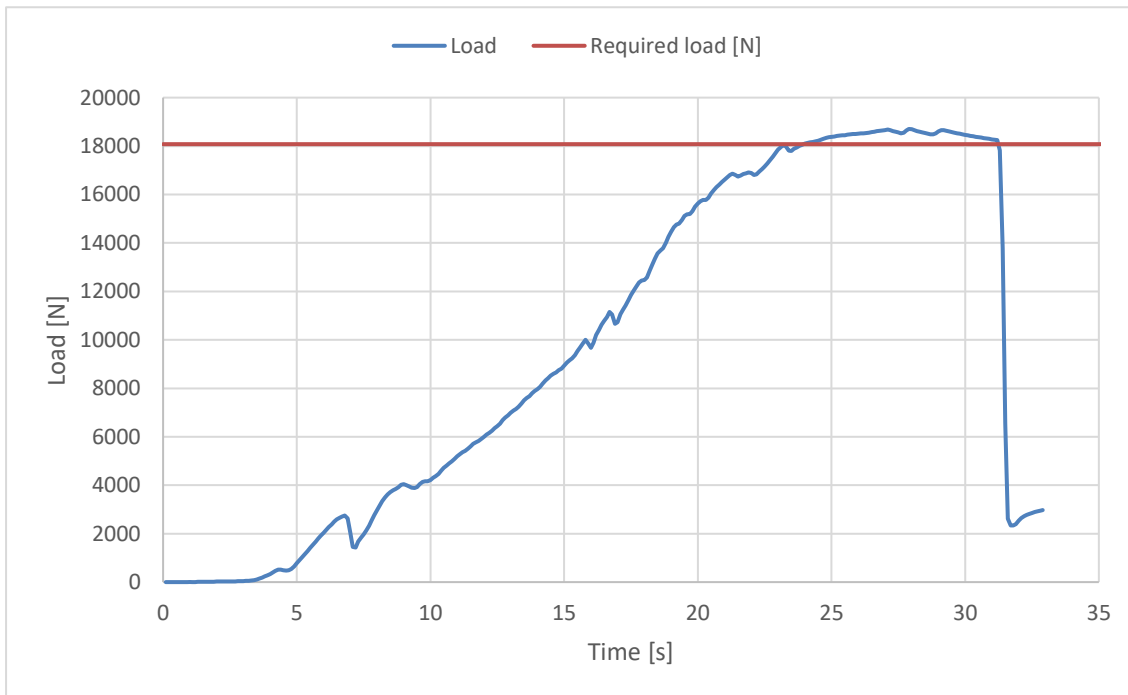
Test ID 13

Test duration [s] **7.3**
 Any signs of structural failure **No**
 Test results **POSITIVE**

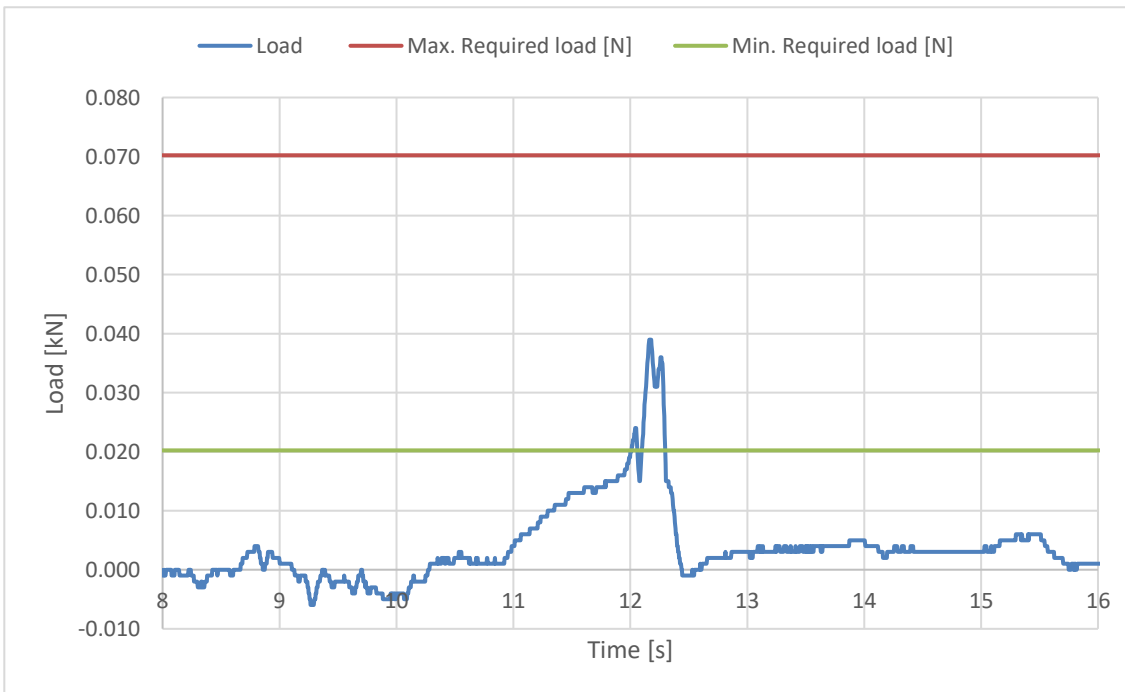
Test ID RRDT

Standard	NfL 2-565-20
Reference	6.1.5
Test setup	Default flying position
Attachment points	Sensor connect to handle, and pull in opening direction
	The test is to simulate the load required to open the emergency parachute(1st action).
Min. Required load [N]	20
Max. Required load [N]	70
Result	
Load for first action [N]	38.80
Test results	POSITIVE

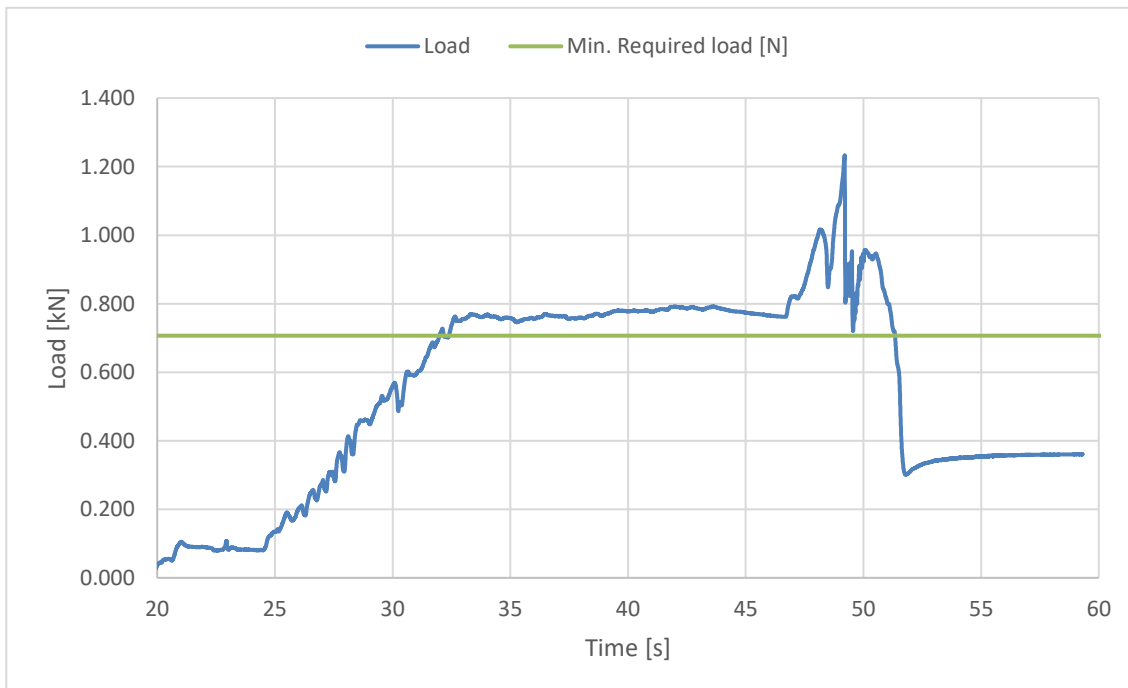
Test ID RRST

Standard	EN 12491
Reference in standard	5.3.2
Test setup	Two end points of handle
Attachment points	Sensor connect to end of handle, pull on the other side
	The handle must support min 700 N for 10 s, after measure breaking strength
Min. Required load [N]	700
Minimum test duration [s]	10
Result	
Test duration [s]:	18.9
Breaking strength [N]	1226.67
Test results	POSITIVE
