Harness Structural test Report - EN

Inspection certificate number: **PH_374.2022**

Name: **MK1 Pro**
 Type: **ABS**
 Size: **M**
 Serial number: **107 0115 002P**
 Impact pad type: ⁽¹⁾ **Foam**
 Clip-in weight [kg]: **120**

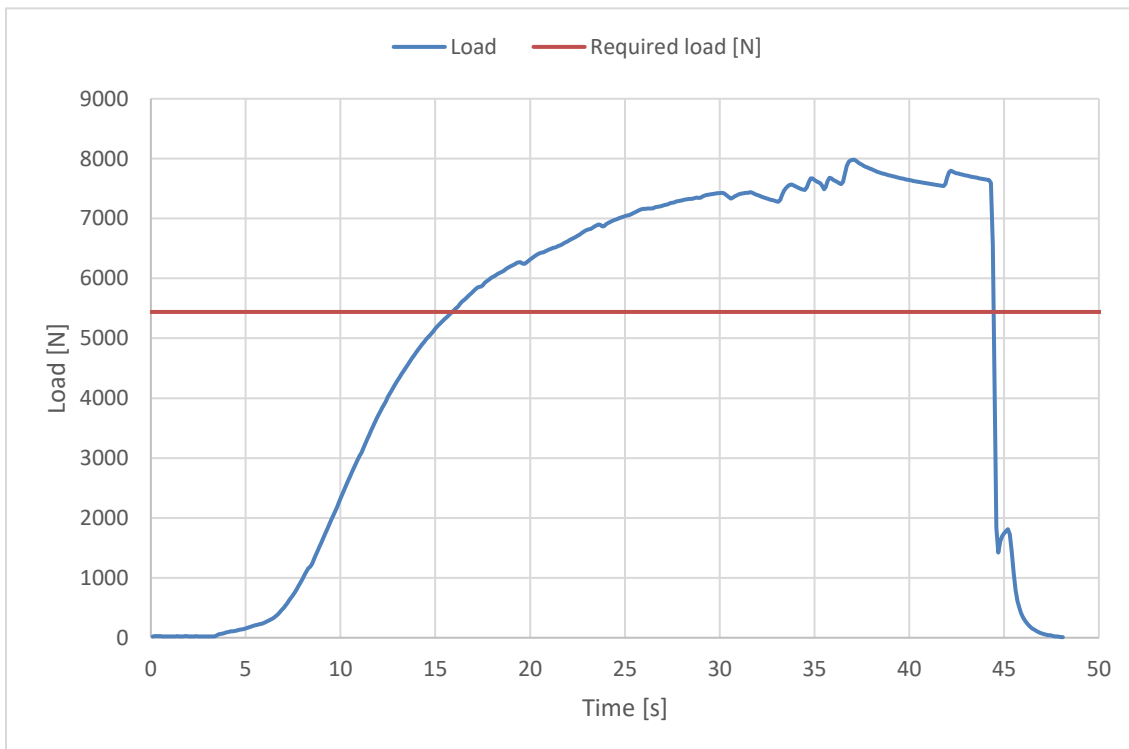
Test ID 01

Standard	EN 1651
Reference in standard	5.5.1.1
Test setup	Positive symmetric load (Slippage)
Attachment points	Both main riser attachment (3,4)
Anchor points	Dummy (B1, B2)
Required load [g]	4.5
Required load [N]	5400
Minimum test duration [s]	5
Result	
Test duration [s]	28.6
Any signs of structural failure	No
Slippery test OK	Yes
Test results	POSITIVE

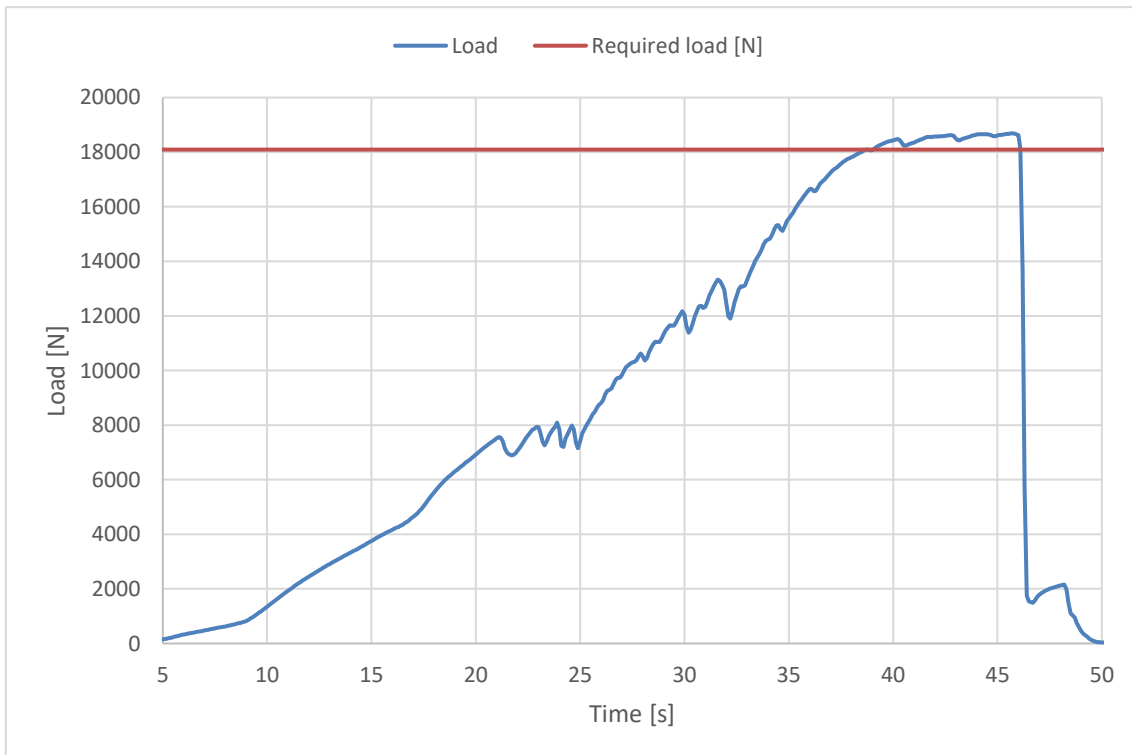
Test ID 03

Test duration [s] **7.1**
 Any signs of structural failure **No**
 Slippery test OK **Yes**
 Test results **POSITIVE**

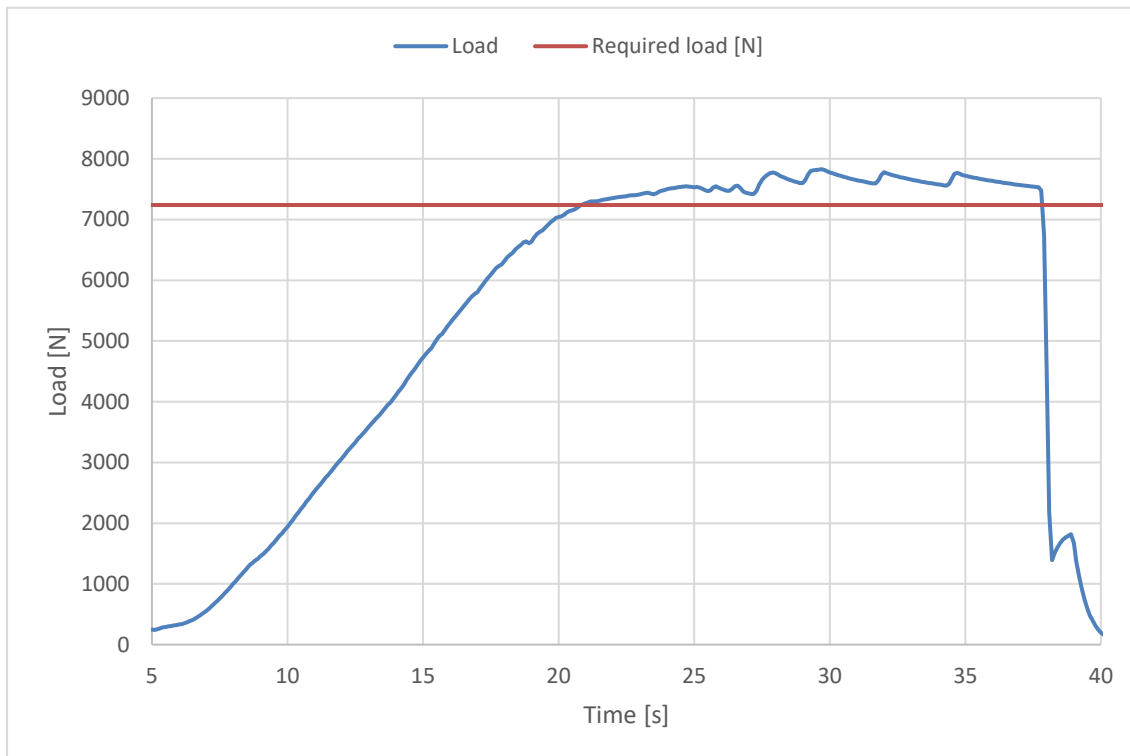
Test ID 05

Standard	EN 1651
Reference in standard	5.5.1.2
Test setup	Positive asymmetric load
Attachment points	One riser attachment (3 or 4)
Anchor points	Dummy (C)
Required load [g]	6
Required load [N]	7200
Minimum test duration [s]	5
Result	
Test duration [s]	17
Any signs of structural failure	No
Test results	POSITIVE

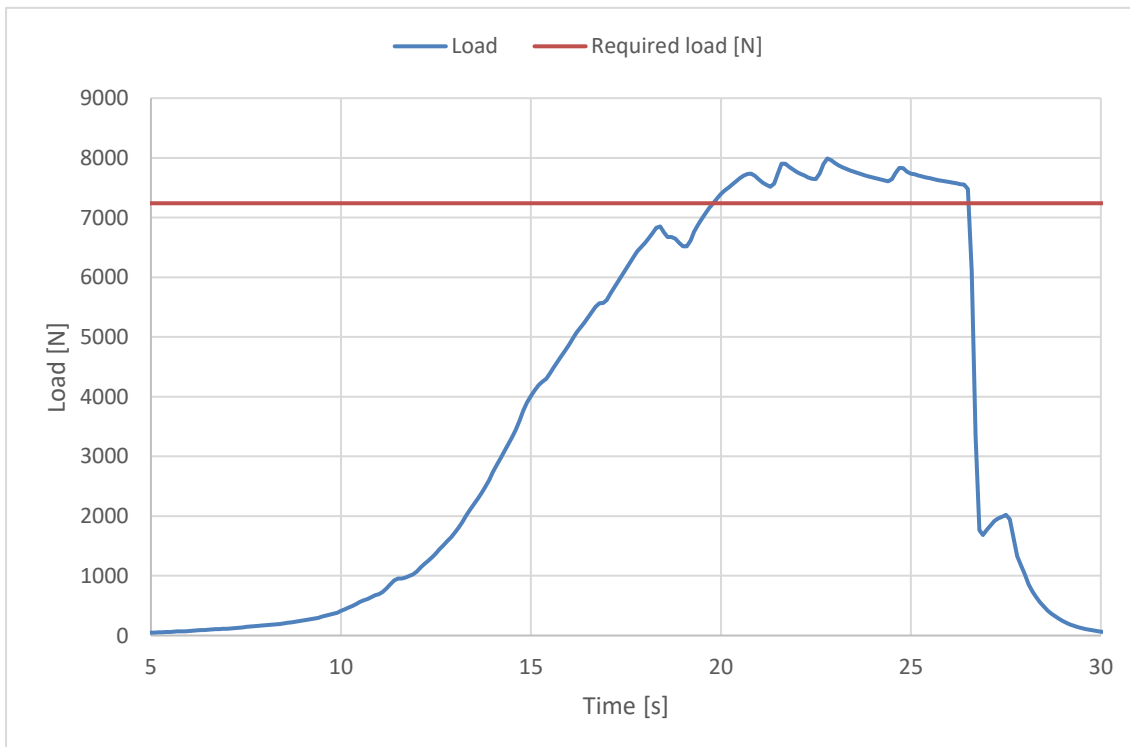
Test ID 06

Standard	EN 1651
Reference in standard	5.5.1.6
Test setup	Negative symmetric load
Attachment points	Both main riser attachment (3,4)
Anchor points	Dummy (A)
Required load [g]	6
Required load [N]	7200
Minimum test duration [s]	5
Result	
Test duration [s]	6.8
Any signs of structural failure	No
Test results	POSITIVE

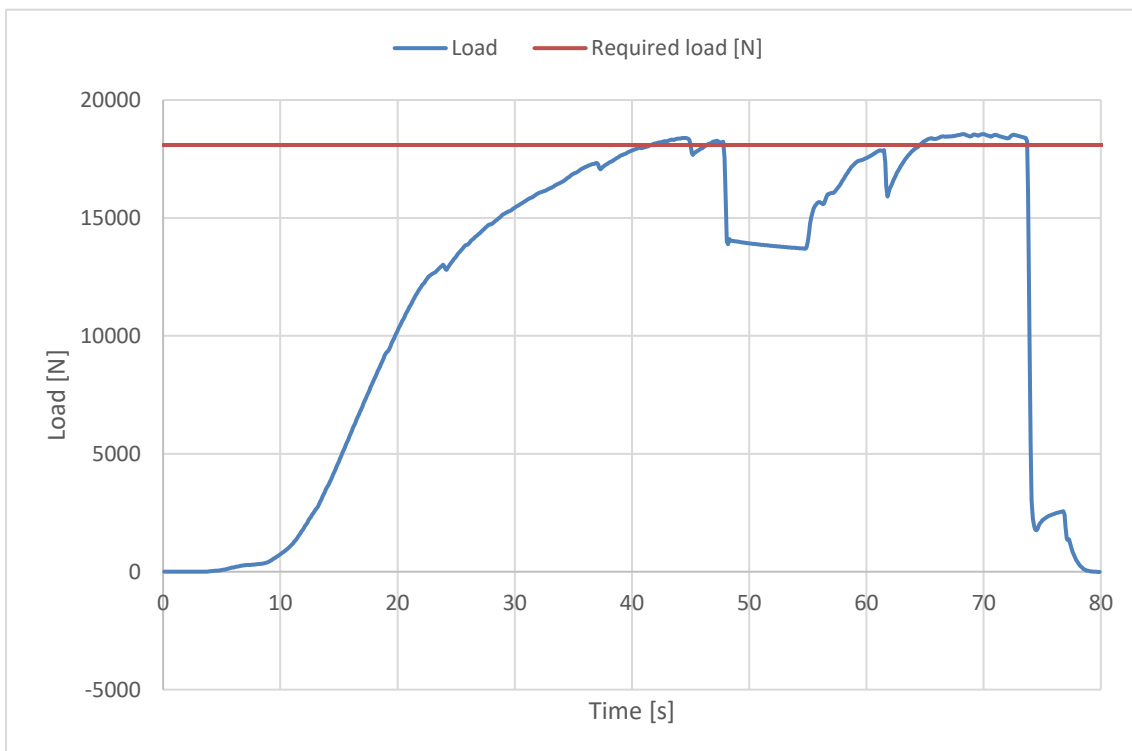
Test ID 09

Standard	EN 1651
Reference in standard	5.5.1.3
Test setup	Positive symmetric load rescue points
Attachment points	Both main riser attachment (1,2)
Anchor points	Dummy (B1,B2)
Required load [g]	15
Required load [N]	18000
Minimum test duration [s]	5
Result	
Test duration [s]	9.2
Any signs of structural failure	No
Slippery test OK	Yes
Test results	POSITIVE

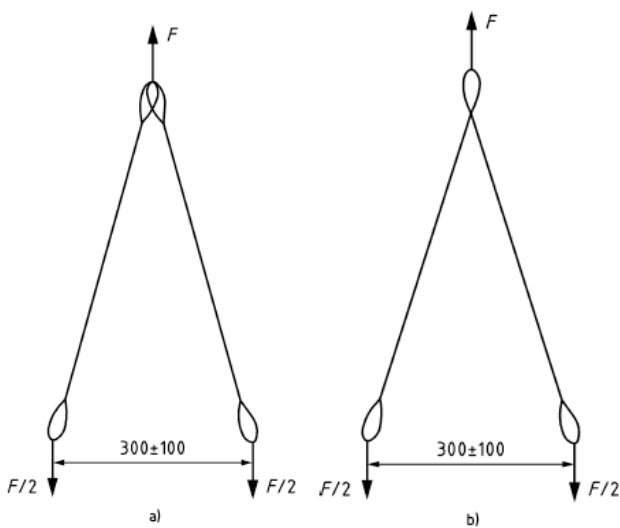
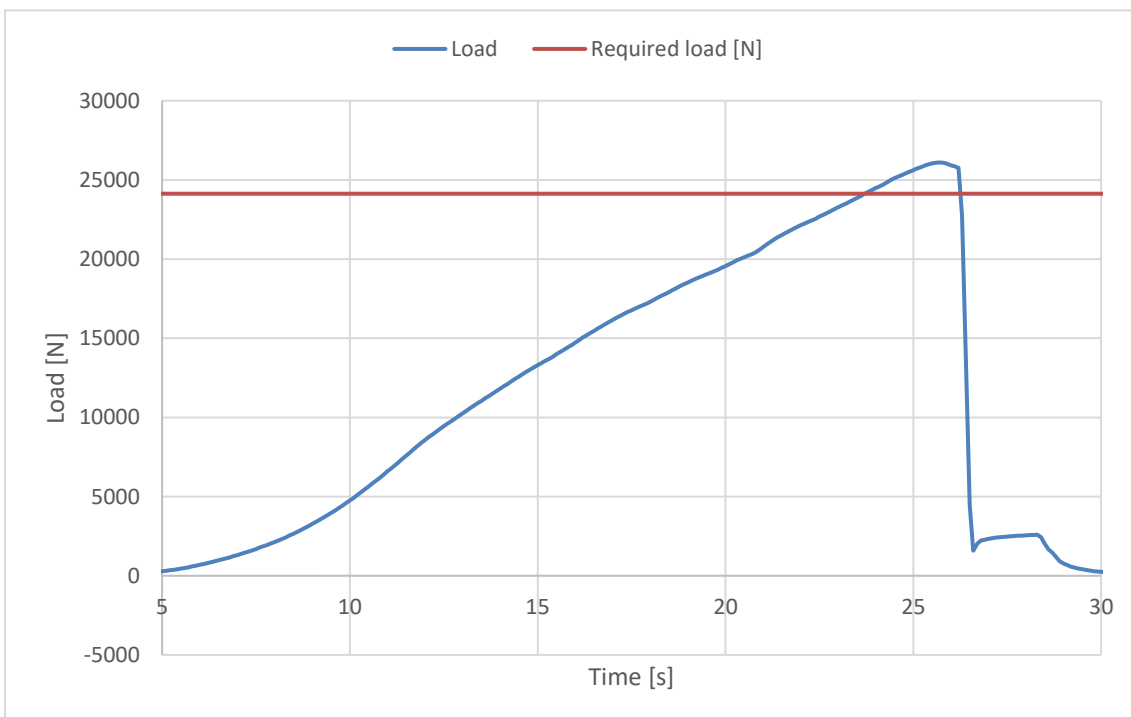
Test ID 11

Standard	EN 1651
Reference in standard	5.5.1.8
Test setup	Connecting element for rescue
Attachment points	End point (emergency parachute)
Anchor points	Both attachment to harness
Required load [g]	n/a
Required load [N]	24000
Minimum test duration [s]	0.3
Type of connecting element	b) standard Y-bridle
Result	
Test duration [s]	2.5
Any signs of structural failure	No
Test results	POSITIVE

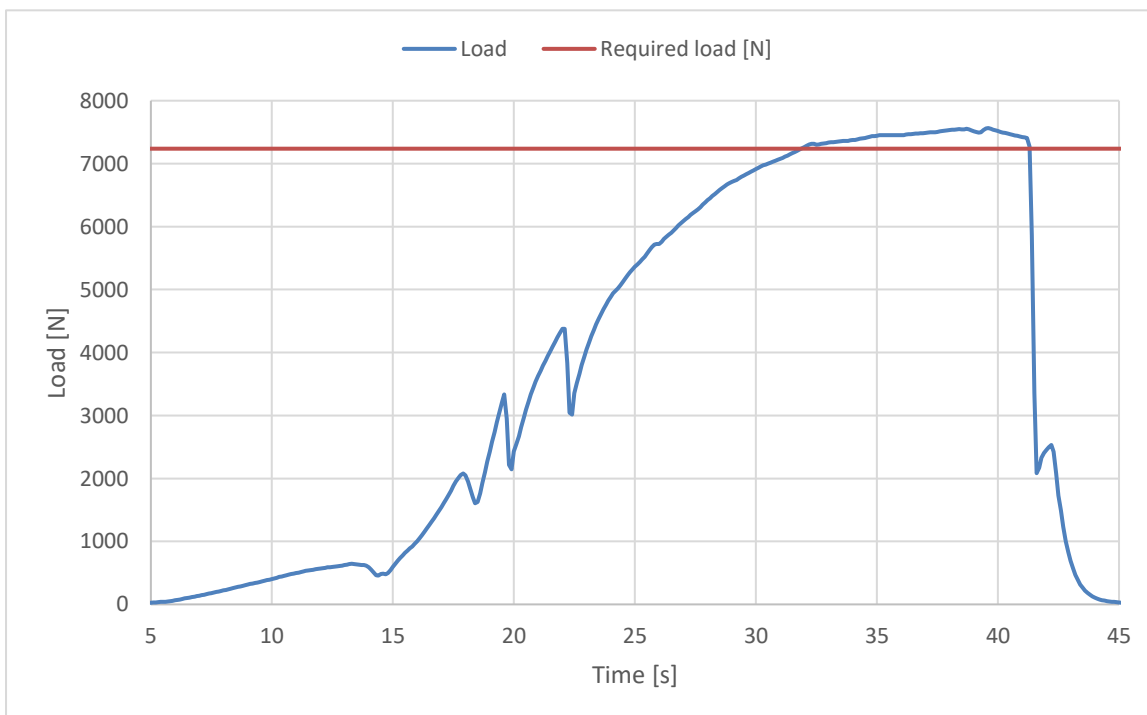
Test ID 12

Standard	EN 1651
Reference in standard	5.5.1.7
Test setup	Upright (landing) position load
Attachment points	Both main riser attachment (3, 4)
Anchor points	Both legstrap of harness (no dummy)
Required load [g]	6
Required load [N]	7200
Minimum test duration [s]	5
Harness type	type a
Result	
Test duration [s]	9.5
Any signs of structural failure	No
Slippery test OK	Yes
Test results	POSITIVE

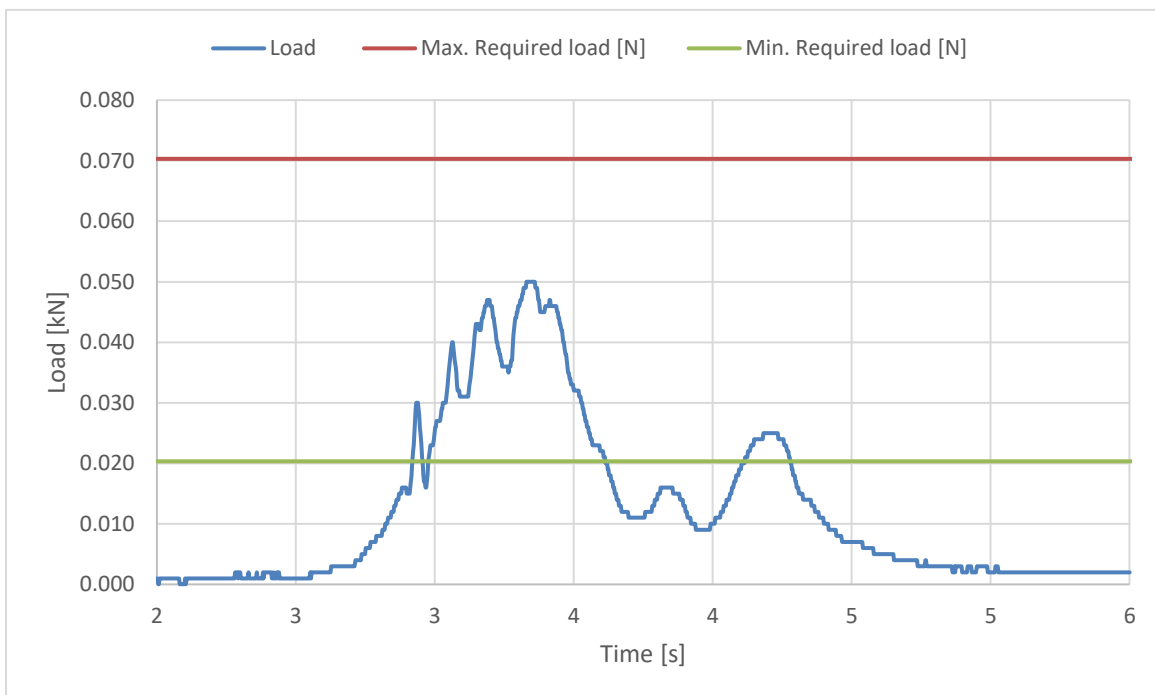
Test ID RRDT

Standard	LTF NfL II 91/09
Reference in standard	6.1.5
Test setup	Default flying position
Attachment points	Sensor connect to handle, and pull in opening direction
	The test is to simulate the load required to open the emergency parachute(1st action).
Min. Required load [N]	20
Max. Required load [N]	70
Result	
Load for first action [N]	49.67
Test results	POSITIVE

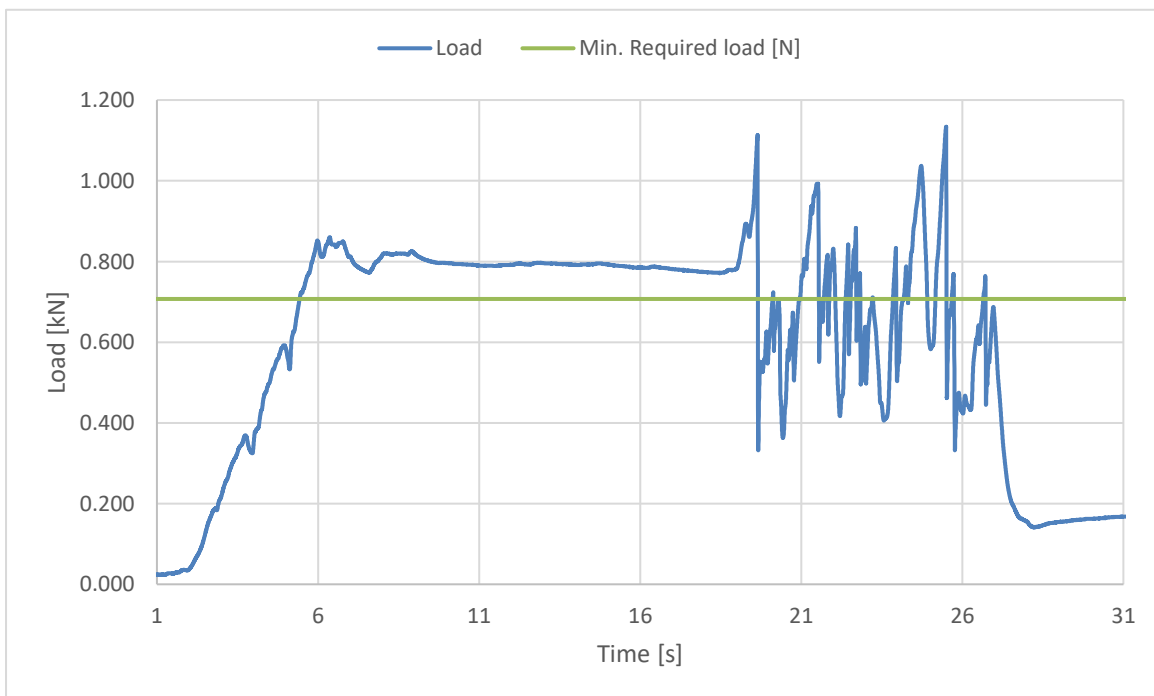
Test ID RRST

Standard	EN12491:2015
Reference in standard	5.3.2
Test setup	Two end points of handle
Attachment points	Sensor connect to end of handle, pull on the other side
	The handle must support min 700 N for 10 s, after measure breaking strength
Min. Required load [N]	700
Minimum test duration [s]	10
Result	
Test duration [s]:	14.2
Breaking strength [N]	1126.47
Test results	POSITIVE
