Harness Structural test Report - NfL

Inspection certificate number: **PH_374.2022**

Name: **MK1 Pro**
 Type: **ABS**
 Size: **M**
 Serial number: **107 0115 002P**
 Impact pad type: ⁽¹⁾ **Foam**
 Clip-in weight [kg]: **120**
 Integrated container: **Yes**
 Date of test: **09.03.2022**

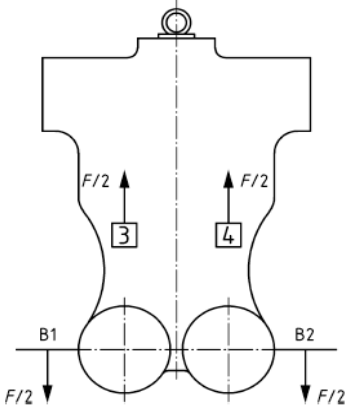
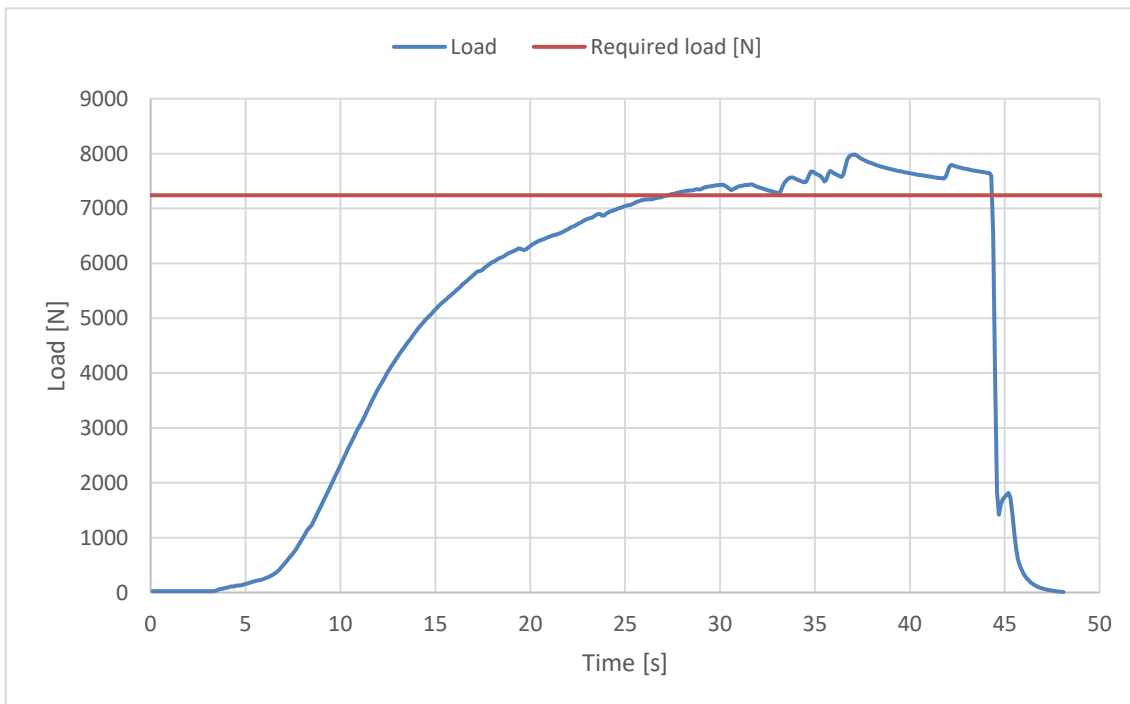
Test ID 02

Standard	NfL 2-565-20
Reference	5.3.2.1
Test setup	Default flying position
Attachment points	Both main riser attachment (3,4)
Anchor points	Dummy (B1, B2)
Required load [g]	6
Required load [N]	7200
Minimum test duration [s]	10
Result	
Test duration [s]	17.1
Any signs of structural failure	No
Test results	POSITIVE

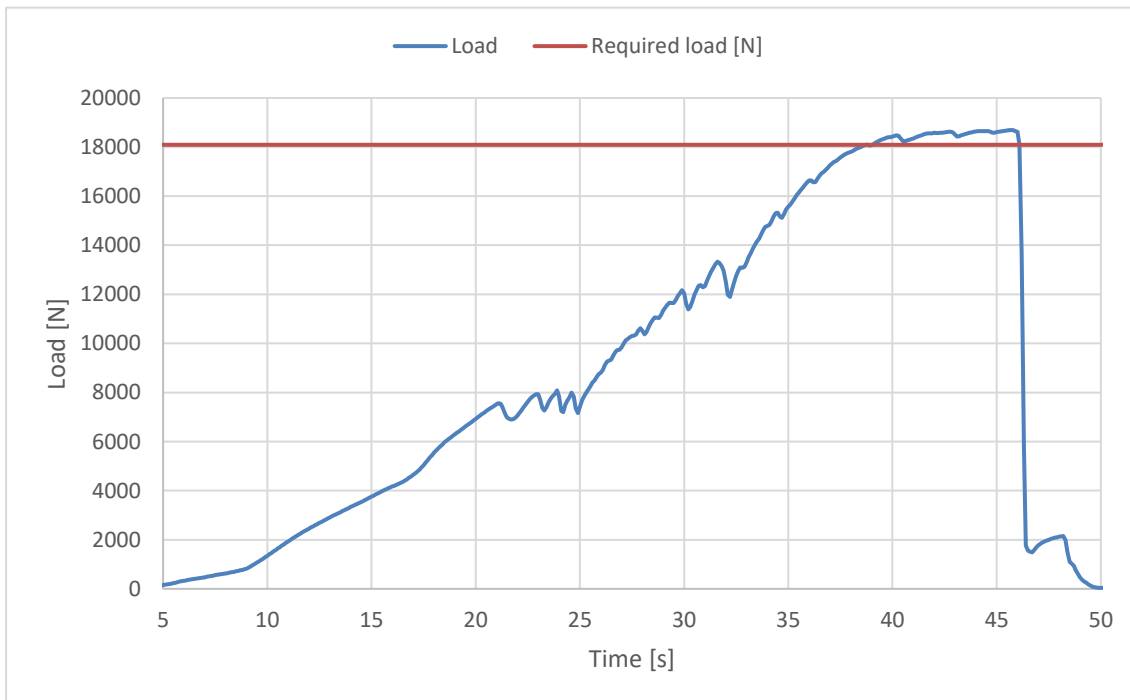
Test ID 03

Test duration [s] **7.1**
 Any signs of structural failure **No**
 Test results **POSITIVE**

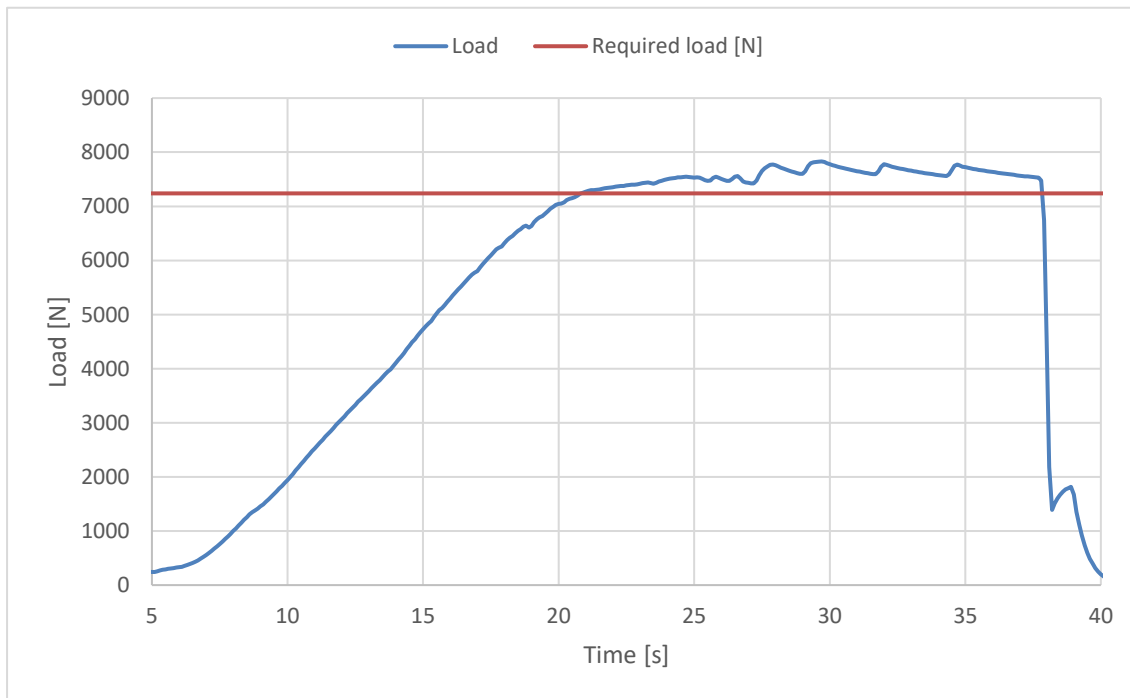
Test ID 04

Standard	NfL 2-565-20
Reference	5.3.2.3
Test setup	Asymmetric, one riser
Attachment points	One main riser attachment (3)
Anchor points	Dummy (B1,B2)
Required load [g]	6
Required load [N]	7200
Minimum test duration [s]	10
Result	
Test duration [s]	17
Any signs of structural failure	No
Test results	POSITIVE

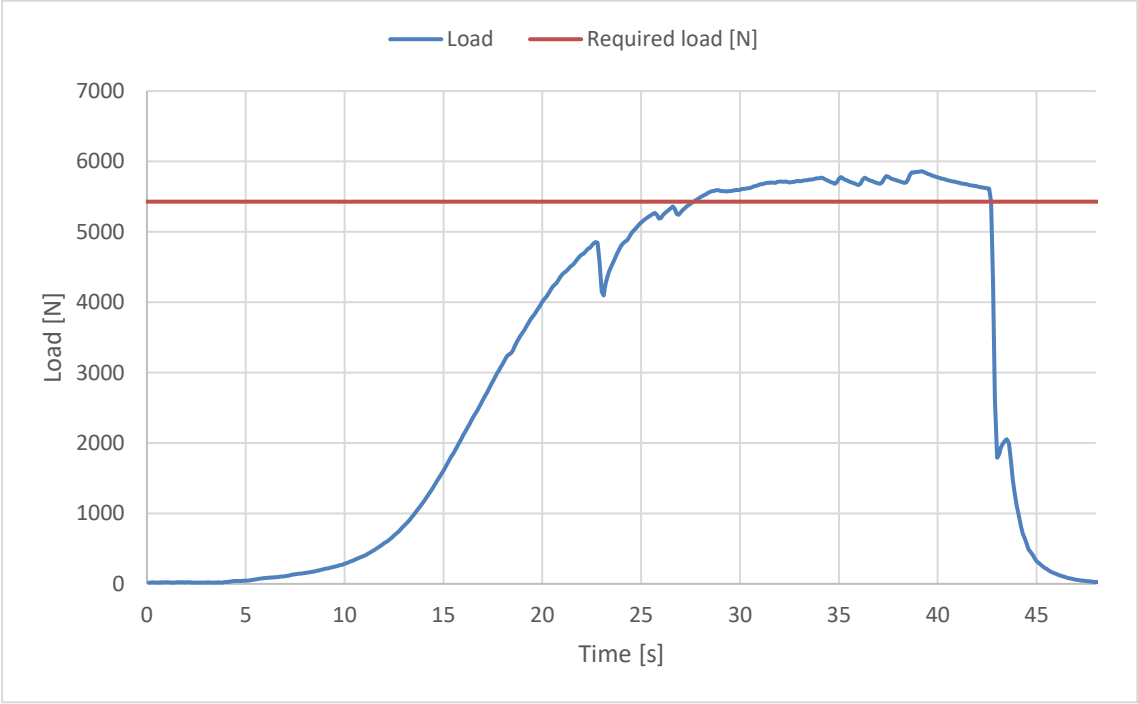
Test ID 07

Reference	5.3.2.6	
Test setup	Asymmetric, negative	
Attachment points	One main riser attachment (3 or 4) downwards	
Anchor points	Dummy (9)	
Required load [g]	4.5	
Required load [N]	5400	
Minimum test duration [s]	10	
Result		
Test duration [s]	15.1	
Any signs of structural failure	No	
Test results	POSITIVE

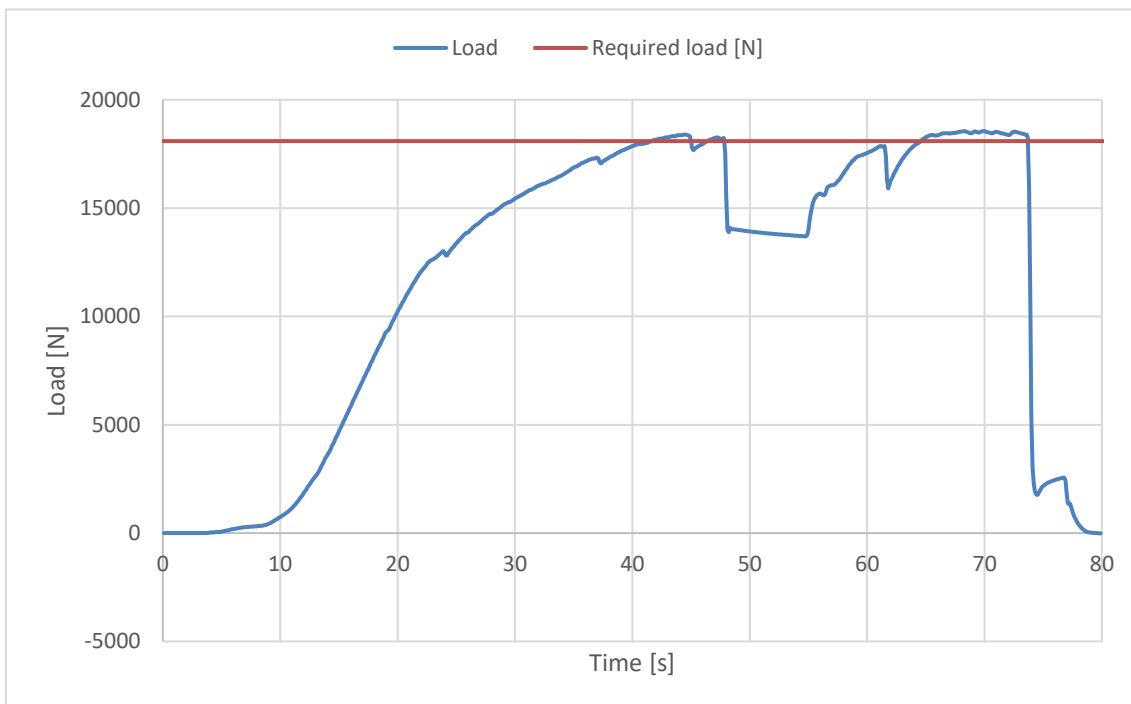
Test ID 09

Standard	NfL 2-565-20
Reference	5.3.2.4
Test setup	Rescue attachments
Attachment points	Rescue riser attachment (1,2)
Anchor points	Dummy (B1,B2)
Required load [g]	15
Required load [N]	18000
Minimum test duration [s]	5
Result	
Test duration [s]	9.2
Any signs of structural failure	No
Test results	POSITIVE

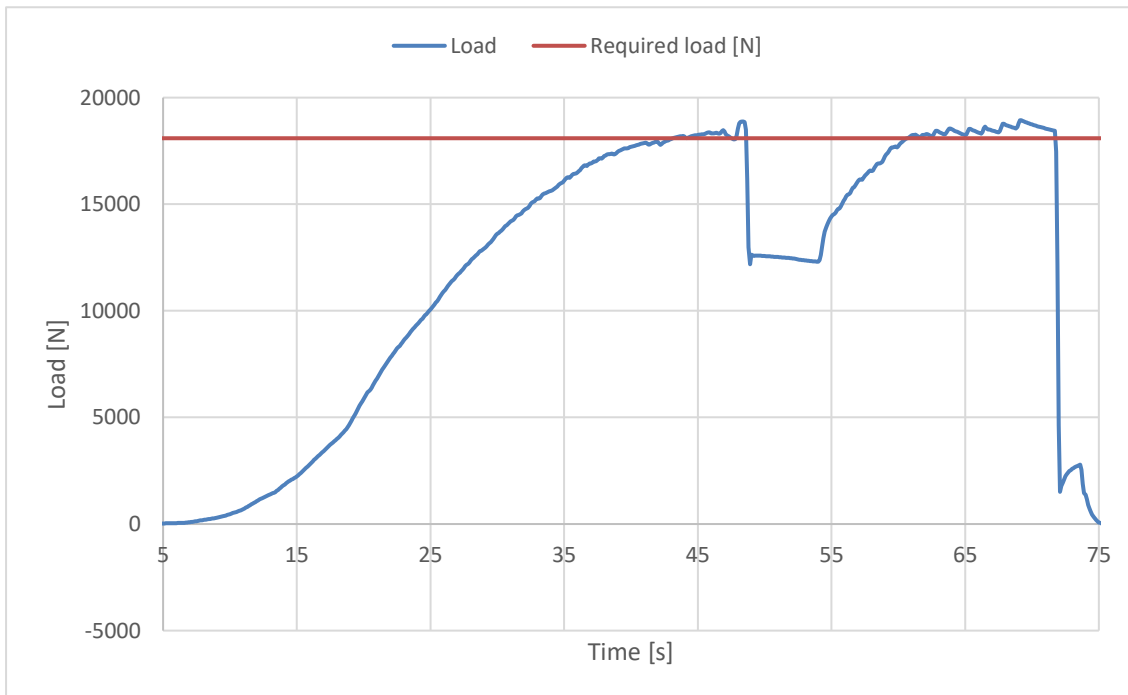
Test ID 13

Standard	NfL 2-565-20
Reference	5.3.2.7
Test setup	Flying position before landing
Attachment points	Both main riser attachment (3,4)
Anchor points	Dummy (7,8)
Required load [g]	15
Required load [N]	18000
Minimum test duration [s]	5
Result	
Test duration [s]	11
Any signs of structural failure	No
Test results	POSITIVE

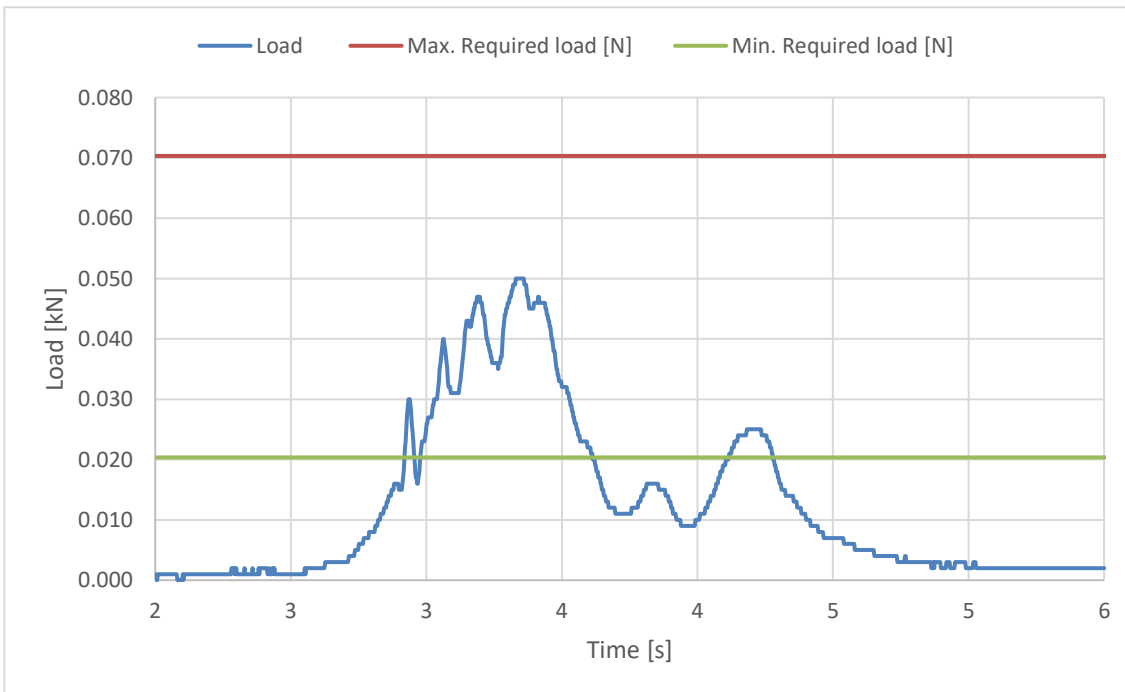
Test ID RRDT

Standard	NfL 2-565-20
Reference	6.1.5
Test setup	Default flying position
Attachment points	Sensor connect to handle, and pull in opening direction
	The test is to simulate the load required to open the emergency parachute(1st action).
Min. Required load [N]	20
Max. Required load [N]	70
Result	
Load for first action [N]	49.67
Test results	POSITIVE

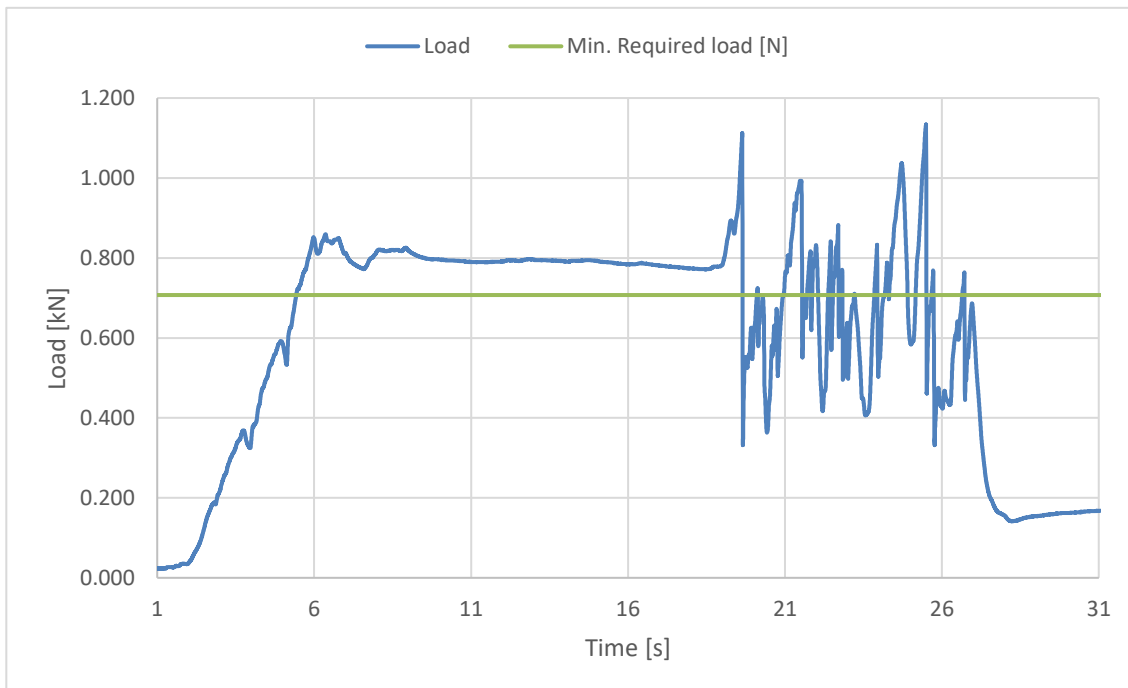
Test ID RRST

Standard	EN12491:2015
Reference in standard	5.3.2
Test setup	Two end points of handle
Attachment points	Sensor connect to end of handle, pull on the other side
	The handle must support min 700 N for 10 s, after measure breaking strength
Min. Required load [N]	700
Minimum test duration [s]	10
Result	
Test duration [s]:	14.2
Breaking strength [N]	1126.47
Test results	POSITIVE
