## Harness Structural test Report - NfL

Inspection certificate number: **PH\_348.2021**

Name: **TransAlp 2**  
 Type: **ABS**  
 Size: **M**  
 Serial number: **105 0115 0002**  
 Impact pad type: <sup>(1)</sup> **Inflatable**  
 Clip-in weight [kg]: **120**  
 Integrated container: **No**  
 Date of test: **23.09.2021**

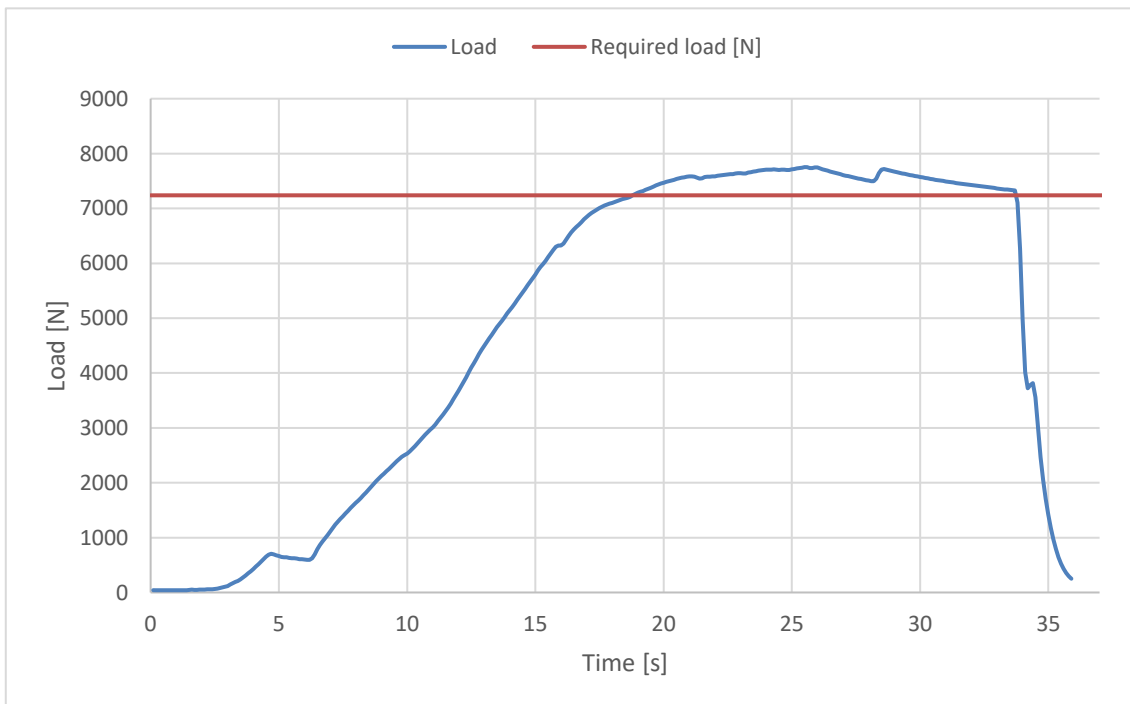
**Test ID 02**

Test duration [s] **14.9**  
 Any signs of structural failure **No**  
 Test results **POSITIVE**

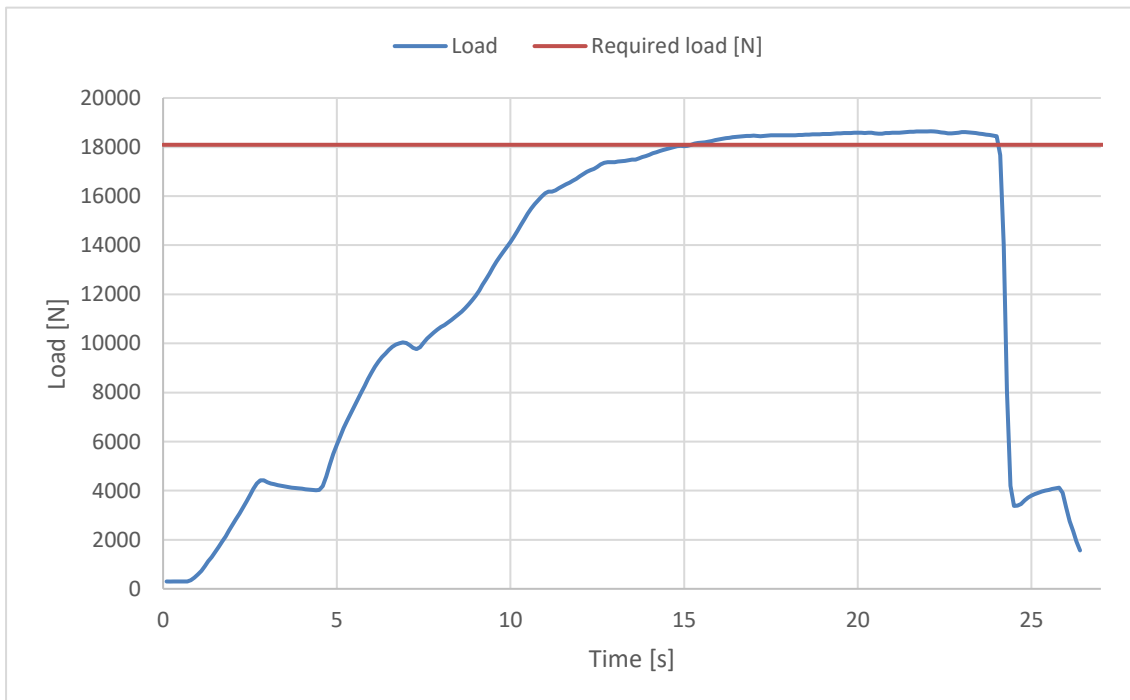
**Test ID 03**

Standard	<b>NfL 2-565-20</b>
Reference	<b>5.3.2.2</b>
Test setup	<b>Default flying position</b>
Attachment points	<b>Both main riser attachment (3,4)</b>
Anchor points	<b>Dummy (B1, B2)</b>
Required load [g]	<b>15</b>
Required load [N]	<b>18000</b>
Minimum test duration [s]	<b>5</b>
<b>Result</b>	
Test duration [s]	<b>8.9</b>
Any signs of structural failure	<b>No</b>
Test results	<b>POSITIVE</b>

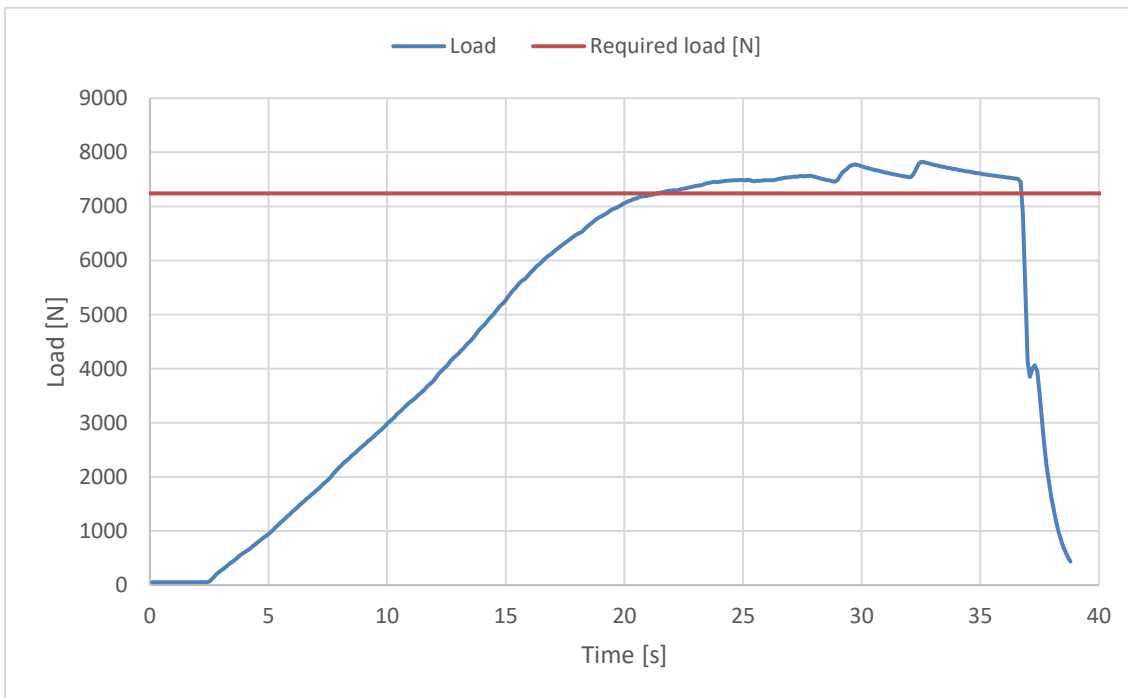
**Test ID 04**

Standard	<b>NfL 2-565-20</b>
Reference	<b>5.3.2.3</b>
Test setup	<b>Asymmetric, one riser</b>
Attachment points	<b>One main riser attachment (3)</b>
Anchor points	<b>Dummy (B1,B2)</b>
Required load [g]	<b>6</b>
Required load [N]	<b>7200</b>
Minimum test duration [s]	<b>10</b>
<b>Result</b>	
Test duration [s]	<b>15.4</b>
Any signs of structural failure	<b>No</b>
Test results	<b>POSITIVE</b>

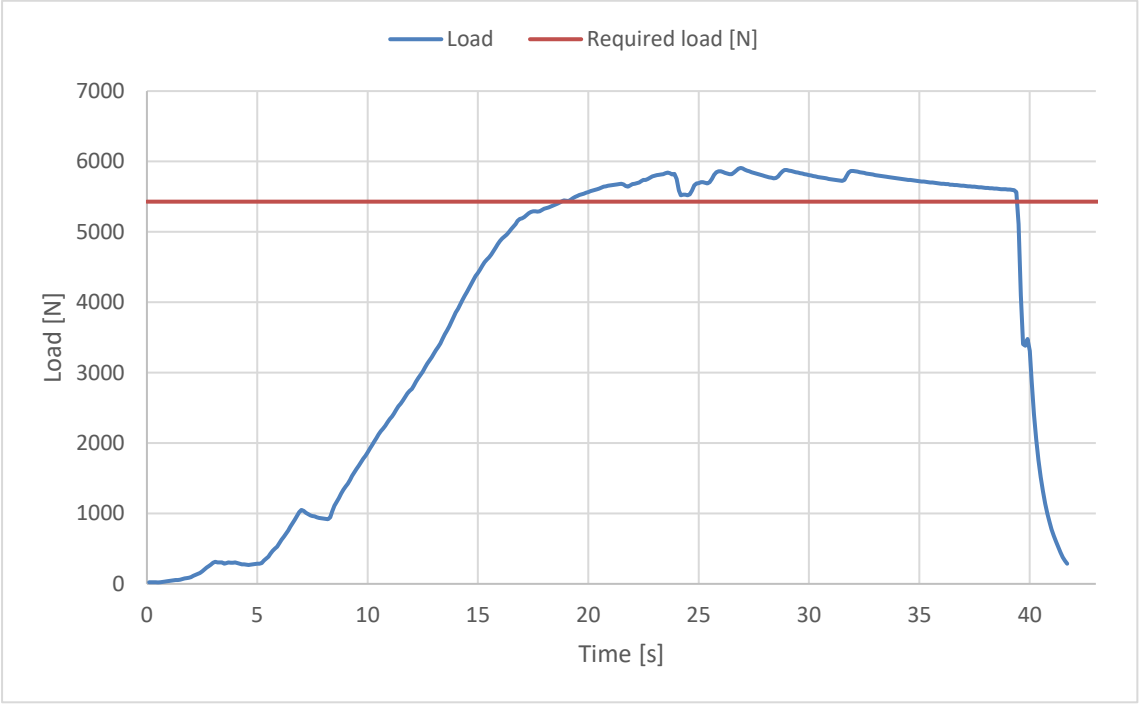
**Test ID 07**

Reference	<b>5.3.2.6</b>	
Test setup	<b>Asymmetric, negative</b>	
Attachment points	<b>One main riser attachment (3 or 4) downwards</b>	
Anchor points	<b>Dummy (9)</b>	
Required load [g]	<b>4.5</b>	
Required load [N]	<b>5400</b>	
Minimum test duration [s]	<b>10</b>	
<b>Result</b>		
Test duration [s]	<b>20.7</b>	
Any signs of structural failure	<b>No</b>	
Test results	<b>POSITIVE</b>

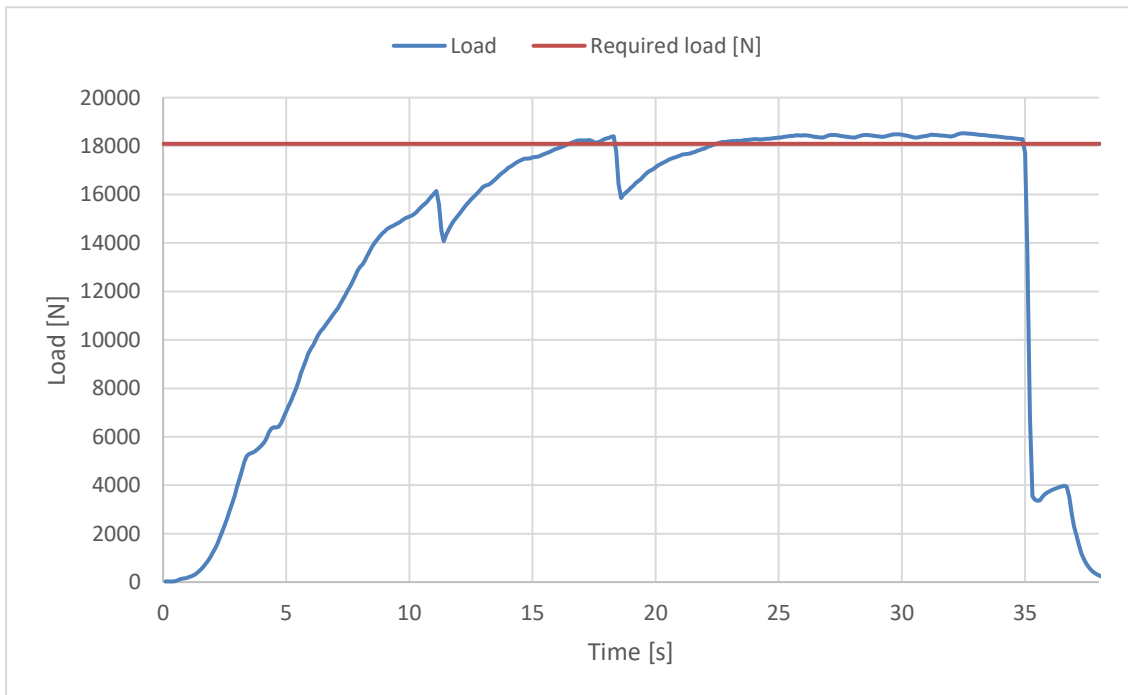
**Test ID 13**

Standard	<b>NfL 2-565-20</b>
Reference	<b>5.3.2.7</b>
Test setup	<b>Flying position before landing</b>
Attachment points	<b>Both main riser attachment (3,4)</b>
Anchor points	<b>Dummy (7,8)</b>
Required load [g]	<b>15</b>
Required load [N]	<b>18000</b>
Minimum test duration [s]	<b>5</b>
<b>Result</b>	
Test duration [s]	<b>12.5</b>
Any signs of structural failure	<b>No</b>
Test results	<b>POSITIVE</b>

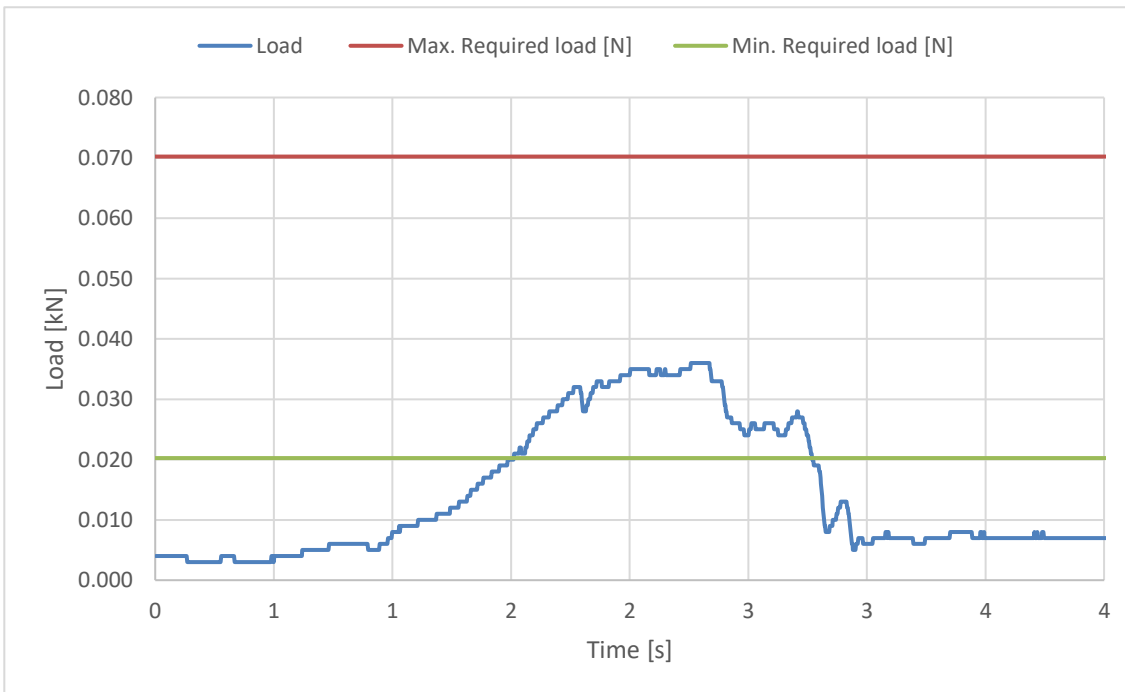
**Test ID RRDT**

Standard	<b>NfL 2-565-20</b>
Reference	<b>6.1.5</b>
Test setup	<b>Default flying position</b>
Attachment points	<b>Sensor connect to handle, and pull in opening direction</b>
	The test is to simulate the load required to open the emergency parachute(1st action).
Min. Required load [N]	<b>20</b>
Max. Required load [N]	<b>70</b>
<b>Result</b>	
Load for first action [N]	<b>35.76</b>
Test results	<b>POSITIVE</b>

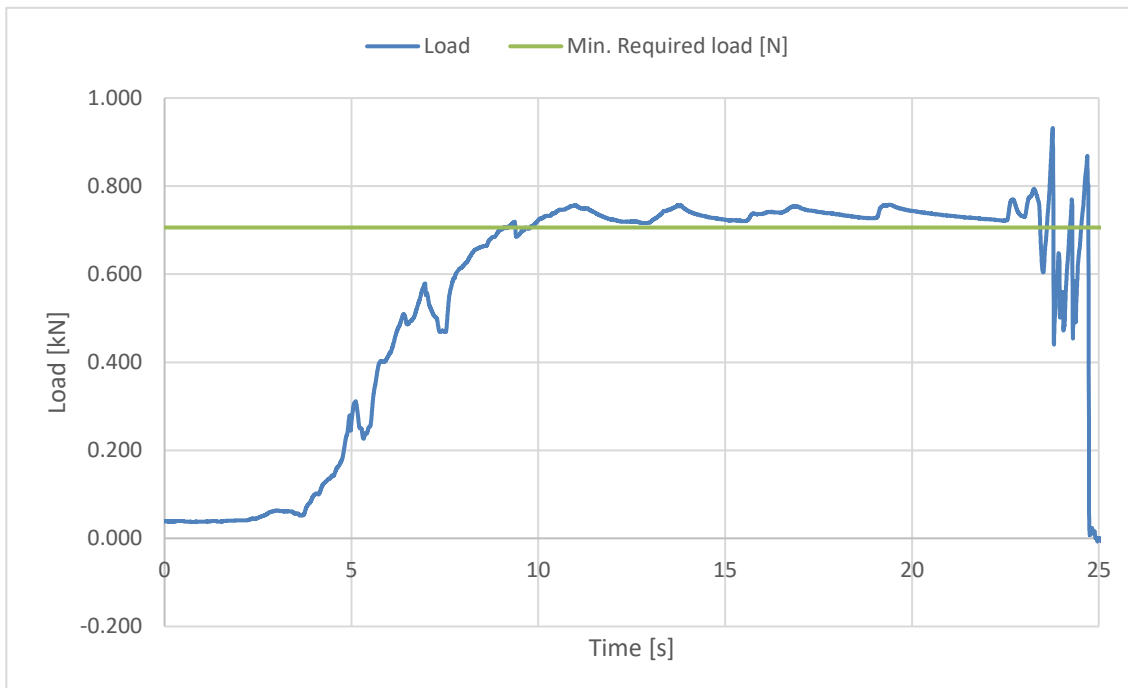
**Test ID RRST**

Standard	<b>EN12491:2015</b>
Reference in standard	<b>5.3.2</b>
Test setup	<b>Two end points of handle</b>
Attachment points	<b>Sensor connect to end of handle, pull on the other side</b>
	The handle must support min 700 N for 10 s, after measure breaking strength
Min. Required load [N]	<b>700</b>
Minimum test duration [s]	<b>10</b>
<b>Result</b>	
Test duration [s]:	<b>13.6</b>
Breaking strength [N]	<b>925.81</b>
Test results	<b>POSITIVE</b>
