Harness Structural test Report

Inspection certificate number: **PH_241.2018**
Manufacturer data:

Name: **KURSI light**
 Type: **ABS**
 Size: **L**
 Serial number: **XLH062018001**
 Impact pad type: ⁽¹⁾ **n/a**
 Clip-in weight [kg]: **110**

Summary of Structural test

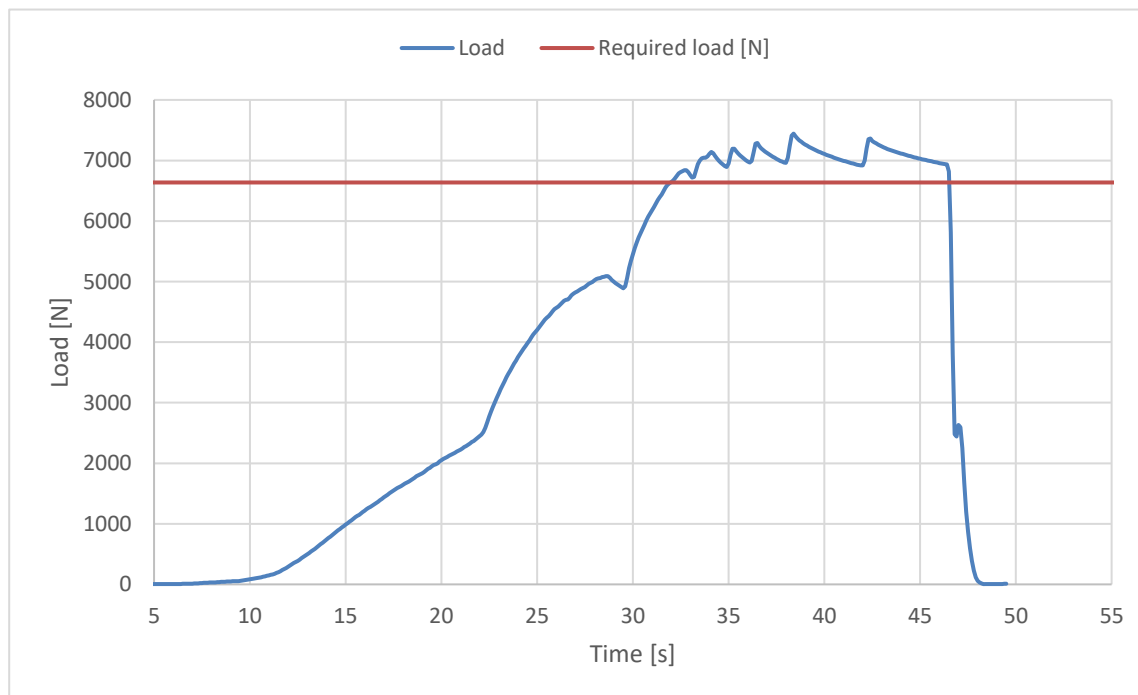
Test ID R0

Reference in standard	5.3.2.1	
Test setup	Default flying position	
Attachment points	Both main riser attachment (3,4)	
Anchor points	Dummy (B1, B2)	
Required load [g]	6	
Required load [N]	6600	
Minimum test duration [s]	10	
Result		
Test duration [s]	14.6	
Any signs of structural failure	No	
Test results	POSITIVE

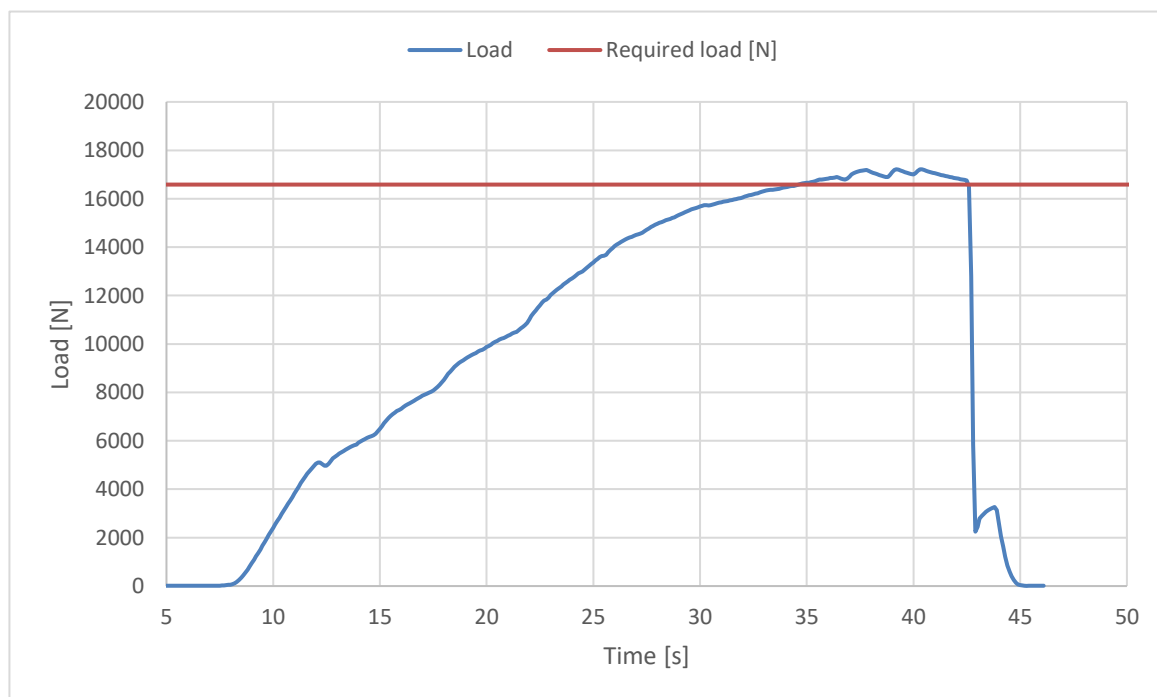
Test ID R2

Standard	EN 1651:1999
Reference in standard	5.3.2.2
Test setup	Default flying position
Attachment points	Both main riser attachment (3,4)
Anchor points	Dummy (B1, B2)
Required load [g]	15
Required load [N]	16500
Minimum test duration [s]	5
Result	
Test duration [s]	7.9
Any signs of structural failure	No
Test results	POSITIVE

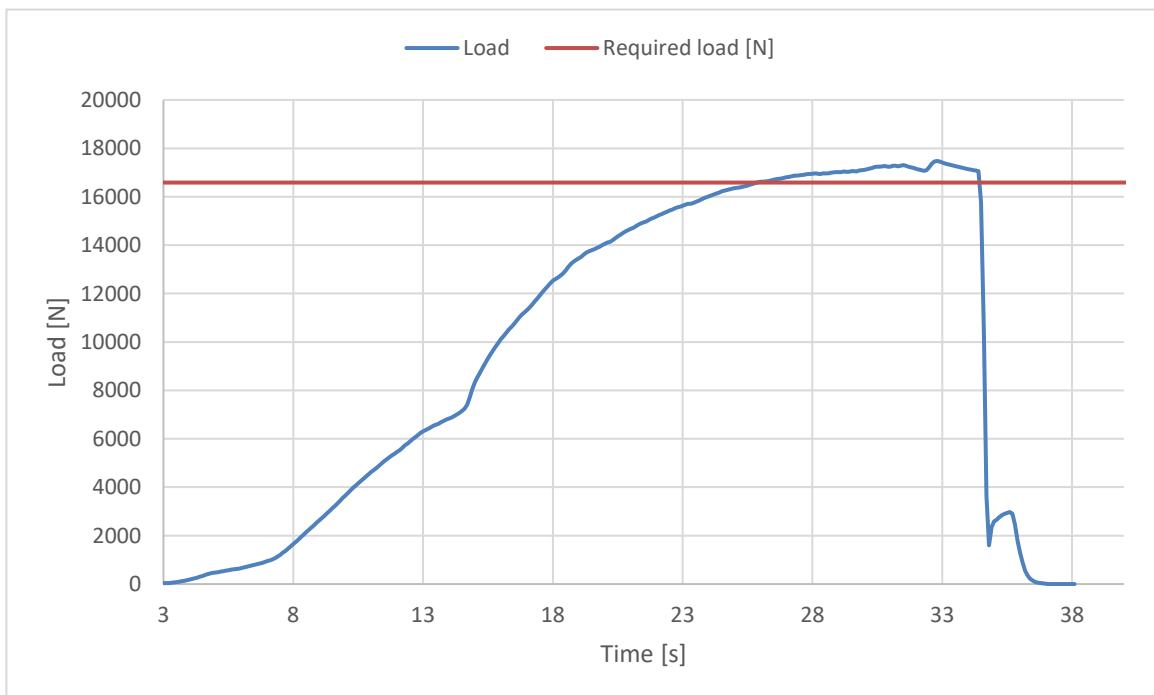
Test ID R4

Standard	EN 1651:1999
Reference in standard	5.3.2.7
Test setup	Flying position before landing
Attachment points	Both main riser attachment (3,4)
Anchor points	Dummy (7,8)
Required load [g]	15
Required load [N]	16500
Minimum test duration [s]	5
Result	
Test duration [s]	8.6
Any signs of structural failure	No
Test results	POSITIVE

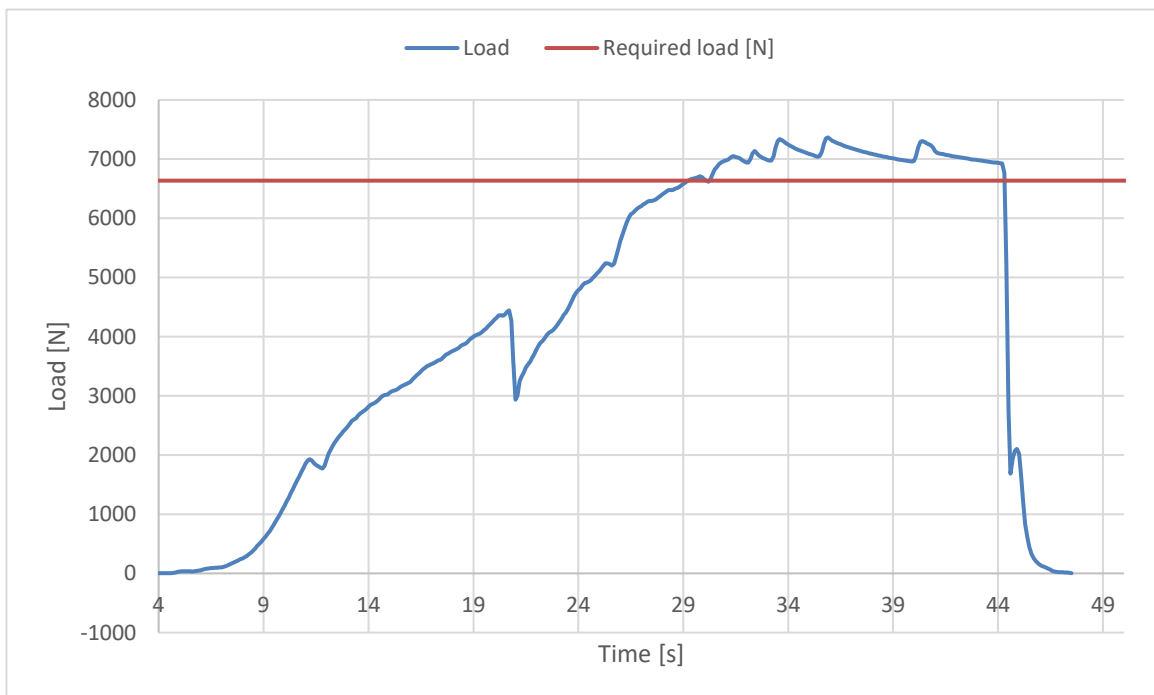
Test ID R8

Standard	EN 1651:1999	
Reference in standard	5.3.2.3	
Test setup	Asymmetric, one riser	
Attachment points	One main riser attachment (3)	
Anchor points	Dummy (B1,B2)	
Required load [g]	6	
Required load [N]	6600	
Minimum test duration [s]	10	
Result		
Test duration [s]	14.1	
Any signs of structural failure	No	
Test results	POSITIVE

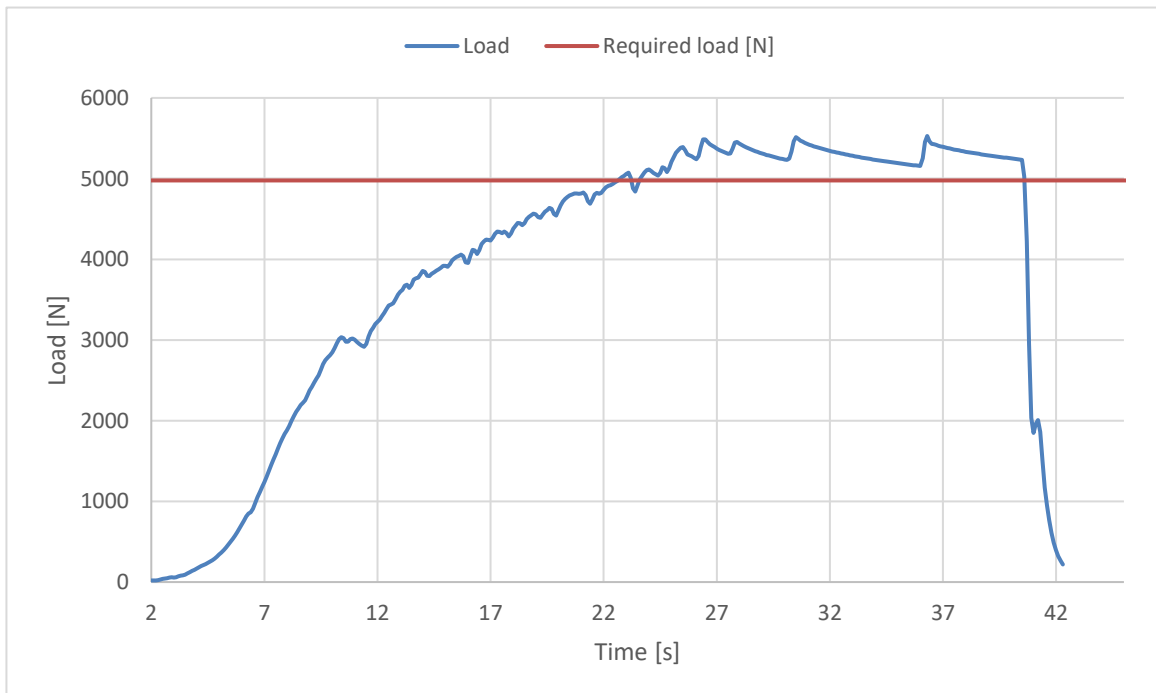
Test ID R10

Reference in standard	5.3.2.6	
Test setup	Asymmetric, negative	
Attachment points	One main riser attachment (3 or 4) downwards	
Anchor points	Dummy (9)	
Required load [g]	4.5	
Required load [N]	4950	
Minimum test duration [s]	10	
Result		
Test duration [s]	17.1	
Any signs of structural failure	No	
Test results	POSITIVE
