Harness Structural test Report - EN

Inspection certificate number: **PH_294.2020**

Name: **Submarine**
 Type: **ABS**
 Size: **M**
 Serial number: **X-49C-068**
 Impact pad type: ⁽¹⁾ **Koroyd**
 Clip-in weight [kg]: **130**

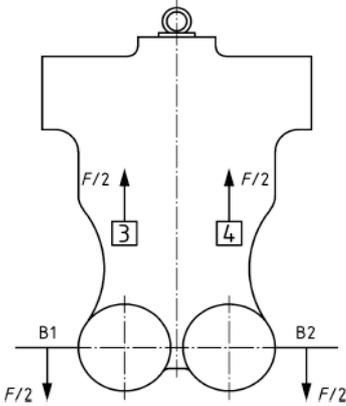
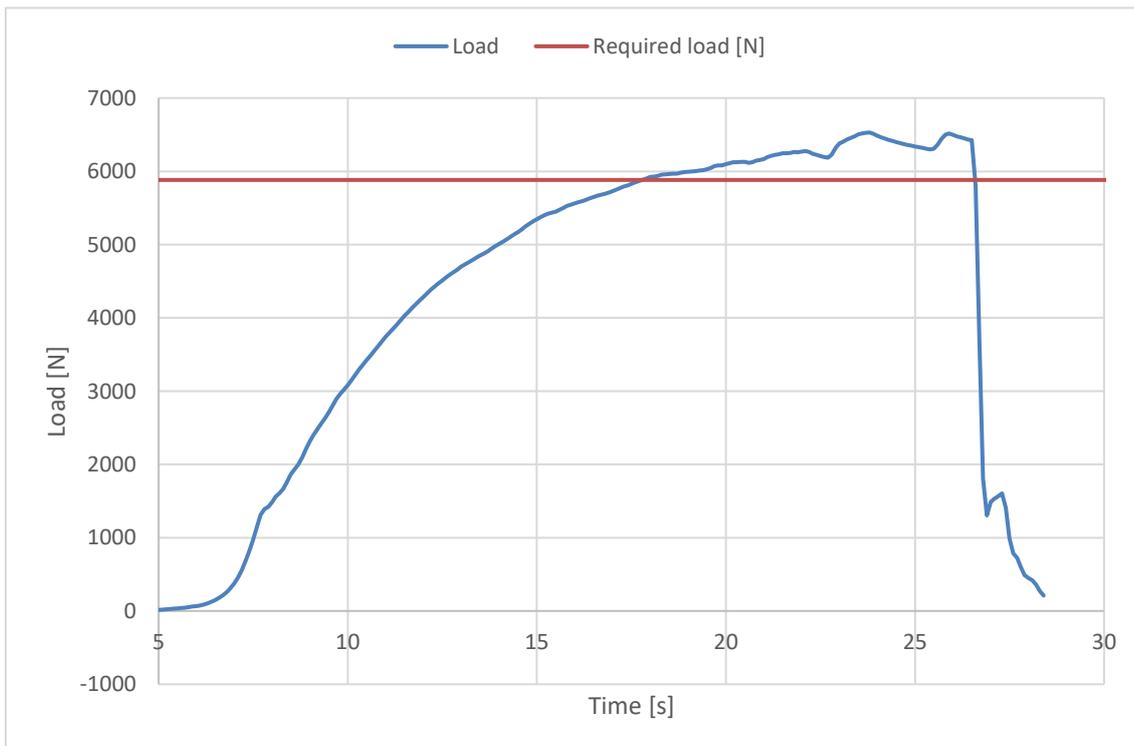
Test ID 01

Standard	EN 1651
Reference in standard	5.5.1.1
Test setup	Positive symmetric load (Slippage)
Attachment points	Both main riser attachment (3,4)
Anchor points	Dummy (B1, B2)
Required load [g]	4.5
Required load [N]	5850
Minimum test duration [s]	5
Result	
Test duration [s]	8.8
Any signs of structural failure	No
Slippery test OK	Yes
Test results	POSITIVE

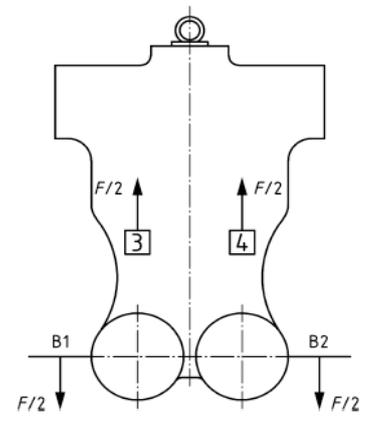
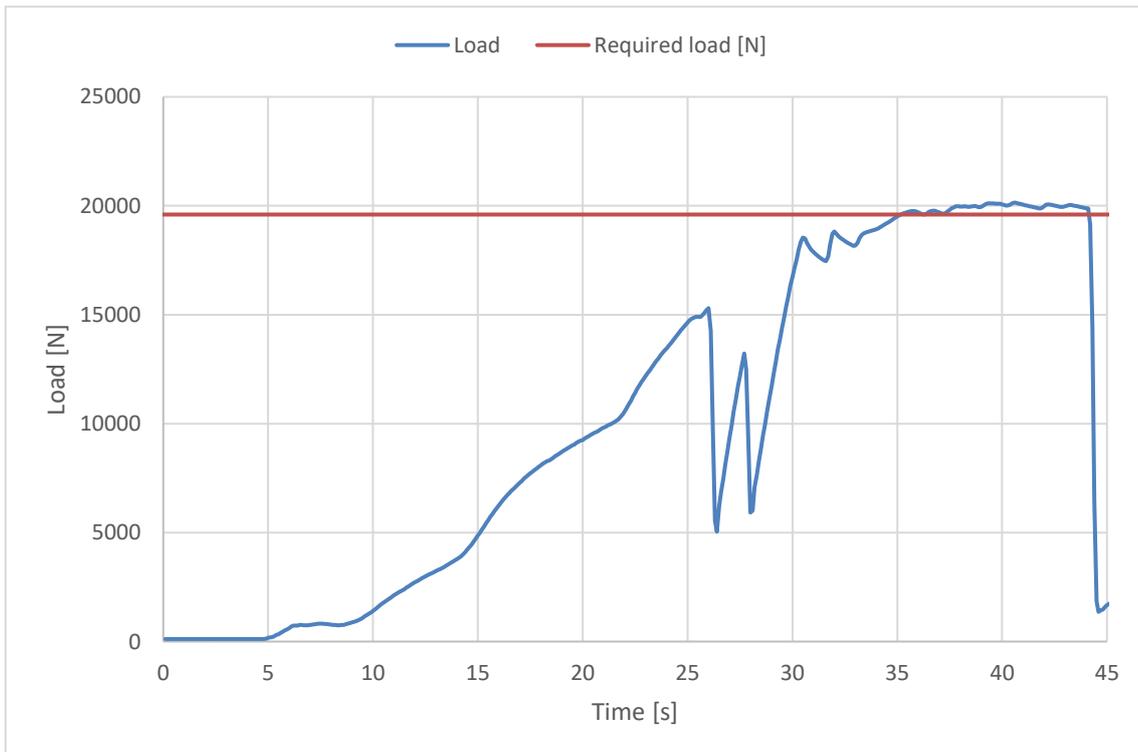
Test ID 03

Standard	EN 1651
Reference in standard	5.5.1.1b
Test setup	Positive symmetric load
Attachment points	Both main riser attachment (3,4)
Anchor points	Dummy (B1, B2)
Required load [g]	15
Required load [N]	19500
Minimum test duration [s]	5
Result	
Test duration [s]	7.8
Any signs of structural failure	No
Slippery test OK	Yes
Test results	POSITIVE

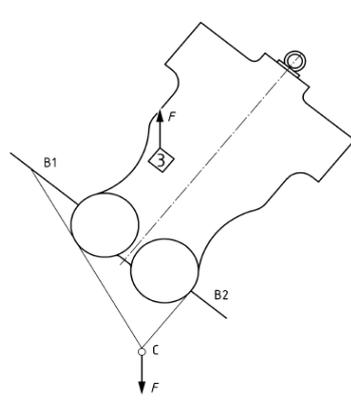
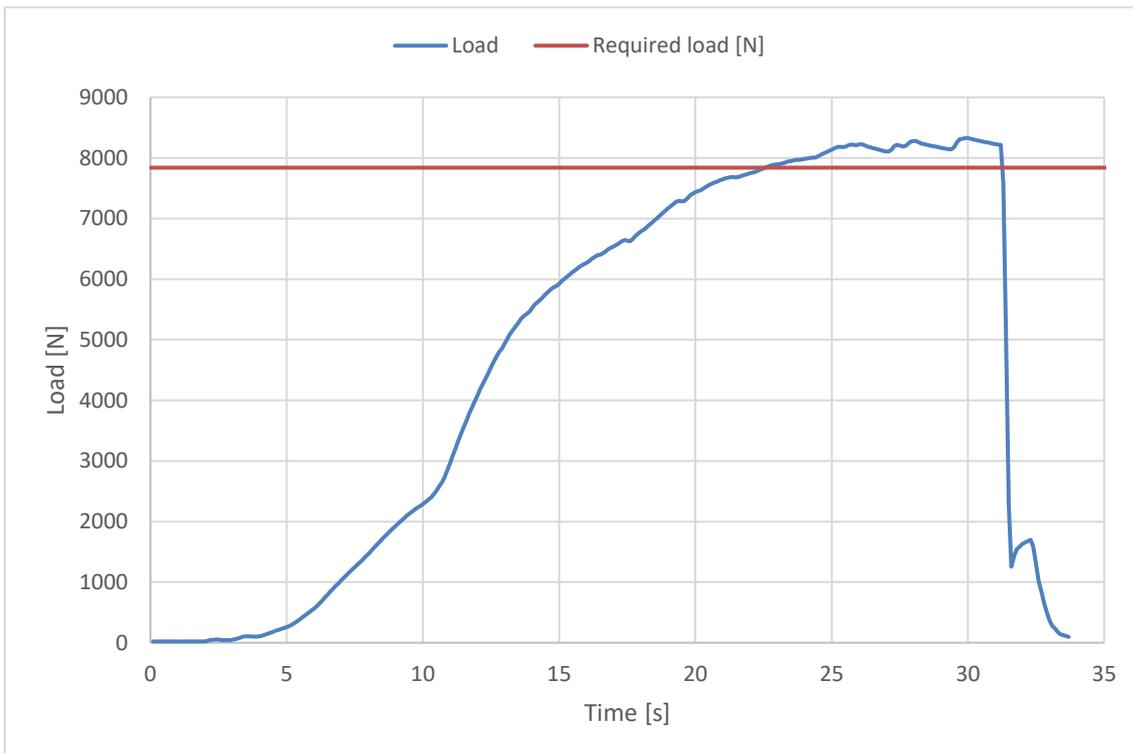
Test ID 05

Standard	EN 1651
Reference in standard	5.5.1.2
Test setup	Positive asymmetric load
Attachment points	One riser attachment (3 or 4)
Anchor points	Dummy (C)
Required load [g]	6
Required load [N]	7800
Minimum test duration [s]	5
Result	
Test duration [s]	8.7
Any signs of structural failure	No
Test results	POSITIVE

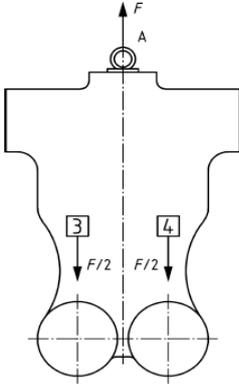
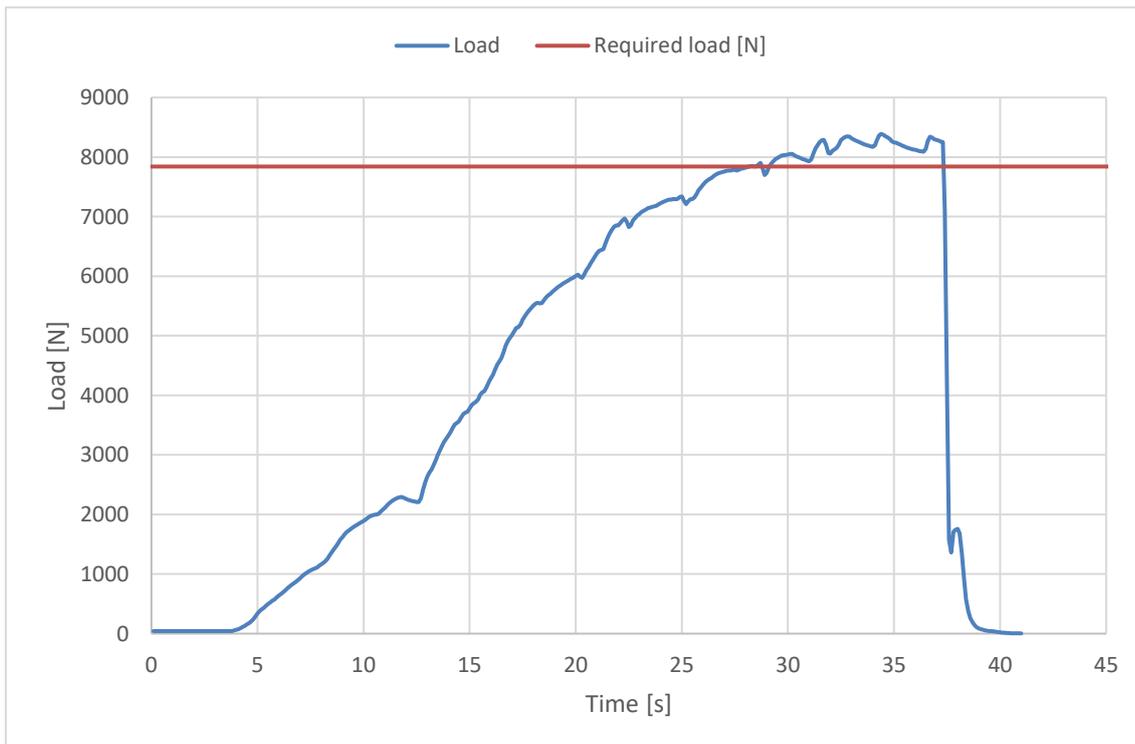
Test ID 06

Standard	EN 1651
Reference in standard	5.5.1.6
Test setup	Negative symmetric load
Attachment points	Both main riser attachment (3,4)
Anchor points	Dummy (A)
Required load [g]	6
Required load [N]	7800
Minimum test duration [s]	5
Result	
Test duration [s]	8.2
Any signs of structural failure	No
Test results	POSITIVE

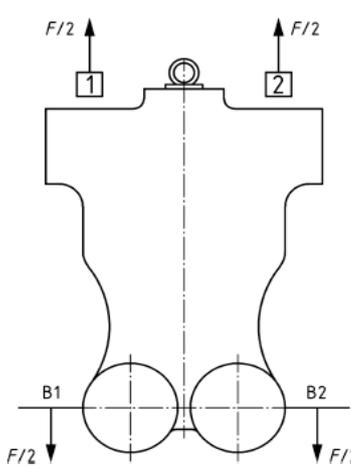
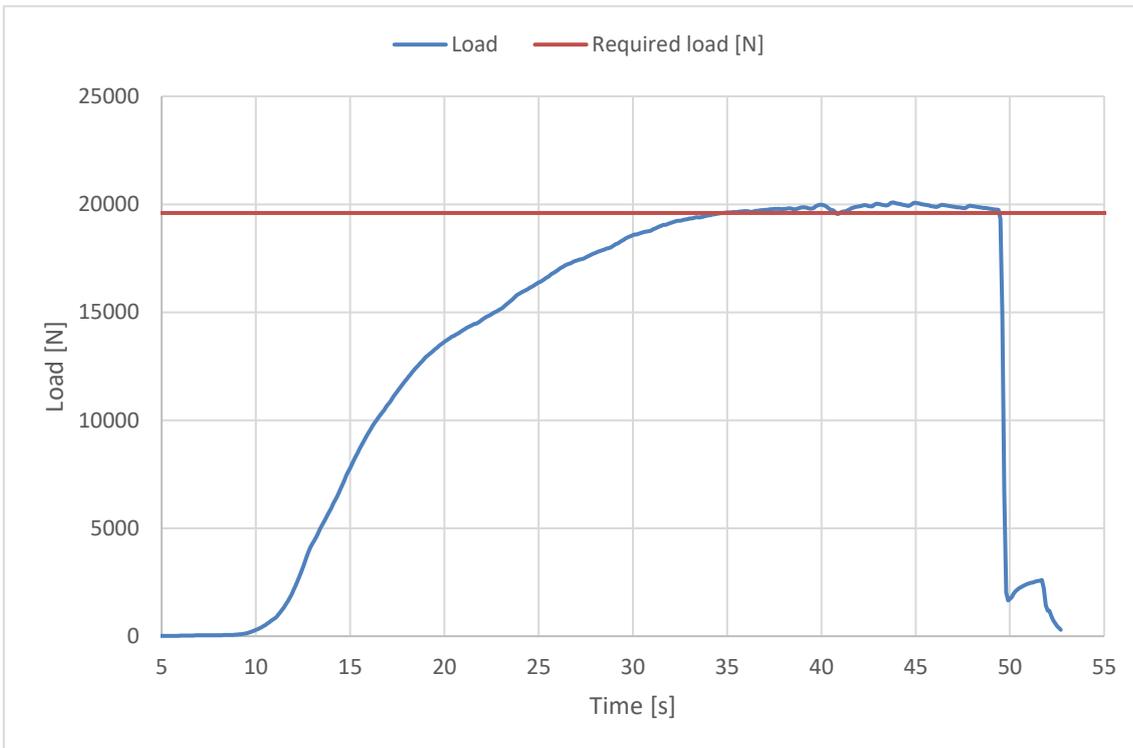
Test ID 09

Reference in standard	5.5.1.3	
Test setup	Positive symmetric load rescue points	
Attachment points	Both main riser attachment (1,2)	
Anchor points	Dummy (B1,B2)	
Required load [g]	15	
Required load [N]	19500	
Minimum test duration [s]	5	
Result		
Test duration [s]	8.5	
Any signs of structural failure	No	
Slippery test OK	Yes	
Test results	POSITIVE

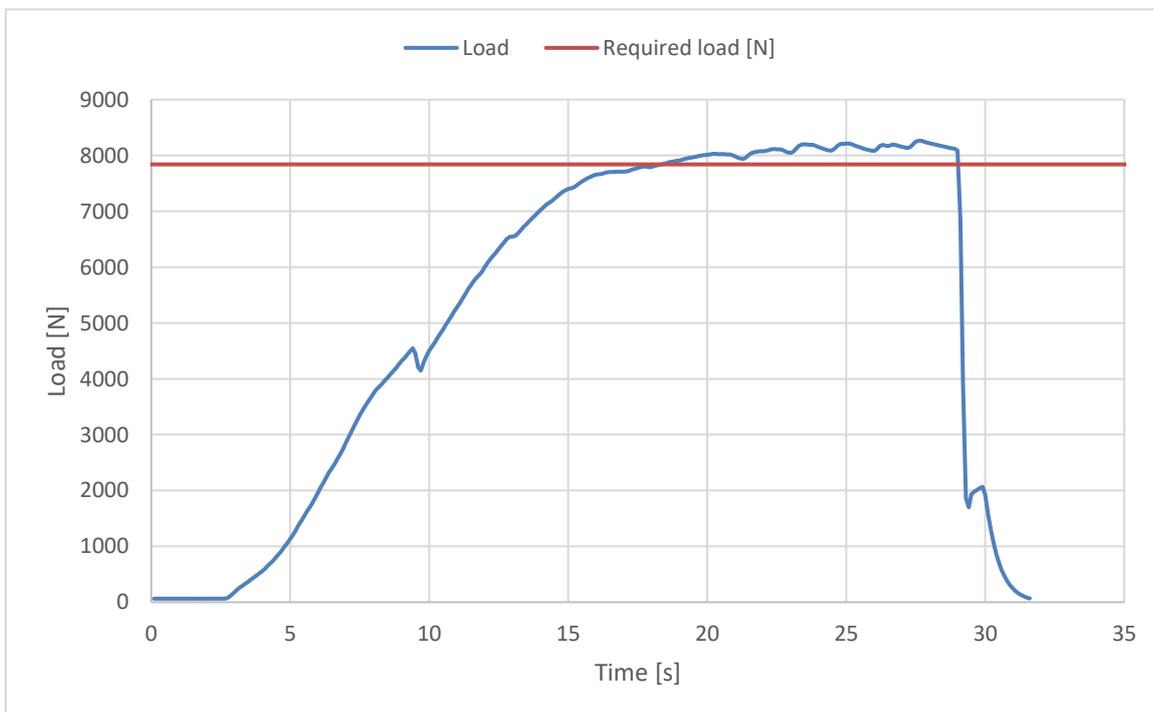
Test ID 12

Standard	EN 1651
Reference in standard	5.5.1.7
Test setup	Upright (landing) position load
Attachment points	Both main riser attachment (3, 4)
Anchor points	Both legstrap of harness (no dummy)
Required load [g]	6
Required load [N]	7800
Minimum test duration [s]	5
Harness type	type b
Result	
Test duration [s]	10.7
Any signs of structural failure	No
Slippery test OK	Yes
Test results	POSITIVE

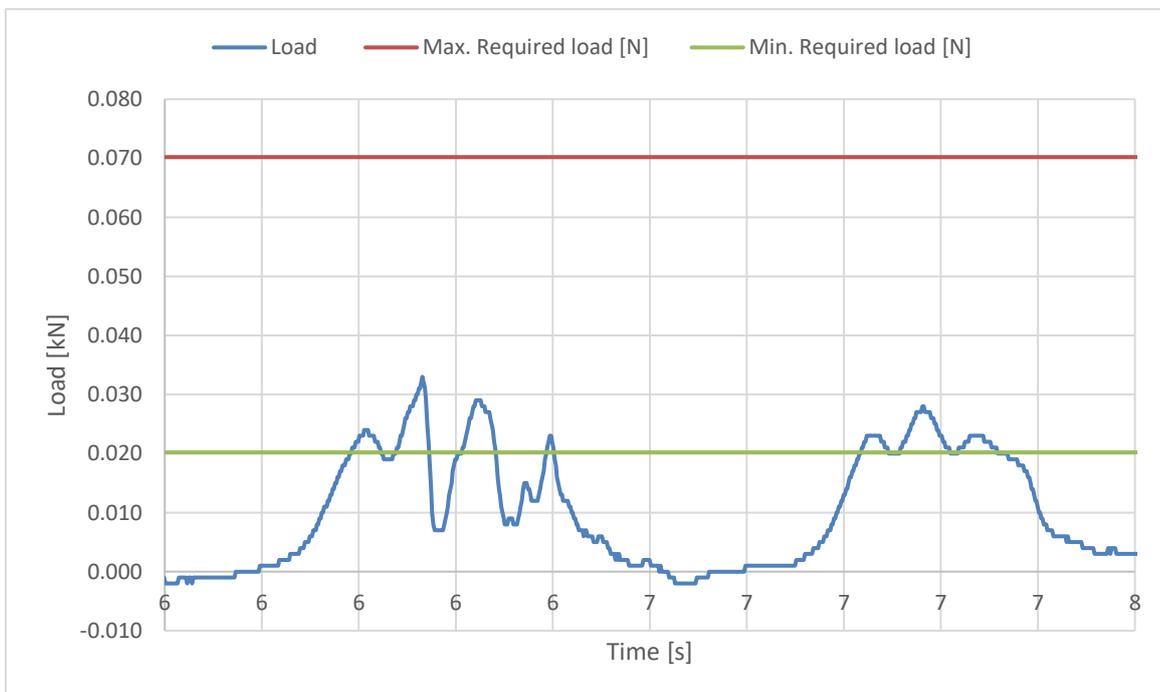
Test ID RRDT

Standard	LTF NfL II 91/09
Reference in standard	6.1.5
Test setup	Default flying position
Attachment points	Sensor connect to handle, and pull in opening direction
	The test is to simulate the load required to open the emergency parachute(1st action).

Load for first action [N]	32.80
Test results	POSITIVE

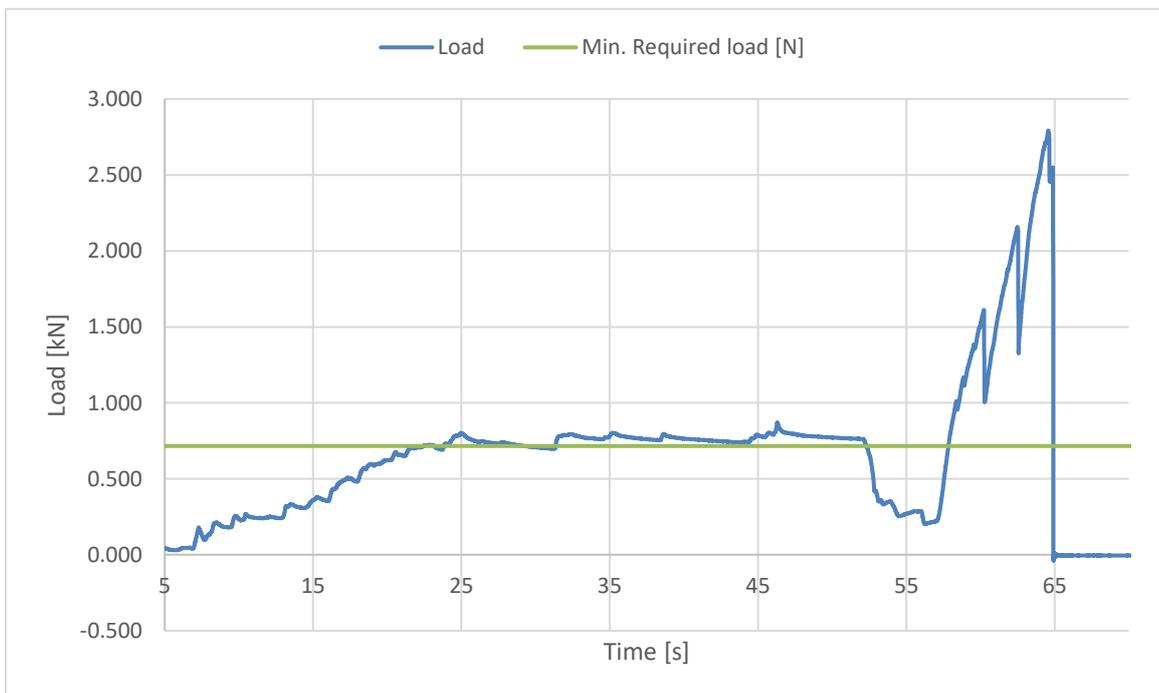
Test ID RRST

Standard	EN12491:2015
Reference in standard	5.3.2
Test setup	Two end points of handle
Attachment points	Sensor connect to end of handle, pull on the other side
	The handle must support min 700 N for 10 s, after measure breaking strength
Min. Required load [N]	700
Minimum test duration [s]	10
Result	
Test duration [s]:	20.9
Breaking strength [N]	2776.22
Test results	POSITIVE
