Harness Structural test Report

Inspection certificate number: **PH_208.2017**
Manufacturer data:

Name: **Minimax Bump**
 Type: **ABS**
 Size: **M**
 Serial number: **2165-07-10**
 Impact pad type: ⁽¹⁾ **Foam**
 Clip-in weight [kg]: **100**

Summary of Structural test

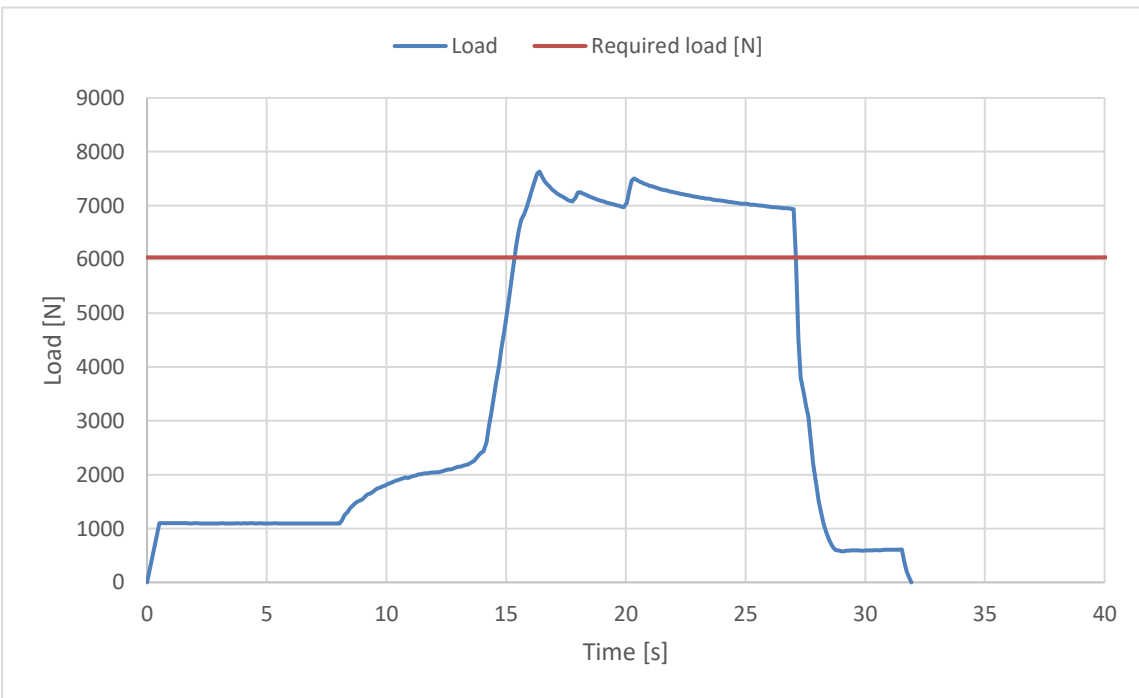
Test ID R0

Reference in standard	5.3.2.1	
Test setup	Default flying position	
Attachment points	Both main riser attachment (3,4)	
Anchor points	Dummy (B1, B2)	
Required load [g]	6	
Required load [N]	6000	
Minimum test duration [s]	10	
Result		
Test duration [s]	11.1	
Any signs of structural failure	No	
Test results	POSITIVE

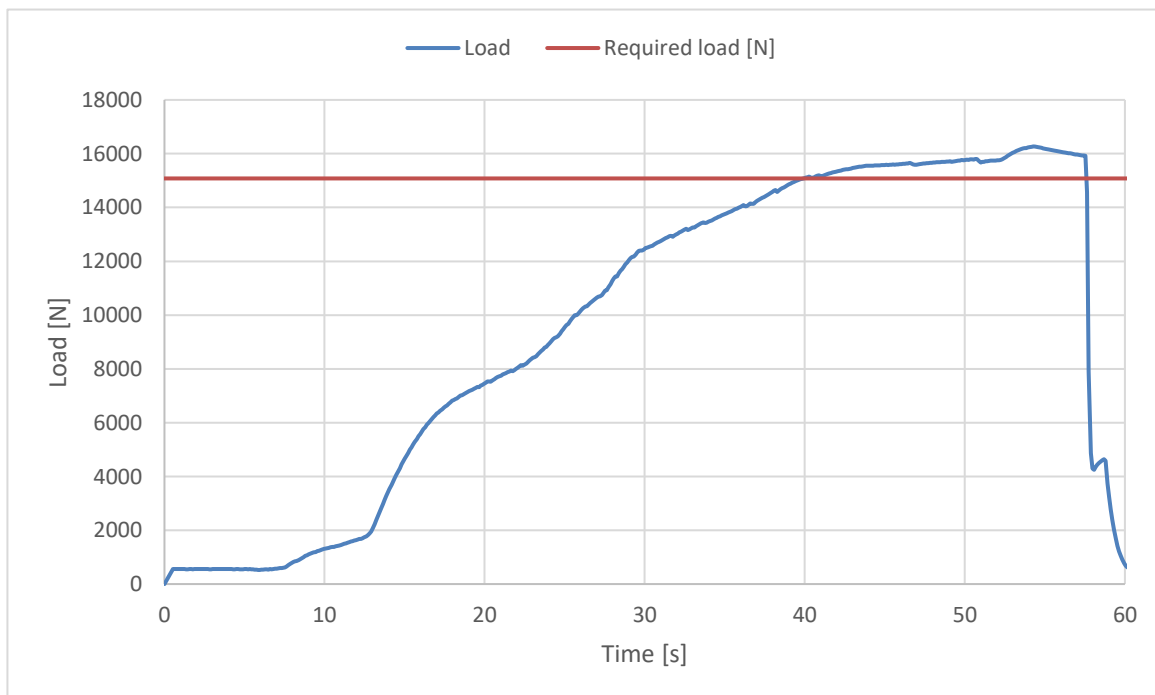
Test ID R2

Standard	EN 1651:1999	
Reference in standard	5.3.2.2	
Test setup	Default flying position	
Attachment points	Both main riser attachment (3,4)	
Anchor points	Dummy (B1, B2)	
Required load [g]	15	
Required load [N]	15000	
Minimum test duration [s]	5	
Result		
Test duration [s]	16.8	
Any signs of structural failure	No	
Test results	POSITIVE

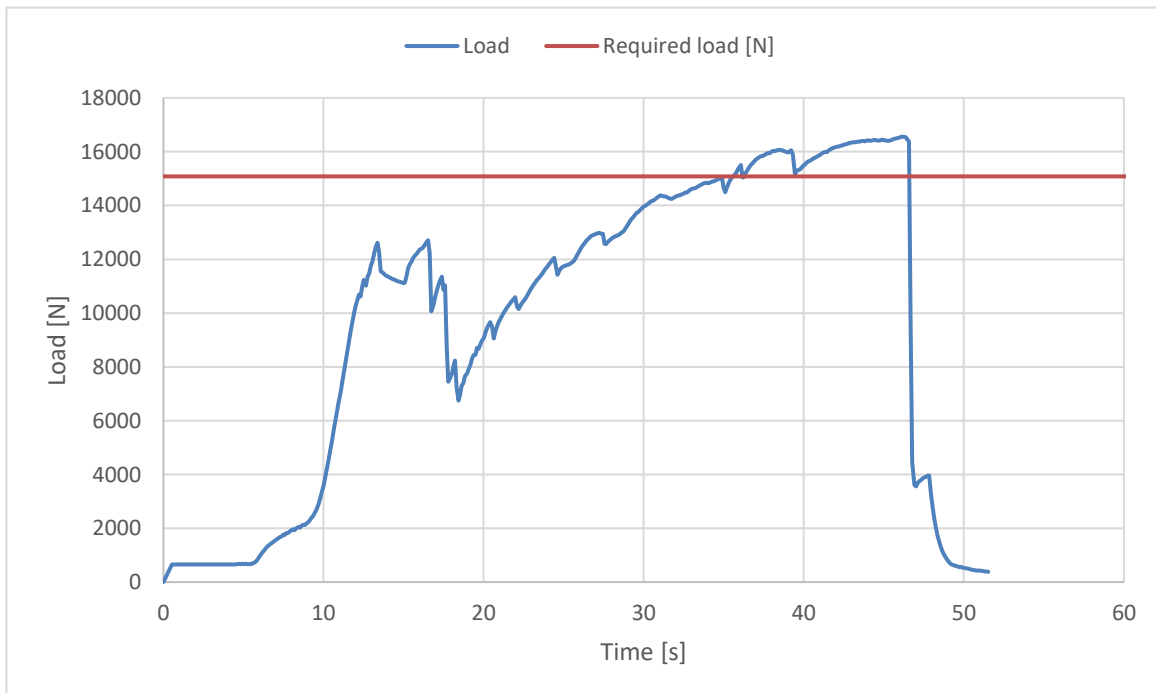
Test ID R4

Standard	EN 1651:1999
Reference in standard	5.3.2.7
Test setup	Flying position before landing
Attachment points	Both main riser attachment (3,4)
Anchor points	Dummy (7,8)
Required load [g]	15
Required load [N]	15000
Minimum test duration [s]	5
Result	
Test duration [s]	9.7
Any signs of structural failure	No
Test results	POSITIVE

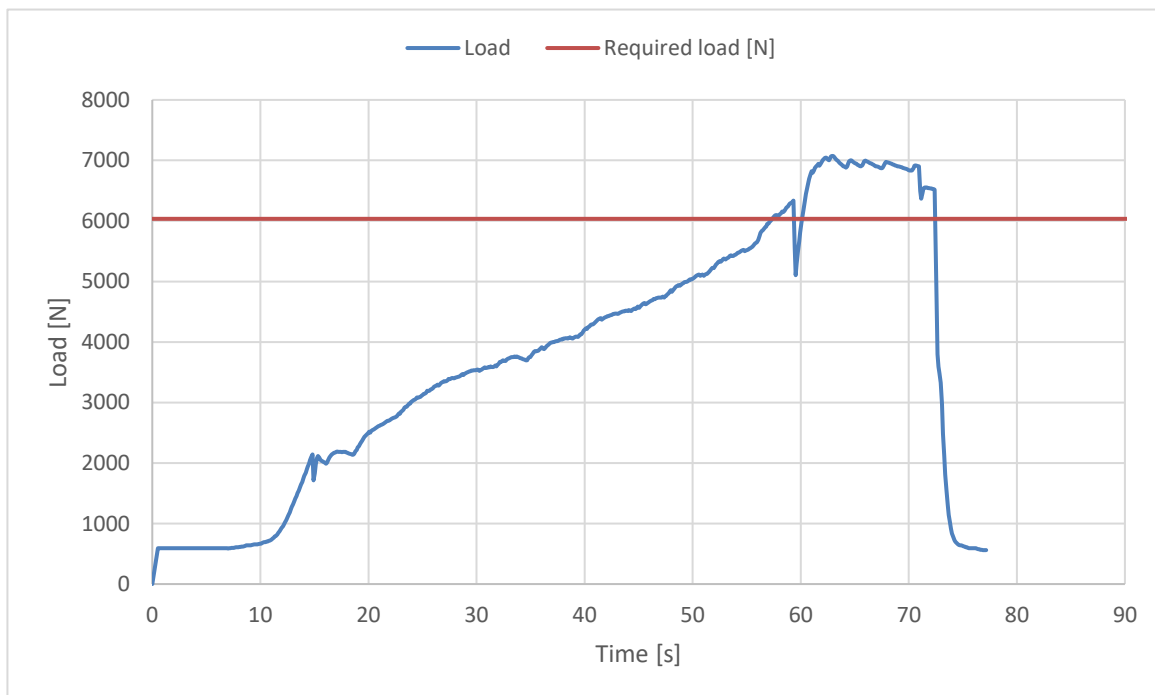
Test ID R8

Reference in standard	5.3.2.3	
Test setup	Asymmetric, one riser	
Attachment points	One main riser attachment (3)	
Anchor points	Dummy (B1,B2)	
Required load [g]	6	
Required load [N]	6000	
Minimum test duration [s]	10	
Result		
Test duration [s]	11.7	
Any signs of structural failure	No	
Test results	POSITIVE

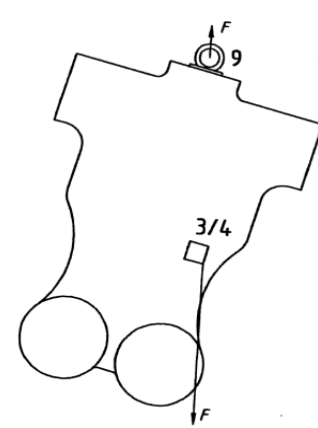
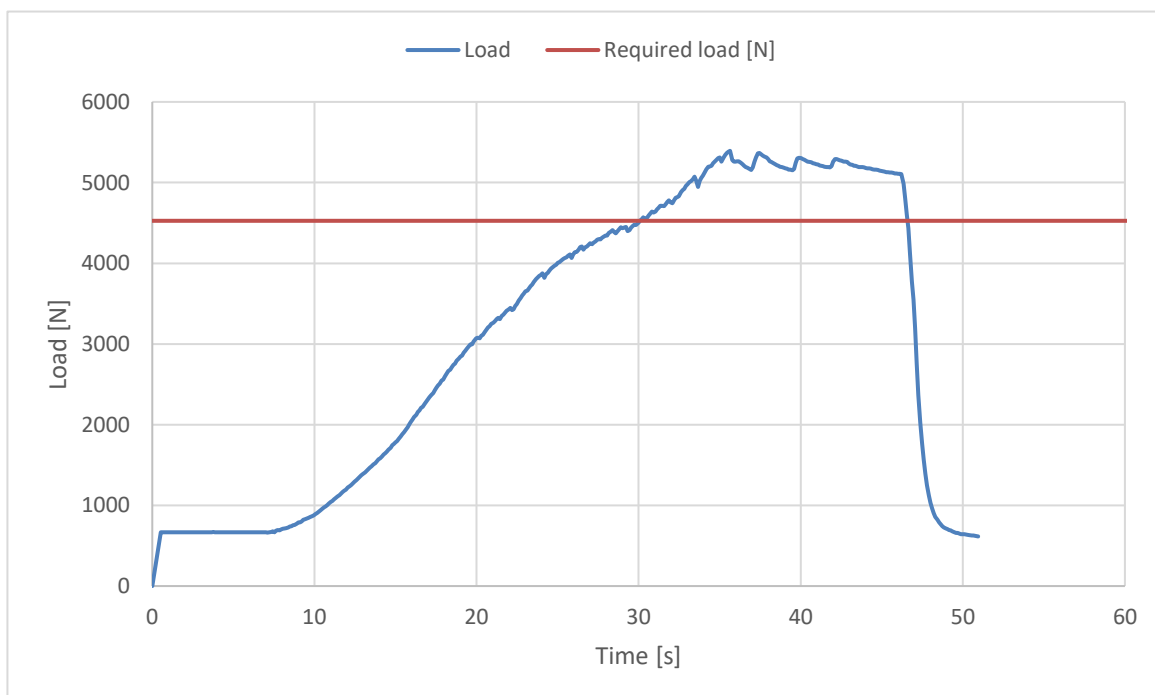
Test ID R10

Reference in standard	5.3.2.6	
Test setup	Asymmetric, negative	
Attachment points	One main riser attachment (3 or 4) downwards	
Anchor points	Dummy (9)	
Required load [g]	4.5	
Required load [N]	4500	
Minimum test duration [s]	10	
Result		
Test duration [s]	15.7	
Any signs of structural failure	No	
Test results	POSITIVE
