Harness Structural test Report

Inspection certificate number: **PH_249.2018**

Name: **Réglable**
 Type: **ABS**
 Size: **M**
 Serial number: **001**
 Impact pad type: ⁽¹⁾ **n/a**
 Clip-in weight [kg]: **100**

model: **Réglable M**

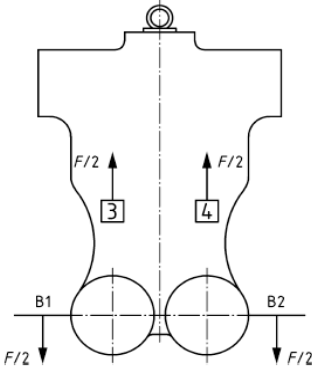
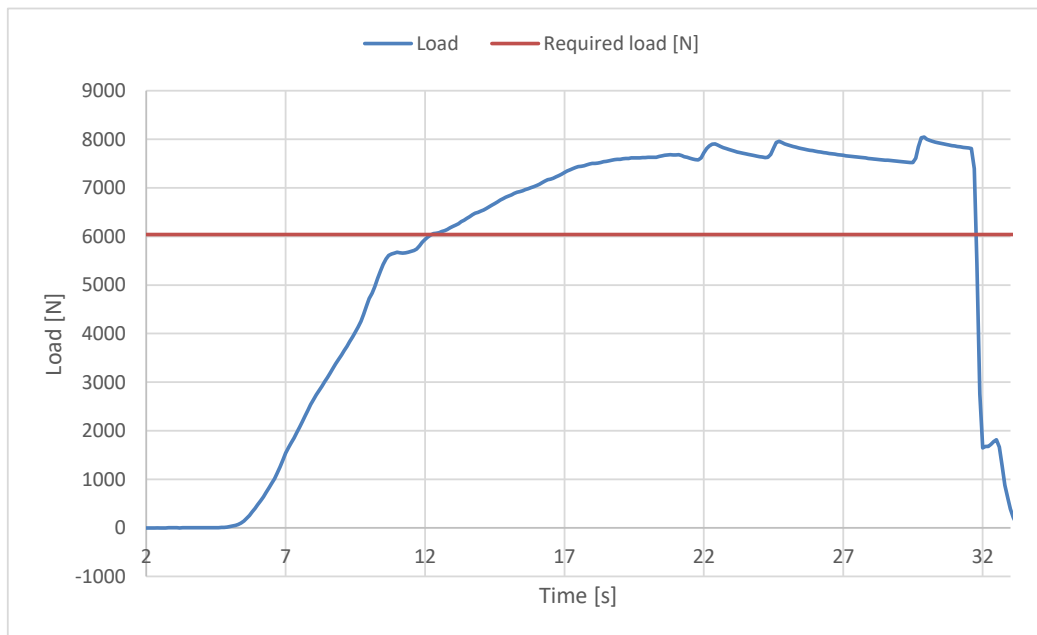
Test ID R0

Standard	EN 1651:1999
Reference in standard	5.3.2.1
Test setup	Default flying position
Attachment points	Both main riser attachment (3,4)
Anchor points	Dummy (B1, B2)
Required load [g]	6
Required load [N]	6000
Minimum test duration [s]	10
Result	
Test duration [s]	19.5
Any signs of structural failure	No
Test results	POSITIVE

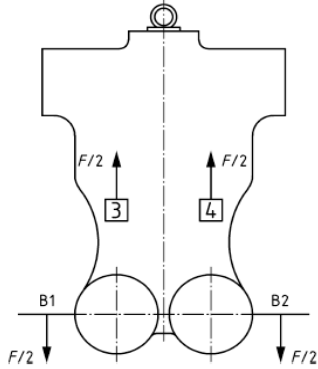
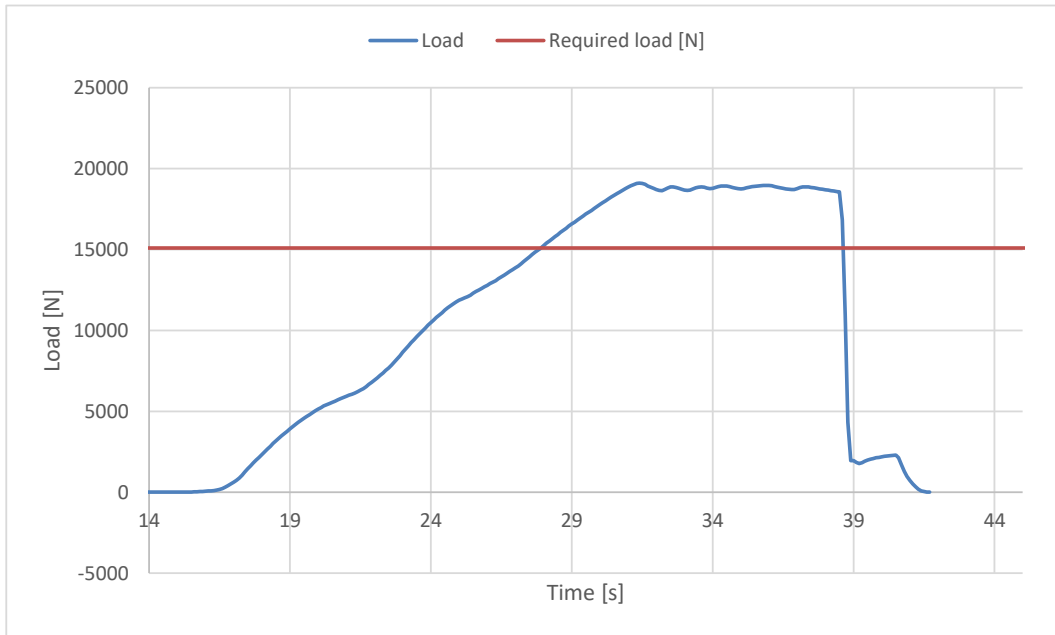
Test ID R2

Reference in standard	5.3.2.2	
Test setup	Default flying position	
Attachment points	Both main riser attachment (3,4)	
Anchor points	Dummy (B1, B2)	
Required load [g]	15	
Required load [N]	15000	
Minimum test duration [s]	5	
Result		
Test duration [s]	10.8	
Any signs of structural failure	No	
Test results	POSITIVE

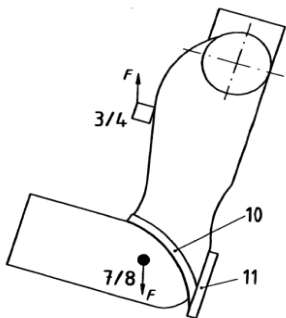
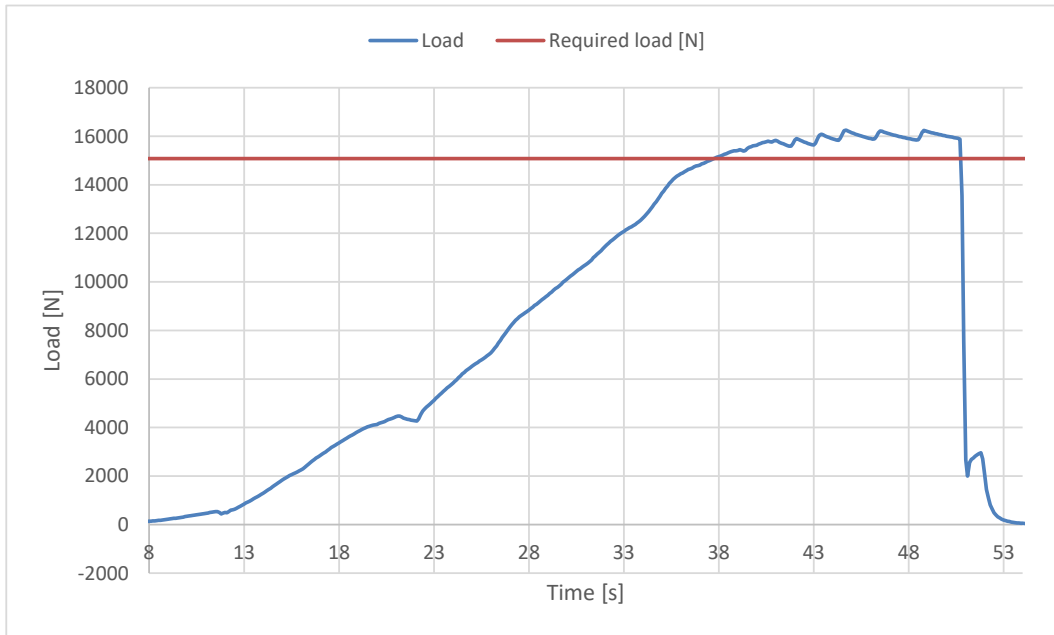
Test ID R4

Standard	EN 1651:1999
Reference in standard	5.3.2.7
Test setup	Flying position before landing
Attachment points	Both main riser attachment (3,4)
Anchor points	Dummy (7,8)
Required load [g]	15
Required load [N]	15000
Minimum test duration [s]	5
Result	
Test duration [s]	13
Any signs of structural failure	No
Test results	POSITIVE

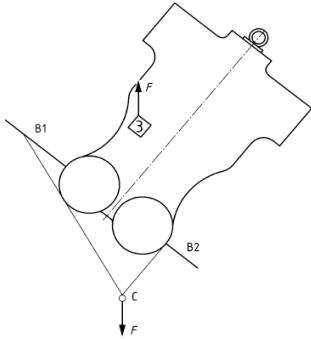
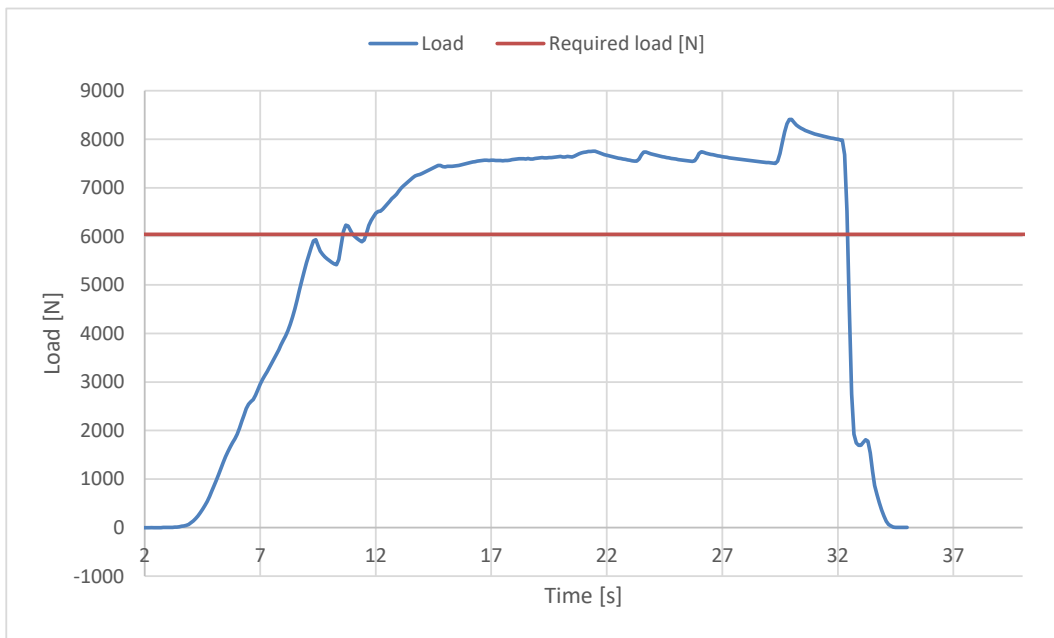
Test ID R8

Standard	EN 1651:1999
Reference in standard	5.3.2.3
Test setup	Asymmetric, one riser
Attachment points	One main riser attachment (3)
Anchor points	Dummy (B1,B2)
Required load [g]	6
Required load [N]	6000
Minimum test duration [s]	10
Result	
Test duration [s]	20.9
Any signs of structural failure	No
Test results	POSITIVE

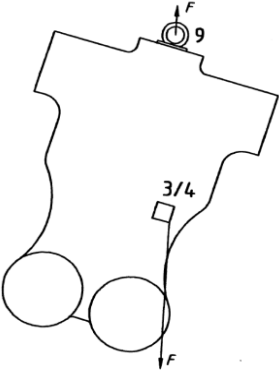
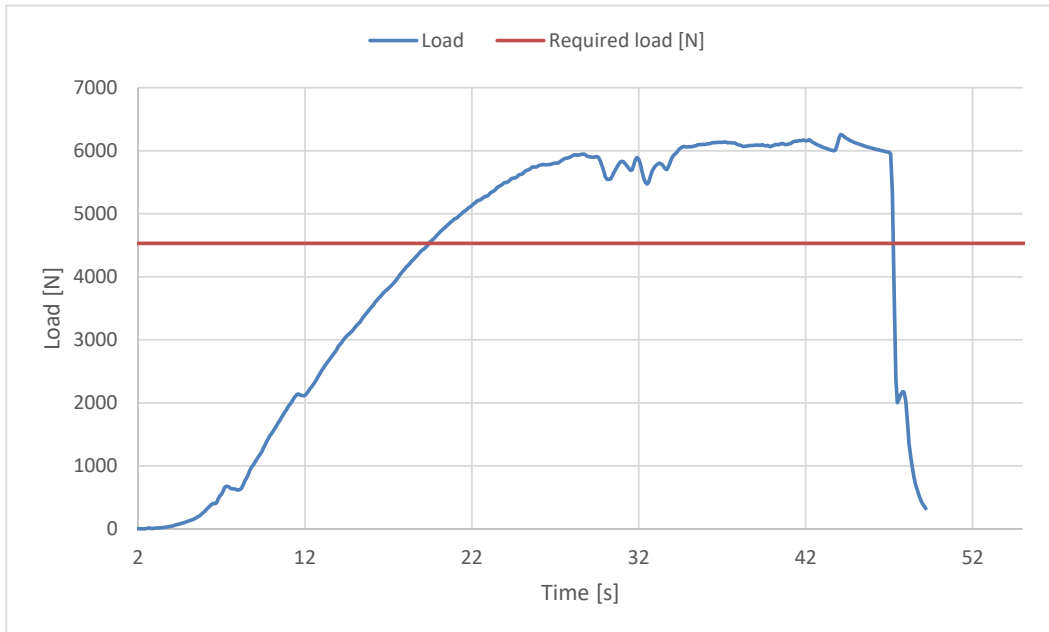
Test ID R10

Standard	EN 1651:1999
Reference in standard	5.3.2.6
Test setup	Asymmetric, negative
Attachment points	One main riser attachment (3 or 4) downwards
Anchor points	Dummy (9)
Required load [g]	4.5
Required load [N]	4500
Minimum test duration [s]	10
Result	
Test duration [s]	27.8
Any signs of structural failure	No
Test results	POSITIVE
