Harness Structural test Report - EN

Inspection certificate number: **PH_298.2020**

Name: **Access2**
 Type: **ABS**
 Size: **M**
 Serial number: **2170MM121ROAA2**
 Impact pad type: ⁽¹⁾ **Airbag**
 Clip-in weight [kg]: **120**
 Date of test: **10.02.2020**

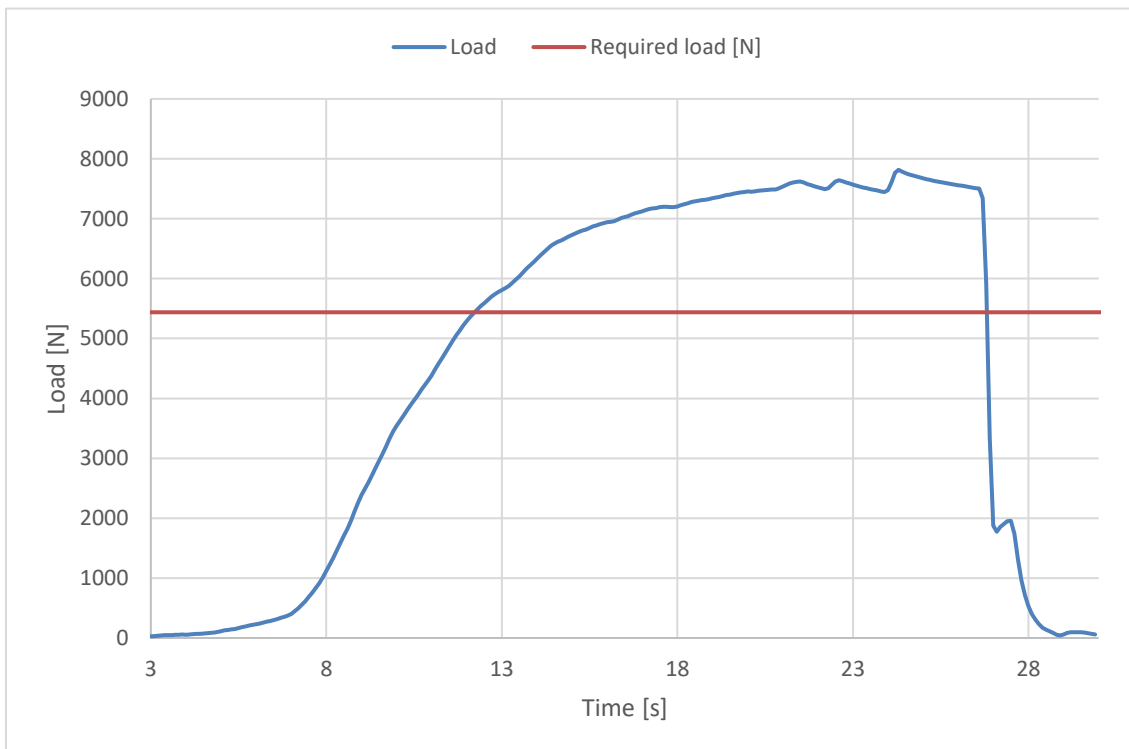
Test ID 01

Standard	EN 1651:2018
Reference in standard	5.5.1.1
Test setup	Positive symmetric load (Slippage)
Attachment points	Both main riser attachment (3,4)
Anchor points	Dummy (B1, B2)
Required load [g]	4.5
Required load [N]	5400
Minimum test duration [s]	5
Result	
Test duration [s]	14.6
Any signs of structural failure	No
Slippery test OK	No
Test results	POSITIVE

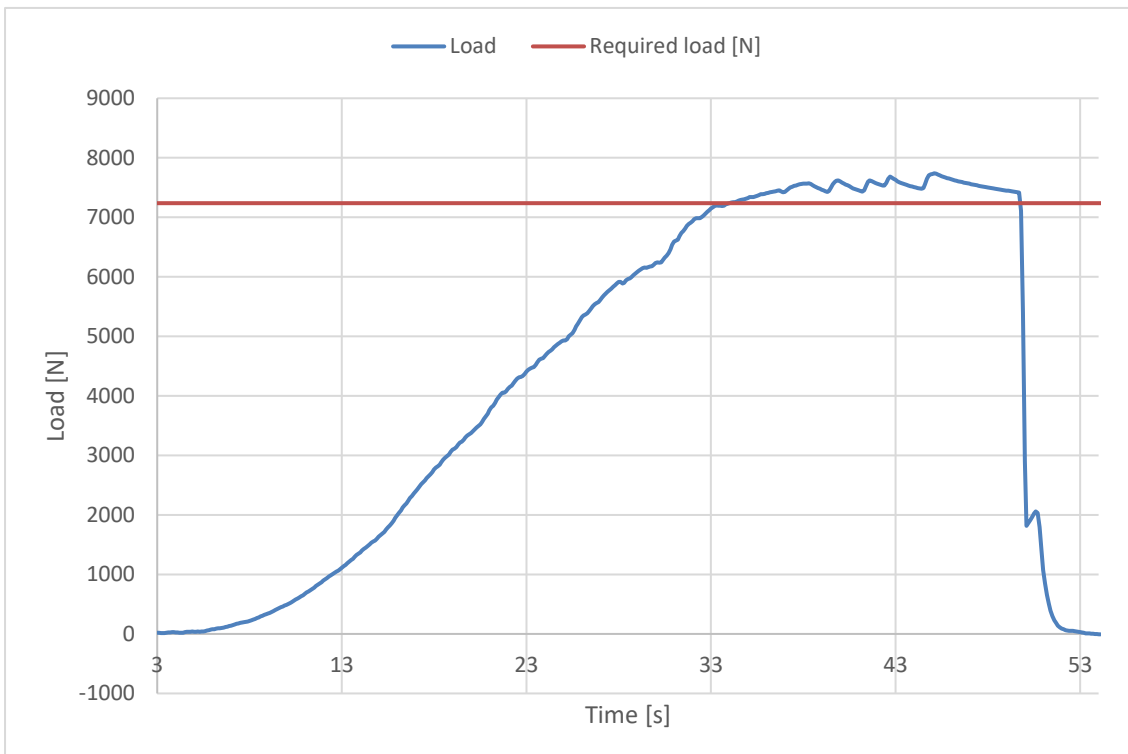
Test ID 05

Reference in standard	5.5.1.2	
Test setup	Positive asymmetric load	
Attachment points	One riser attachment (3 or 4)	
Anchor points	Dummy (C)	
Required load [g]	6	
Required load [N]	7200	
Minimum test duration [s]	5	
Result		
Test duration [s]	15.8	
Any signs of structural failure	No	
Test results	POSITIVE

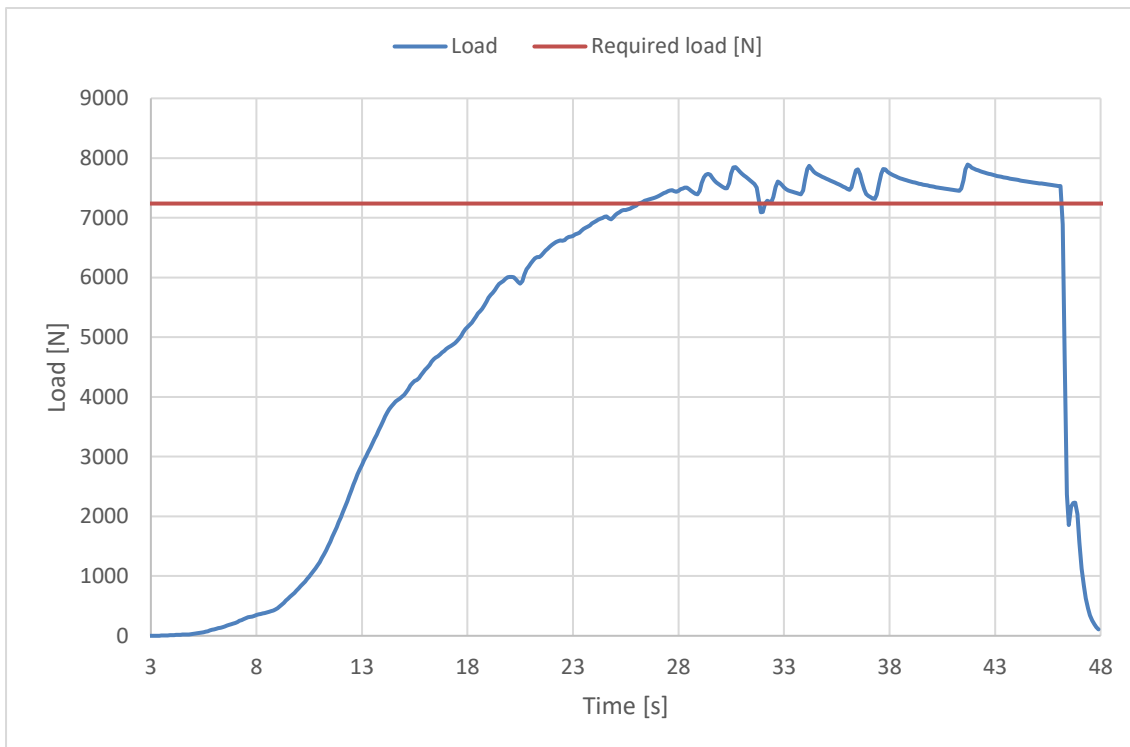
Test ID 06

Standard	EN 1651:2018
Reference in standard	5.5.1.6
Test setup	Negative symmetric load
Attachment points	Both main riser attachment (3,4)
Anchor points	Dummy (A)
Required load [g]	6
Required load [N]	7200
Minimum test duration [s]	5
Result	
Test duration [s]	14
Any signs of structural failure	No
Test results	POSITIVE

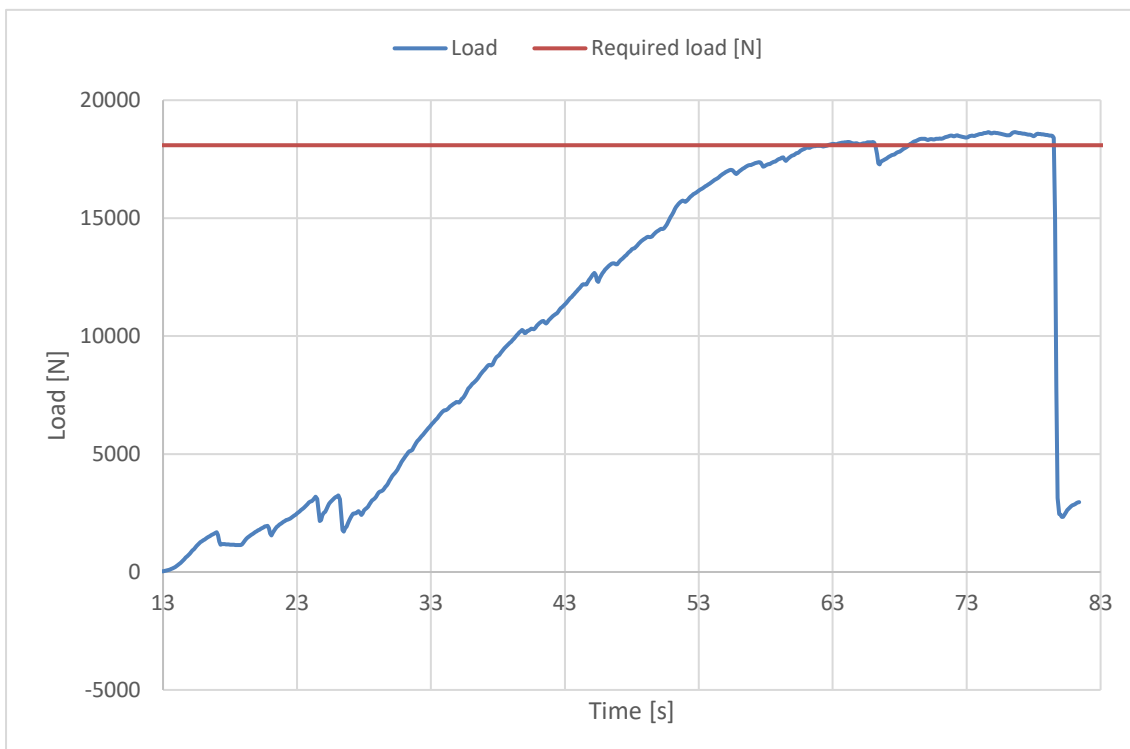
Test ID 09

Standard	EN 1651:2018
Reference in standard	5.5.1.3
Test setup	Positive symmetric load rescue points
Attachment points	Both main riser attachment (1,2)
Anchor points	Dummy (B1,B2)
Required load [g]	15
Required load [N]	18000
Minimum test duration [s]	5
Result	
Test duration [s]	10.9
Any signs of structural failure	No
Slippery test OK	No
Test results	POSITIVE

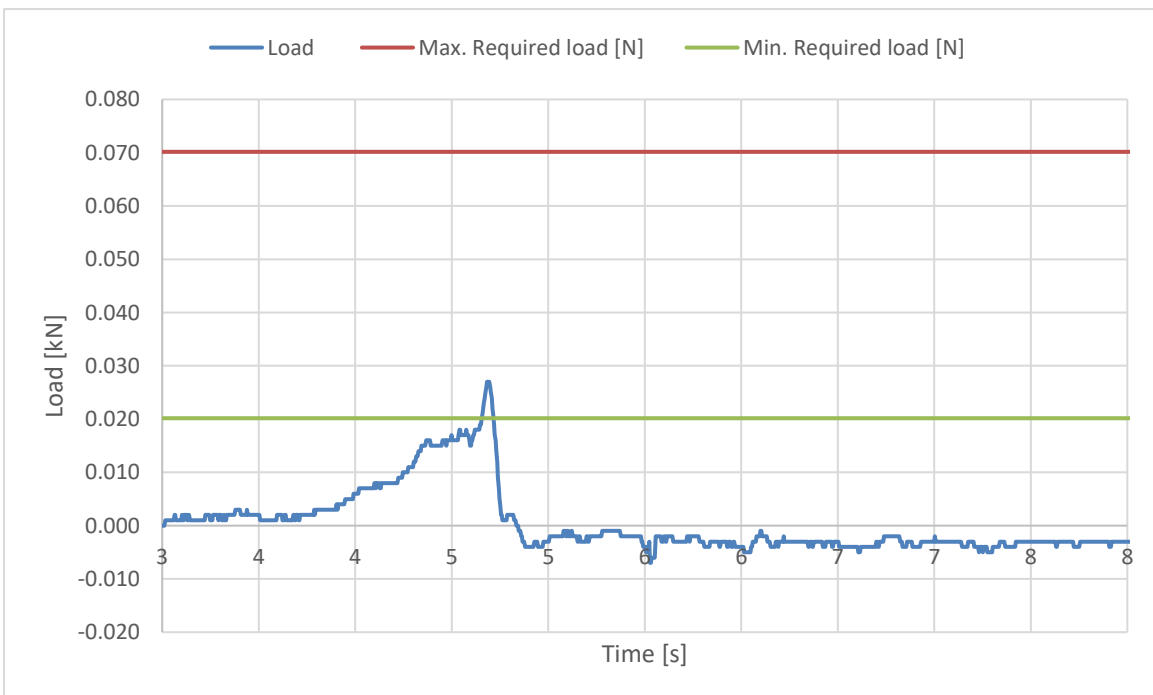
Test ID RRDT

Standard	LTF NfL II 91/09
Reference in standard	6.1.5
Test setup	Default flying position
Attachment points	Sensor connect to handle, and pull in opening direction
	The test is to simulate the load required to open the emergency parachute(1st action).

Load for first action [N]	26.84
Test results	POSITIVE

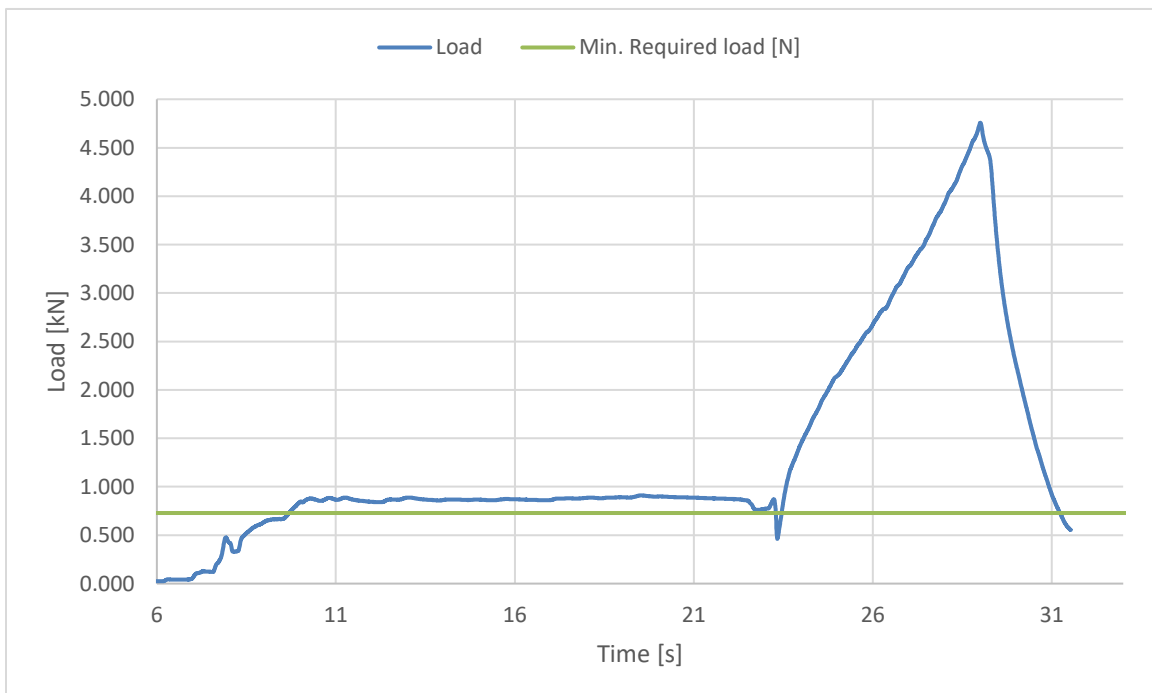
Test ID RRST

Standard	EN12491:2015
Reference in standard	5.3.2
Test setup	Two end points of handle
Attachment points	Sensor connect to end of handle, pull on the other side
	The handle must support min 700 N for 10 s, after measure breaking strength
Min. Required load [N]	700
Minimum test duration [s]	10
Result	
Test duration [s]:	13.6
Breaking strength [N]	4728.42
Test results	POSITIVE
