Harness Spreader Report

Inspection certificate number: MISC_205.2022

Name Spreader: **Tandem Spreader Hard**
 Max Load [kg]: **225**
 Serial number: **TSH001**
 Date of reception: **22.03.2022**

Airworthiness Requirements **NfL 2-565-20**

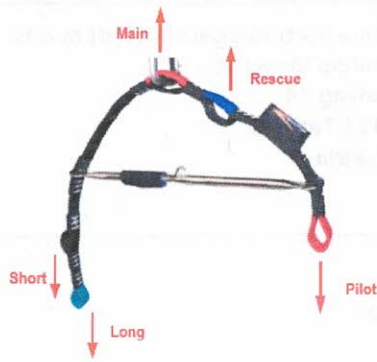
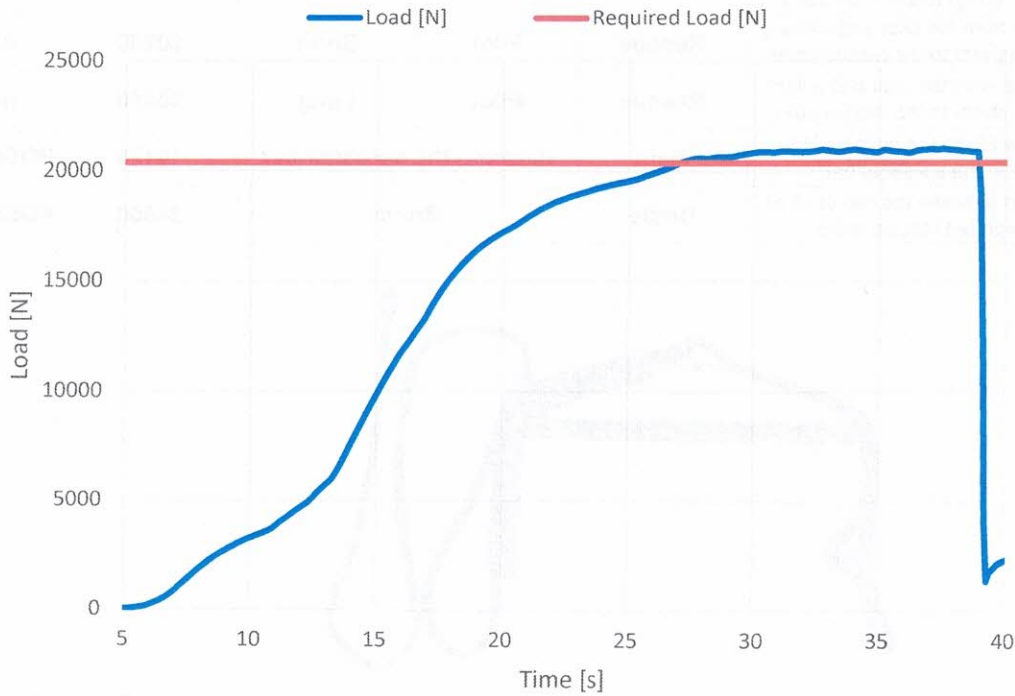
Test 1

Standard	NfL 2-565-20
Test setup	Induced load from the pilot and a heavy passenger (short) to the main point
Min. Required load [g]	9
Min. Required load [N]	20250
Min. Required duration [s]	10
Result	
Test duration [s]	11.9
Any signs of structural failure	No
Test results	POSITIVE

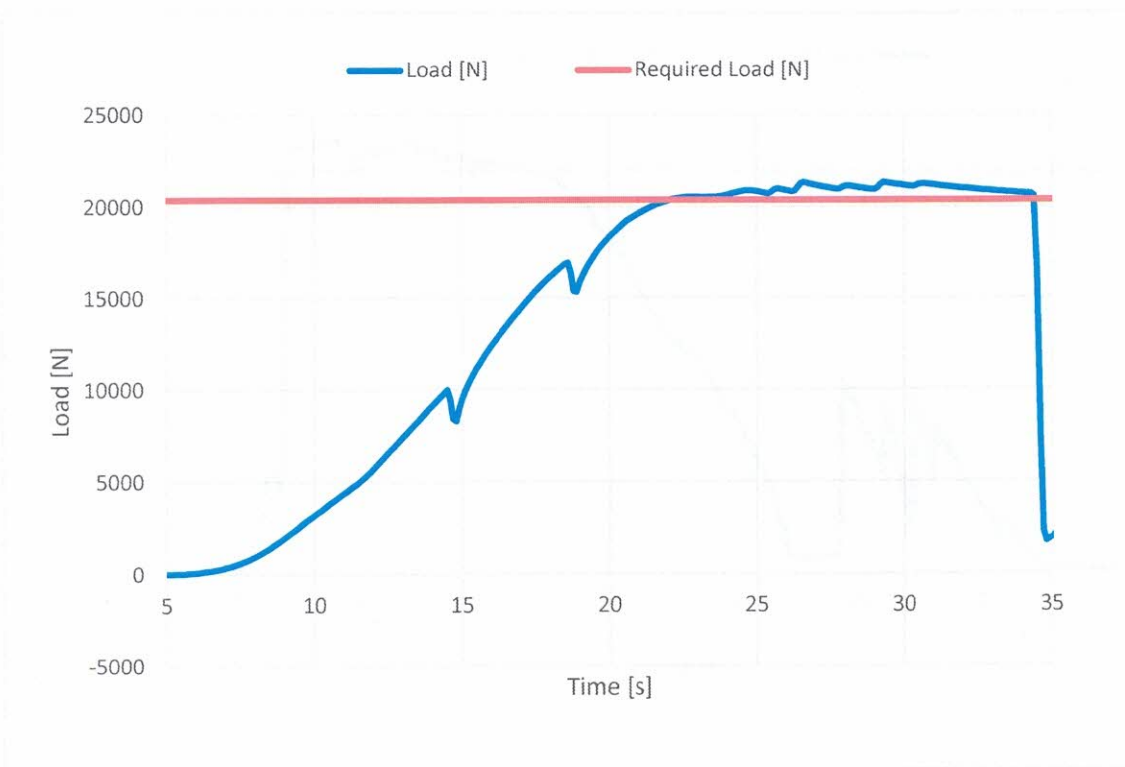
Test 2

Standard	NfL 2-565-20
Test setup	Induced load from the pilot and a light passenger (long) to the main point
Min. Required load [g]	9
Min. Required load [N]	20250
Duration [s]	10
Result	
Test duration [s]	12.4
Any signs of structural failure	No
Test results	POSITIVE

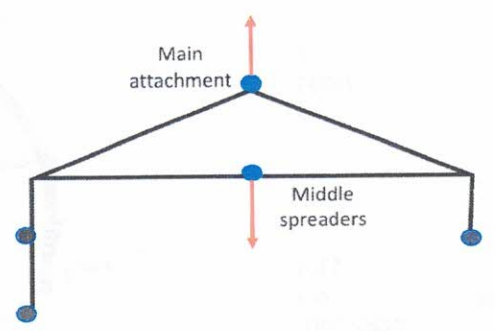
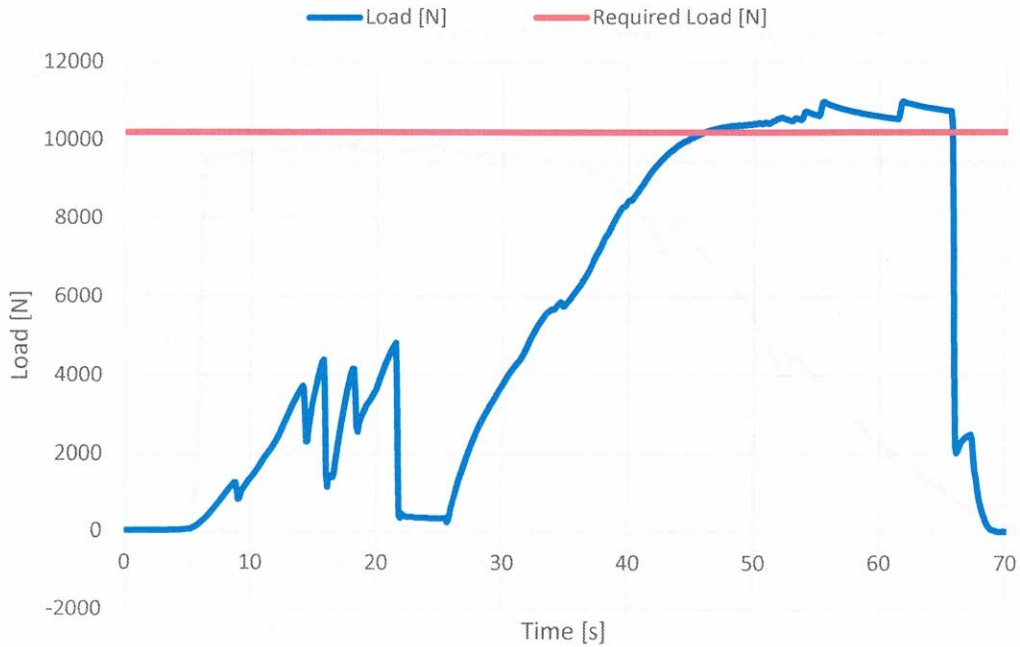
Test 5

Standard	NfL 2-565-20
Test setup	Induced load from the main point to between the spreader bar
Min. Required load [g]	4.5
Min. Required load [N]	10125
Duration [s]	10
Result	
Test duration [s]	19.8
Any signs of structural failure	No
Test results	POSITIVE

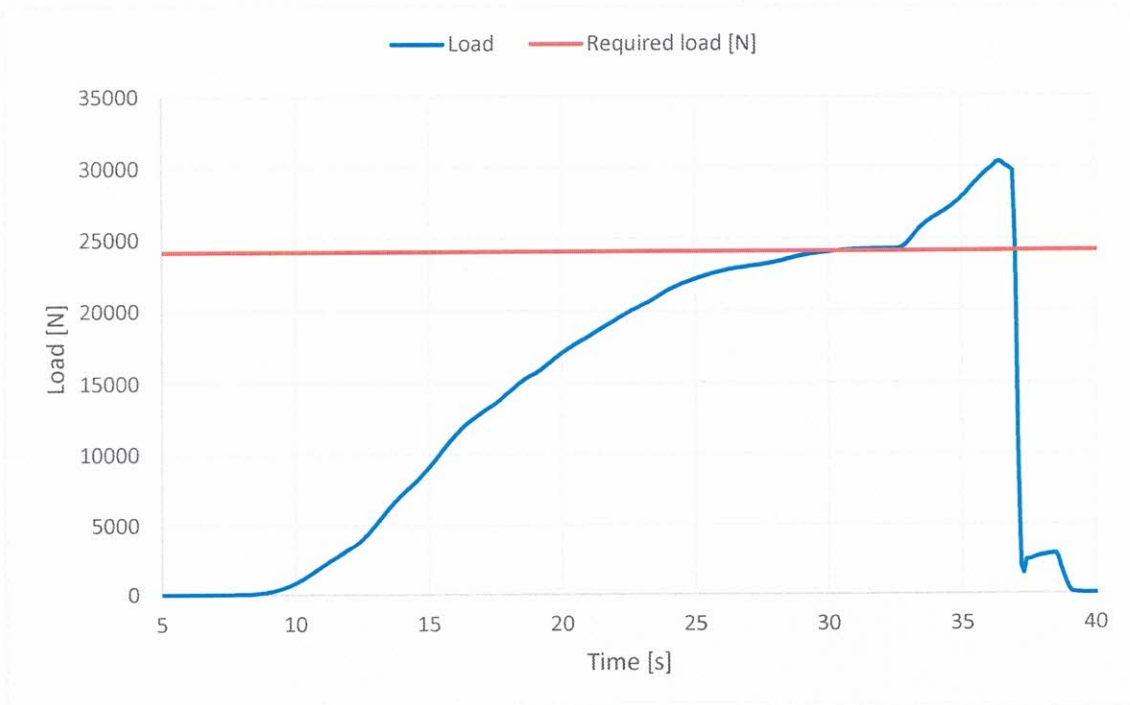
Test ID 11

Standard	NfL 2-565-20
Test setup	Connecting element for rescue
Attachment points	End point (emergency parachute)
Anchor points	Both attachment to spreader
Required load [g]	n/a
Required load [N]	24000
Minimum test duration [s]	0.3
Type of connecting element	a) two single elements
Result	
Test duration [s]	6.6
Any signs of structural failure	No
Test results	POSITIVE
