Harness Structural test Report - LTF

Inspection certificate number: **PH_315.2020**

Name: **Weightless**
 Type: **ABS**
 Size: **M**
 Serial number: **116040**
 Impact pad type: ⁽¹⁾ **Foam**
 Clip-in weight [kg]: **120**

Air Turquoise SA, having thoroughly assessed the sample mentioned above, declare it was found conform with
 Airworthiness Requirements **LTF n°L II 91/09 - EN12491:2015 5.3.2**

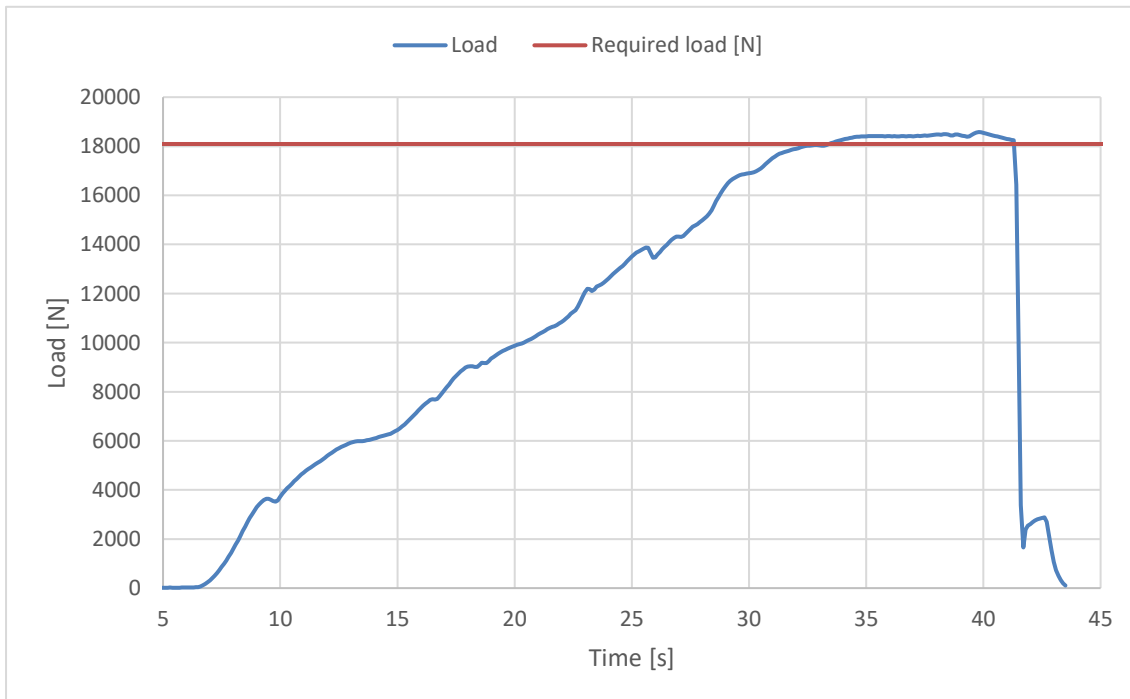
Test ID 03

Standard	LTF NfL II 91/09
Reference	5.3.2.2
Test setup	Default flying position
Attachment points	Both main riser attachment (3,4)
Anchor points	Dummy (B1, B2)
Required load [g]	15
Required load [N]	18000
Minimum test duration [s]	5
Result	
Test duration [s]	7.9
Any signs of structural failure	No
Test results	POSITIVE

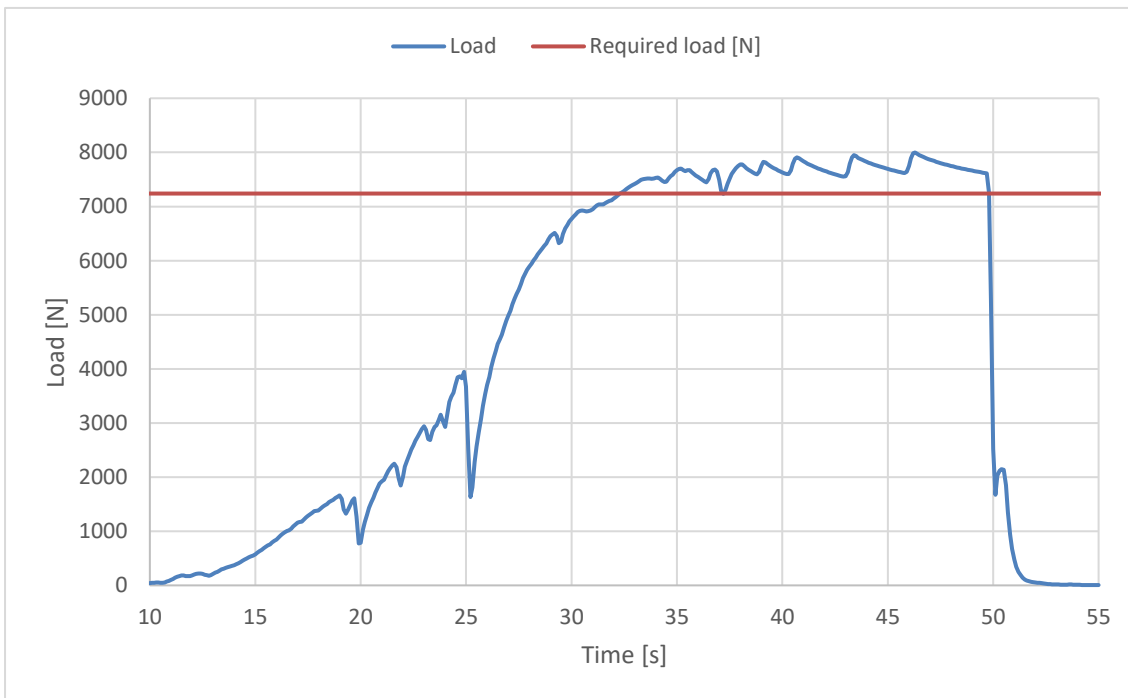
Test ID 04

Standard **LTF NfL II 91/09**
 Reference **5.3.2.3**
 Test setup **Asymmetric, one riser**
 Attachment points **One main riser attachment (3)**
 Anchor points **Dummy (B1,B2)**

Required load [g] **6**
 Required load [N] **7200**
 Minimum test duration [s] **10**

Test duration [s] **12.6**
 Any signs of structural failure **No**
 Test results **POSITIVE**

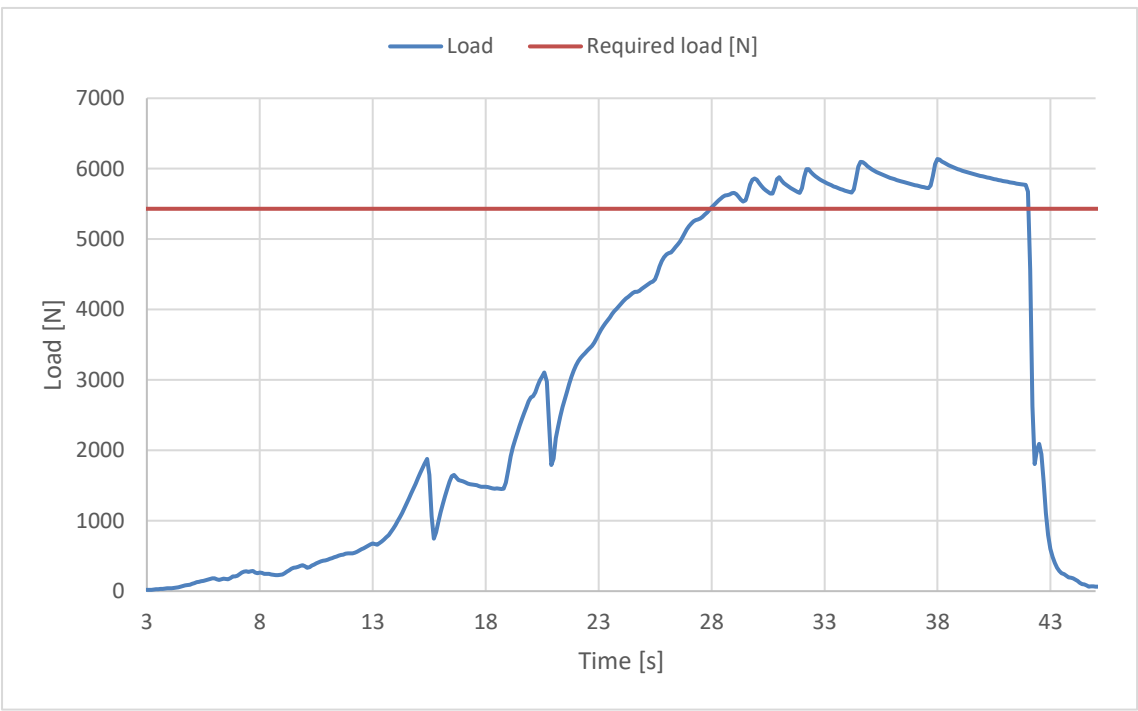
Test ID 07

Standard	LTF NfL II 91/09

Reference	5.3.2.6	
Test setup	Asymmetric, negative	
Attachment points	One main riser attachment (3 or 4) downwards	
Anchor points	Dummy (9)	
Required load [g]	4.5	
Required load [N]	5400	
Minimum test duration [s]	10	
Result		
Test duration [s]	14.1	
Any signs of structural failure	No	
Test results	POSITIVE

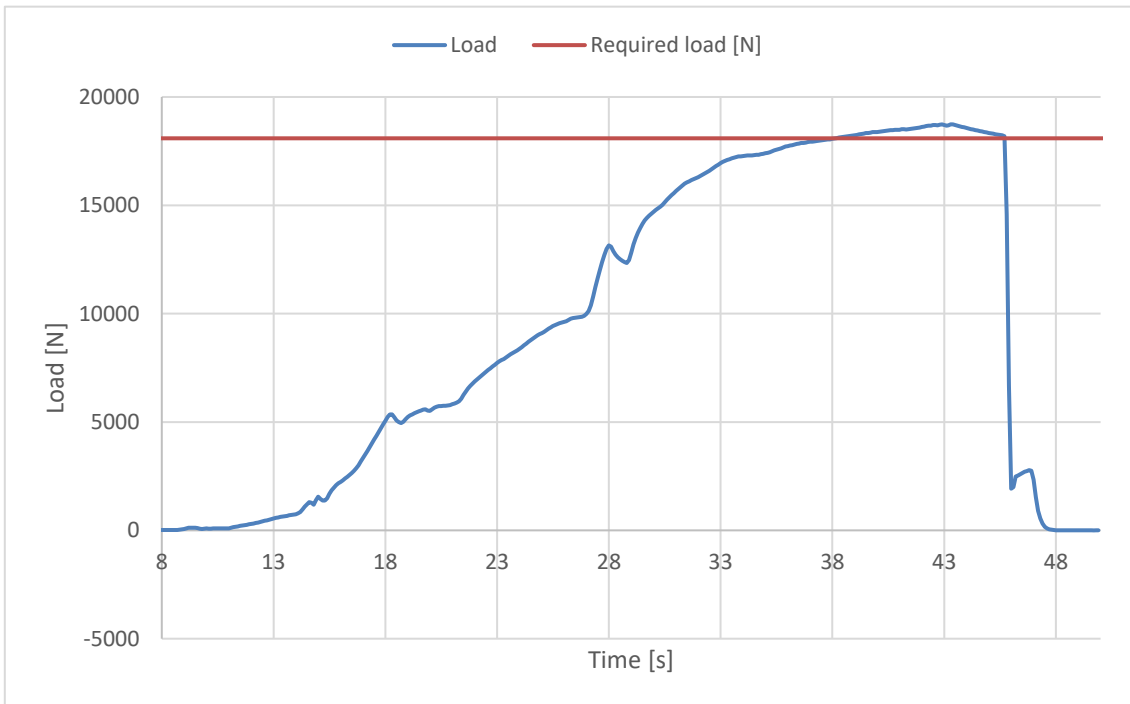
Test ID 09

Standard	LTF NfL II 91/09
Reference	5.3.2.4
Test setup	Rescue attachments
Attachment points	Rescue riser attachment (1,2)
Anchor points	Dummy (B1,B2)
Required load [g]	15
Required load [N]	18000
Minimum test duration [s]	5
Result	
Test duration [s]	7.6
Any signs of structural failure	No
Test results	POSITIVE

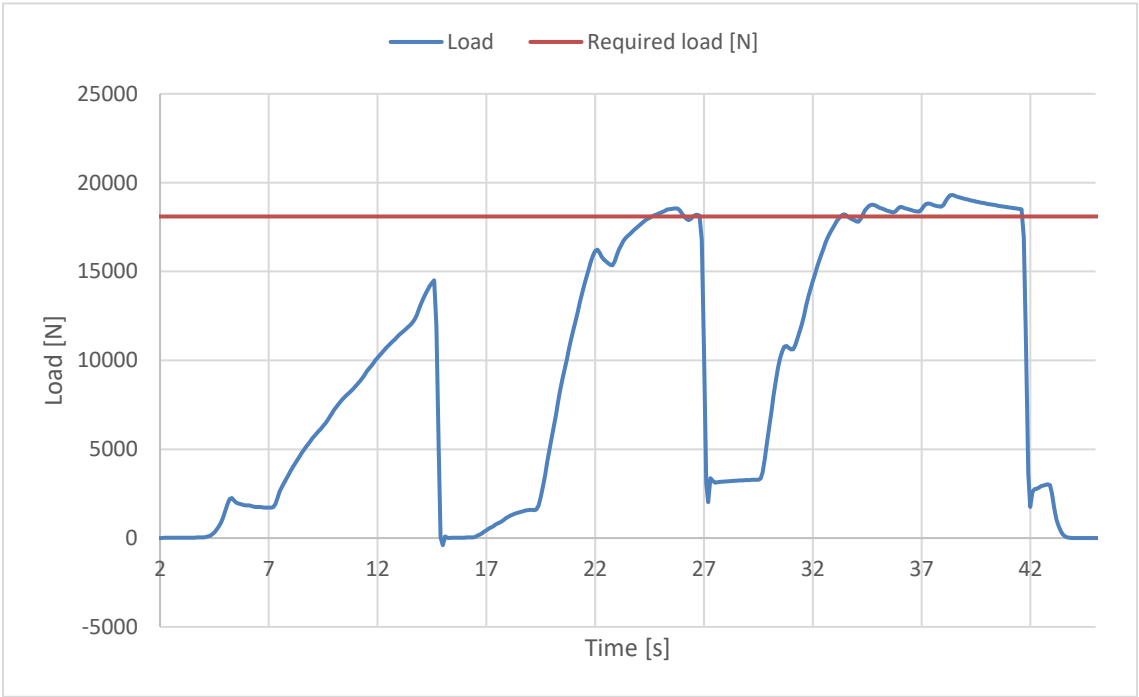
Test ID 13

Standard	LTF NfL II 91/09
Reference	5.3.2.7
Test setup	Flying position before landing
Attachment points	Both main riser attachment (3,4)
Anchor points	Dummy (7,8)
Required load [g]	15
Required load [N]	18000
Minimum test duration [s]	5
Result	
Test duration [s]	7.4
Any signs of structural failure	No
Test results	POSITIVE

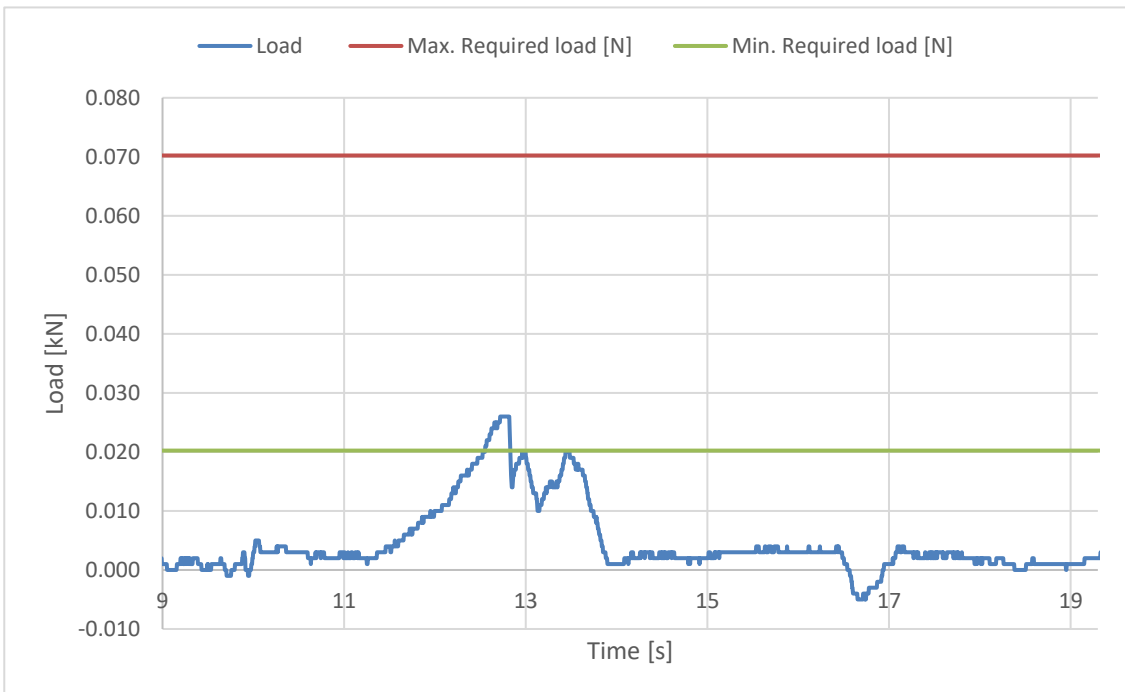
Test ID RRDT

Standard	LTF NfL II 91/09
Reference	6.1.5
Test setup	Default flying position
Attachment points	Sensor connect to handle, and pull in opening direction
	The test is to simulate the load required to open the emergency parachute(1st action).
Min. Required load [N]	20
Max. Required load [N]	70
Result	
Load for first action [N]	25.77
Test results	POSITIVE

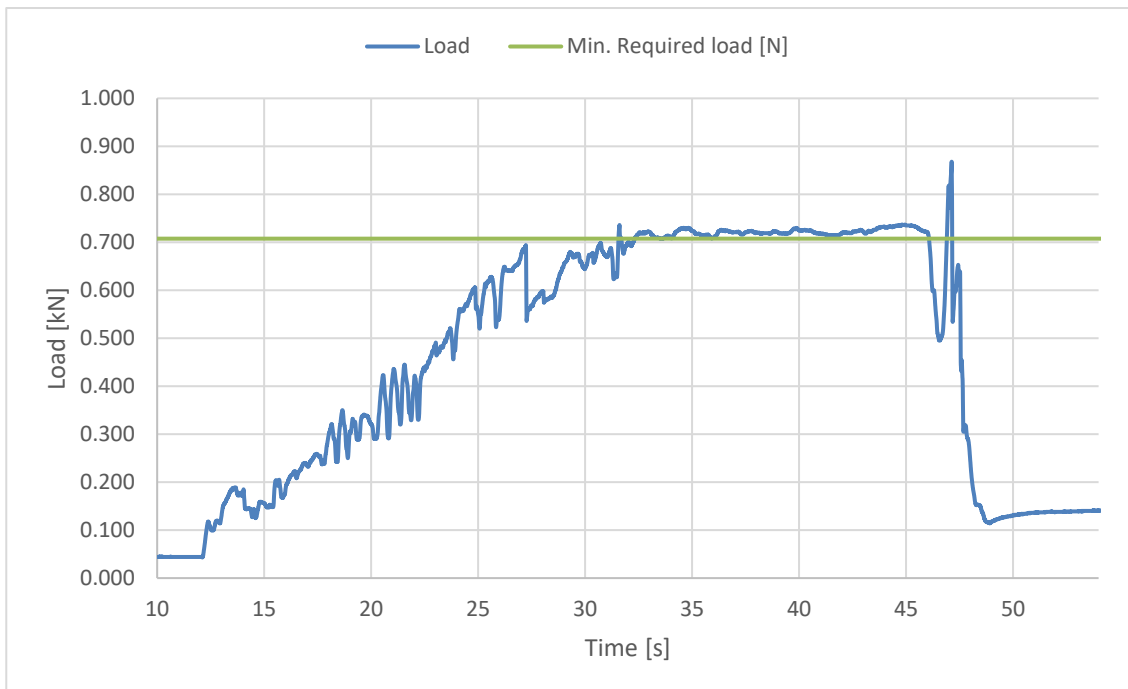
Test ID RRST

Standard	EN12491:2015
Reference in standard	5.3.2
Test setup	Two end points of handle
Attachment points	Sensor connect to end of handle, pull on the other side
	The handle must support min 700 N for 10 s, after measure breaking strength
Min. Required load [N]	700
Minimum test duration [s]	10
Result	
Test duration [s]:	12.5
Breaking strength [N]	860.47
Test results	POSITIVE
