Test laboratory for paragliders, paraglider harnesses and paraglider reserve parachutes

Test report - Spreader

MISC_024.2017

Spreaderbar - rigid

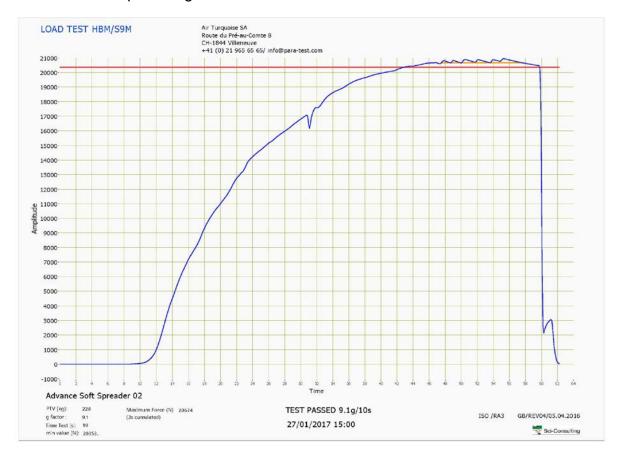
Test 1:

The load has been induced from pilot- and the first (long) passenger attachment to the main attachment point of glider.

Tested successfully, up to 20674 [N] more as 10 seconds

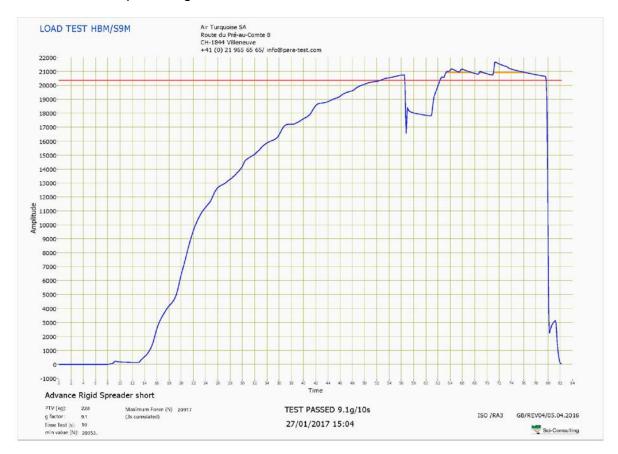
Test 2:

The load has been induced from pilot- and the second passenger attachment to the main attachment point to glider.

Tested successfully, up to 20917 [N] more as 10 seconds
