Harness Structural test Report - NfL

Inspection certificate number: **PH_442.2024**

Name: **Goal**
 Type: **ABS**
 Size: **S/M**
 Serial number: **23184**
 Impact pad type: ⁽¹⁾ **Foam**
 Clip-in weight [kg]: **120**
 Integrated container: **Yes**
 Date of test: **17.01.2024**

model: **Goal**

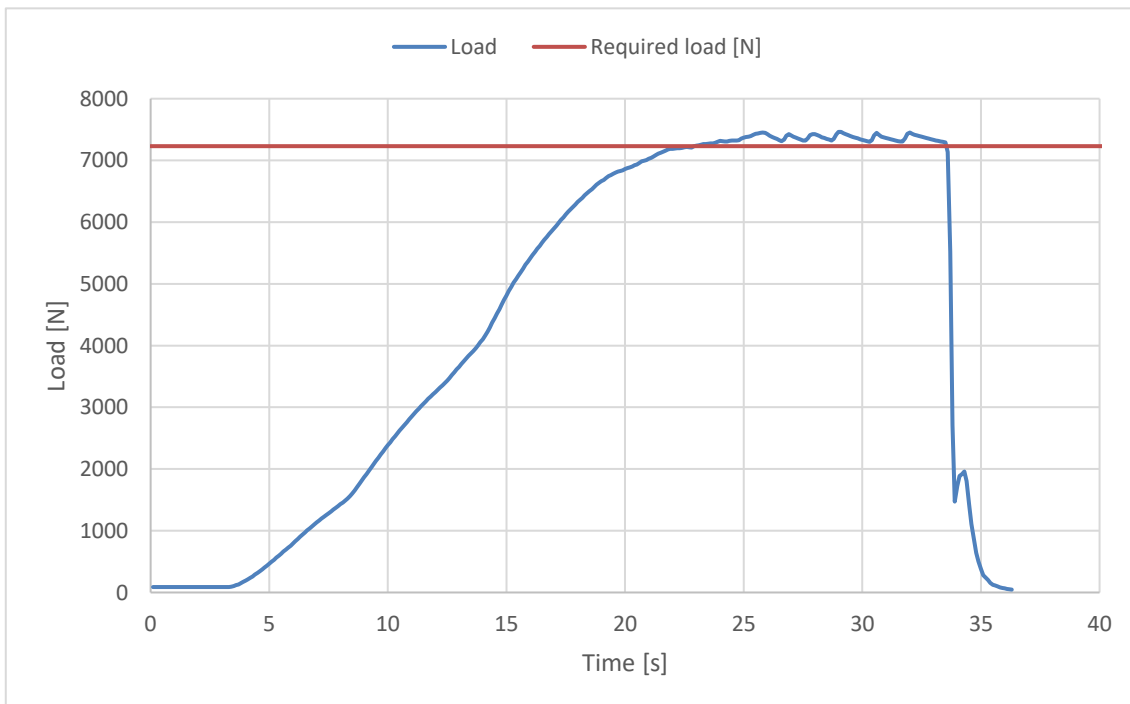
Test ID 02

Standard **EN 1651:1999**
 Reference **5.3.2.1**
 Test setup **Default flying position**
 Attachment points **Both main riser attachment (3,4)**
 Anchor points **Dummy (B1, B2)**

Required load [g] **6**
 Required load [N] **7200**
 Minimum test duration [s] **10**

Test duration [s] **10.6**
 Any signs of structural failure **No**
 Test results **POSITIVE**

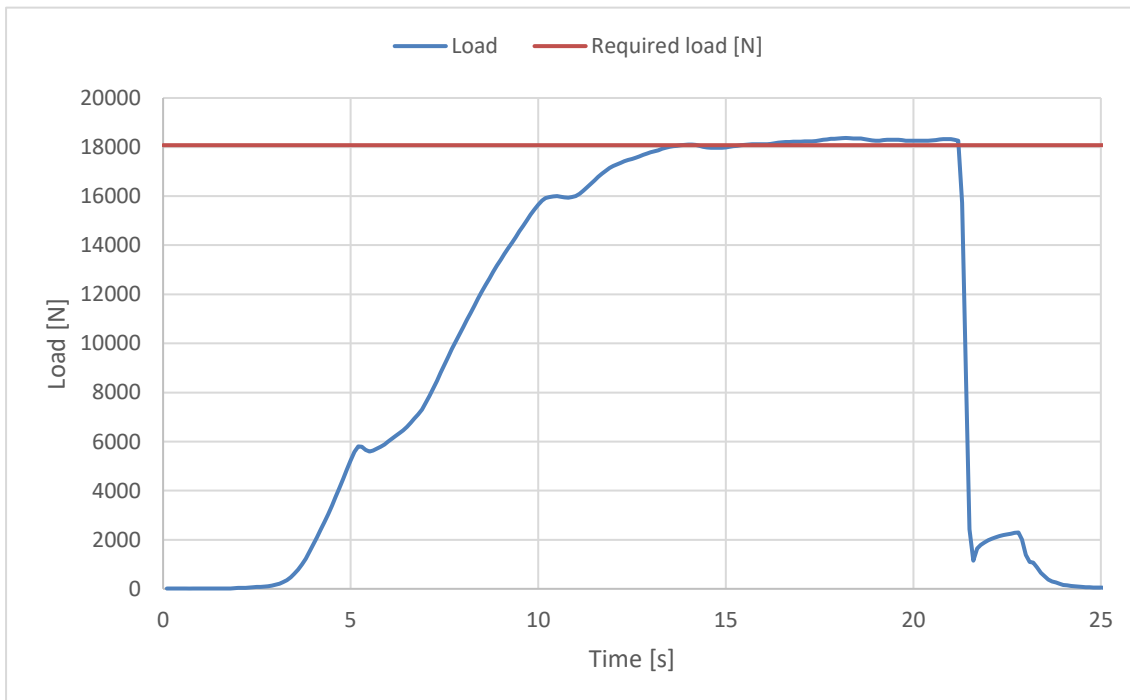
Test ID 03

Standard **EN 1651:1999**
 Reference **5.3.2.2**
 Test setup **Default flying position**
 Attachment points **Both main riser attachment (3,4)**
 Anchor points **Dummy (B1, B2)**

Required load [g] **15**
 Required load [N] **18000**
 Minimum test duration [s] **5**

Test duration [s] **5.8**
 Any signs of structural failure **No**
 Test results **POSITIVE**

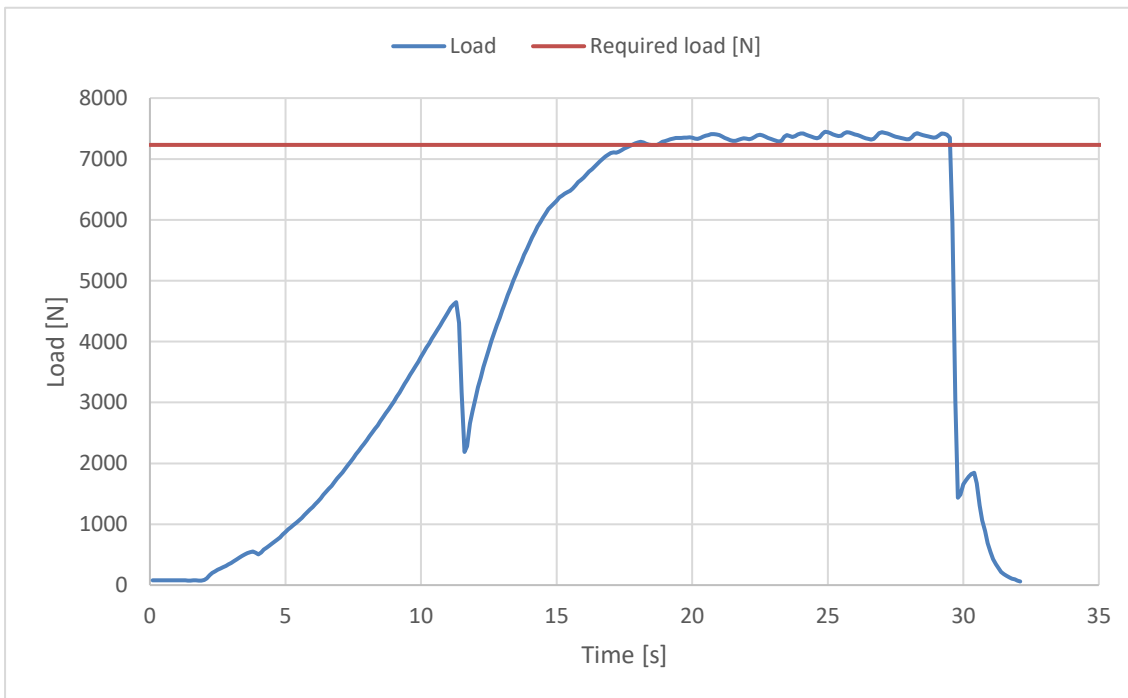
Test ID 04

Standard **EN 1651:1999**
 Reference **5.3.2.3**
 Test setup **Asymmetric, one riser**
 Attachment points **One main riser attachment (3)**
 Anchor points **Dummy (B1,B2)**

Required load [g] **6**
 Required load [N] **7200**
 Minimum test duration [s] **10**

Test duration [s] **10.8**
 Any signs of structural failure **No**
 Test results **POSITIVE**

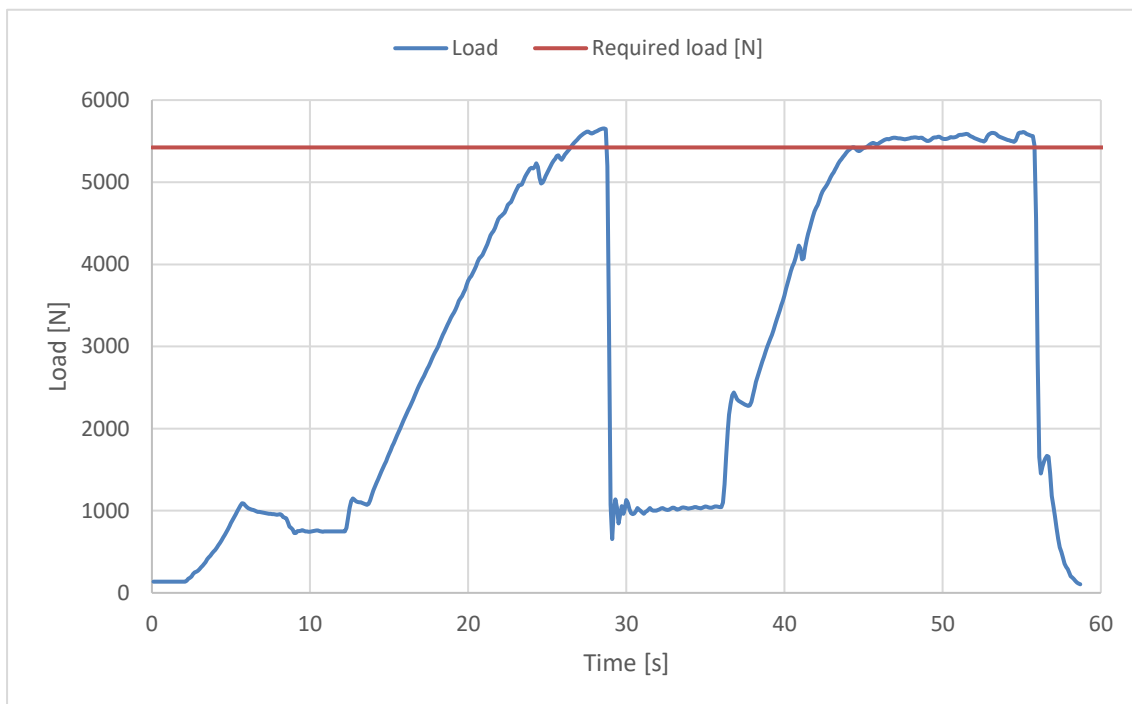
Test ID 07

Standard	EN 1651:1999

Reference	5.3.2.6	
Test setup	Asymmetric, negative	
Attachment points	One main riser attachment (3 or 4) downwards	
Anchor points	Dummy (9)	
Required load [g]	4.5	
Required load [N]	5400	
Minimum test duration [s]	10	
Result		
Test duration [s]	10.7	
Any signs of structural failure	No	
Test results	POSITIVE

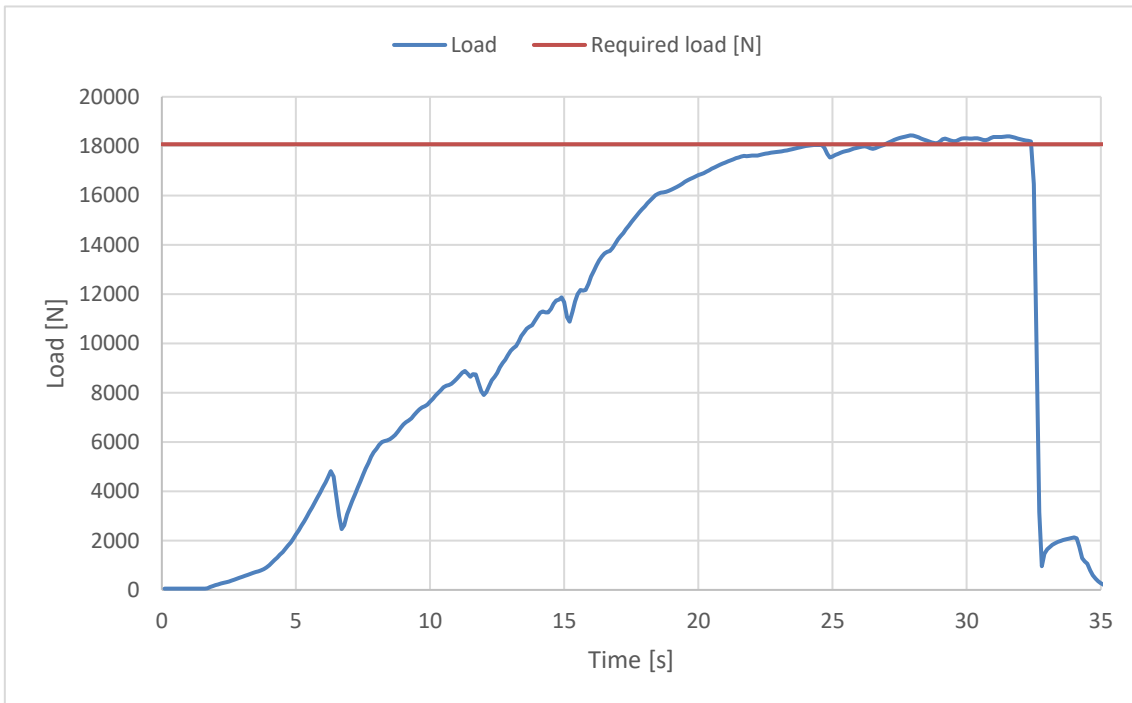
Test ID 09

Standard	EN 1651:1999
Reference	5.3.2.4
Test setup	Rescue attachments
Attachment points	Rescue riser attachment (1,2)
Anchor points	Dummy (B1,B2)
Required load [g]	15
Required load [N]	18000
Minimum test duration [s]	5
Result	
Test duration [s]	5.5
Any signs of structural failure	No
Test results	POSITIVE

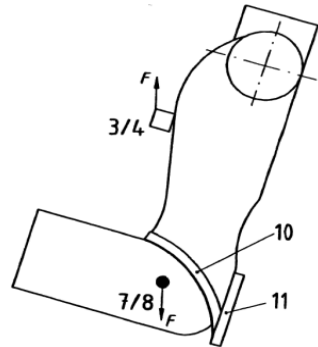
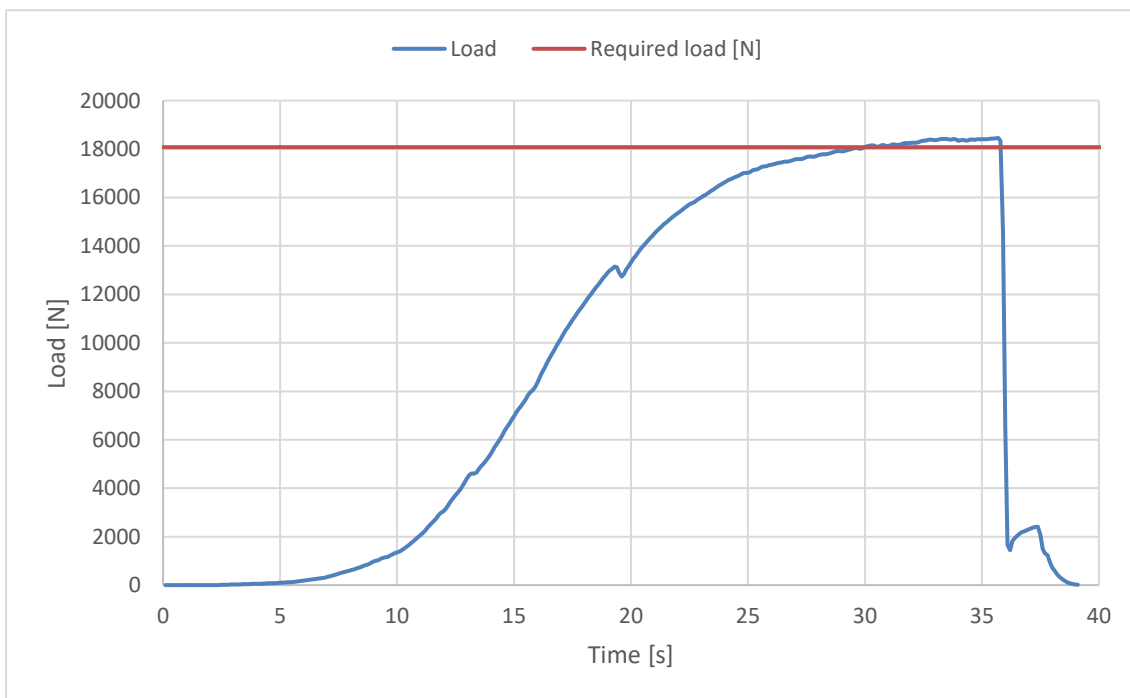
Test ID 13

Standard	EN 1651:1999
Reference	5.3.2.7
Test setup	Flying position before landing
Attachment points	Both main riser attachment (3,4)
Anchor points	Dummy (7,8)
Required load [g]	15
Required load [N]	18000
Minimum test duration [s]	5
Result	
Test duration [s]	5.9
Any signs of structural failure	No
Test results	POSITIVE

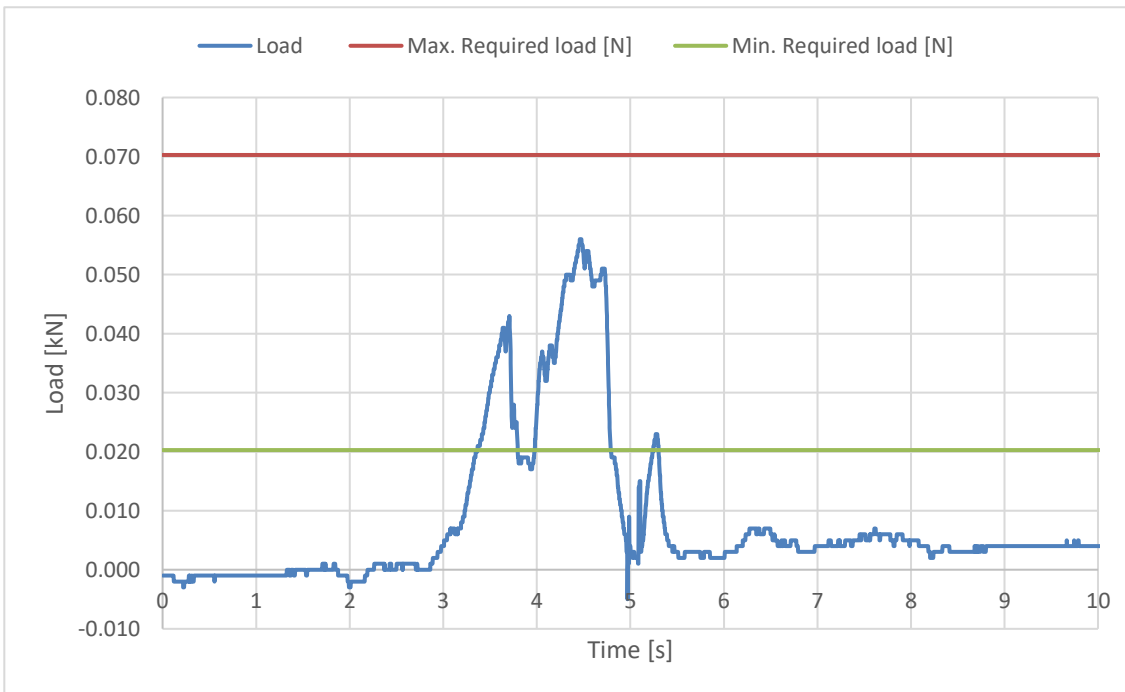
Test ID RRDT

Standard **NfL 2-565-20**
 Reference **6.1.5**
 Test setup **Default flying position**
 Attachment points **Sensor connect to handle, and pull in opening direction**
 The test is to simulate the load required to open the emergency parachute(1st action).

Min. Required load [N] **20**
 Max. Required load [N] **70**

Load for first action [N] **55.71**
 Test results **POSITIVE**

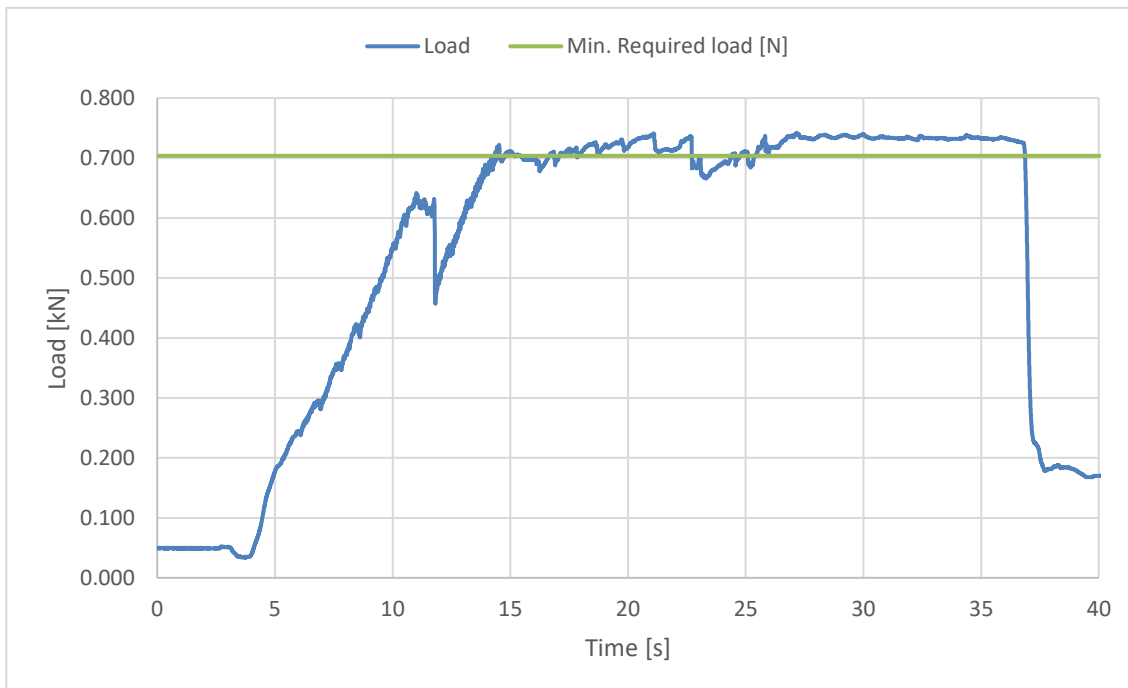
Test ID RRST

Standard	EN 12491
Reference in standard	5.3.2
Test setup	Two end points of handle
Attachment points	Sensor connect to end of handle, pull on the other side
	The handle must support min 700 N for 10 s, after measure breaking strength
Min. Required load [N]	700
Minimum test duration [s]	10
Result	
Test duration [s]:	11.5
Breaking strength [N]	738.19
Test results	POSITIVE
