Harness Structural test Report - NfL

Inspection certificate number: **PH_379.2022**

Name: **Gingo Airlite 5**
 Type: **ABS**
 Size: **M**
 Serial number: **0922-VGA0001M**
 Impact pad type: ⁽¹⁾ **Airbag**
 Clip-in weight [kg]: **120**
 Integrated container: **Yes**
 Date of test: **06.12.2022**

Summary of Structural test

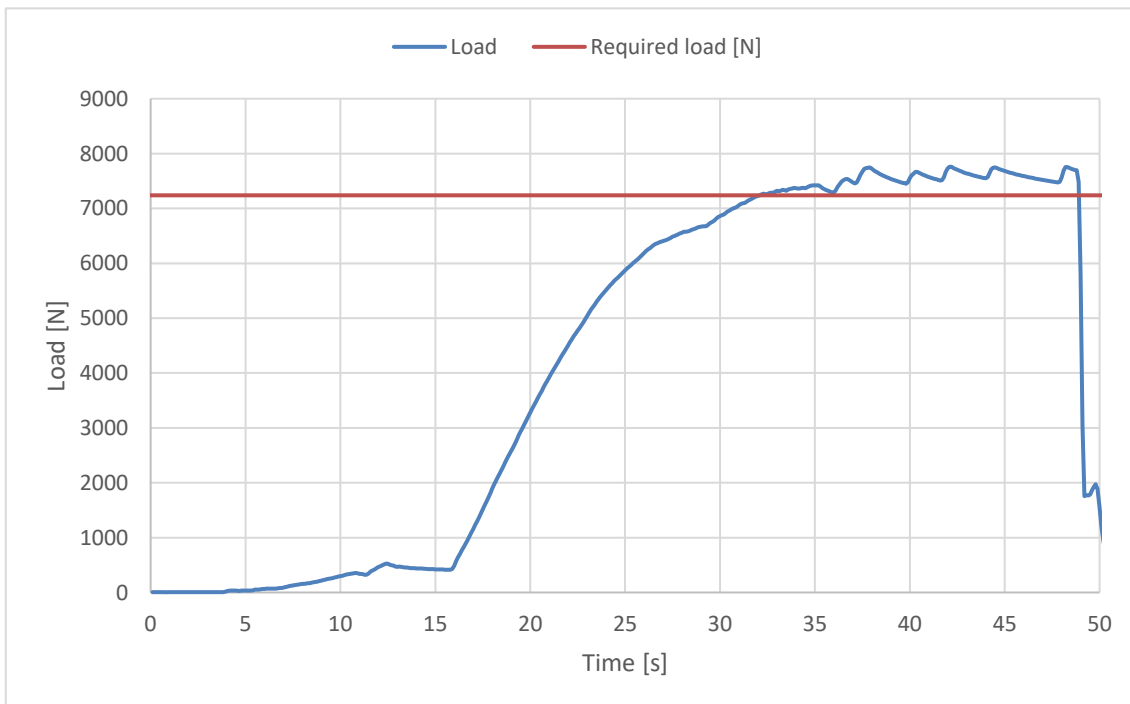
Test ID 02

Standard **EN 1651:1999**
 Reference **5.3.2.1**
 Test setup **Default flying position**
 Attachment points **Both main riser attachment (3,4)**
 Anchor points **Dummy (B1, B2)**

Required load [g] **6**
 Required load [N] **7200**
 Minimum test duration [s] **10**

Test duration [s] **16.9**
 Any signs of structural failure **No**
 Test results **POSITIVE**

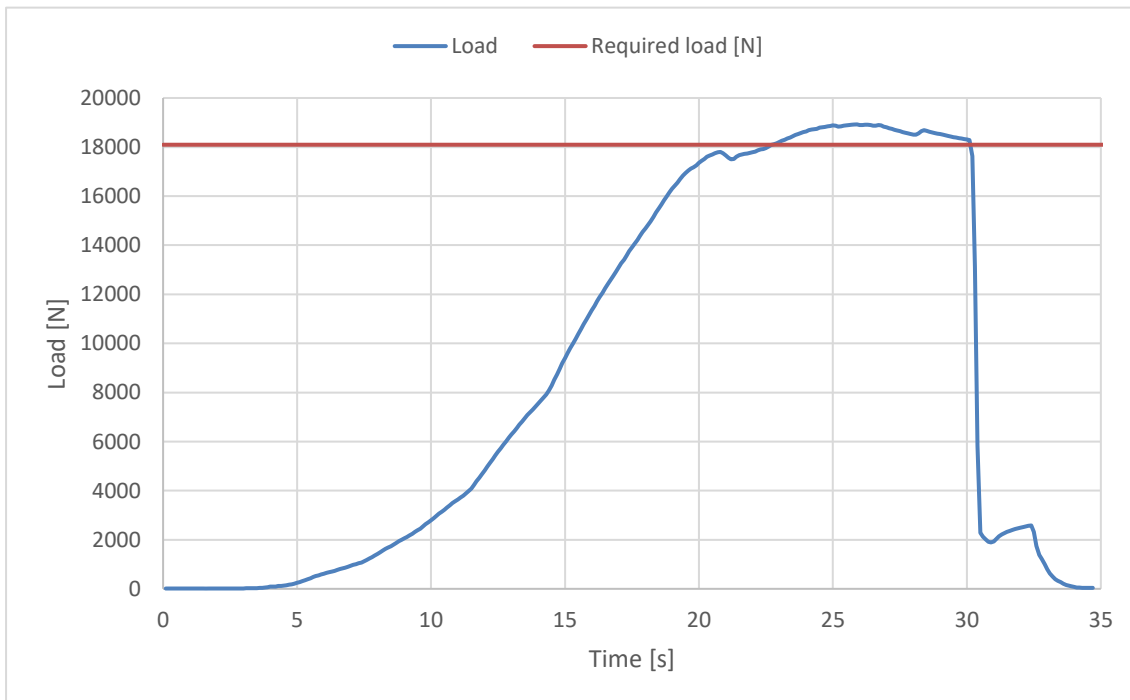
Test ID 03

Standard	EN 1651:1999
Reference	5.3.2.2
Test setup	Default flying position
Attachment points	Both main riser attachment (3,4)
Anchor points	Dummy (B1, B2)
Required load [g]	15
Required load [N]	18000
Minimum test duration [s]	5
Result	
Test duration [s]	7.4
Any signs of structural failure	No
Test results	POSITIVE

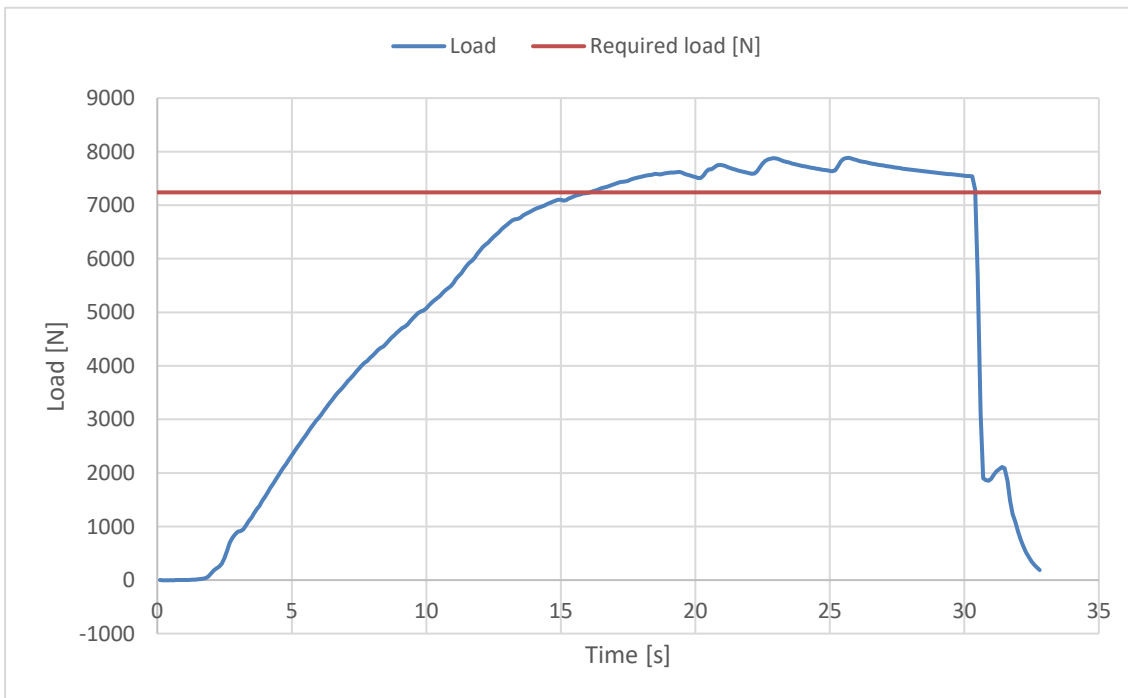
Test ID 04

Reference	5.3.2.3	
Test setup	Asymmetric, one riser	
Attachment points	One main riser attachment (3)	
Anchor points	Dummy (B1,B2)	
Required load [g]	6	
Required load [N]	7200	
Minimum test duration [s]	10	
Result		
Test duration [s]	14.4	
Any signs of structural failure	No	
Test results	POSITIVE

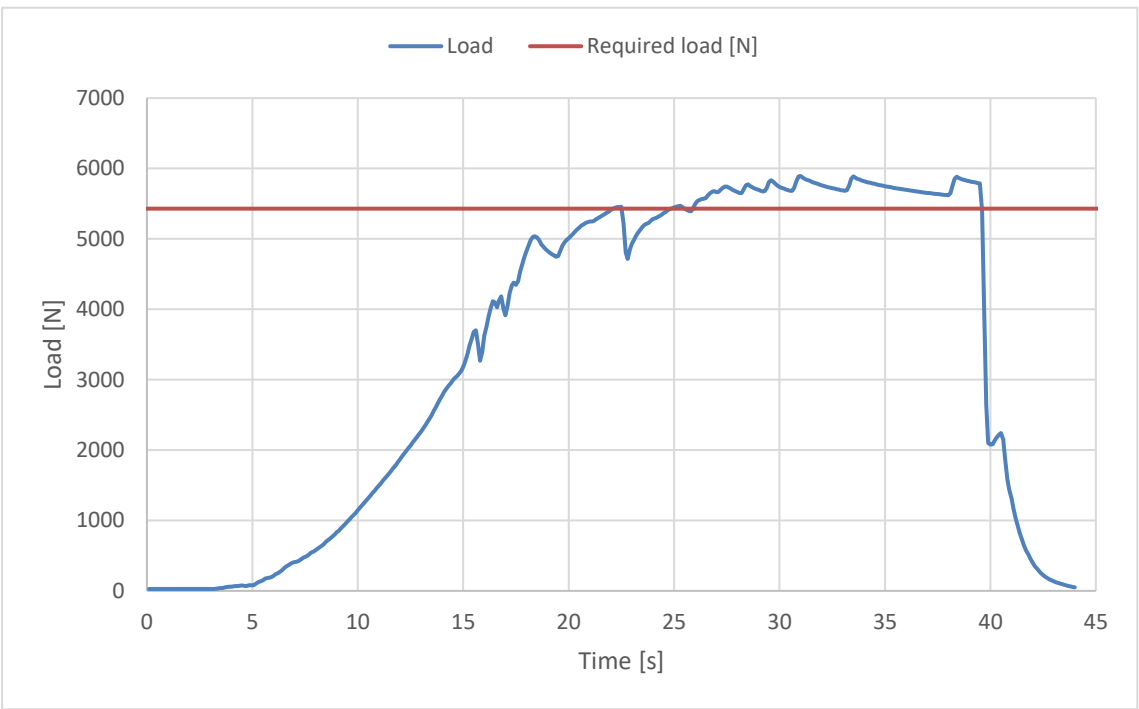
Test ID 07

Reference	5.3.2.6	
Test setup	Asymmetric, negative	
Attachment points	One main riser attachment (3 or 4) downwards	
Anchor points	Dummy (9)	
Required load [g]	4.5	
Required load [N]	5400	
Minimum test duration [s]	10	
Result		
Test duration [s]	13.7	
Any signs of structural failure	No	
Test results	POSITIVE

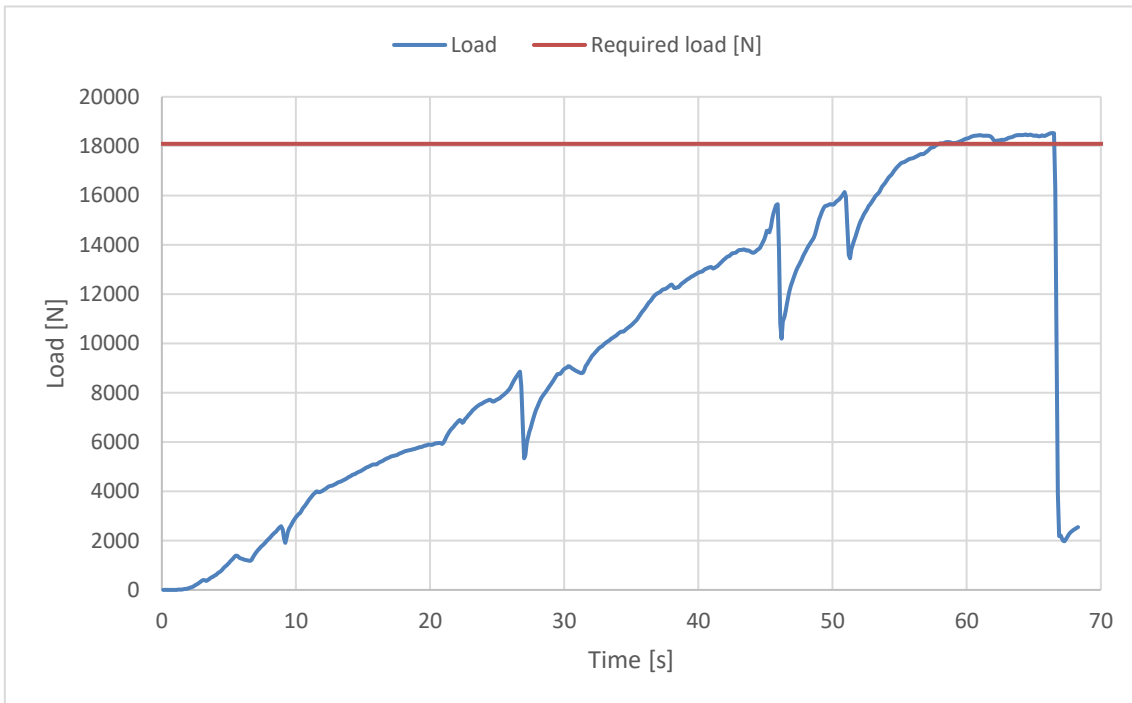
Test ID 09

Reference	5.3.2.4	
Test setup	Rescue attachments	
Attachment points	Rescue riser attachment (1,2)	
Anchor points	Dummy (B1,B2)	
Required load [g]	15	
Required load [N]	18000	
Minimum test duration [s]	5	
Result		
Test duration [s]	8.6	
Any signs of structural failure	No	
Test results	POSITIVE

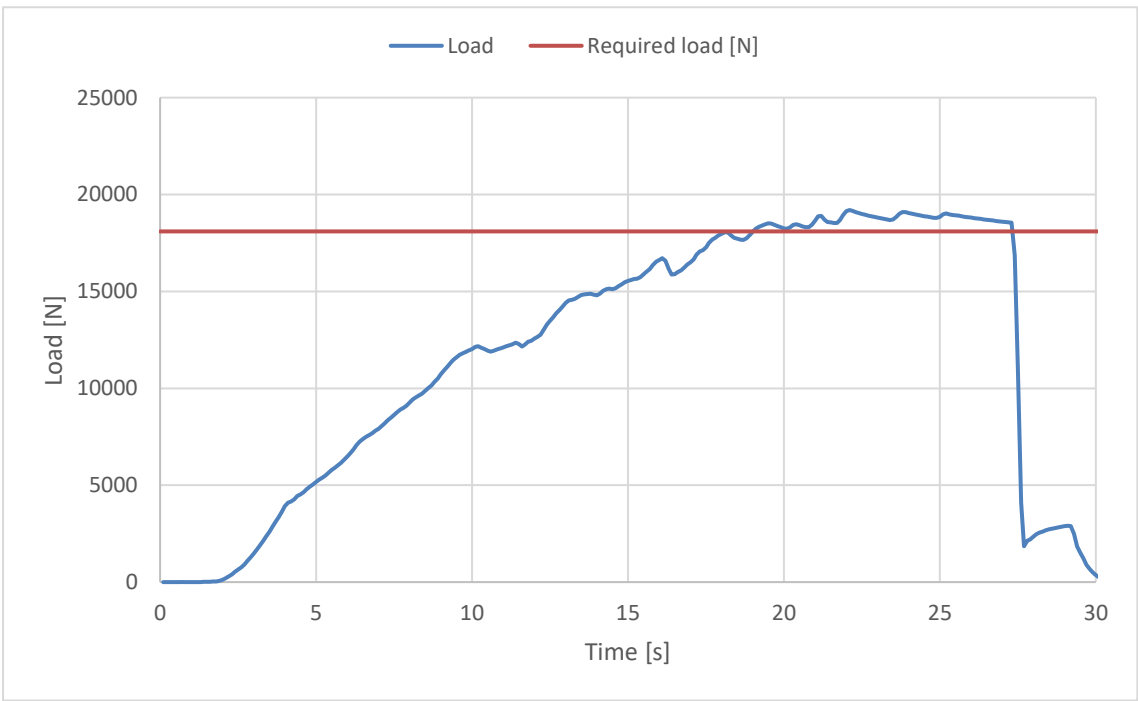
Test ID 13

Standard	EN 1651:1999
Reference	5.3.2.7
Test setup	Flying position before landing
Attachment points	Both main riser attachment (3,4)
Anchor points	Dummy (7,8)
Required load [g]	15
Required load [N]	18000
Minimum test duration [s]	5
Result	
Test duration [s]	8.3
Any signs of structural failure	No
Test results	POSITIVE

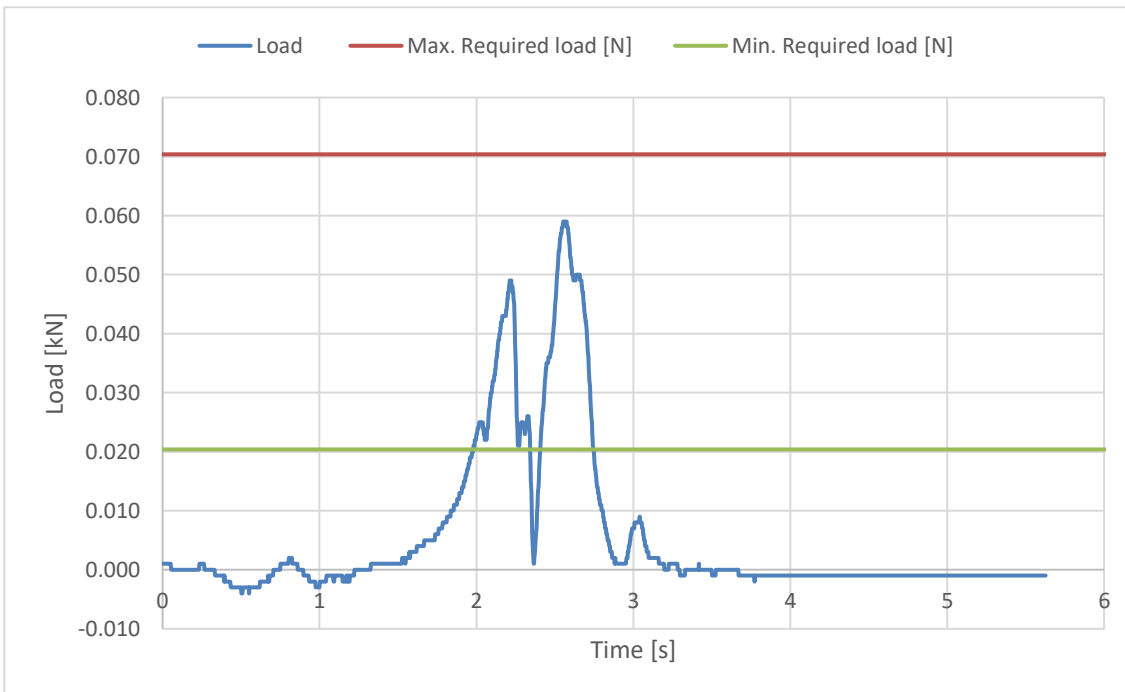
Test ID RRDT

Standard **NfL 2-565-20**
 Reference **6.1.5**
 Test setup **Default flying position**
 Attachment points **Sensor connect to handle, and pull in opening direction**
 The test is to simulate the load required to open the emergency parachute(1st action).

Min. Required load [N] **20**
 Max. Required load [N] **70**

Load for first action [N] **58.61**
 Test results **POSITIVE**

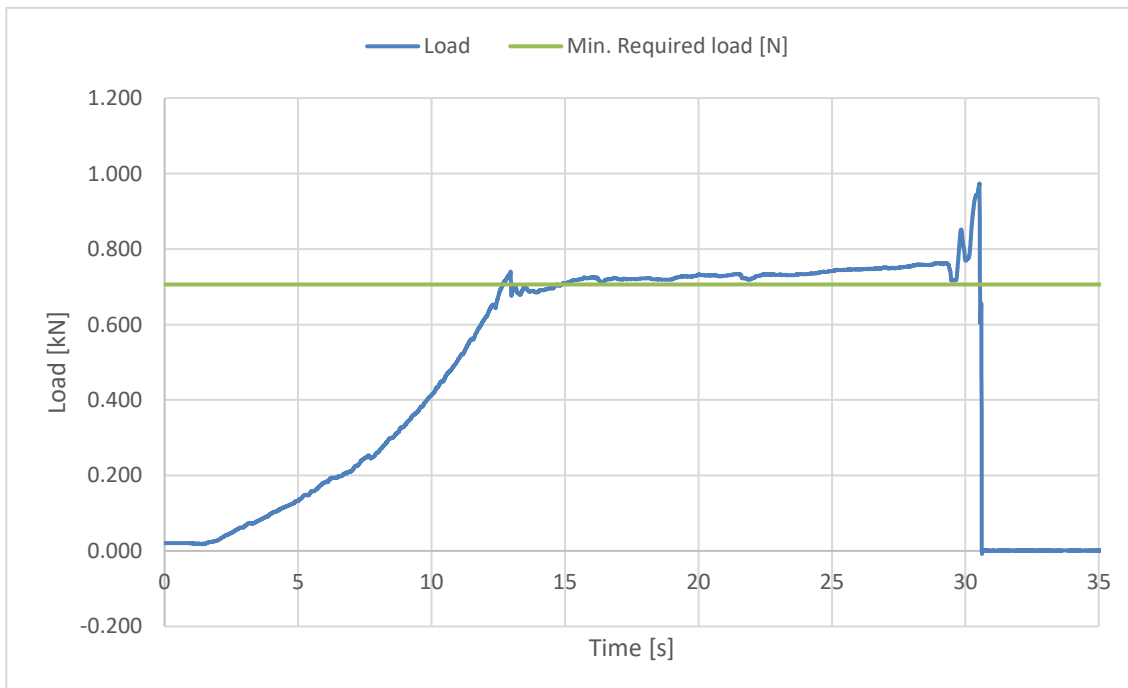
Test ID RRST

Standard	EN 12491
Reference in standard	5.3.2
Test setup	Two end points of handle
Attachment points	Sensor connect to end of handle, pull on the other side
	The handle must support min 700 N for 10 s, after measure breaking strength
Min. Required load [N]	700
Minimum test duration [s]	10
Result	
Test duration [s]:	15.7
Breaking strength [N]	966.54
Test results	POSITIVE
