Harness Structural test Report - NfL

Inspection certificate number: **PH_416.2023**

Name: **Puma**
 Type: **ABS**
 Size: **L**
 Serial number: **02.L.07.2023-BL**
 Impact pad type: ⁽¹⁾ **Inflatable**
 Clip-in weight [kg]: **120**
 Integrated container: **Yes**
 Date of test: **17.08.2023**

Summary of Structural test

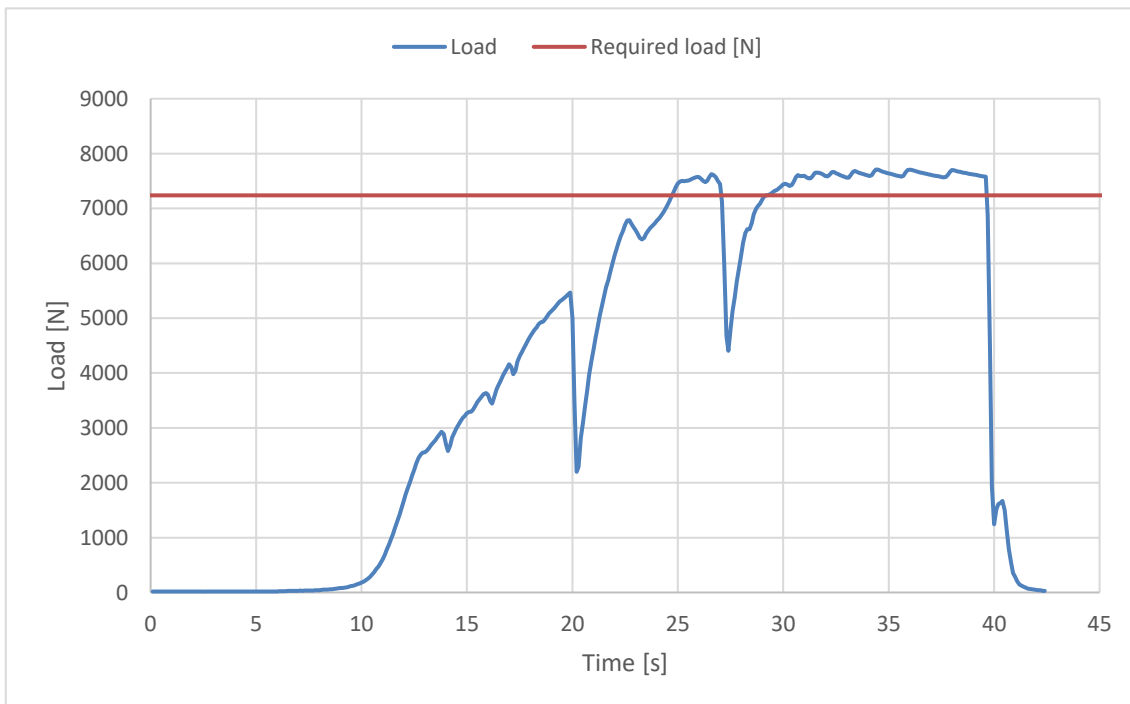
Test ID 02

Standard **EN 1651:1999**
 Reference **5.3.2.1**
 Test setup **Default flying position**
 Attachment points **Both main riser attachment (3,4)**
 Anchor points **Dummy (B1, B2)**

Required load [g] **6**
 Required load [N] **7200**
 Minimum test duration [s] **10**

Test duration [s] **10.5**
 Any signs of structural failure **No**
 Test results **POSITIVE**

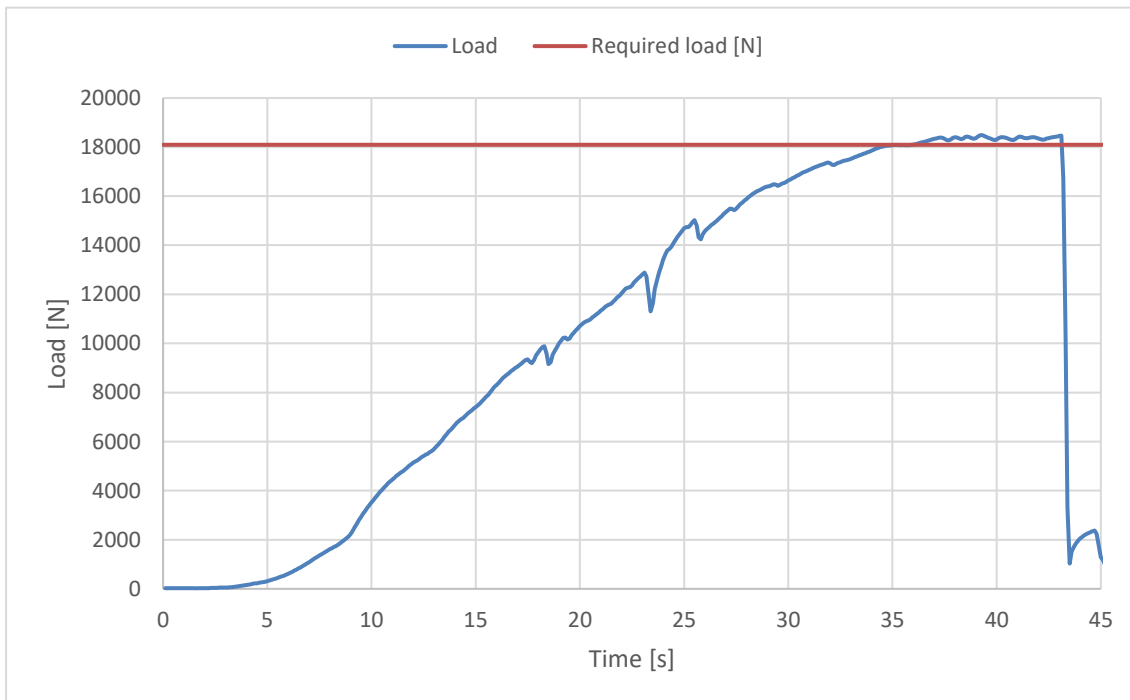
Test ID 03

Standard **EN 1651:1999**
 Reference **5.3.2.2**
 Test setup **Default flying position**
 Attachment points **Both main riser attachment (3,4)**
 Anchor points **Dummy (B1, B2)**

Required load [g] **15**
 Required load [N] **18000**
 Minimum test duration [s] **5**

Test duration [s] **7.2**
 Any signs of structural failure **No**
 Test results **POSITIVE**

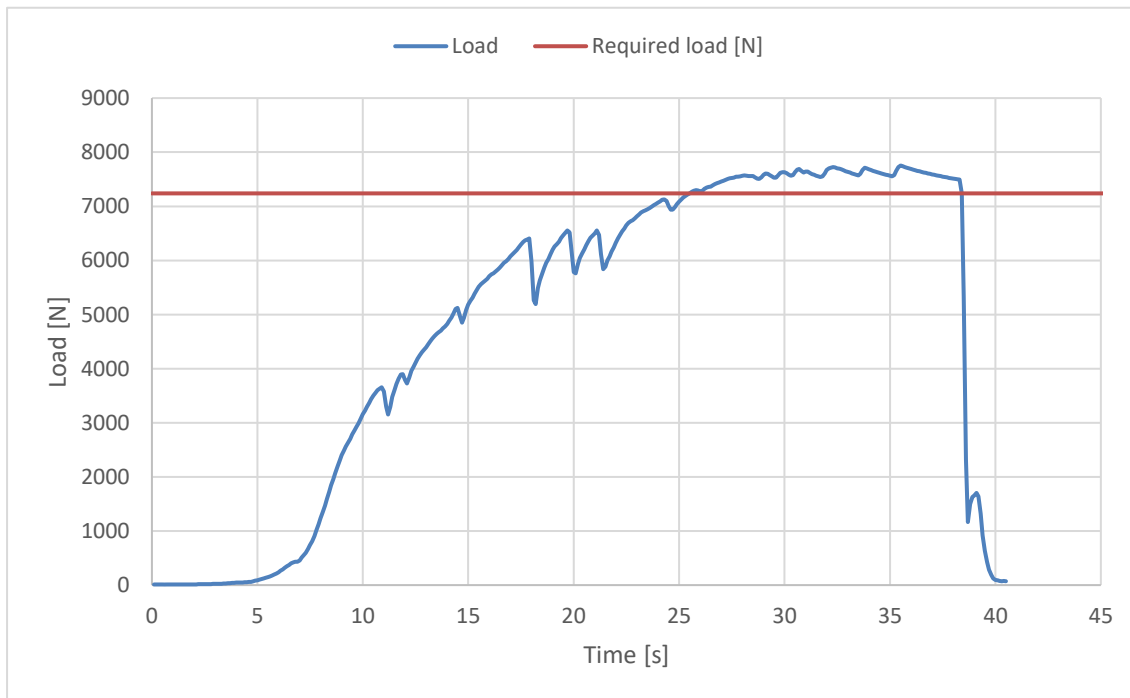
Test ID 04

Standard **EN 1651:1999**
 Reference **5.3.2.3**
 Test setup **Asymmetric, one riser**
 Attachment points **One main riser attachment (3)**
 Anchor points **Dummy (B1,B2)**

Required load [g] **6**
 Required load [N] **7200**
 Minimum test duration [s] **10**

Test duration [s] **13**
 Any signs of structural failure **No**
 Test results **POSITIVE**

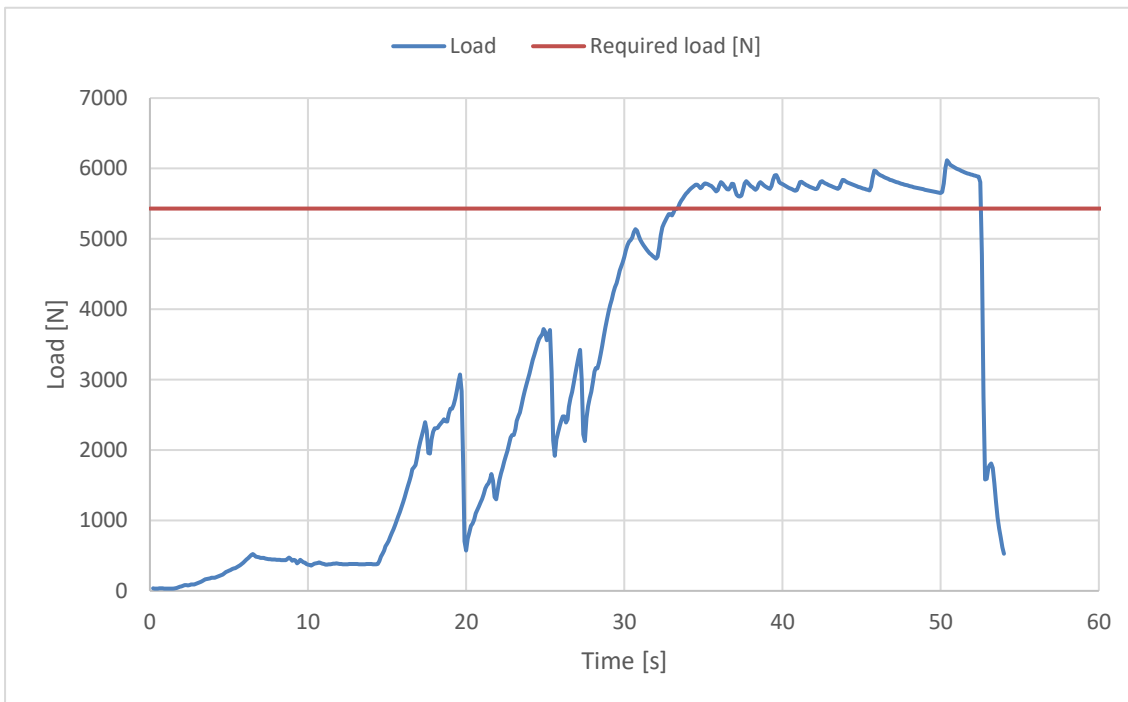
Test ID 07

Standard	EN 1651:1999
Reference	5.3.2.6
Test setup	Asymmetric, negative
Attachment points	One main riser attachment (3 or 4) downwards
Anchor points	Dummy (9)
Required load [g]	4.5
Required load [N]	5400
Minimum test duration [s]	10
Result	
Test duration [s]	19.2
Any signs of structural failure	No
Test results	POSITIVE

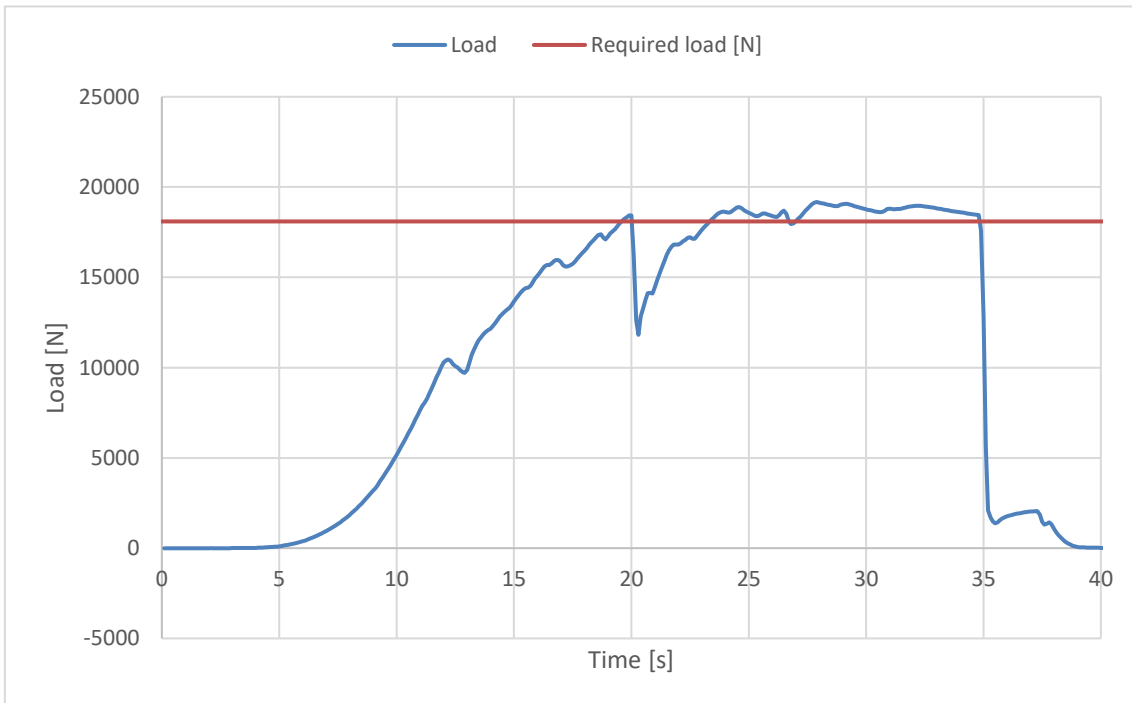
Test ID 09

Standard	EN 1651:1999

Reference	5.3.2.4	
Test setup	Rescue attachments	
Attachment points	Rescue riser attachment (1,2)	
Anchor points	Dummy (B1,B2)	
Required load [g]	15	
Required load [N]	18000	
Minimum test duration [s]	5	
Result		
Test duration [s]	7.8	
Any signs of structural failure	No	
Test results	POSITIVE

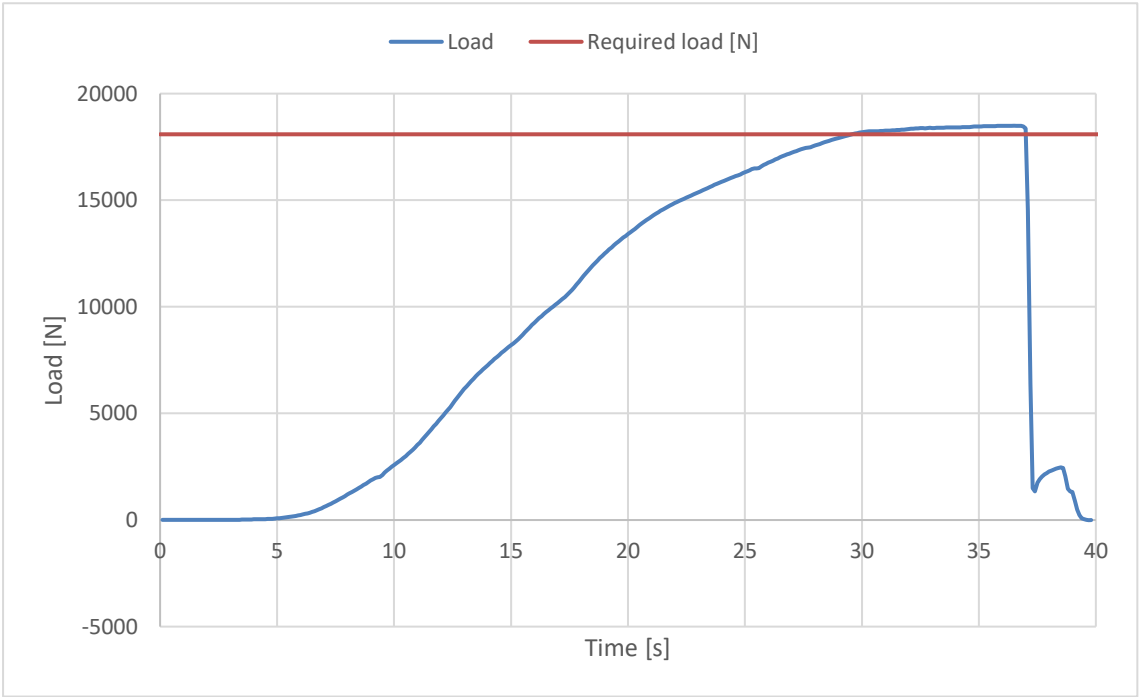
Test ID 13

Standard	EN 1651:1999
Reference	5.3.2.7
Test setup	Flying position before landing
Attachment points	Both main riser attachment (3,4)
Anchor points	Dummy (7,8)
Required load [g]	15
Required load [N]	18000
Minimum test duration [s]	5
Result	
Test duration [s]	7.5
Any signs of structural failure	No
Test results	POSITIVE

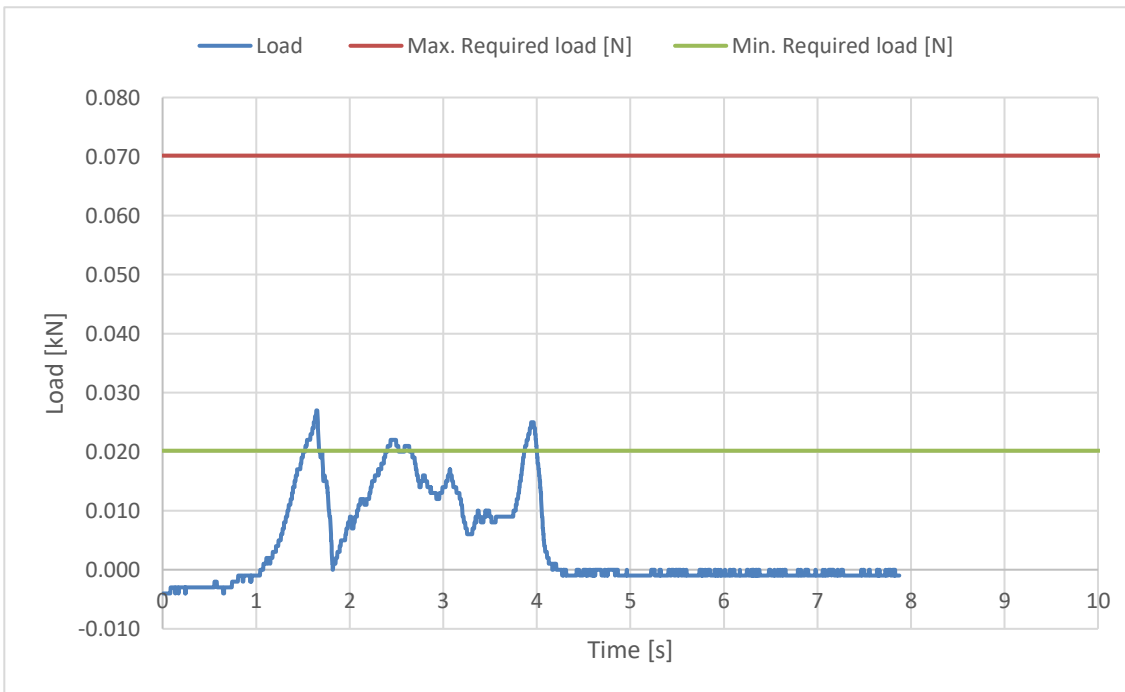
Test ID RRDT

Standard	NfL 2-565-20
Reference	6.1.5
Test setup	Default flying position
Attachment points	Sensor connect to handle, and pull in opening direction
	The test is to simulate the load required to open the emergency parachute(1st action).
Min. Required load [N]	20
Max. Required load [N]	70
Result	
Load for first action [N]	26.82
Test results	POSITIVE

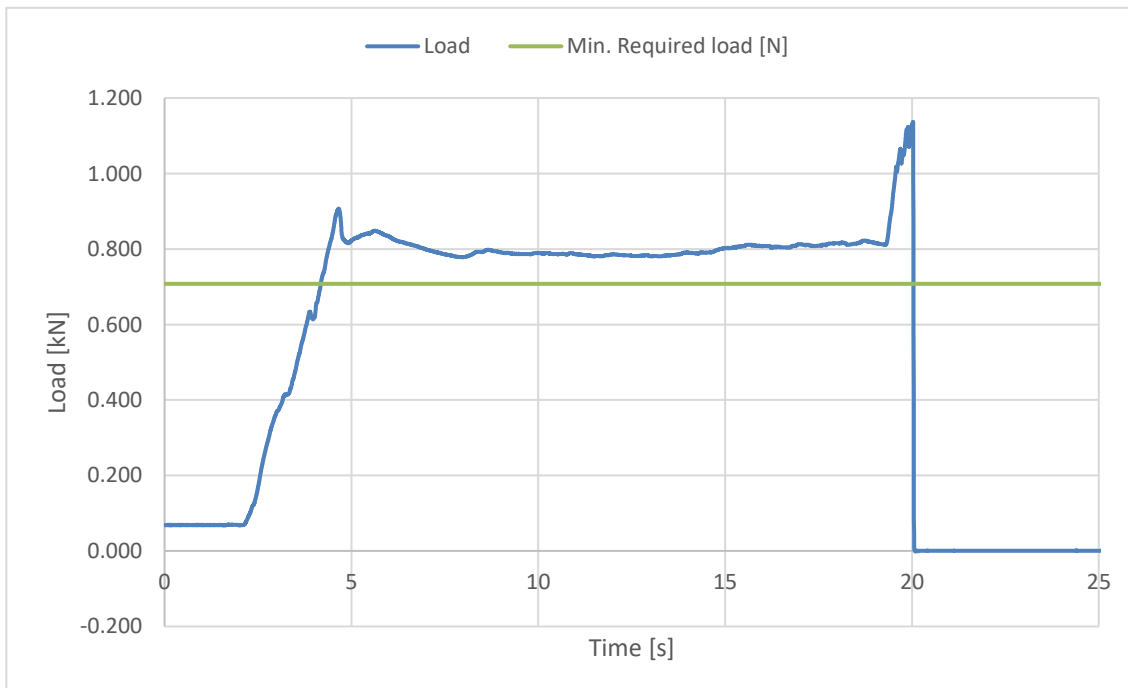
Test ID RRST

Standard	EN 12491
Reference in standard	5.3.2
Test setup	Two end points of handle
Attachment points	Sensor connect to end of handle, pull on the other side
	The handle must support min 700 N for 10 s, after measure breaking strength
Min. Required load [N]	700
Minimum test duration [s]	10
Result	
Test duration [s]:	15.9
Breaking strength [N]	1129.45
Test results	POSITIVE
