Harness Structural test Report - NfL

Inspection certificate number: **PH_406.2023**

Name: **ATACMS**
 Type: **ABS**
 Size: **L**
 Serial number: **1**
 Impact pad type: ⁽¹⁾ **Foam**
 Clip-in weight [kg]: **100**
 Integrated container: **Yes**
 Date of test: **17.05.2023**

Summary of Structural test

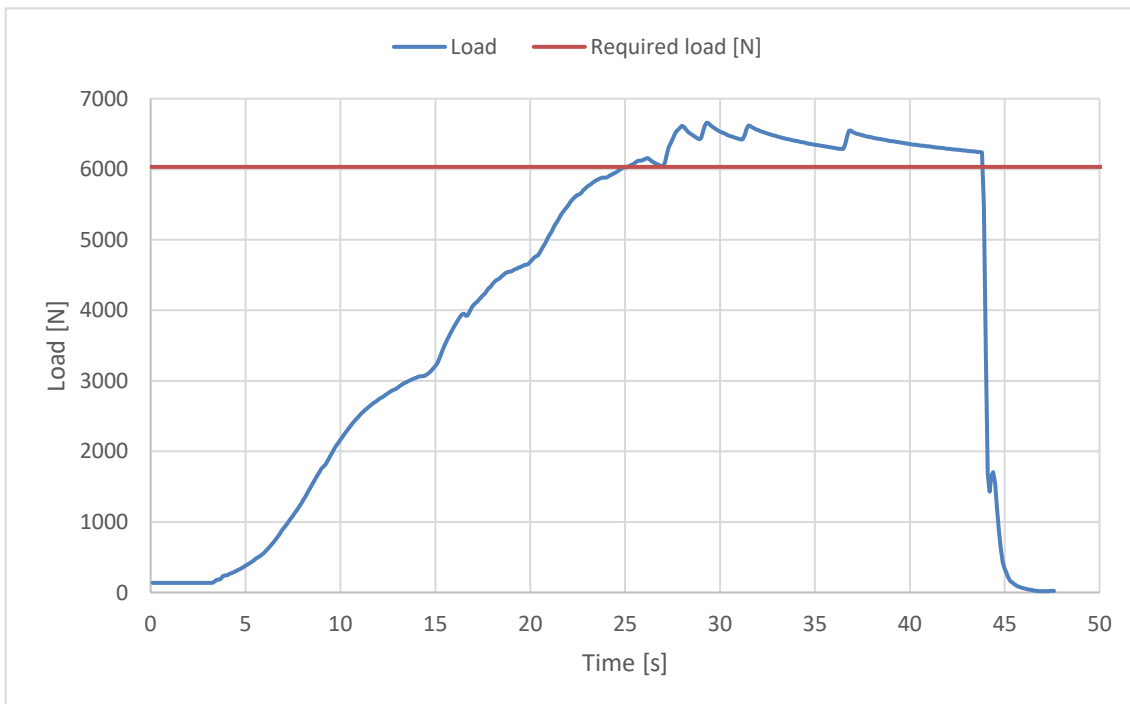
Test ID 02

Standard	EN 1651:1999
Reference	5.3.2.1
Test setup	Default flying position
Attachment points	Both main riser attachment (3,4)
Anchor points	Dummy (B1, B2)
Required load [g]	6
Required load [N]	6000
Minimum test duration [s]	10
Result	
Test duration [s]	18.7
Any signs of structural failure	No
Test results	POSITIVE

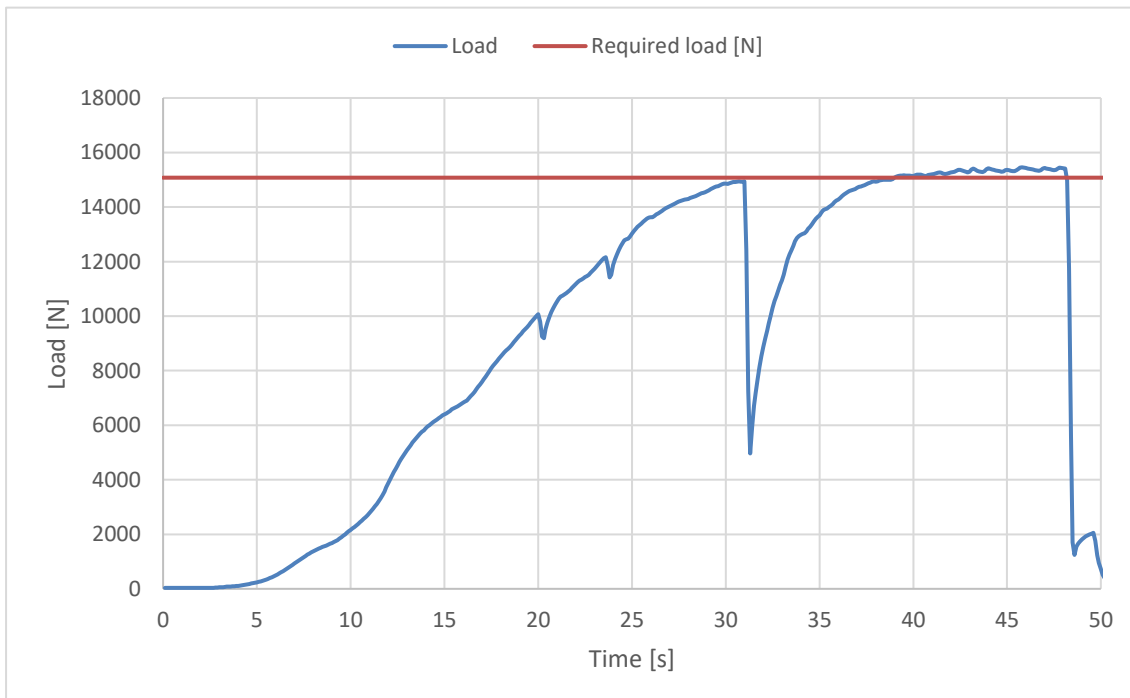
Test ID 03

Standard	EN 1651:1999
Reference	5.3.2.2
Test setup	Default flying position
Attachment points	Both main riser attachment (3,4)
Anchor points	Dummy (B1, B2)
Required load [g]	15
Required load [N]	15000
Minimum test duration [s]	5
Result	
Test duration [s]	9.2
Any signs of structural failure	No
Test results	POSITIVE

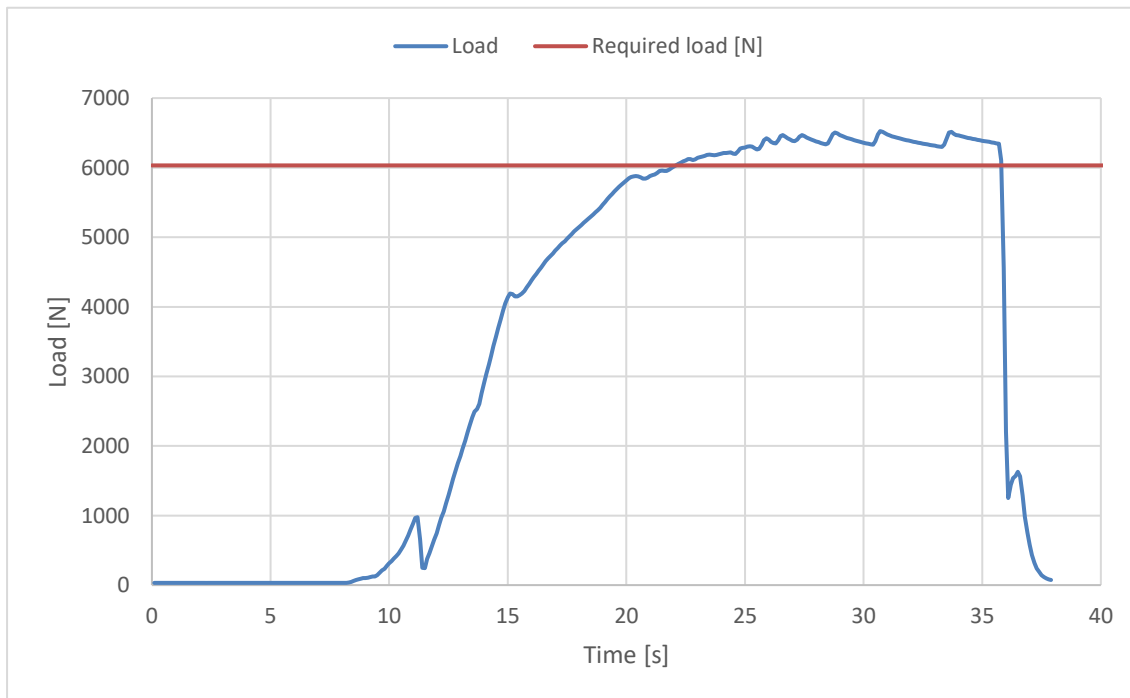
Test ID 04

Standard	EN 1651:1999
Reference	5.3.2.3
Test setup	Asymmetric, one riser
Attachment points	One main riser attachment (3)
Anchor points	Dummy (B1,B2)
Required load [g]	6
Required load [N]	6000
Minimum test duration [s]	10
Result	
Test duration [s]	13.8
Any signs of structural failure	No
Test results	POSITIVE

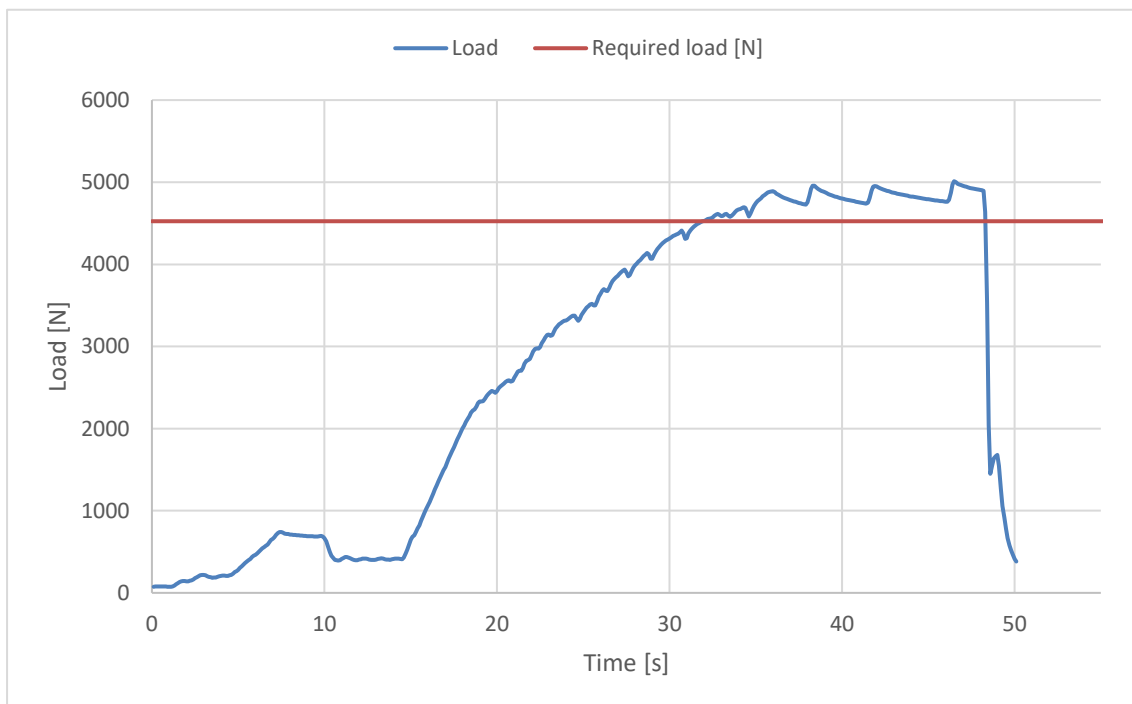
Test ID 07

Standard	EN 1651:1999
Reference	5.3.2.6
Test setup	Asymmetric, negative
Attachment points	One main riser attachment (3 or 4) downwards
Anchor points	Dummy (9)
Required load [g]	4.5
Required load [N]	4500
Minimum test duration [s]	10
Result	
Test duration [s]	16.5
Any signs of structural failure	No
Test results	POSITIVE

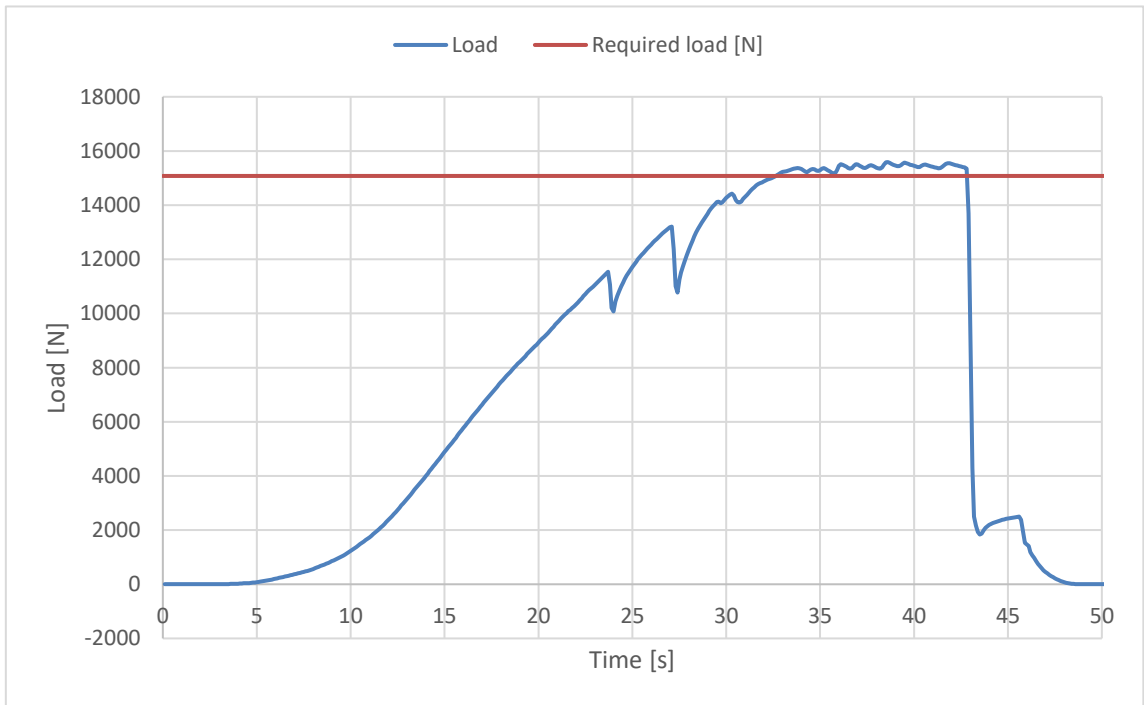
Test ID 09

Standard	EN 1651:1999
Reference	5.3.2.4
Test setup	Rescue attachments
Attachment points	Rescue riser attachment (1,2)
Anchor points	Dummy (B1,B2)
Required load [g]	15
Required load [N]	15000
Minimum test duration [s]	5
Result	
Test duration [s]	10.2
Any signs of structural failure	No
Test results	POSITIVE

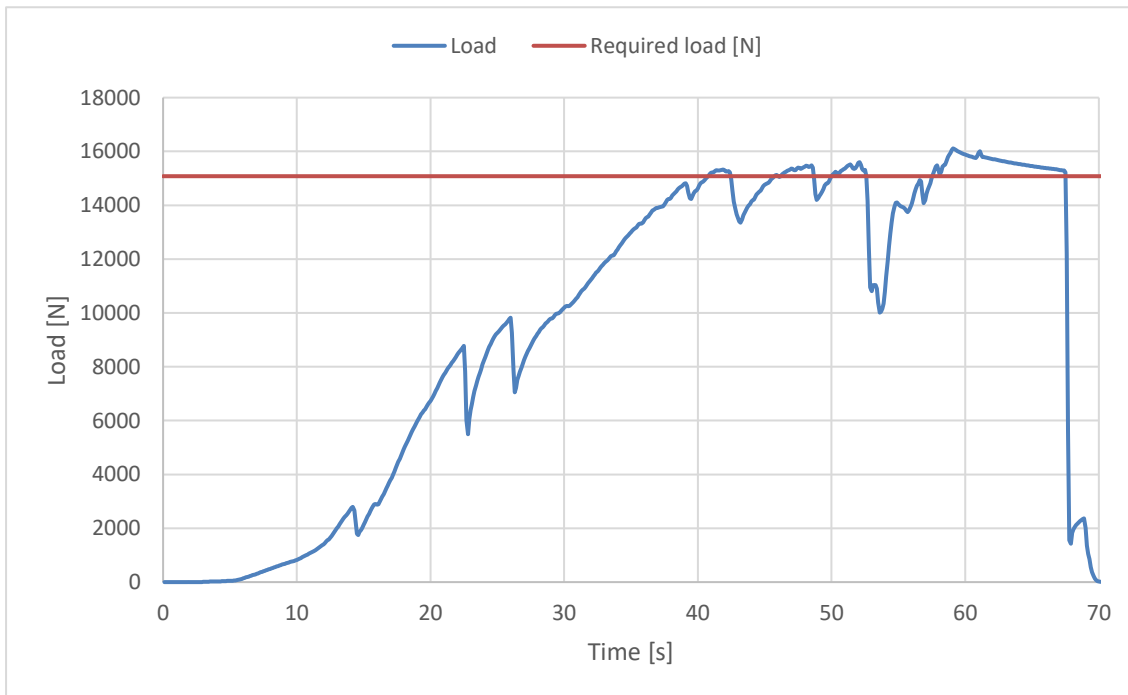
Test ID 13

Standard **EN 1651:1999**
 Reference **5.3.2.7**
 Test setup **Flying position before landing**
 Attachment points **Both main riser attachment (3,4)**
 Anchor points **Dummy (7,8)**

Required load [g] **15**
 Required load [N] **15000**
 Minimum test duration [s] **5**

Test duration [s] **10**
 Any signs of structural failure **No**
 Test results **POSITIVE**

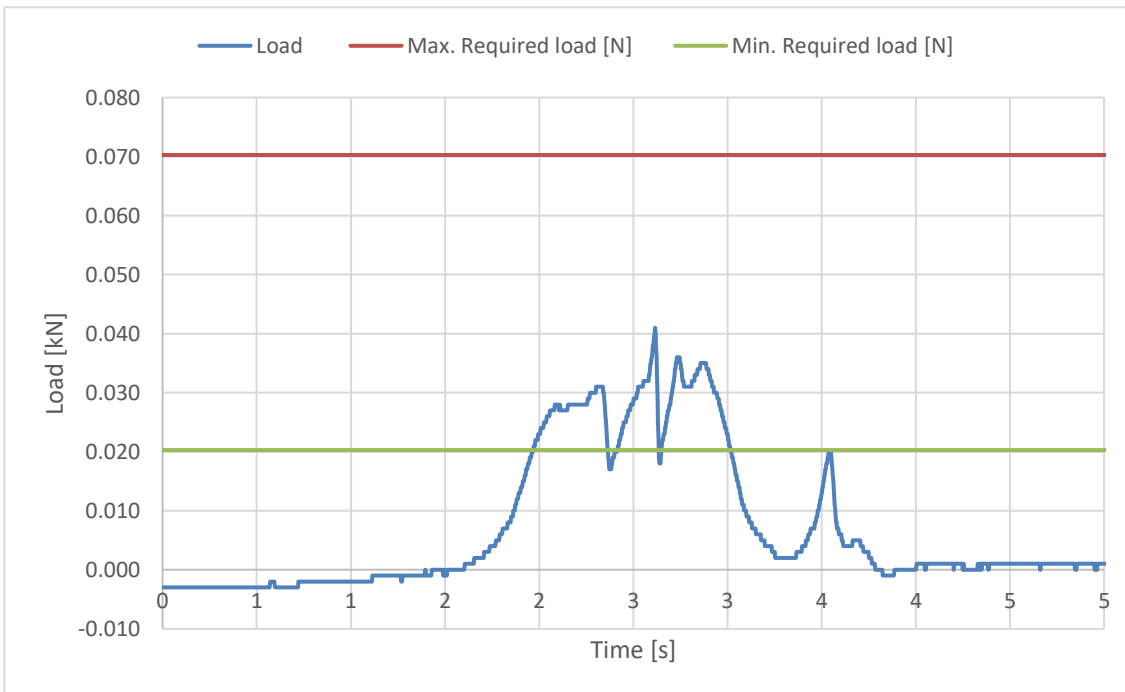
Test ID RRDT

Standard	NfL 2-565-20
Reference	6.1.5
Test setup	Default flying position
Attachment points	Sensor connect to handle, and pull in opening direction
	The test is to simulate the load required to open the emergency parachute(1st action).
Min. Required load [N]	20
Max. Required load [N]	70
Result	
Load for first action [N]	40.73
Test results	POSITIVE

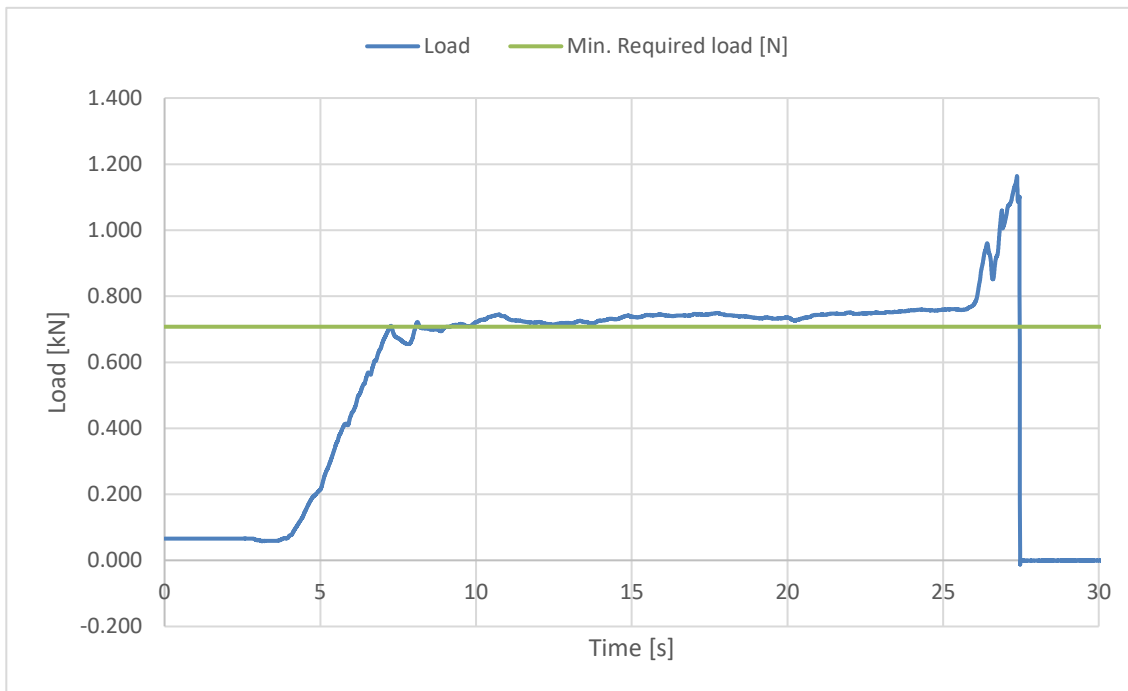
Test ID RRST

Standard	EN 12491
Reference in standard	5.3.2
Test setup	Two end points of handle
Attachment points	Sensor connect to end of handle, pull on the other side
	The handle must support min 700 N for 10 s, after measure breaking strength
Min. Required load [N]	700
Minimum test duration [s]	10
Result	
Test duration [s]:	18.3
Breaking strength [N]	1156.27
Test results	POSITIVE
